Inspection Photos

API: 009-06441

Operator: INVESTMENT EQUIPMENT LLC

Inspection Date: 1/10/2023

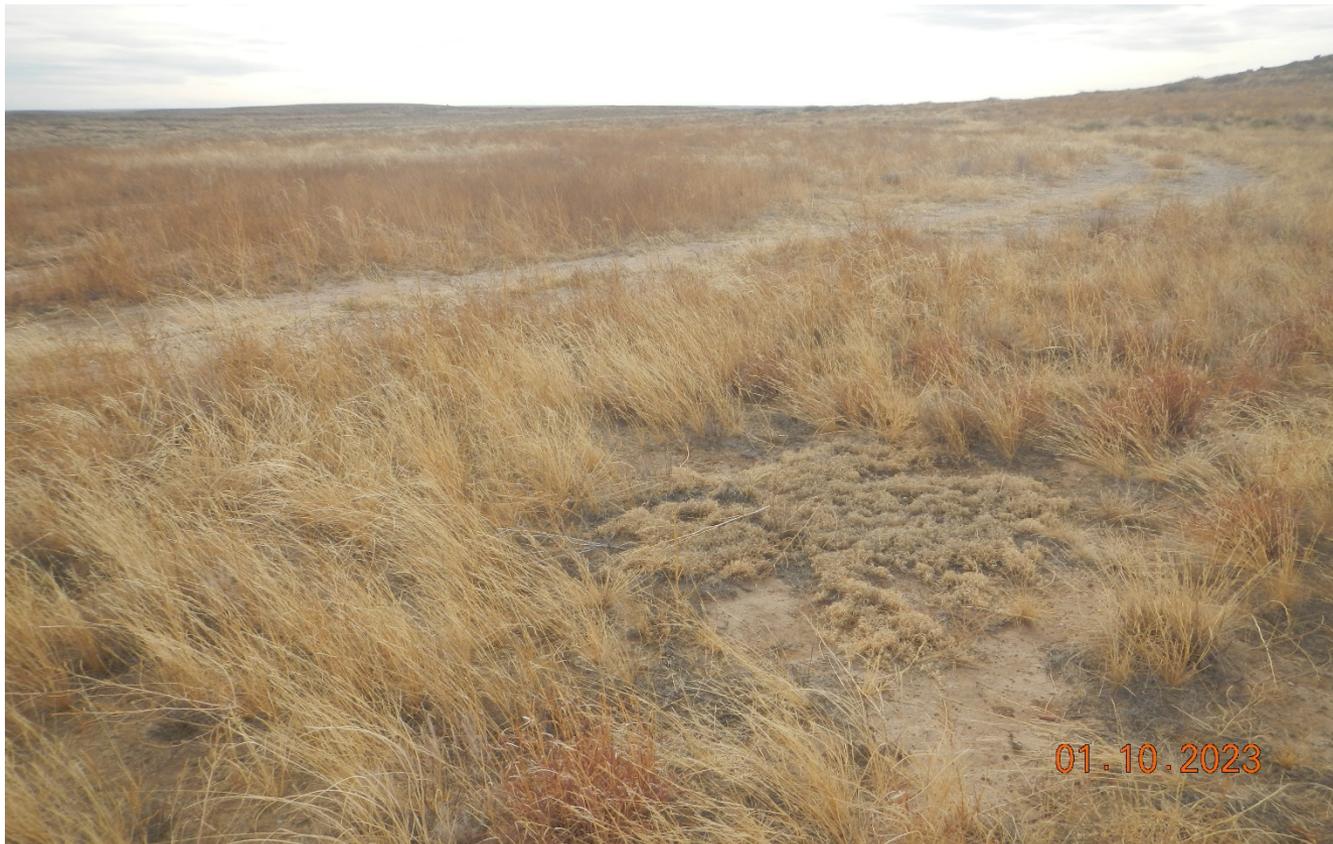
Photo 1. Facing southeast toward the location. The access road continues thru the location.

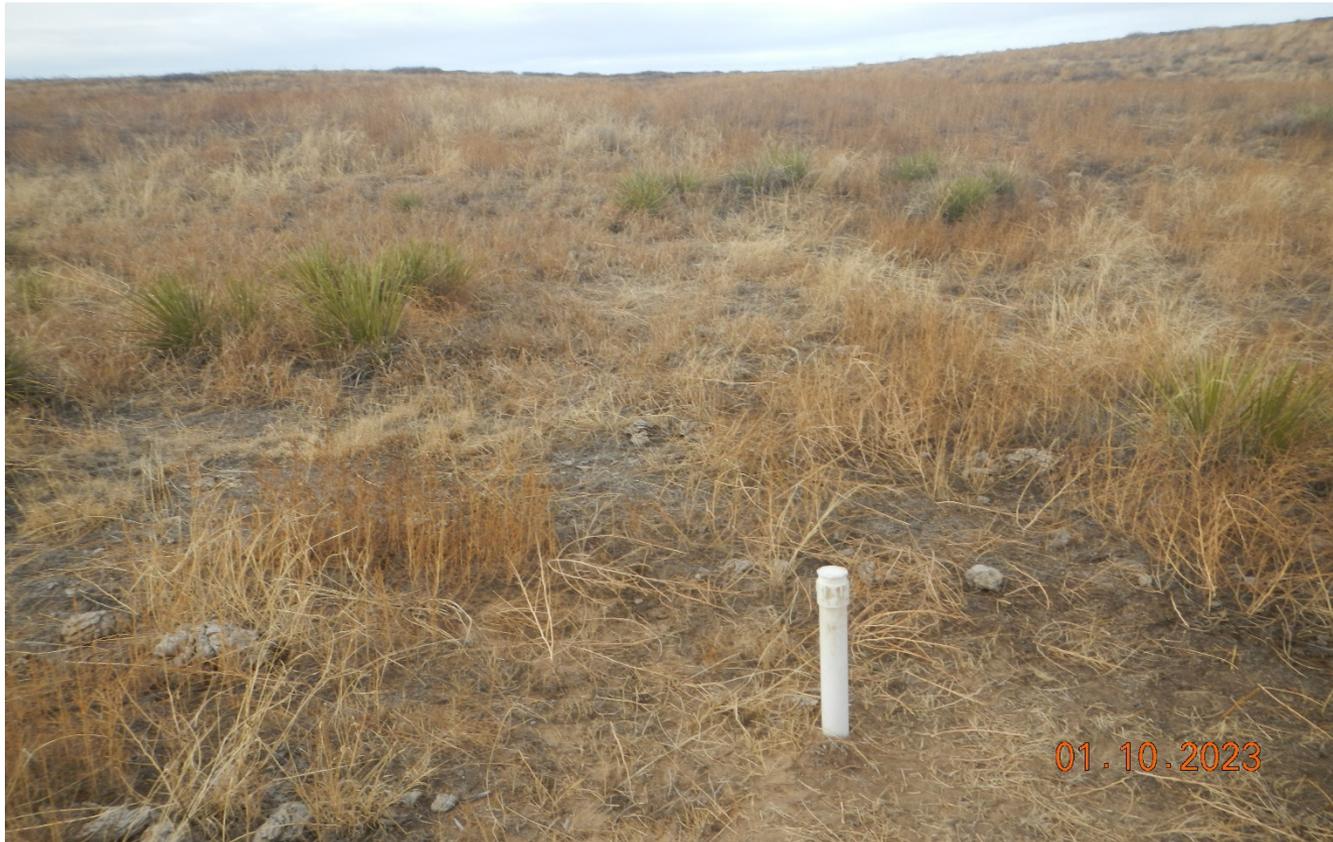
Photo 2. There is a plastic pipe at northeast side of the location.

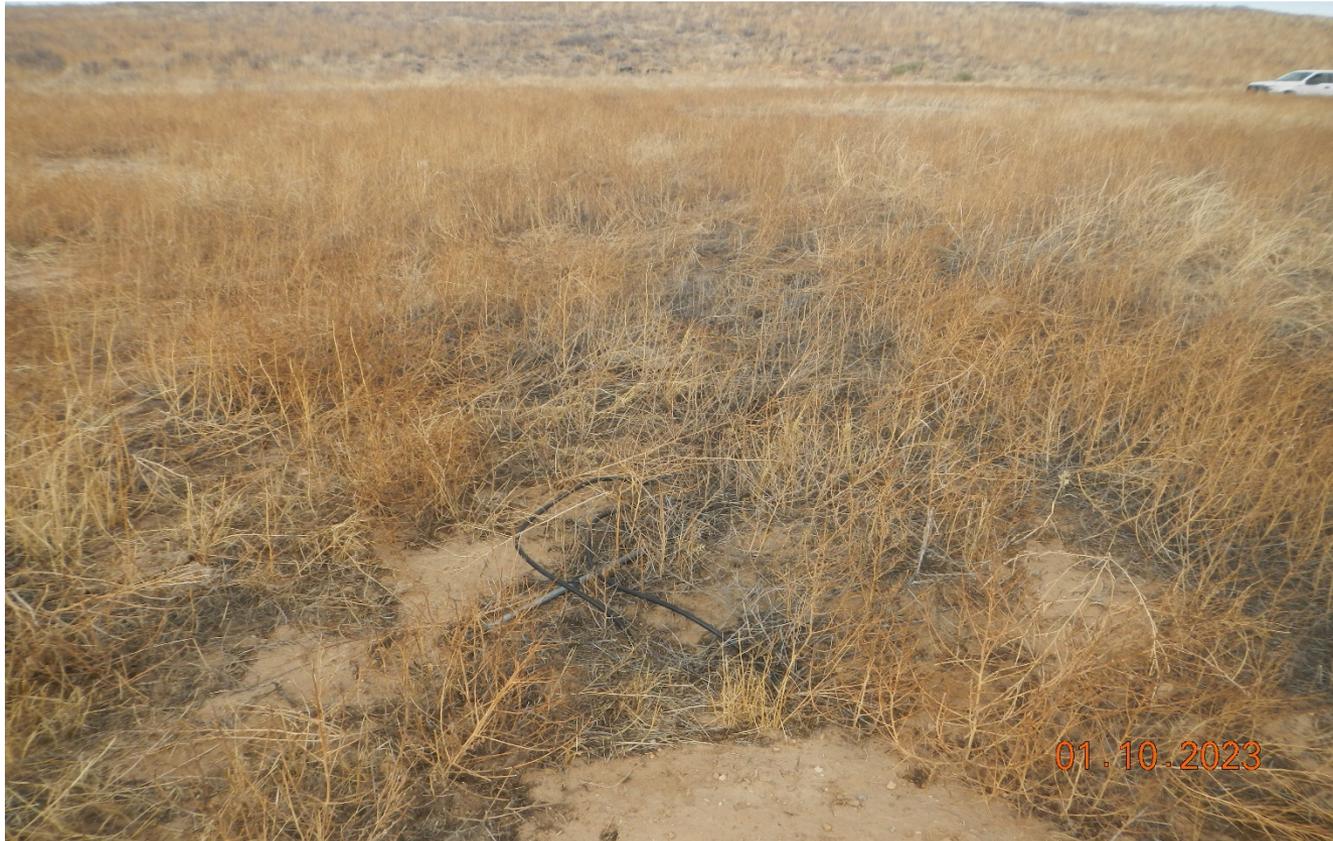
Photo 3. There is electrical wires that remain at the southeast side of the location which needs to be removed.

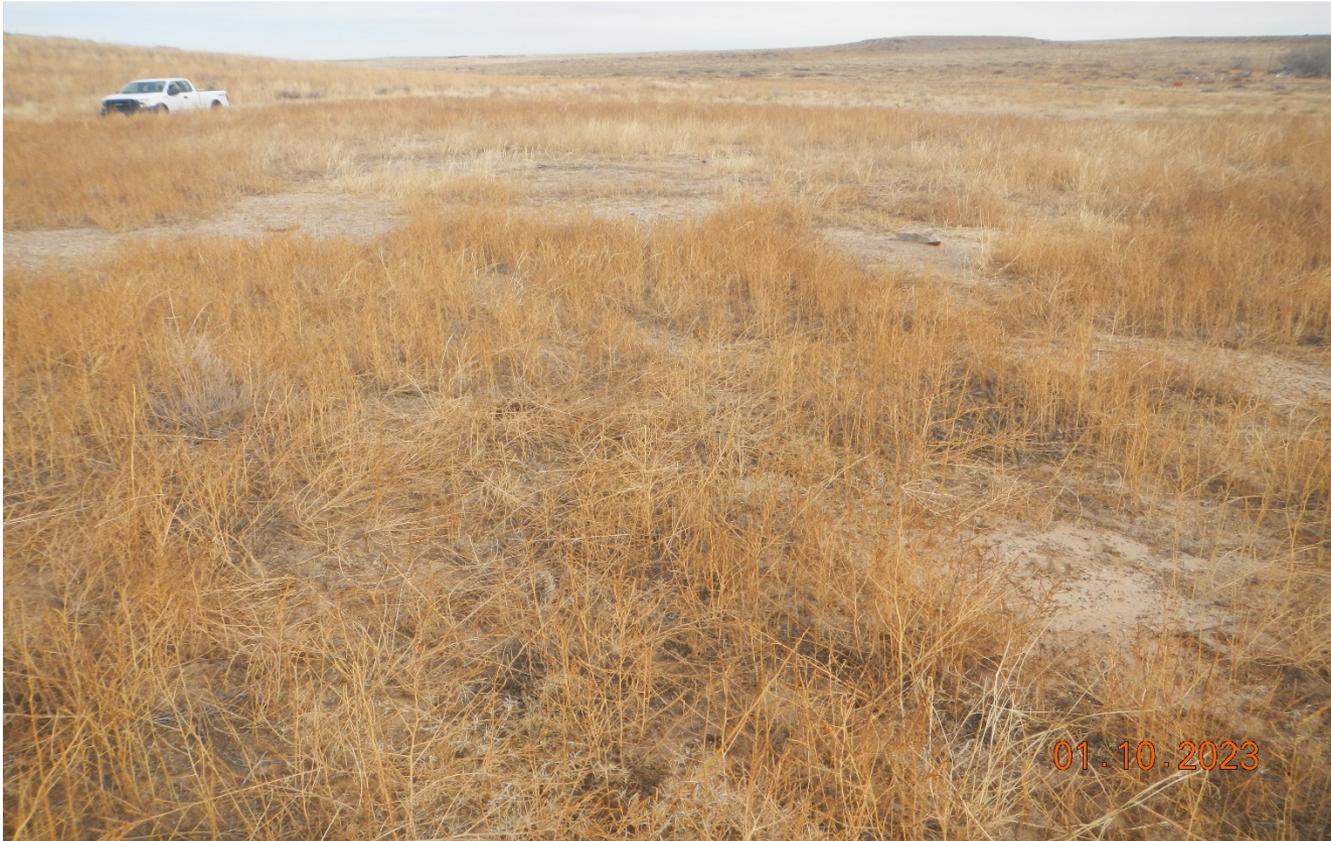
Photo 4. Facing northeast at the south side of the location. This area consists mostly of undesirable weeds (Russian thistle, Kochia).
