# Inspection Photos

API: 071-09838

Operator: WAPITI OPERATING LLC

Inspection Date: 3/22/2023

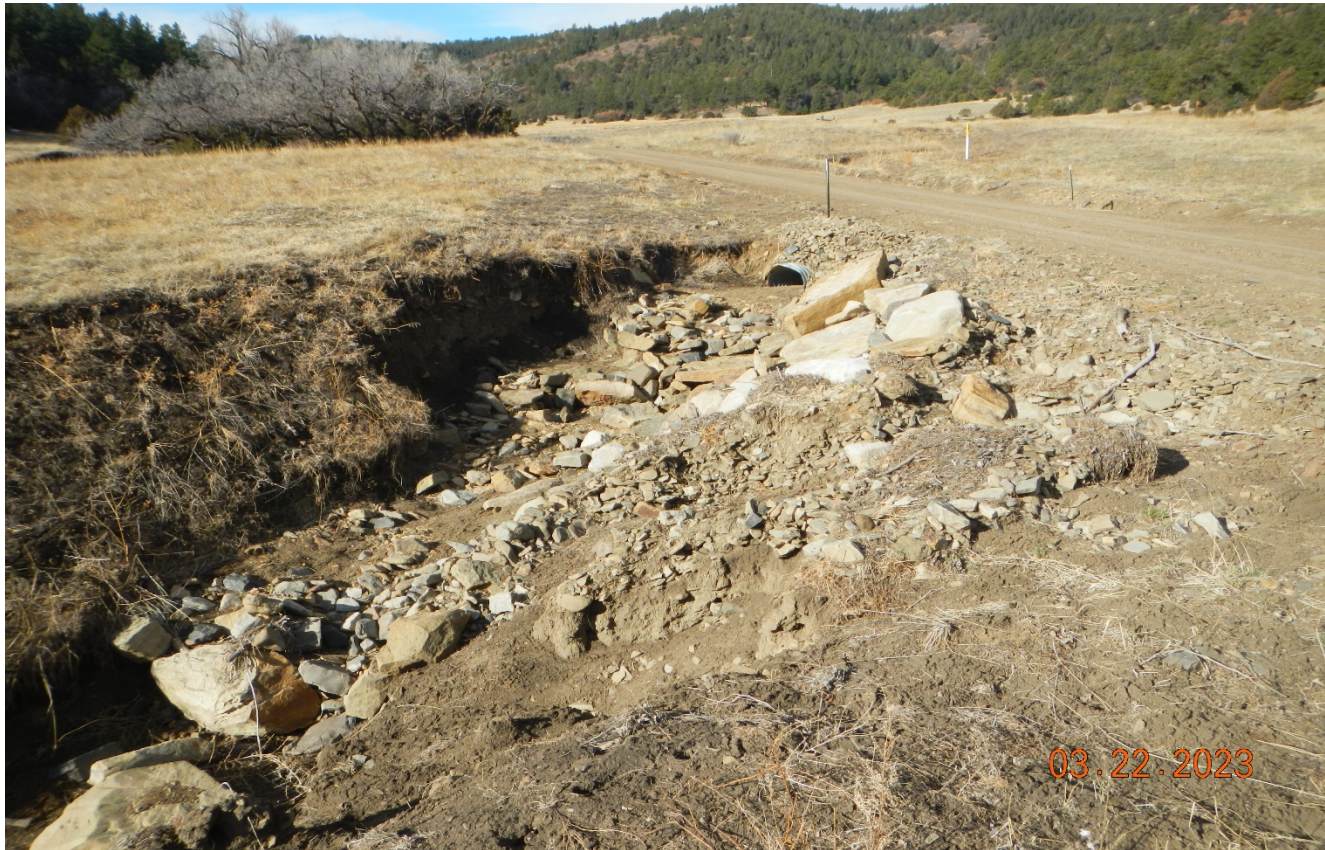
**Photo 1.** The culvert outlet has eroded and needs to be repaired. Previous corrective action was not completed.

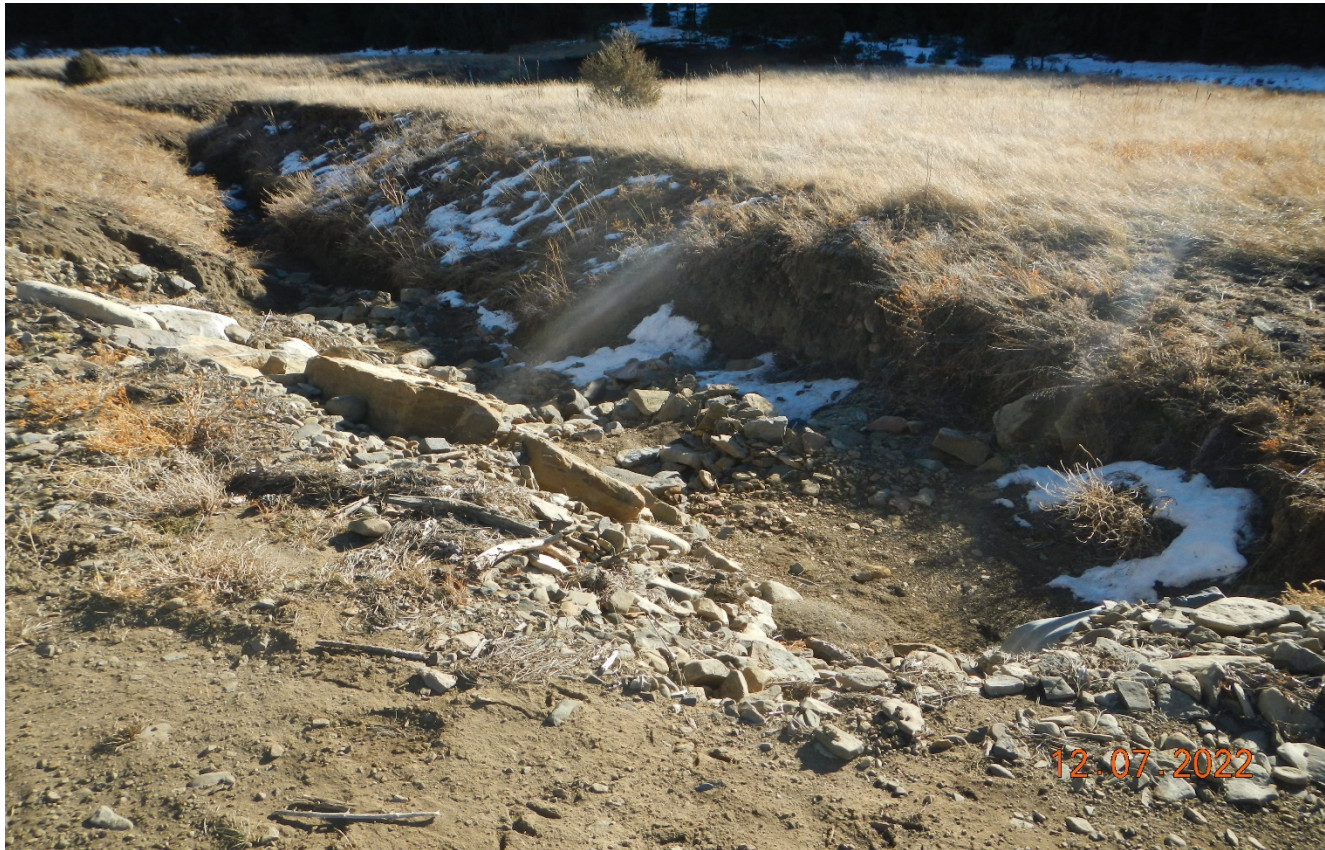
**Photo 2.** Facing toward the culvert outlet. The culvert outlet has eroded and needs to be repaired. Previous corrective action was not completed. BMP's must be installed per good engineering practice. (E.g. Rock outlet protection should include geotextile fabric)

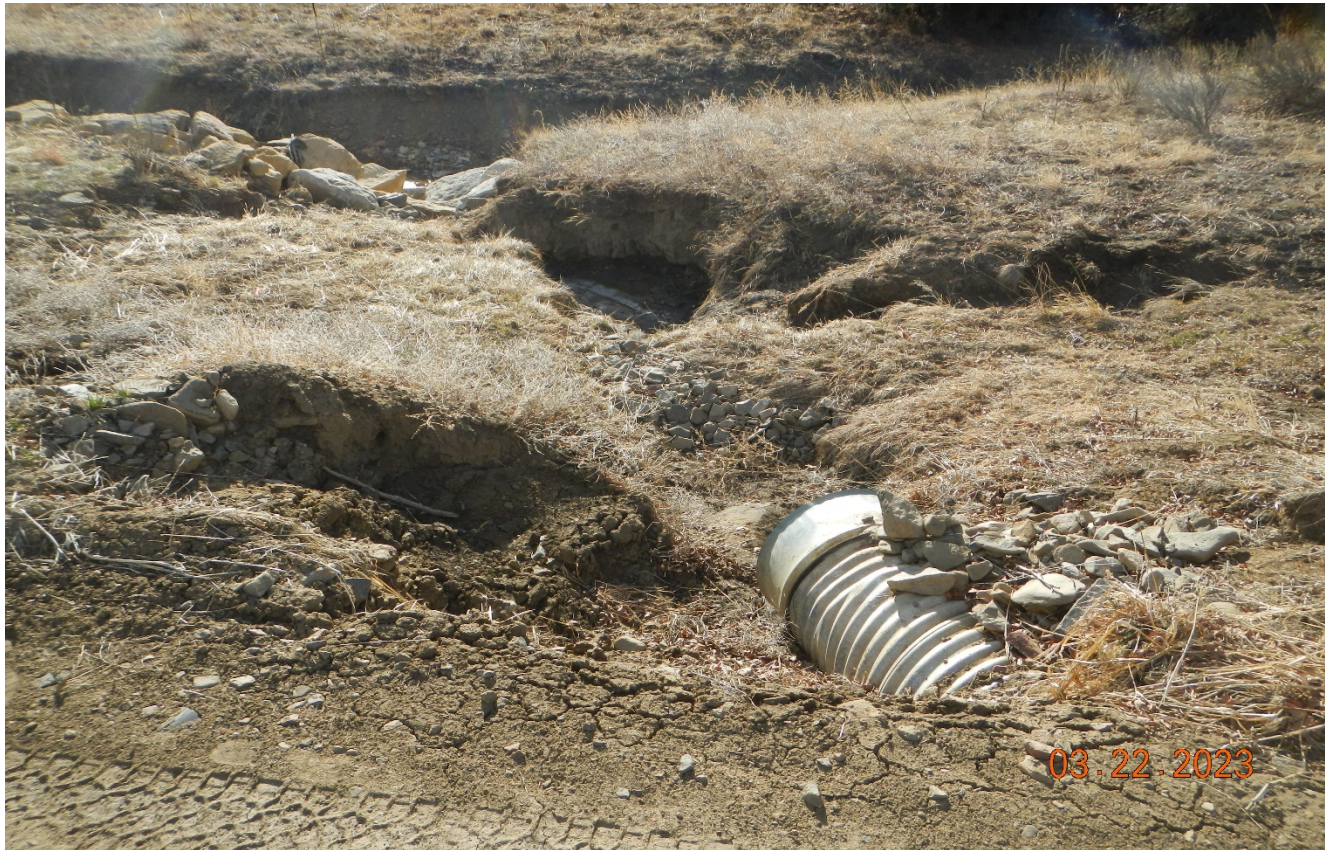
**Photo 3.** The next culvert along the road is also eroded at the culvert outlet with no outlet protection. Previous corrective action was not completed.

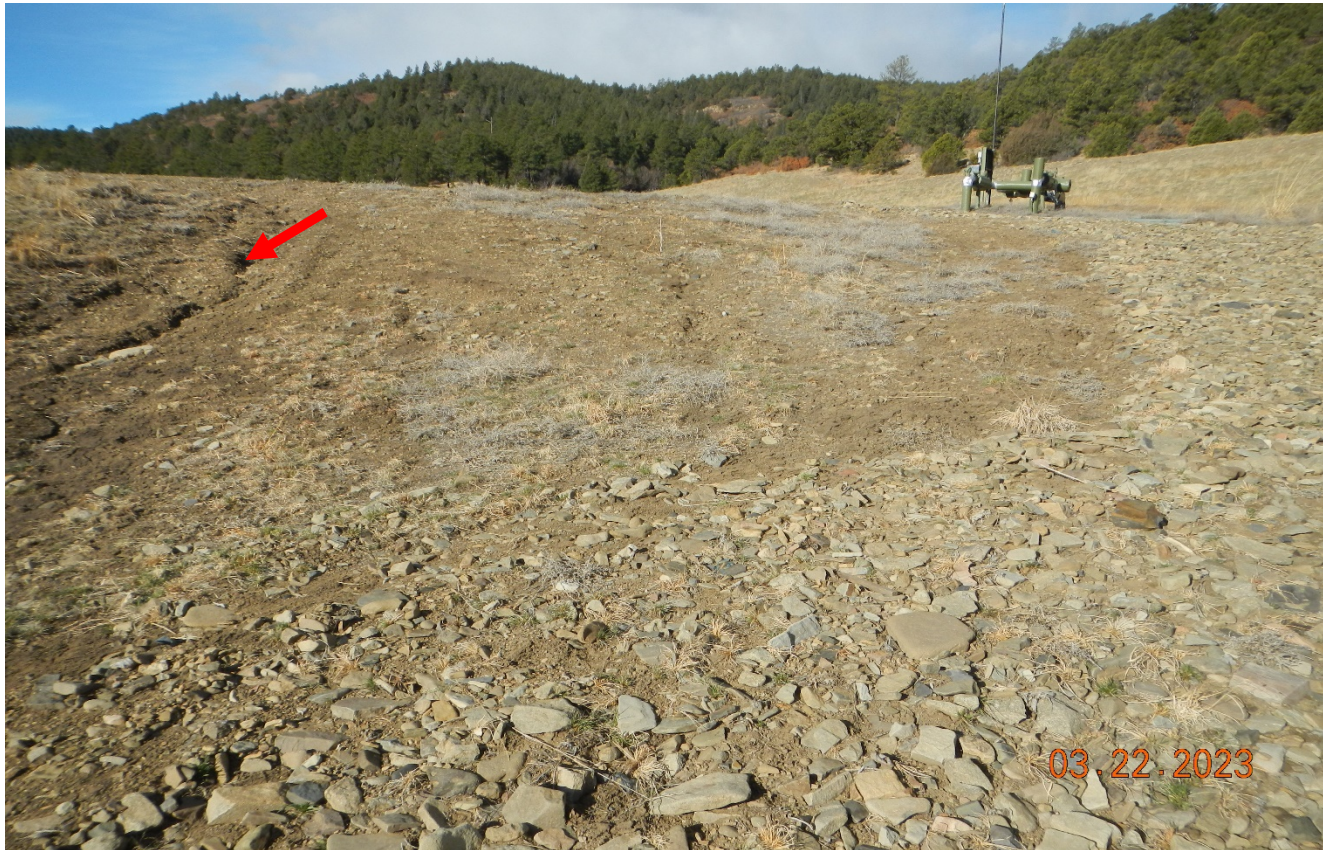
**Photo 4.** Facing southwest at the location. There is erosion occurring off the northeast side of the location. Additional BMP's need to be installed in this area including reseeding of this area.

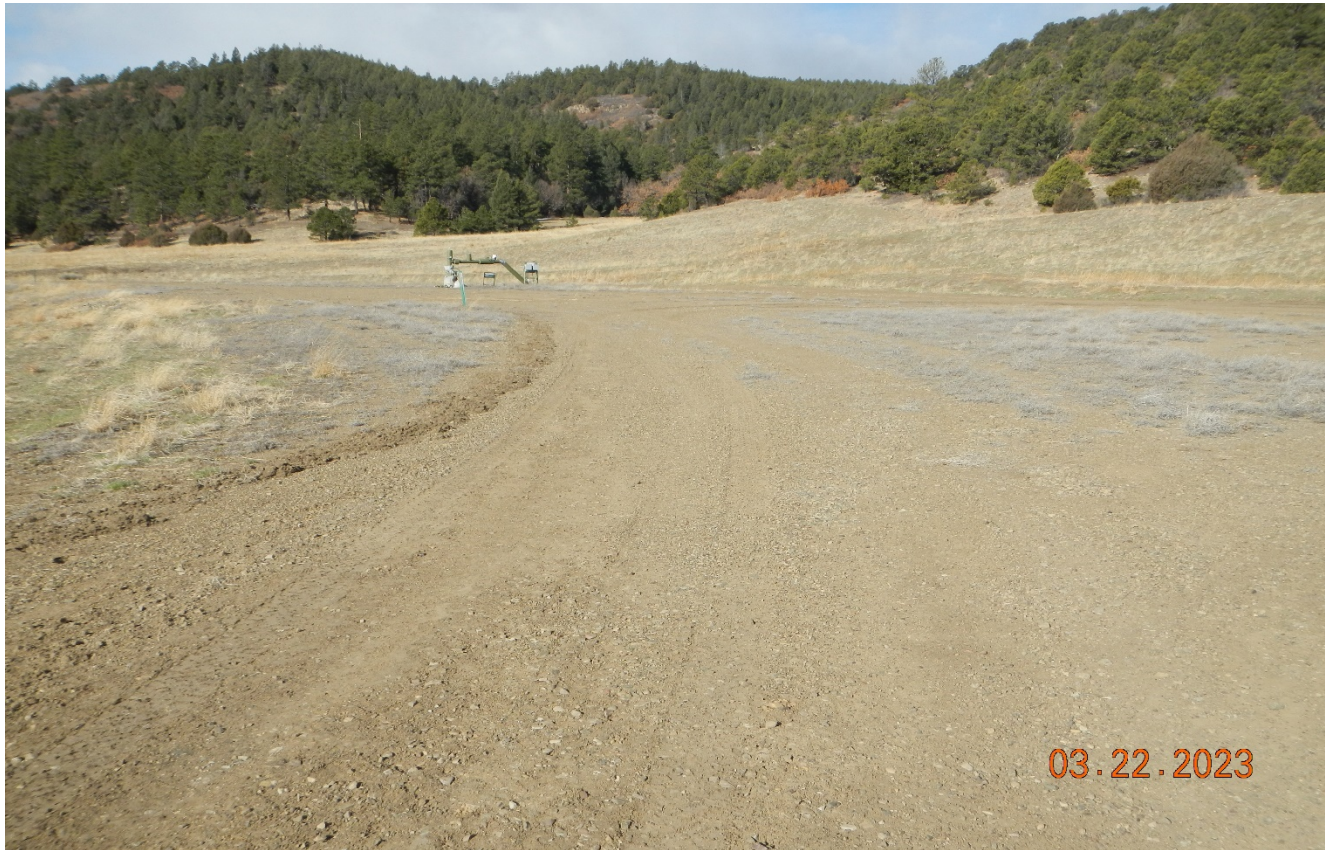
**Photo 5.** Facing northwest toward the wellsite.

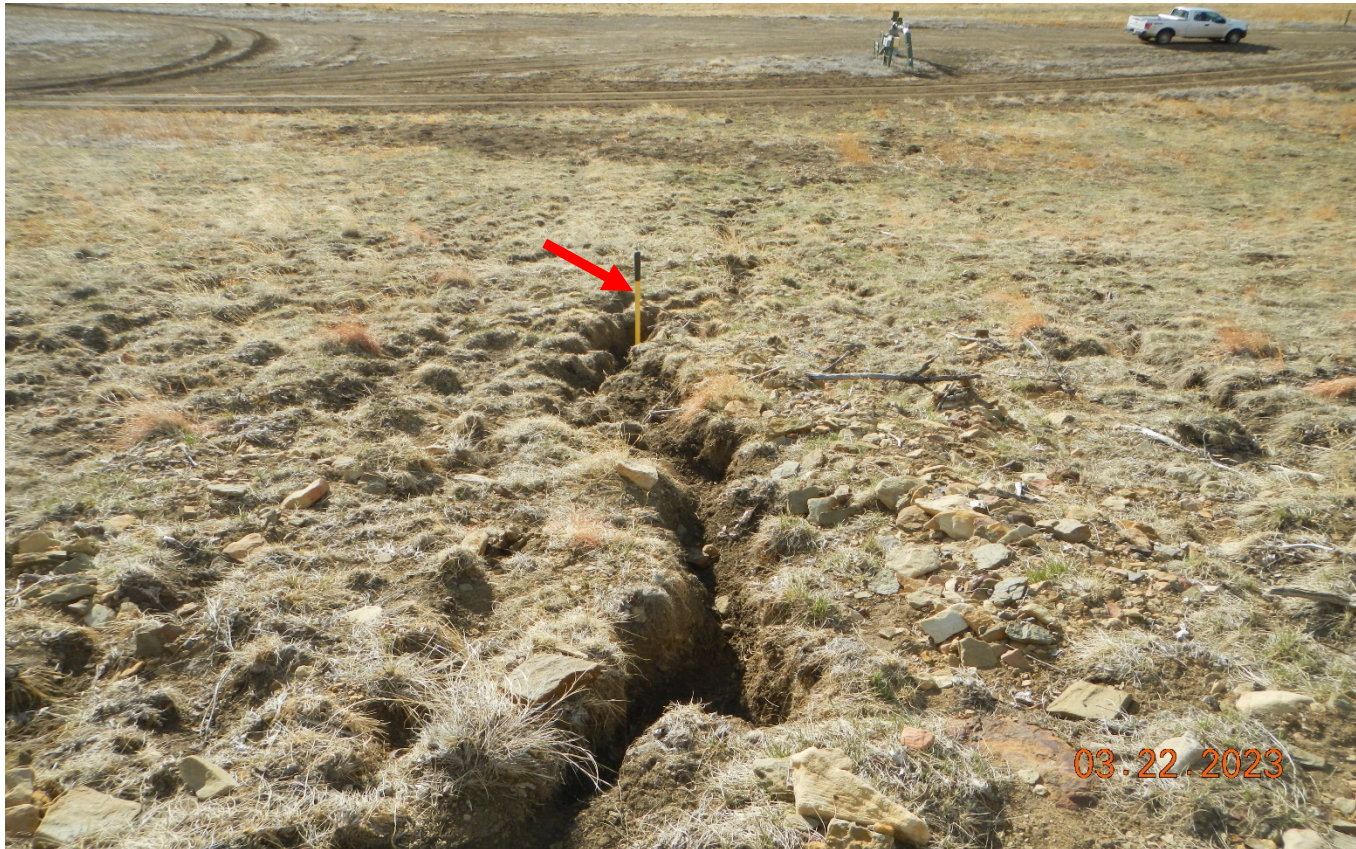
**Photo 6.** Facing east toward the location at the upper cut slope area. Stormwater run-on is causing erosion and is not properly diverted by the perimeter ditch. This area needs to be repaired and stabilized. Previous corrective action is not completed.

Red arrow points to 4.5 ft. shovel placed in the erosion channel.

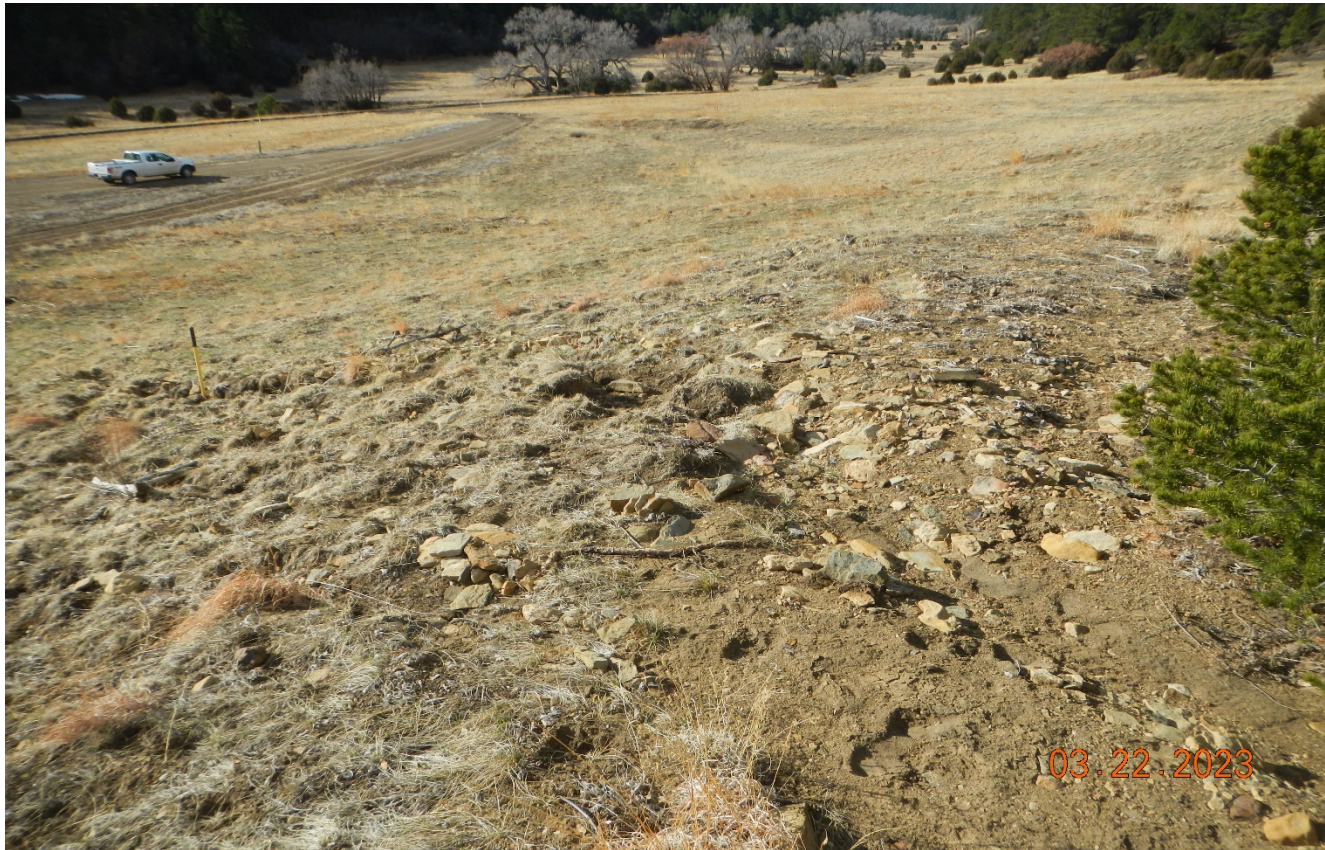
**Photo 7.** Facing south toward the run-on ditch which is filled in with sediment causing erosion of the cut slope. Previous corrective action is not completed.

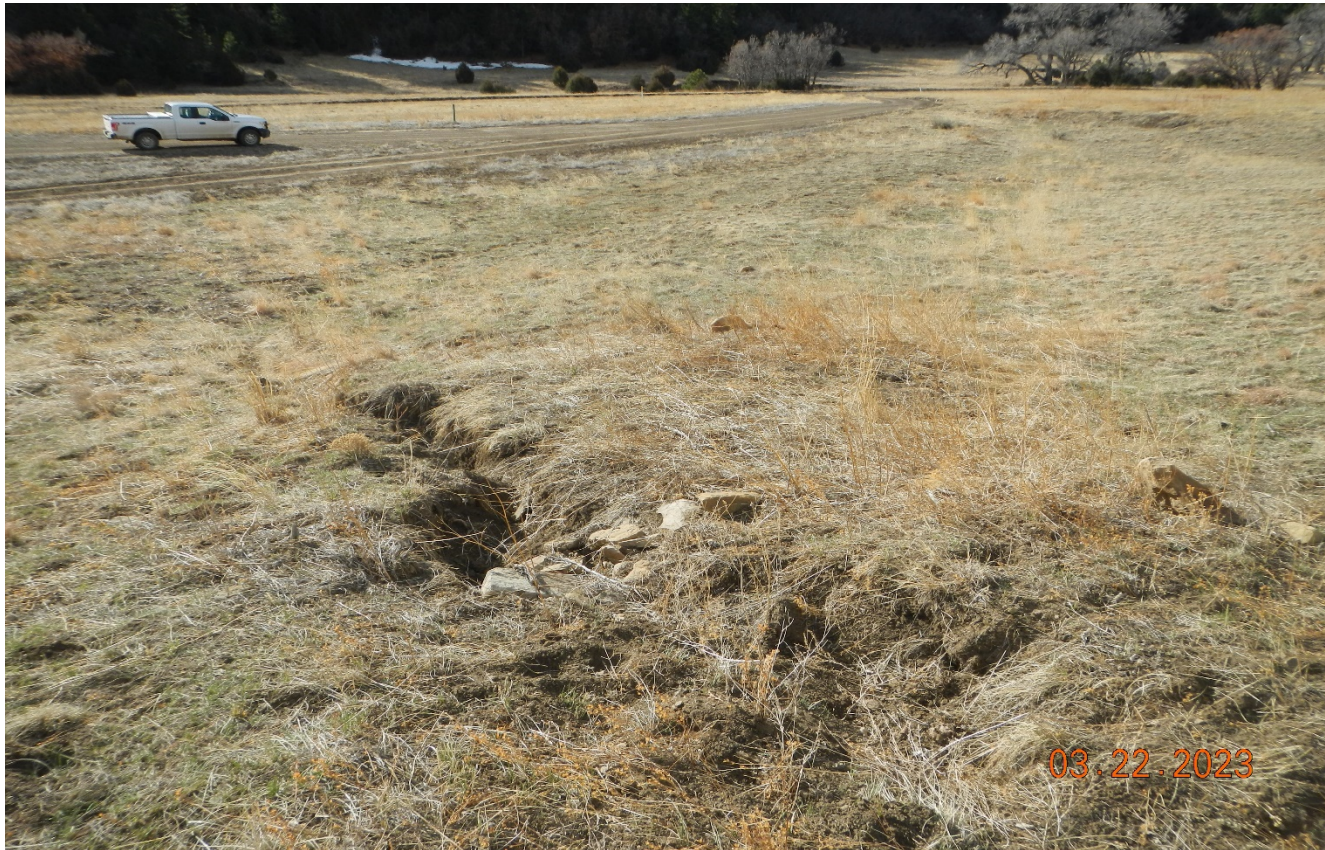
**Photo 8.** There are additional erosion channels along the south side of the location. Previous corrective action is not completed.

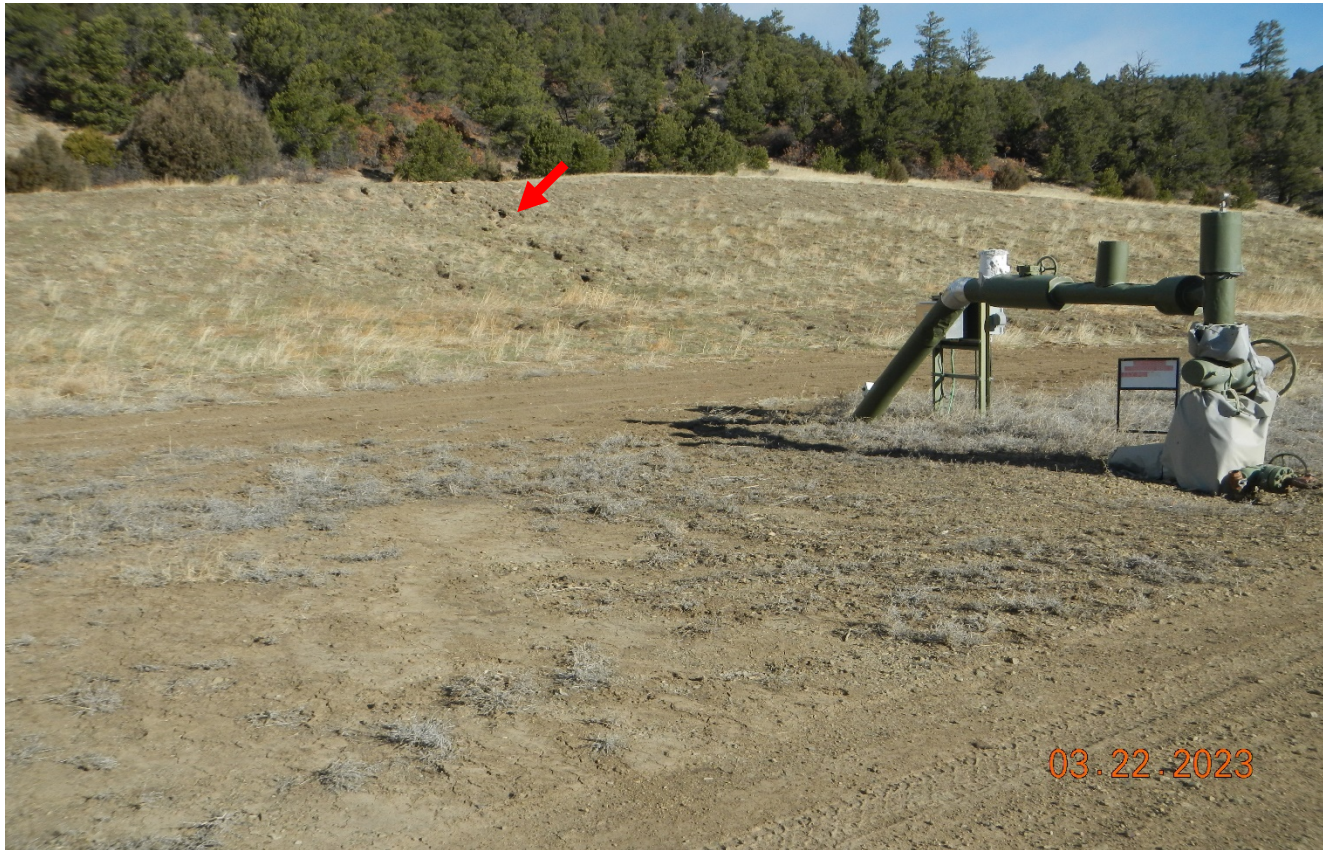
**Photo 9.** Facing north at the wellsite. Areas of erosion are visible at red arrow along the cut slope.
