Inspection Photos

API: 071-08769

Operator: WAPITI OPERATING LLC

Inspection Date: 3/22/2023

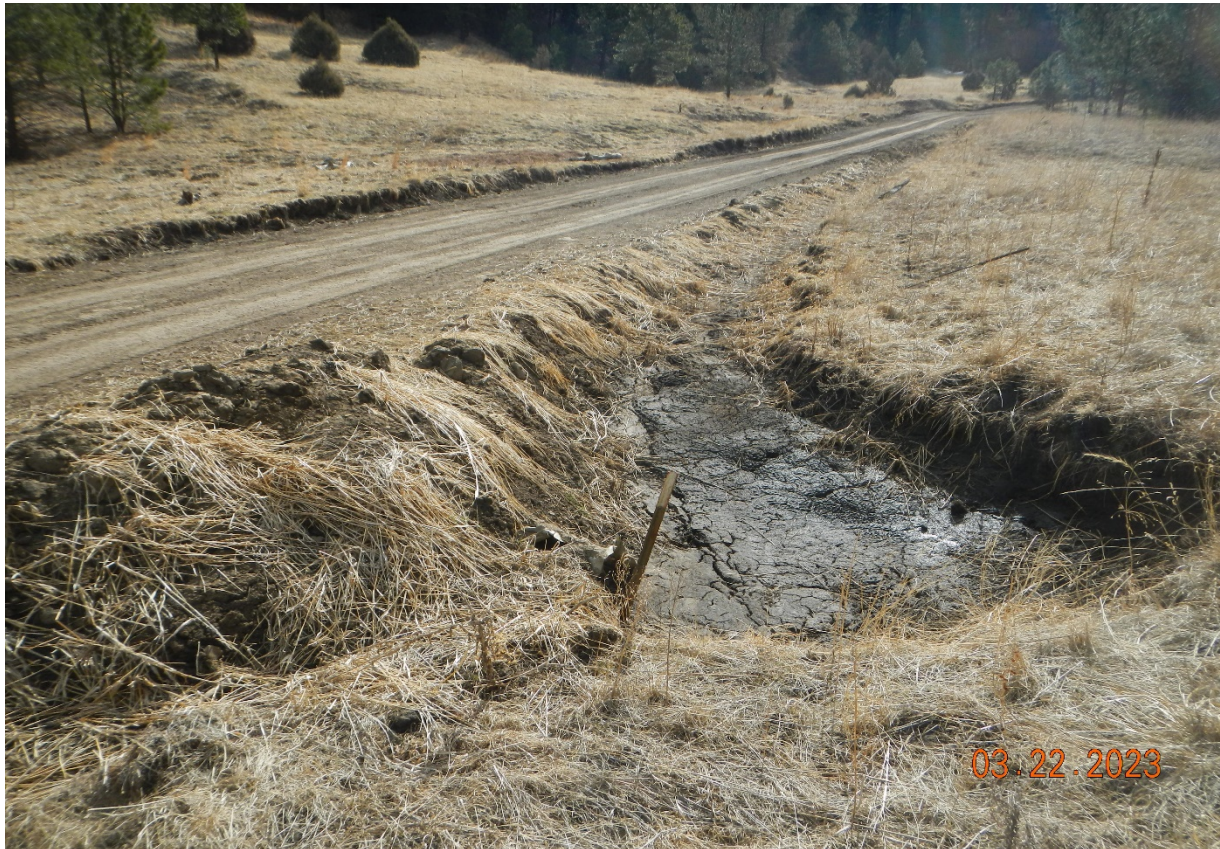
Photo 1. This culvert inlet was cleaned out by the Operator however, the culvert is full of sediment and the inlet has filled back in with sediment. Previous corrective action was not completed. Lat/Long:37.00581,-104.83861.

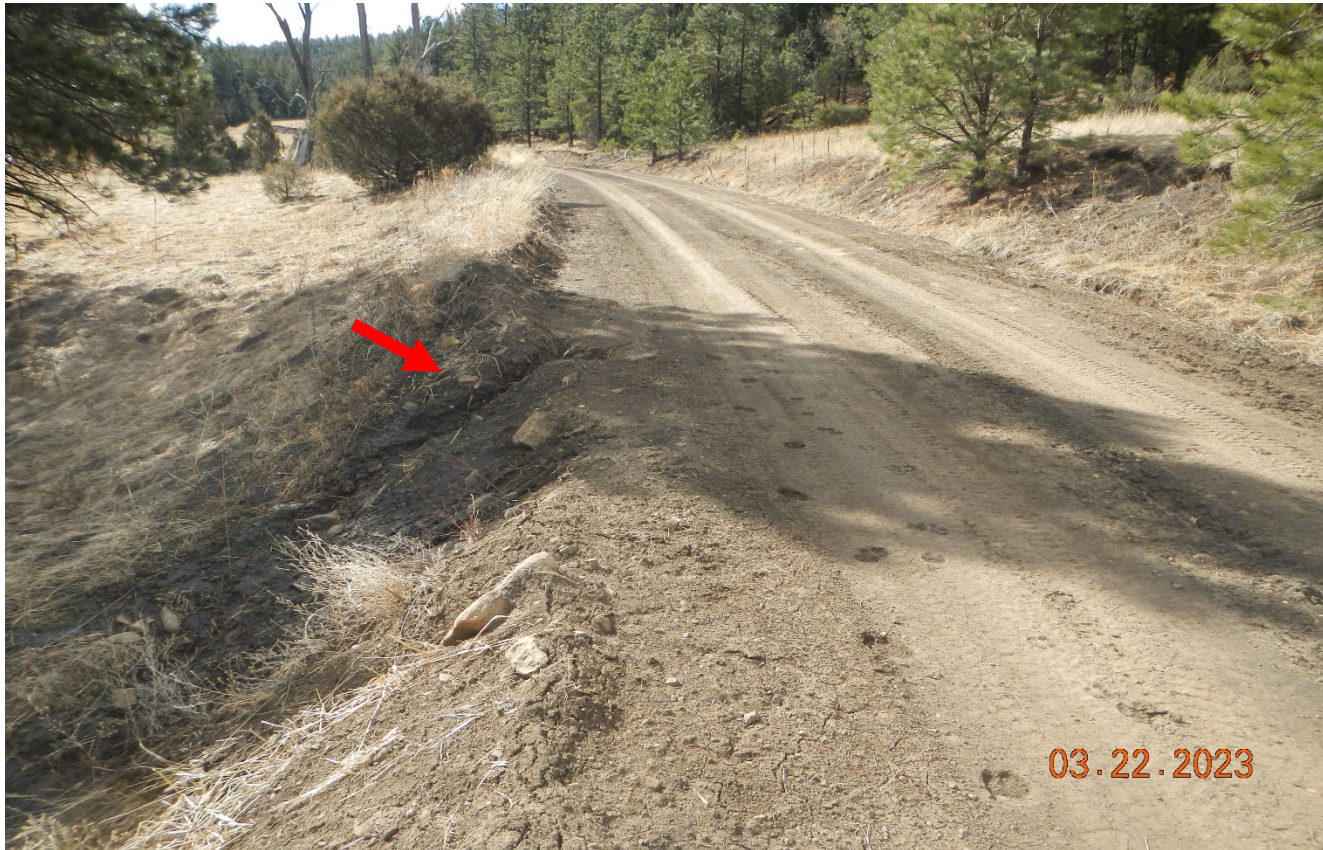
Photo 2. There is an erosion gully along the road that needs to be repaired and stabilized. It appears grading operations has partially filled in this gully however it still needs to be stabilized. Previous corrective action was not completed.

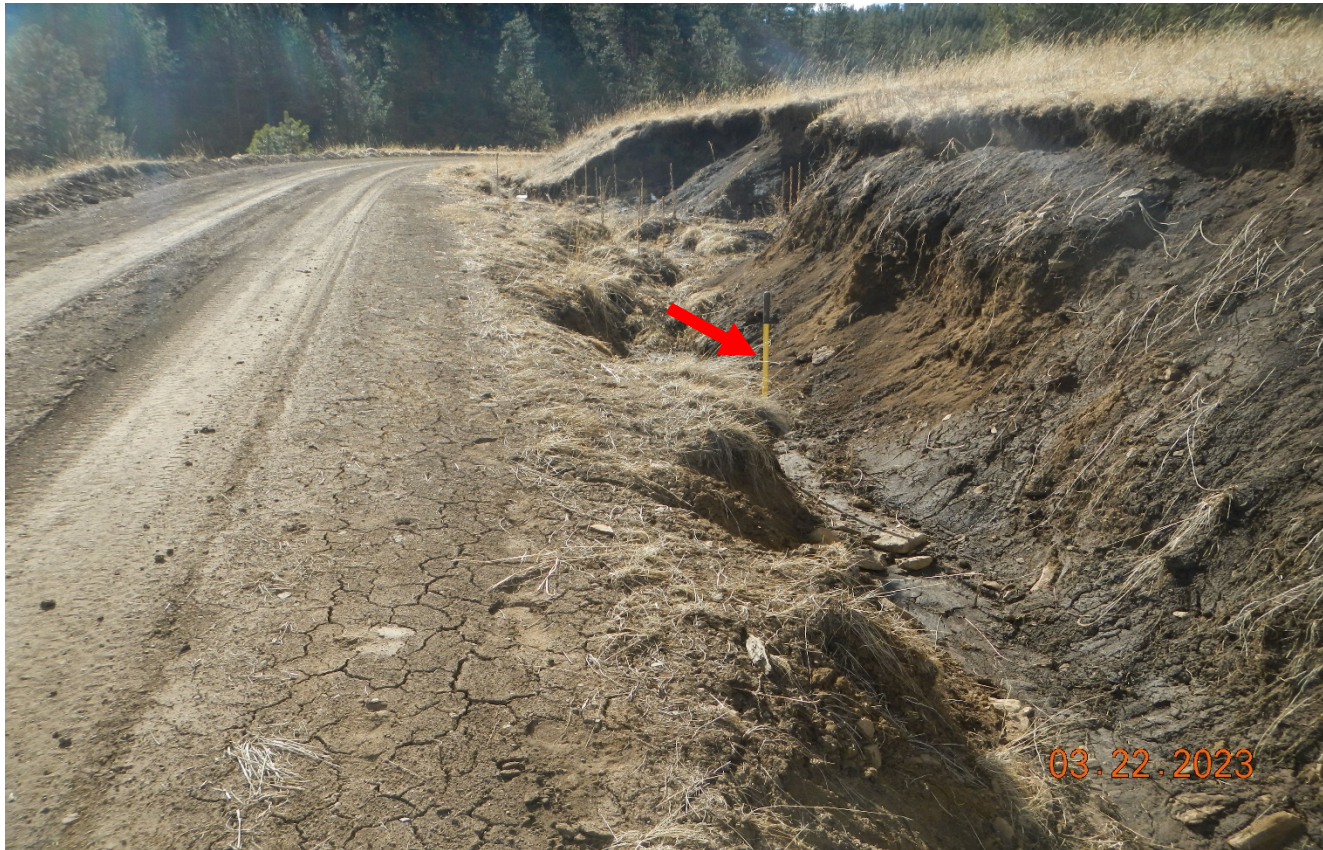
Photo 3. The side of the road is eroded and not stabilized. Erosion head cutting is continuing to occur further back into the slope. This area needs to be repaired and stabilized. Previous corrective action not completed. Red arrow points to 4.5 ft. shovel. Lat/Long:36.99952,-104.83425.

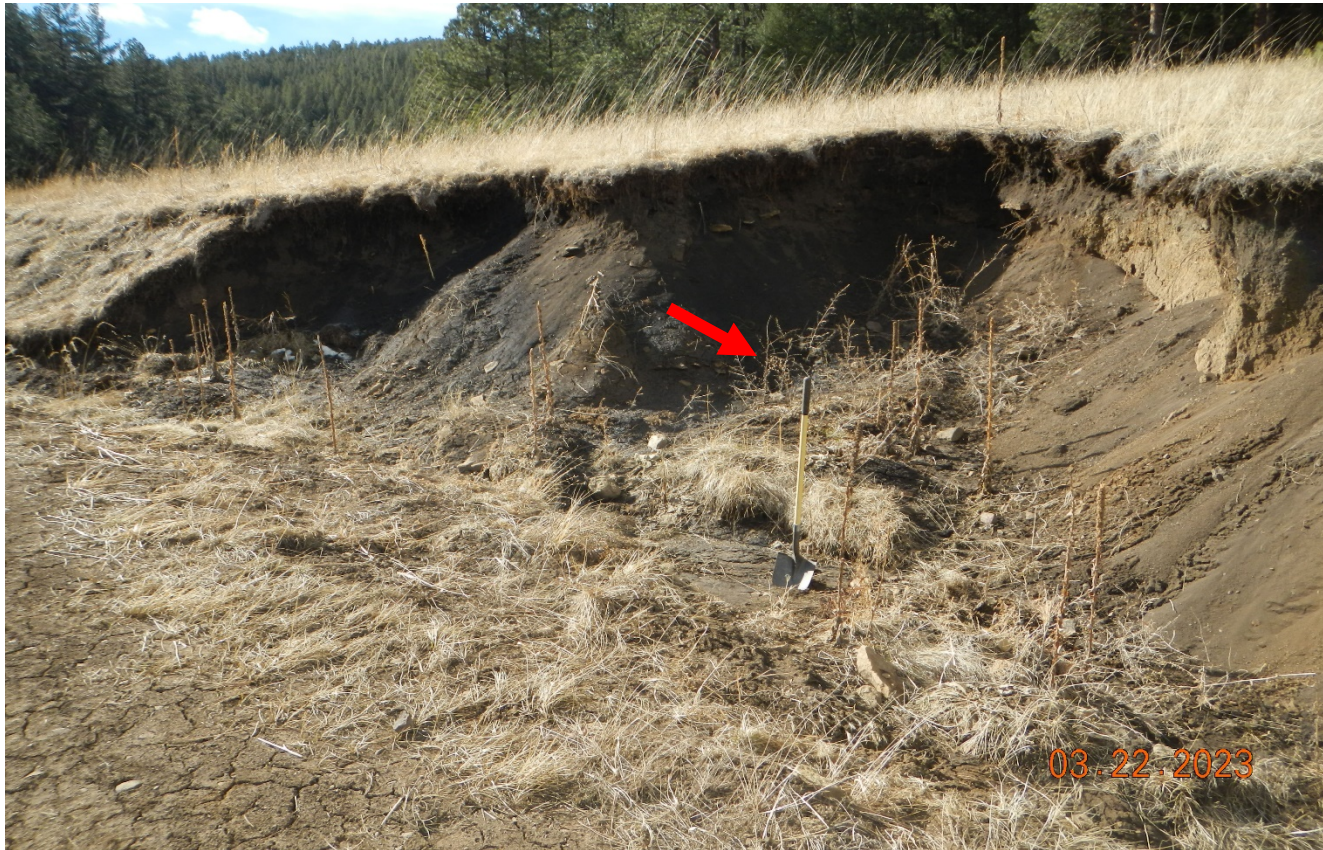
Photo 4. The side of the road is eroded and not stabilized. Erosion head cutting is continuing to occur further back into the slope. This area needs to be repaired and stabilized. Previous corrective action not completed. Red arrow points to 4.5 ft. shovel. Lat/Long:36.99952,-104.83425.

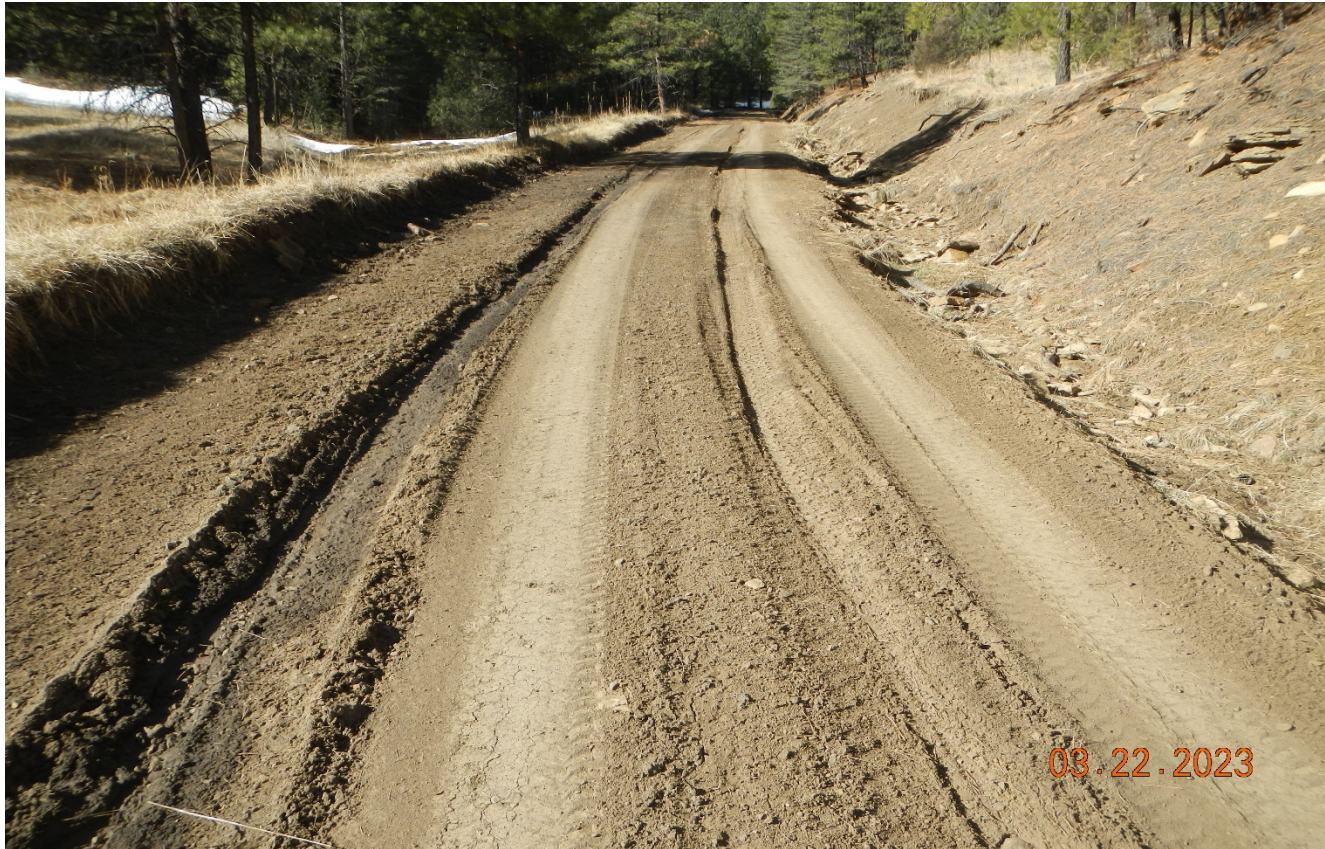
Photo 5. Further along the road near the Colorado line. The roadside and road is eroded and needs to be repaired and stabilized. Previous corrective action not completed.

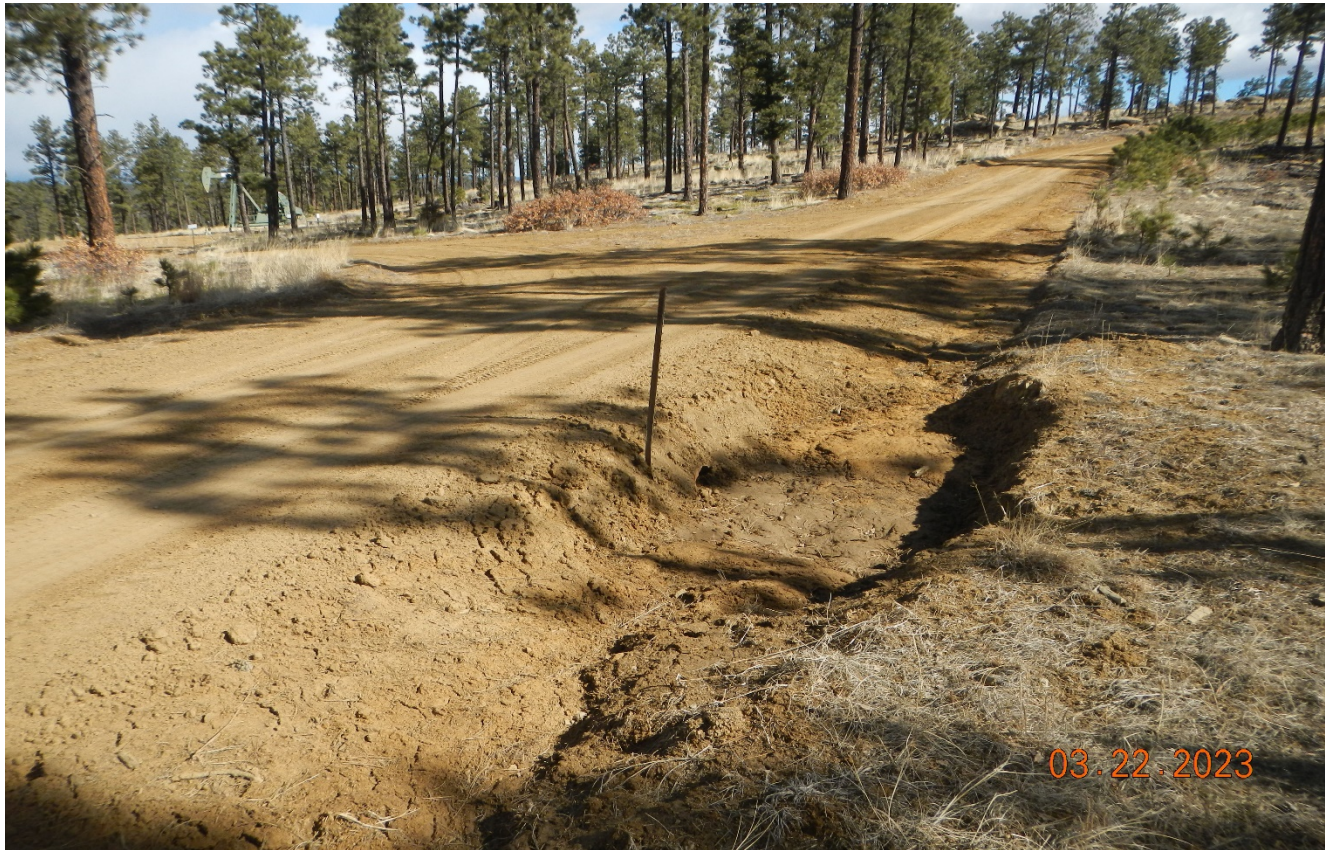
Photo 6. This culvert inlet was cleaned out however, the culvert is full of sediment which needs to be cleaned out. Lat/Long:36.99405,-104.84710.

Previous corrective action not completed.
