**Inspection Photos**  
**Location Name: State 2-12**  
**Location ID: 328919**

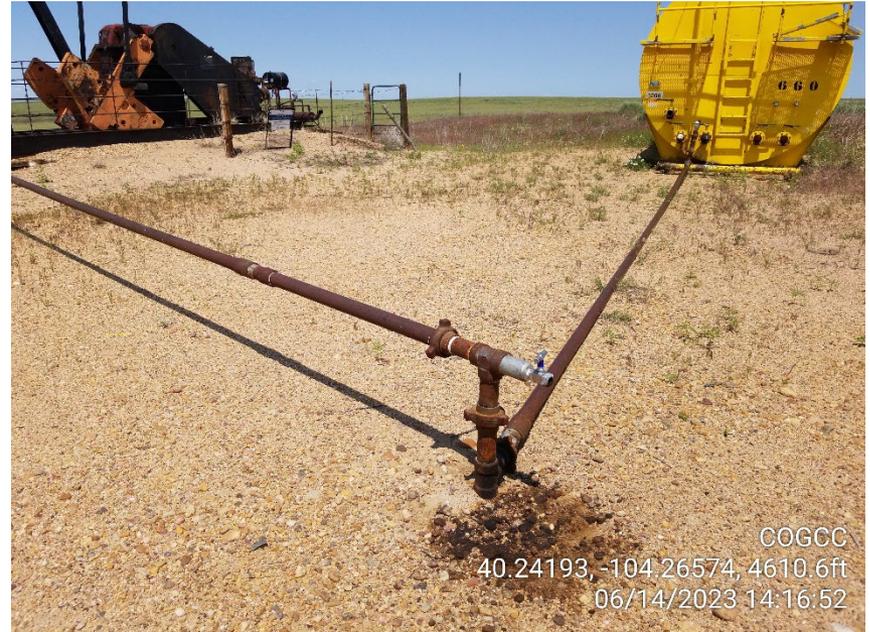
**Photo 2 – Stained Soil at Hardline Connection**

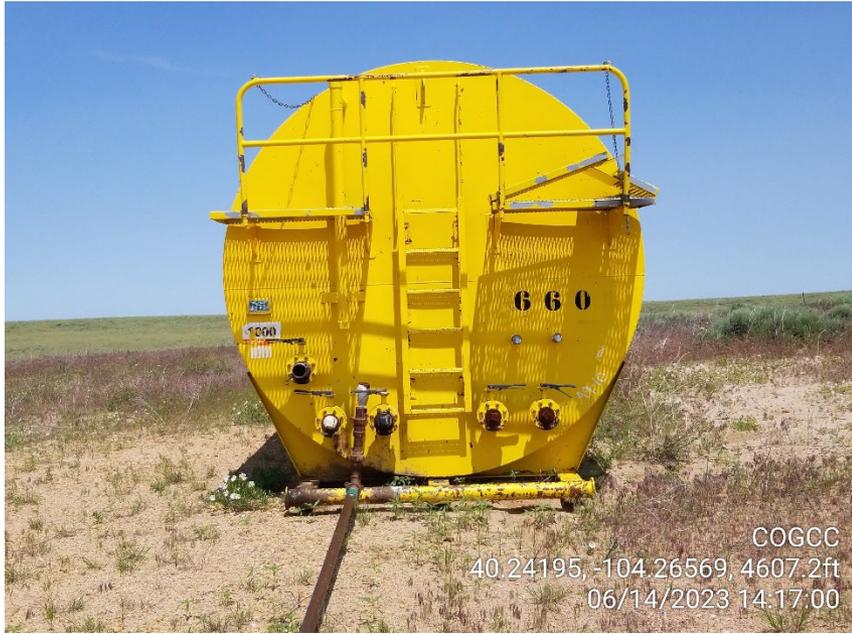
**Photo 3 – Temp Tank – No labels**

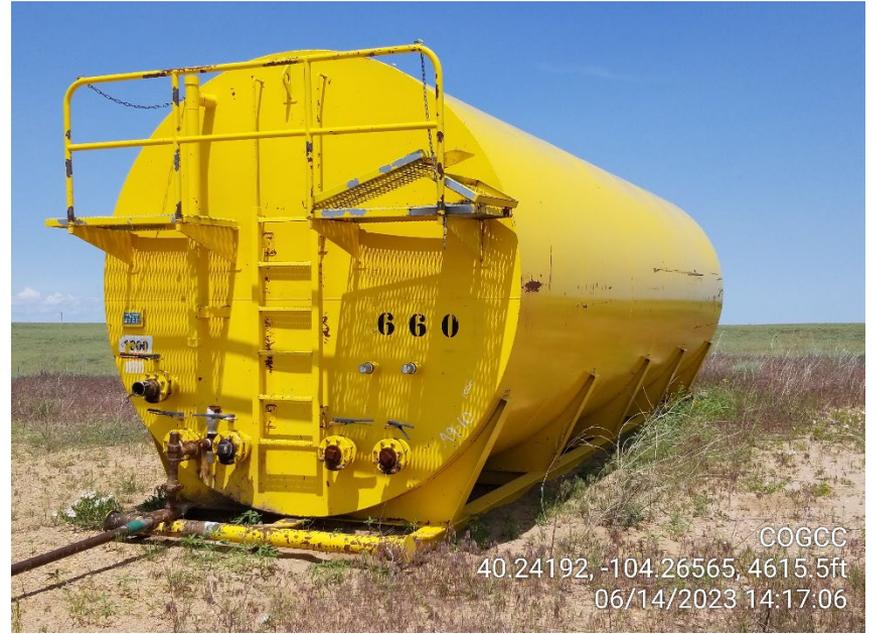
**Photo 4 – Temp Tank – No labels**

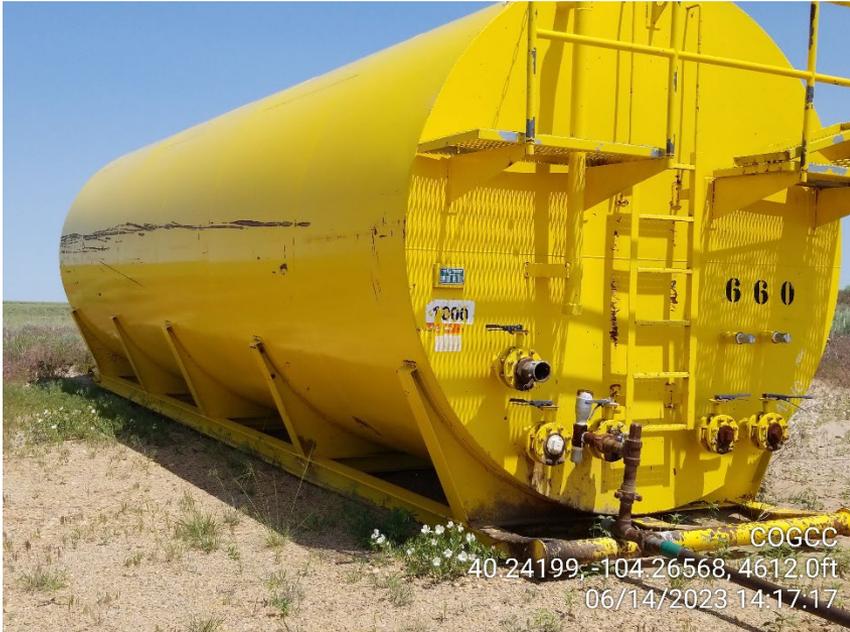
**Photo 5 – Temp Tank – No labels**

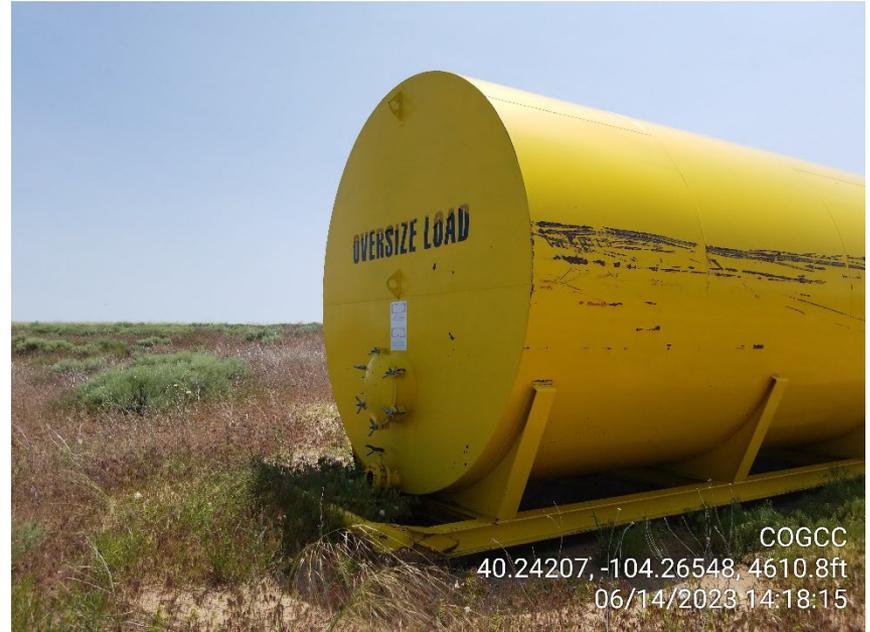
**Photo 6 – Temp Tank – No labels**

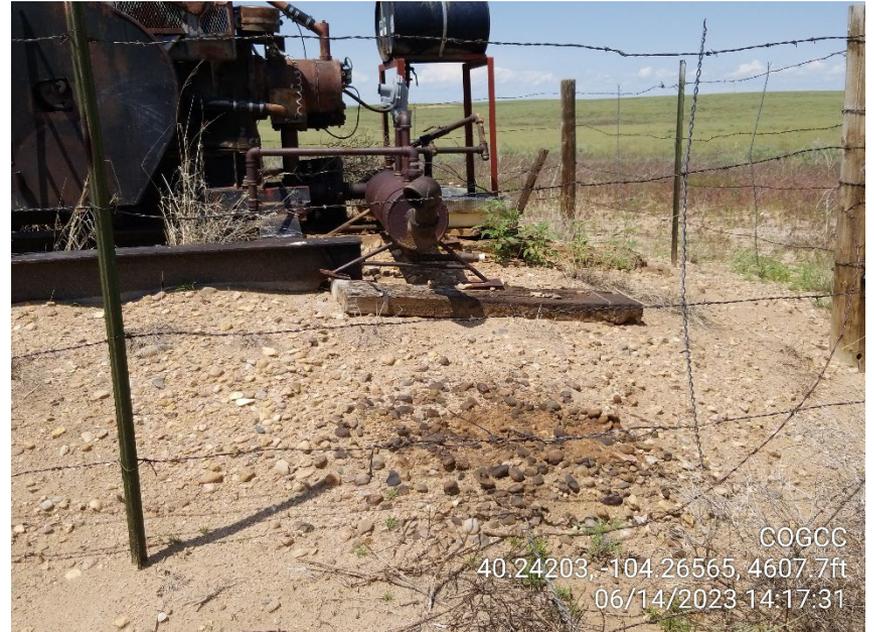
Photo 8 – Stained Soil at Exhaust

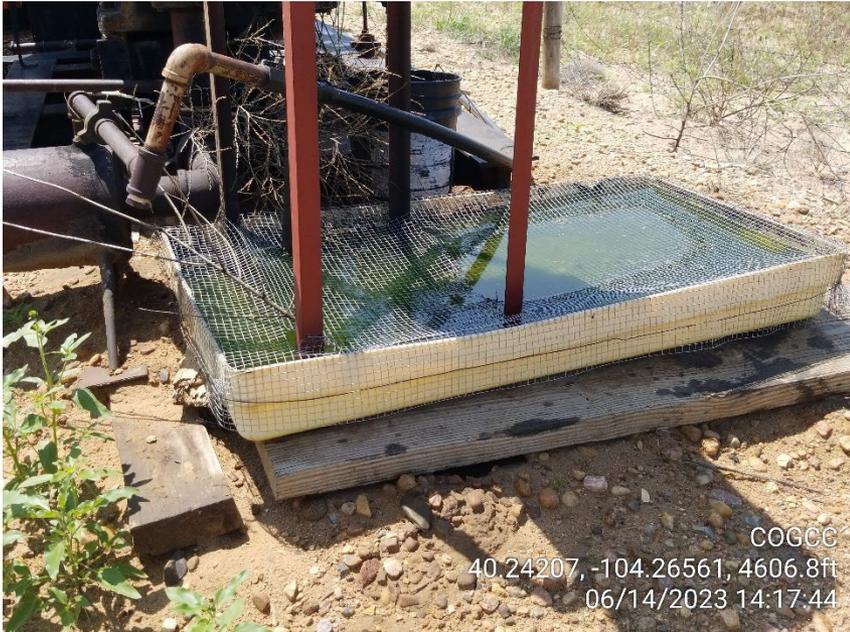
**Photo 9 – Strom Water in Containment**
