SITE-SPECIFIC QUALITY ASSURANCE & QUALITY CONTROL AUDIT

PERMIT CLOSURE REPORT – RANGELAND

Location ID 305223

Location Name DOW LAURA-65N63W/28NESE

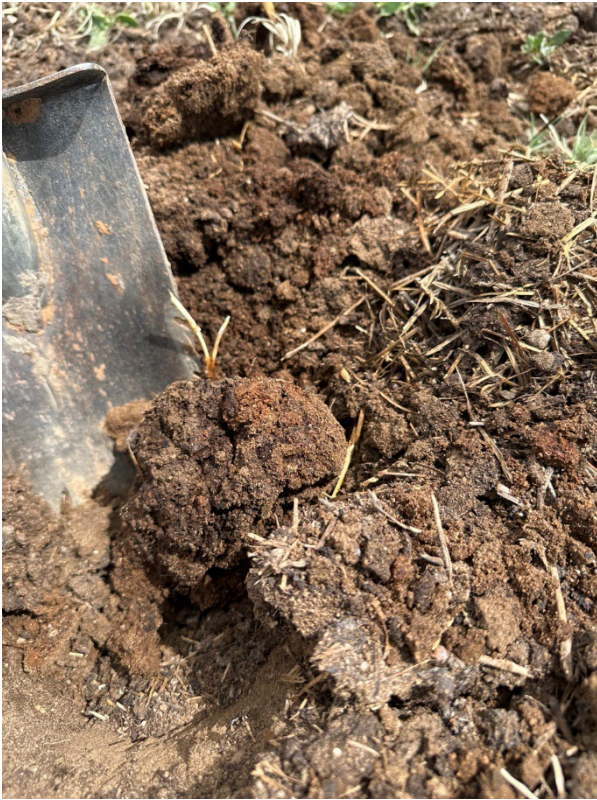
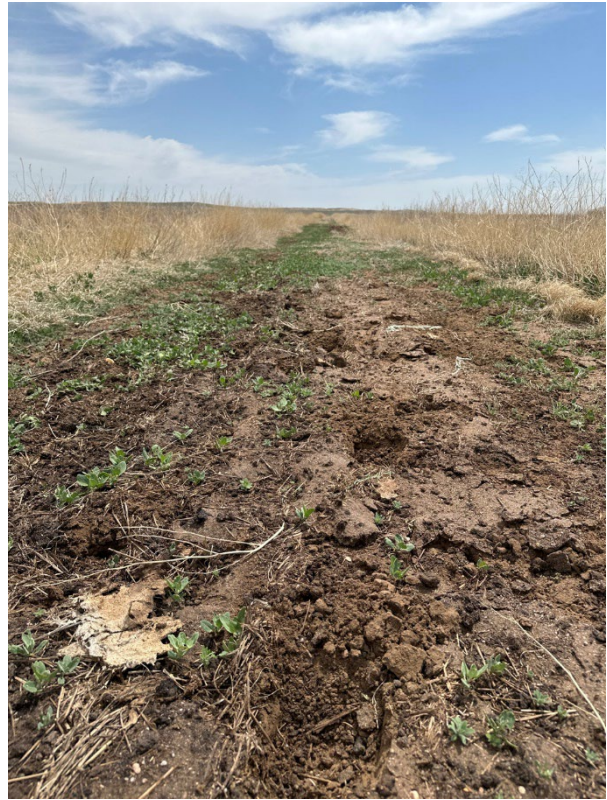
Observation 13 - ROAD- North

Manure in the top 4 inches then compaction

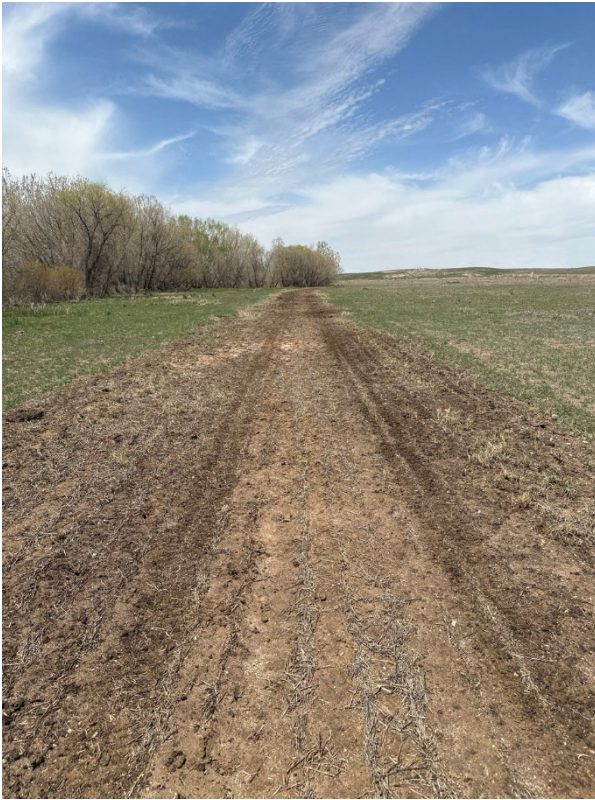
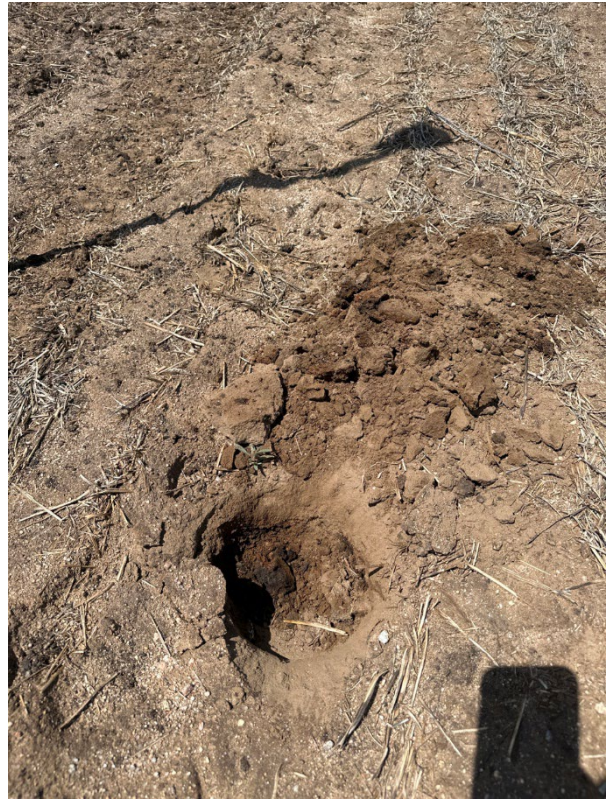
Observation 14 - ROAD- North

Sand and manure with compaction

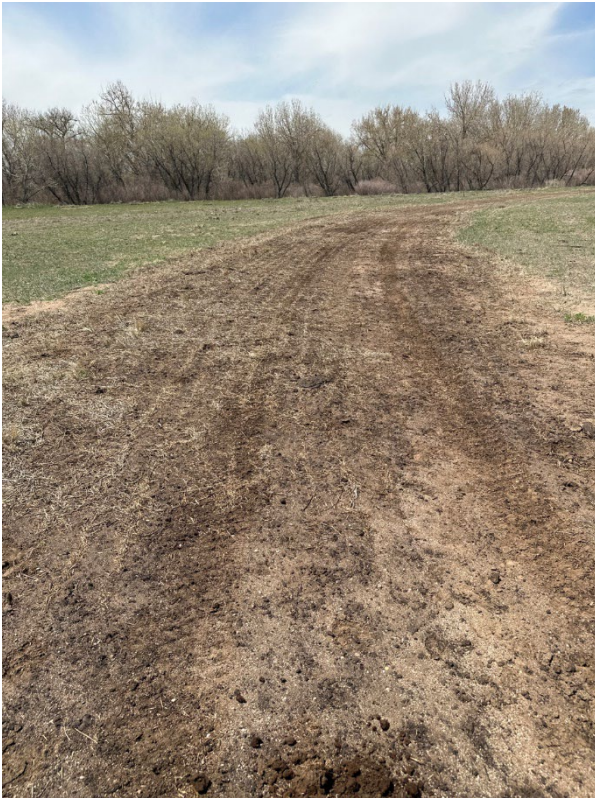
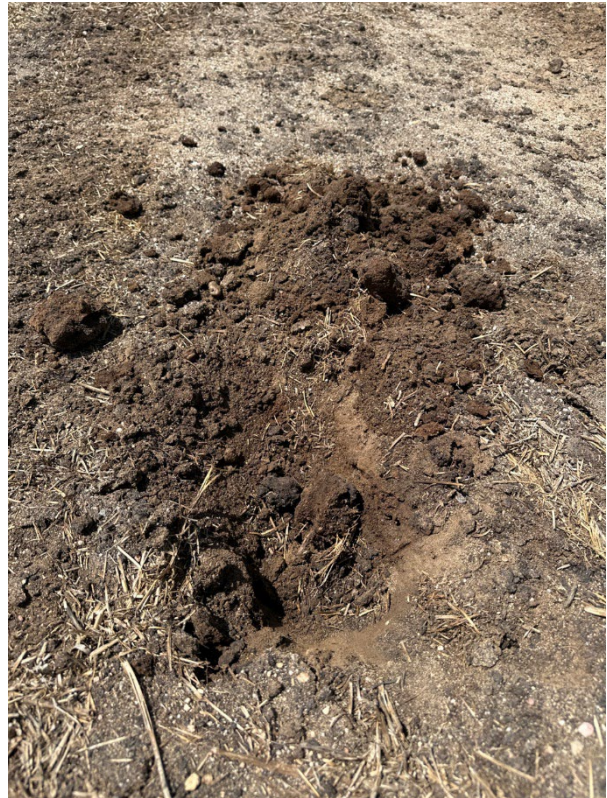
Observation 15 – ROAD - North

Top 6 inches is manure, sand with compaction

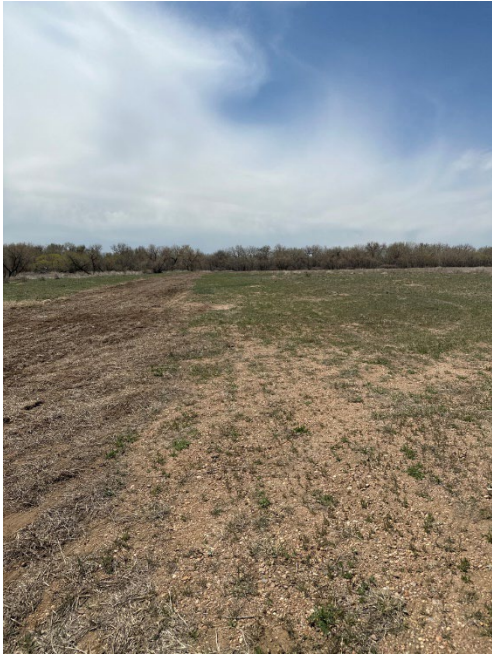
Cheatgrass and gravel

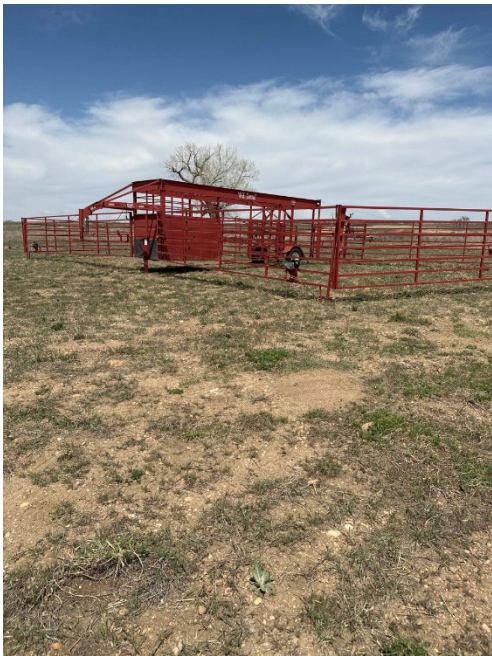
OK Corral on the footprint of the disturbance

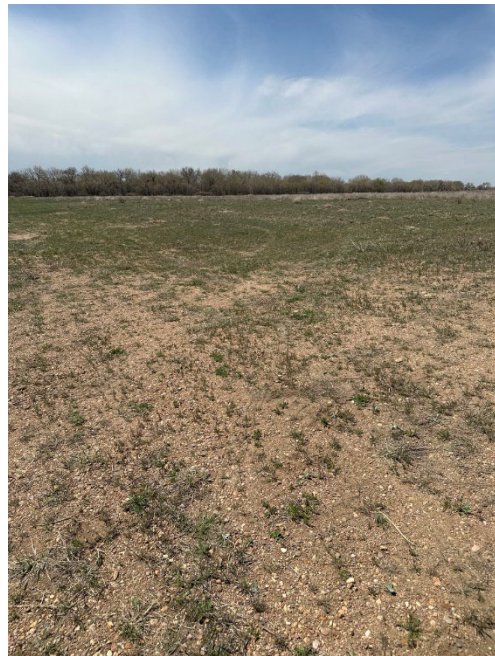
Gravel and weds

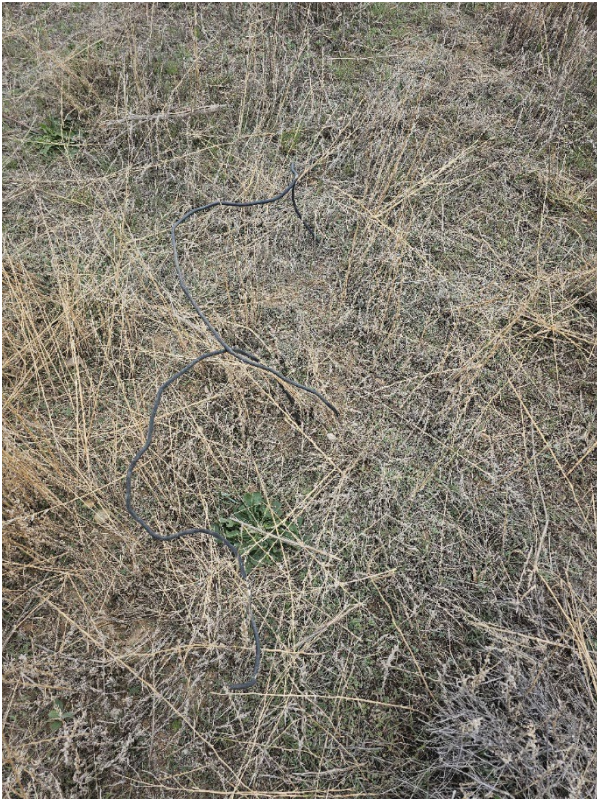
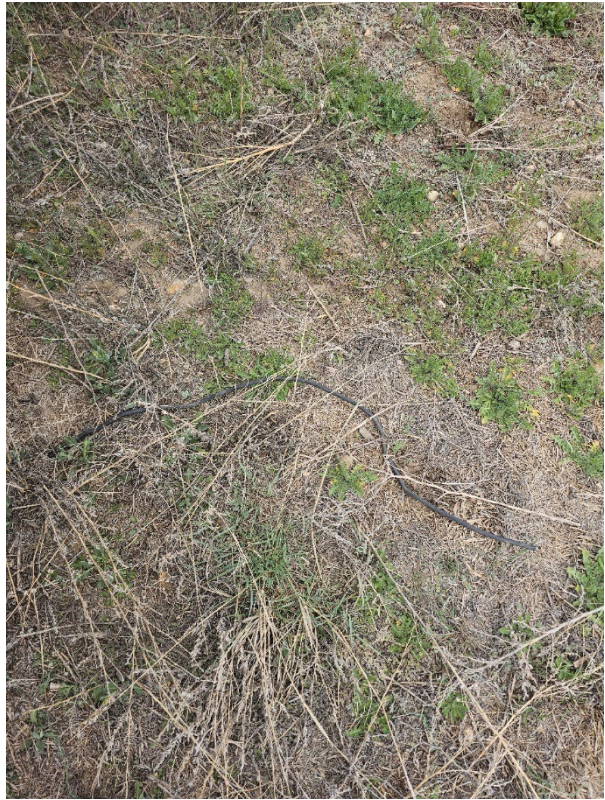
Observation 18 - DEBRIS - North

Trash – buried cable

- There are active and abandoned midstream assets in both the northern and southern parts of the reclamation area.
- Remove silt fencing, waddles and remaining oil and gas operational equipment.

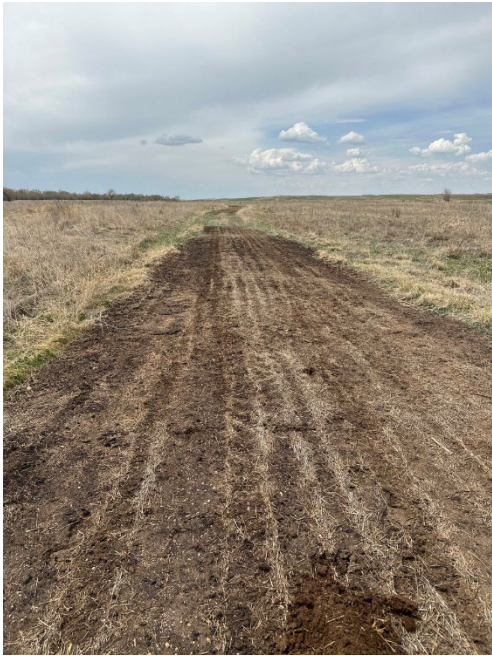
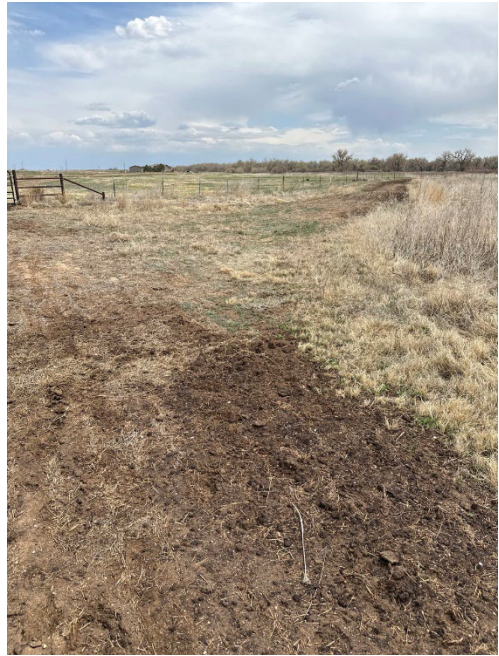
Observation 19 - ROAD - North

4inches of manure with compactions

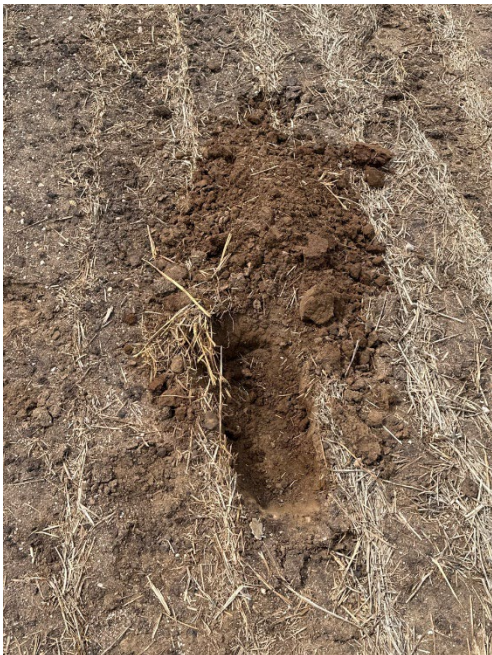
Unincorporated manure

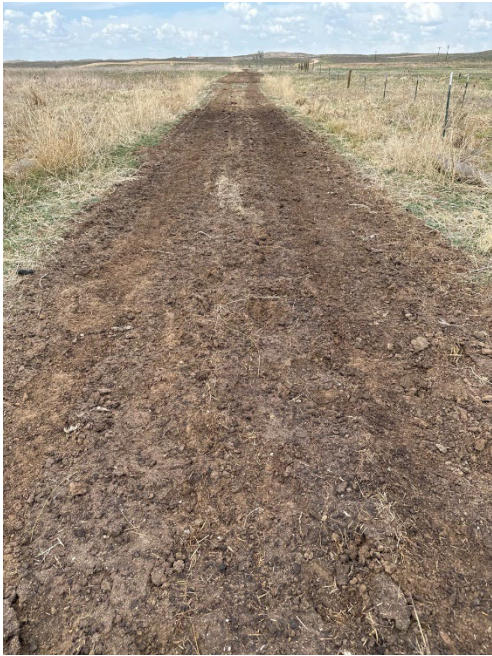
Observation 20 – ROAD and WADDLES- North

Manure, sand, and compaction

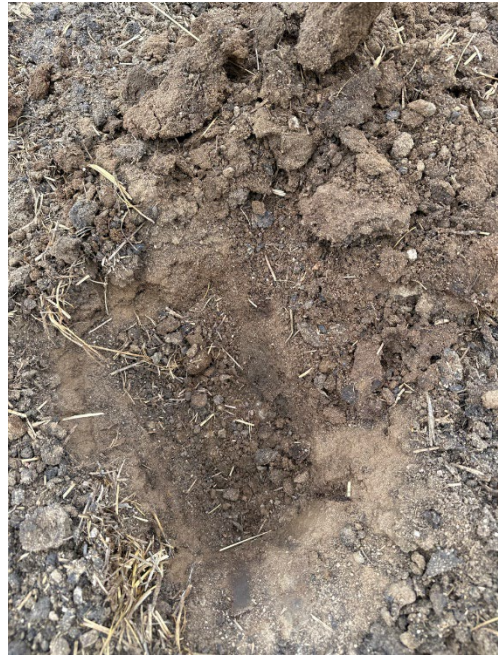
Unincorporated manure

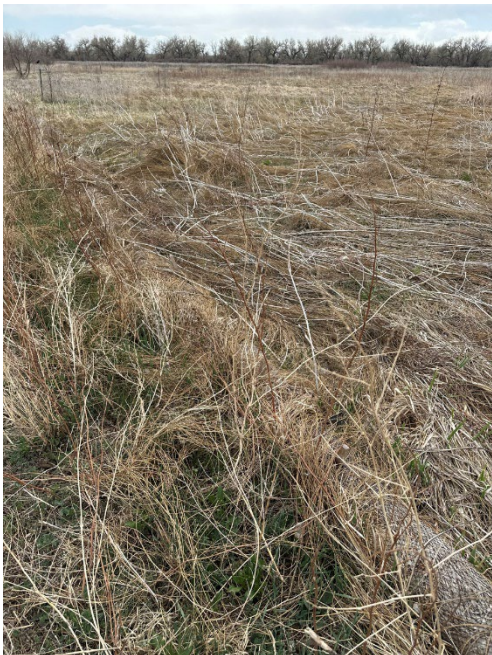
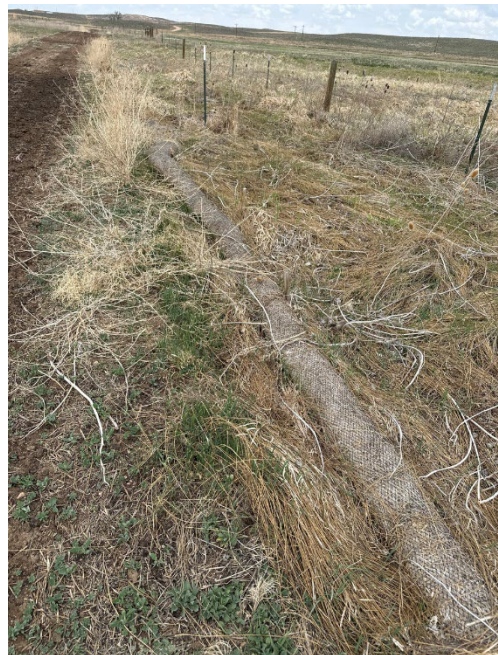
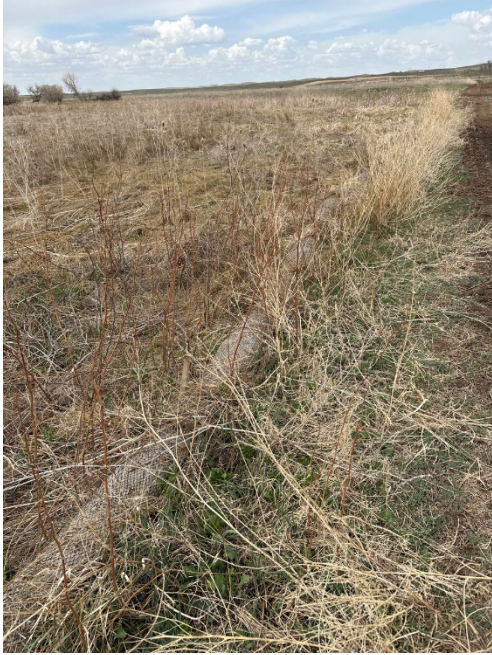
Waddles

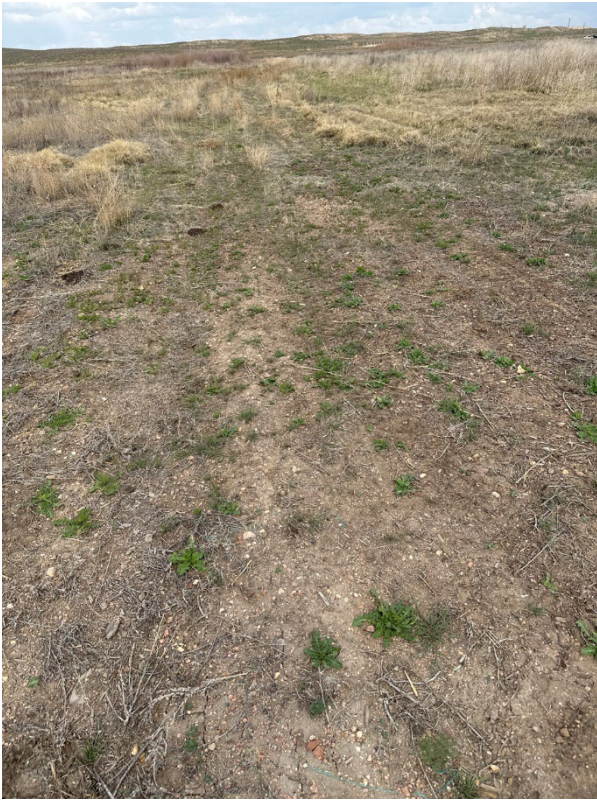
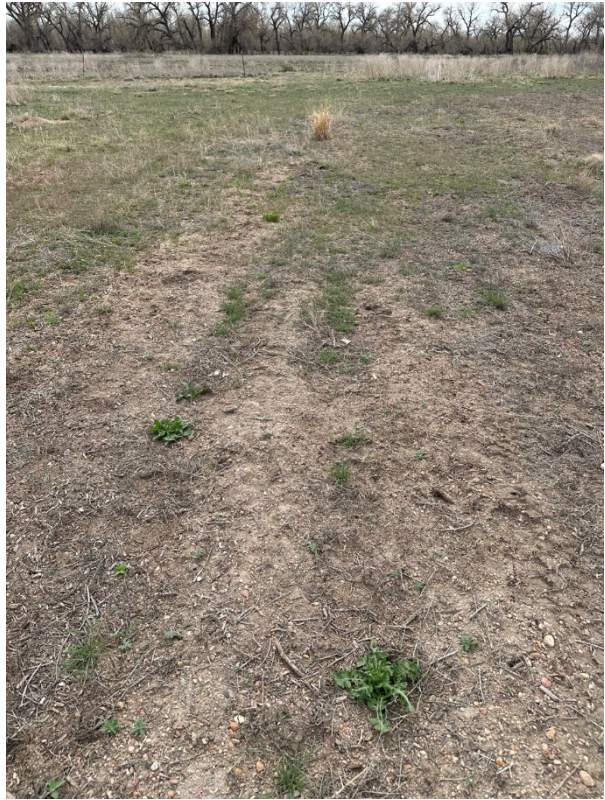
Observation 21 – ROAD- North

Gravel on access road

Road: 12 inches remove and replace

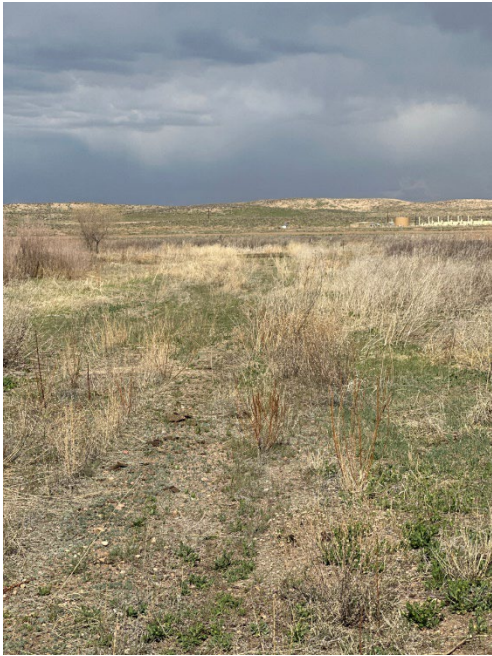
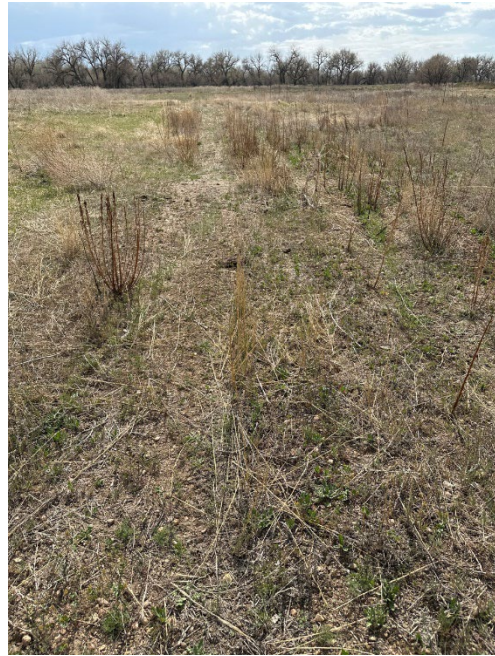
Observation 23 - ROAD - North

Weeds and 6 inches of gravel and rock and compaction on the access road

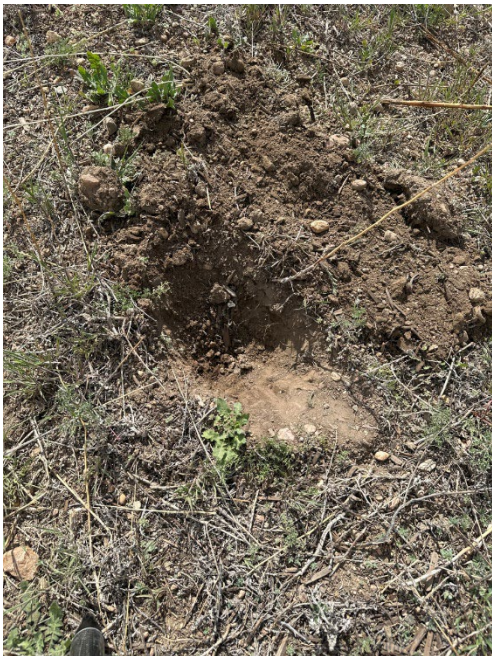
Gravel and rocks

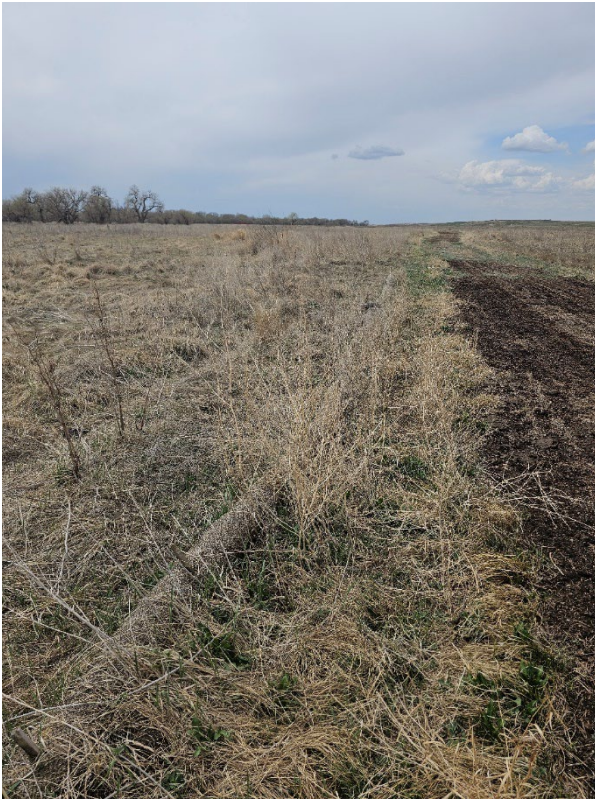
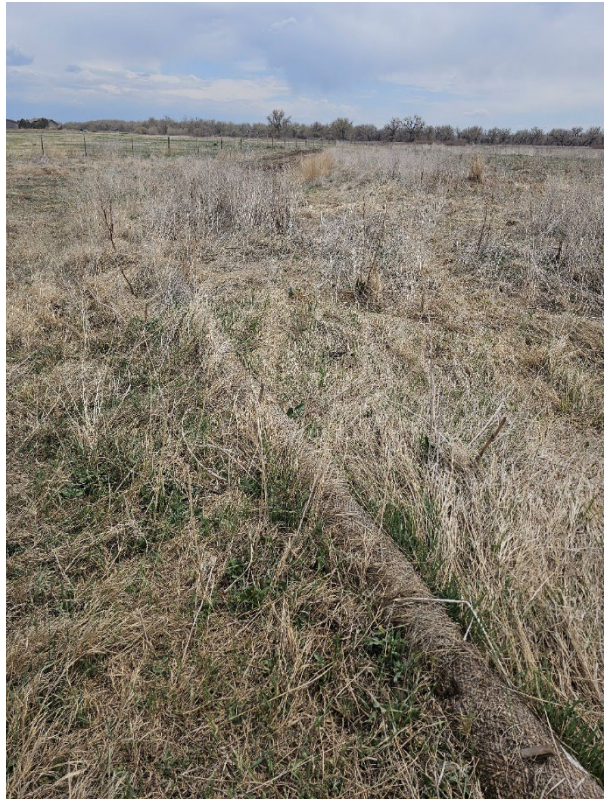
Observation 26 – ROAD - North

Trash – Straw Waddle
