**TEP Rocky Mountain LLC
GM 14-27
Loc ID: 335306**

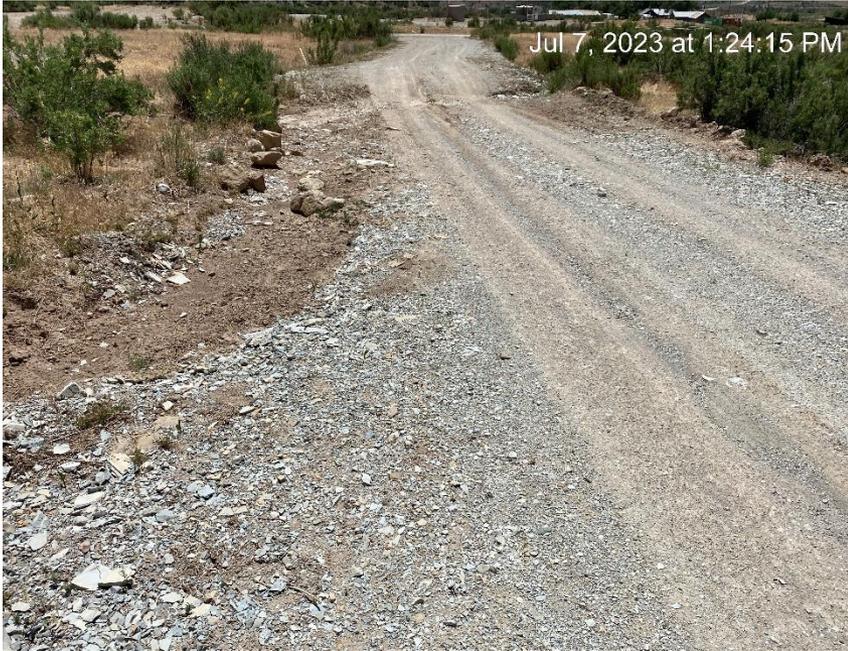
Drainage crossing access road

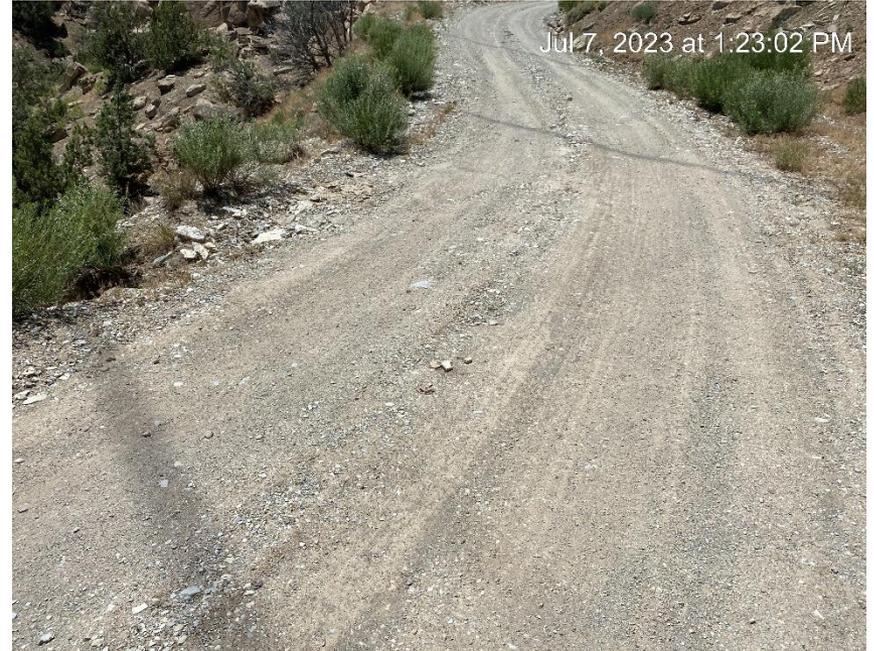
Stormwater crosses road before reaching culvert

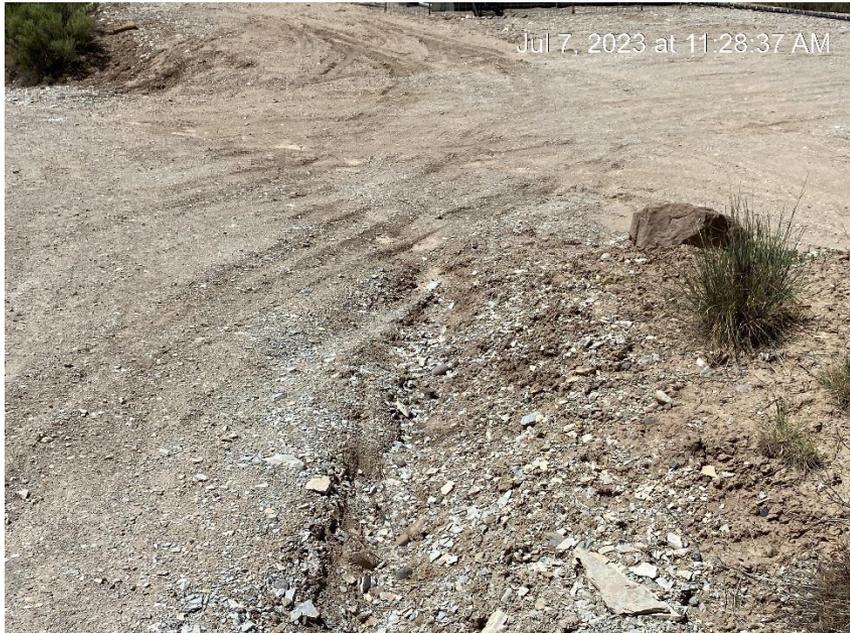
Erosion and sediment migration

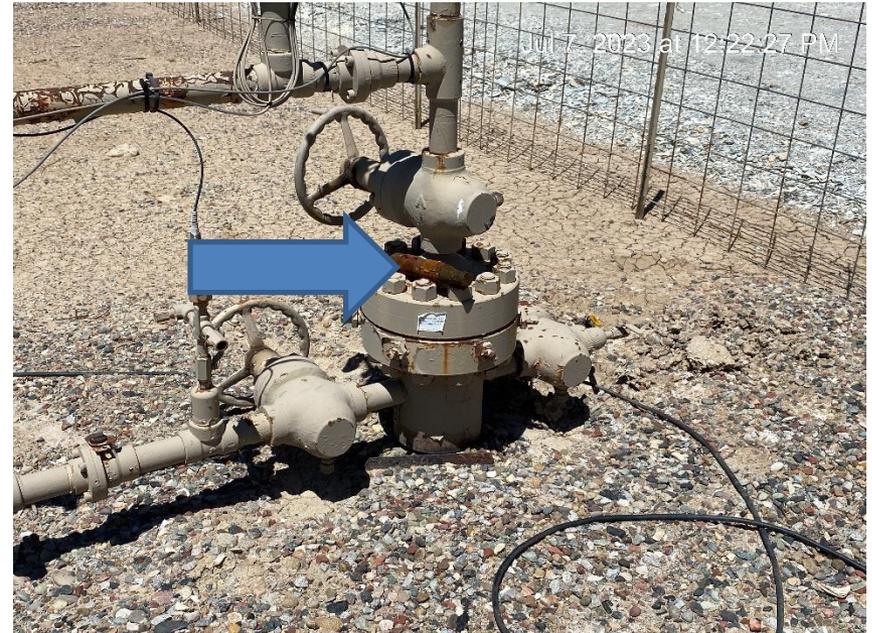
Debris

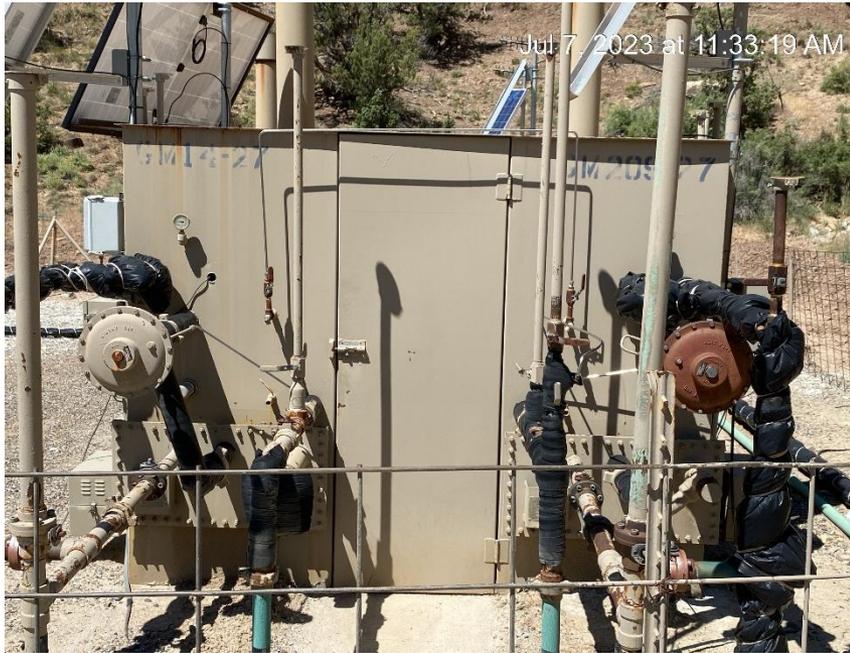
No visible display of gas meter calibration

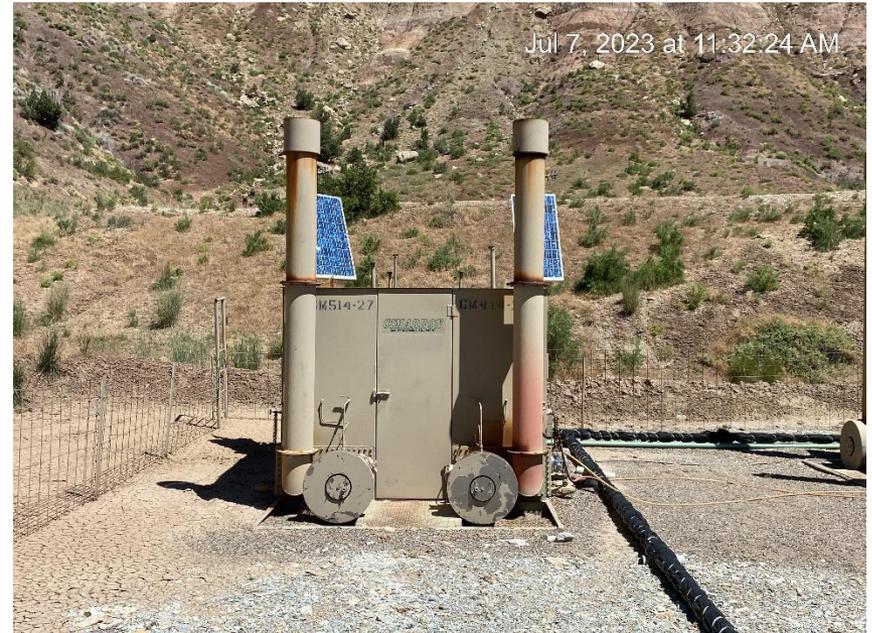
Gas meter calibration not displayed

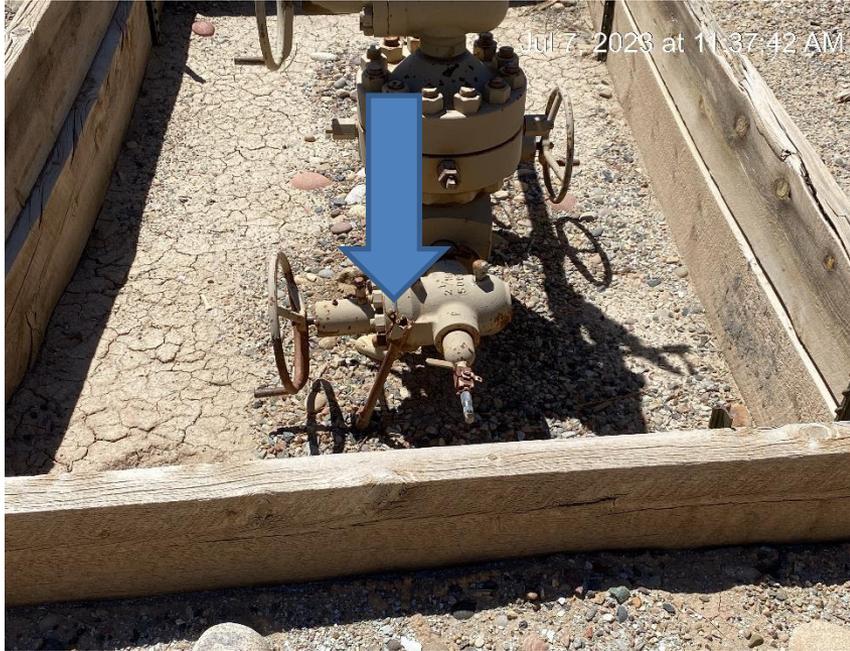
Open surface casing valve

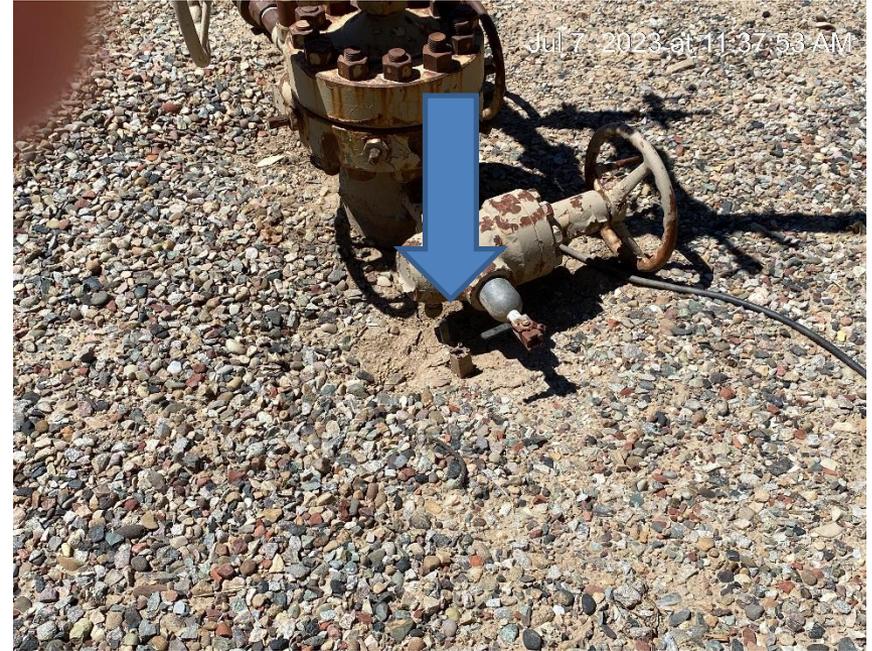
Surface casing valve left open

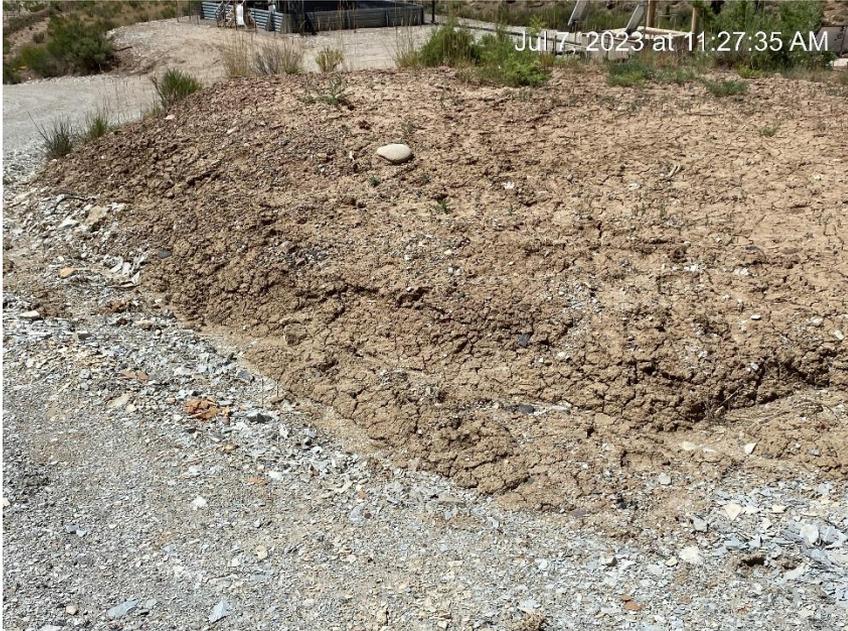
Erosion and sediment migration

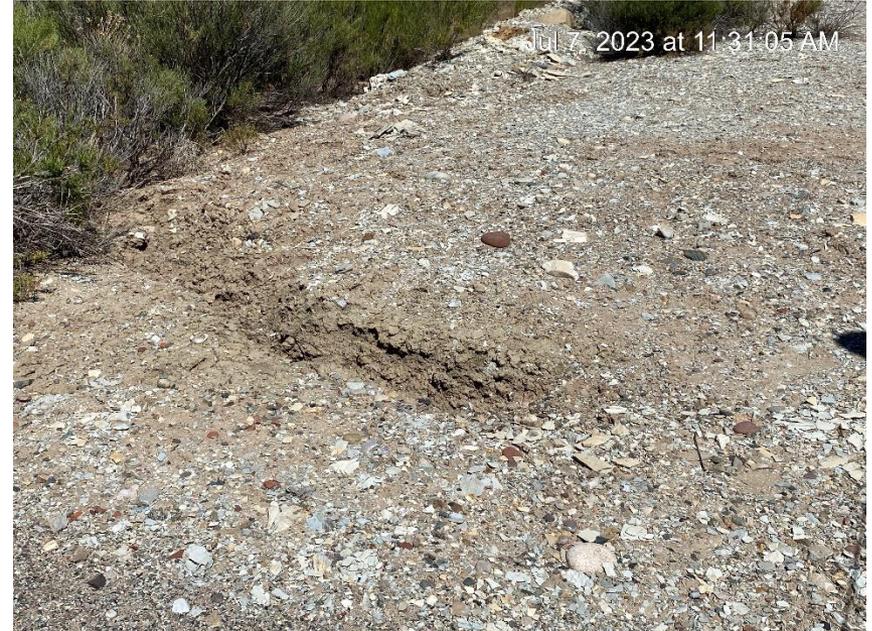
Erosion off location to production pad

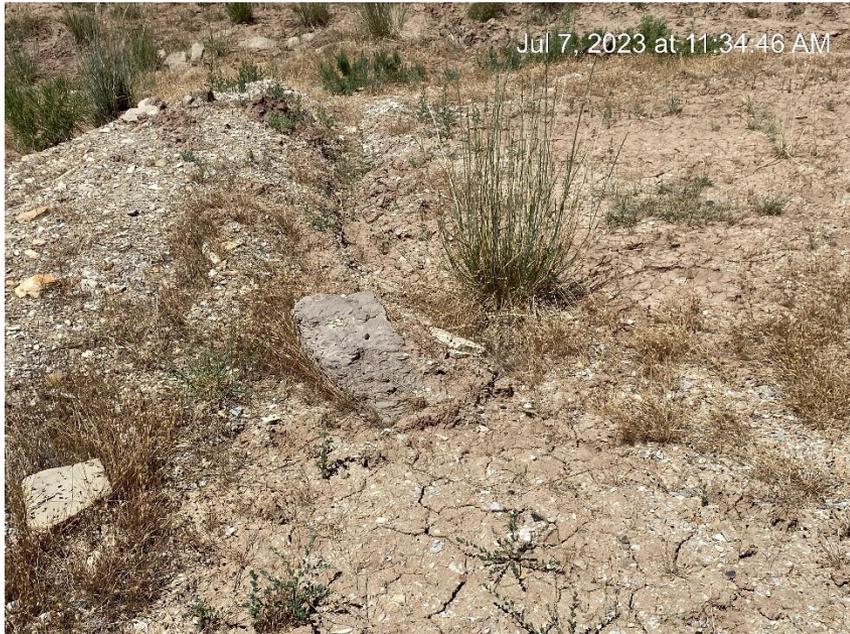
Erosion and sediment migration from location

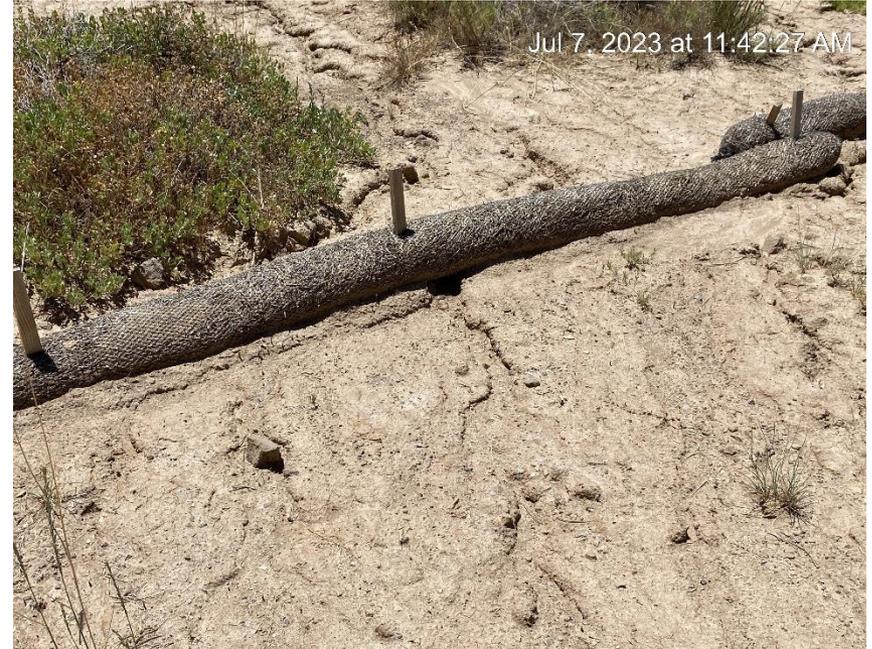
Wattles ineffective in places

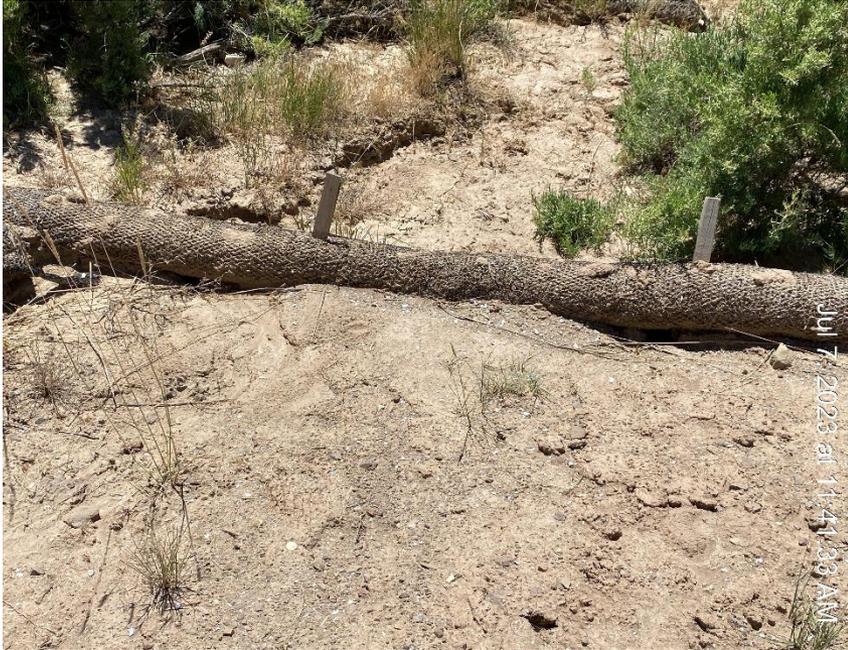
Wattle failure

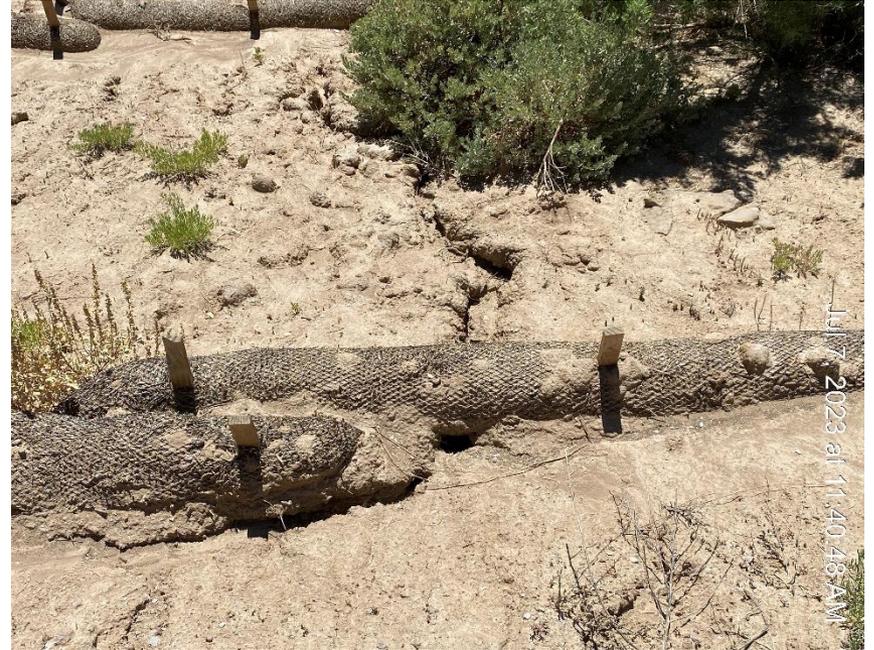
Wattle erosion
