# Inspection Photos

API: 061-06166

Operator: RENEGADE OIL & GAS COMPANY

Inspection Date: 8/24/2023

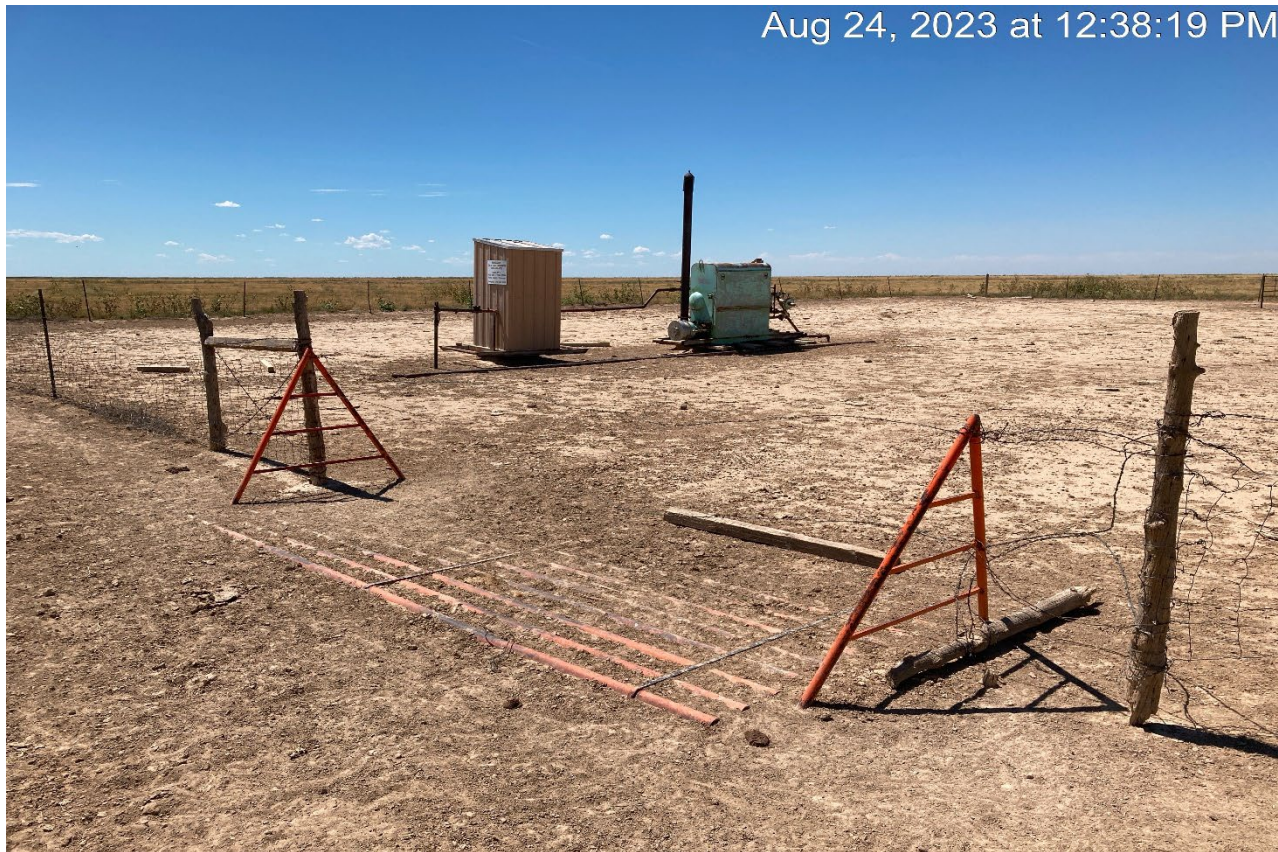
**Photo 1.** Facing southwest toward the location. The cattlegurd entering the location is filled in with sediment and needs to be maintained.

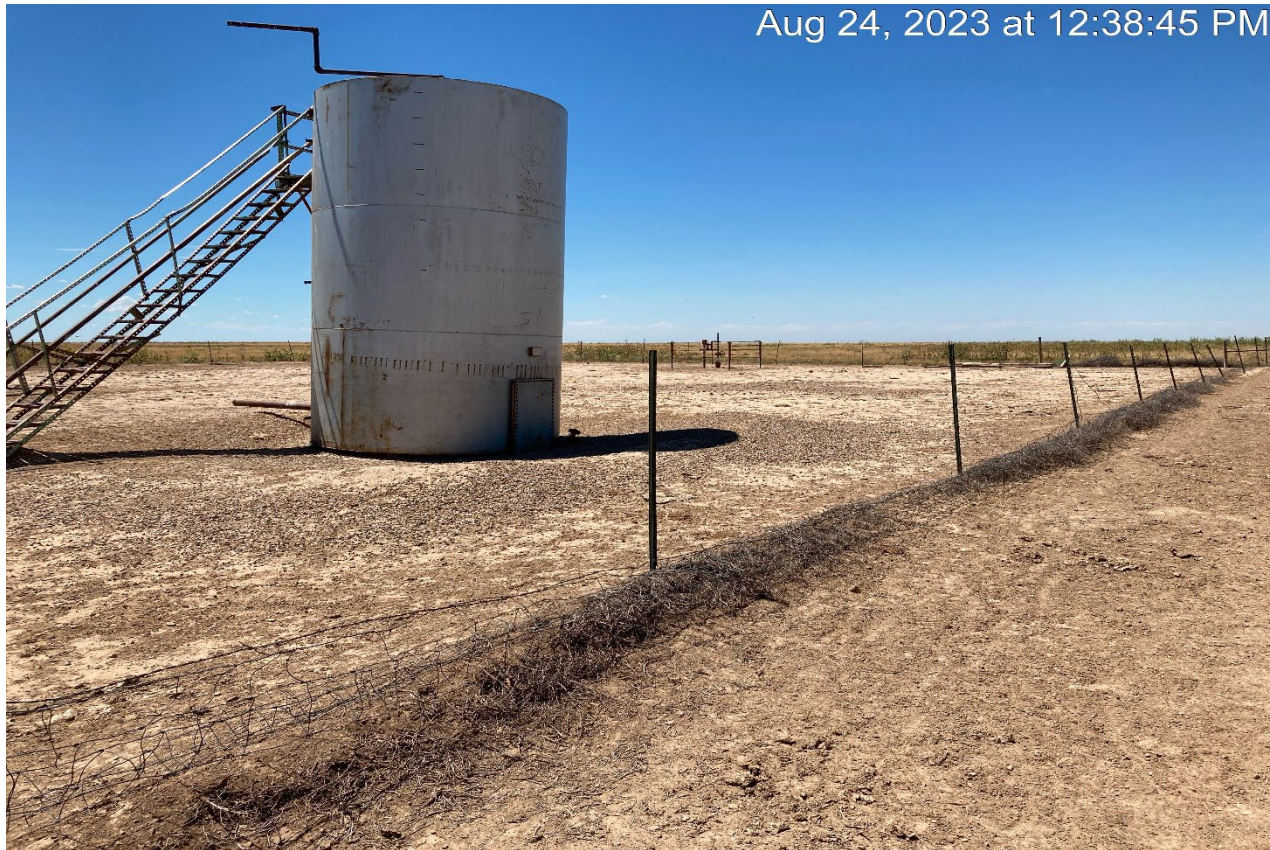
**Photo 2.** The secondary containment at the tank is insufficient to contain a spill.

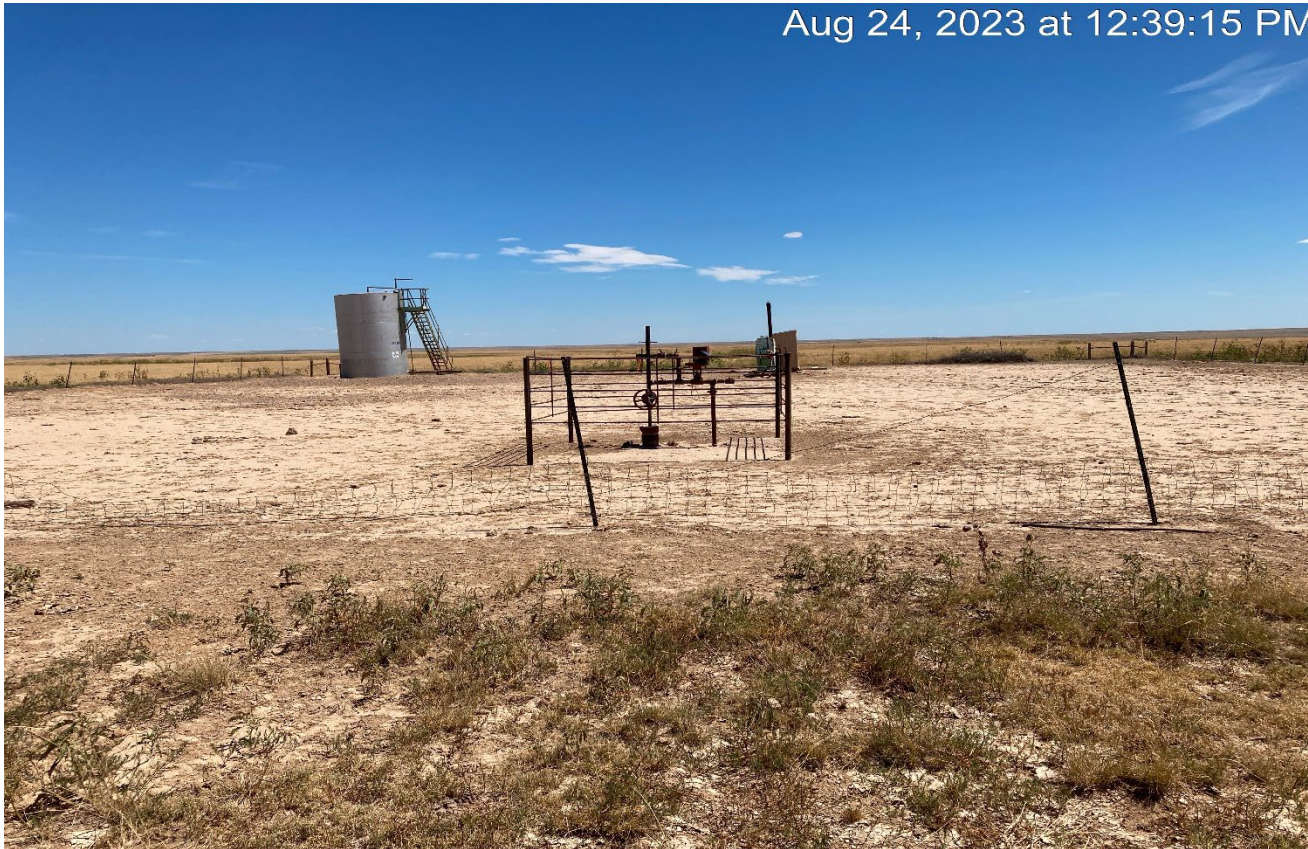
**Photo 3.** Facing toward the well. There was a gas hissing noise heard from the wellhead and a hydrocarbon odor was present. Operator was immediately notified.

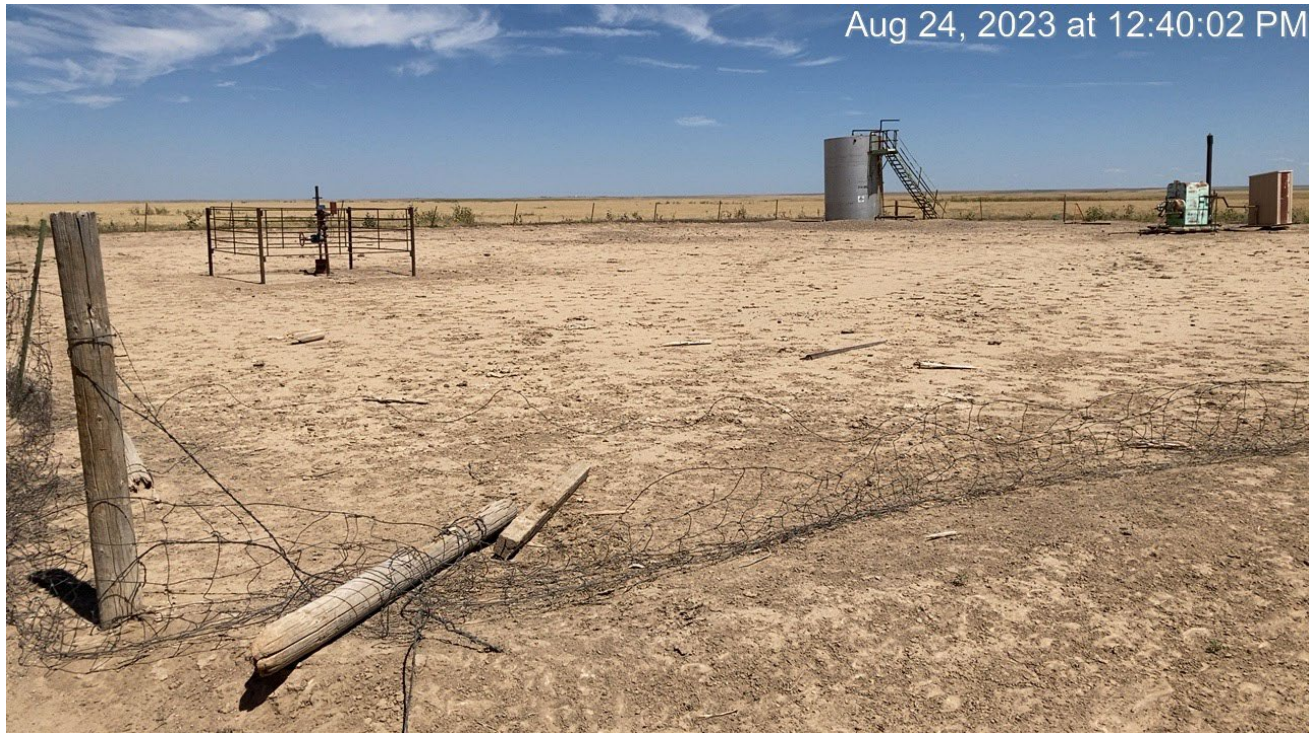
**Photo 4.** Facing northwest toward the location. The fence around the location is in disrepair. There are unused areas of the location that should be reclaimed.
