# Inspection Photos

API: 061-06271

Operator: SAMSON OIL COMPANY

Inspection Date: 8/24/2023

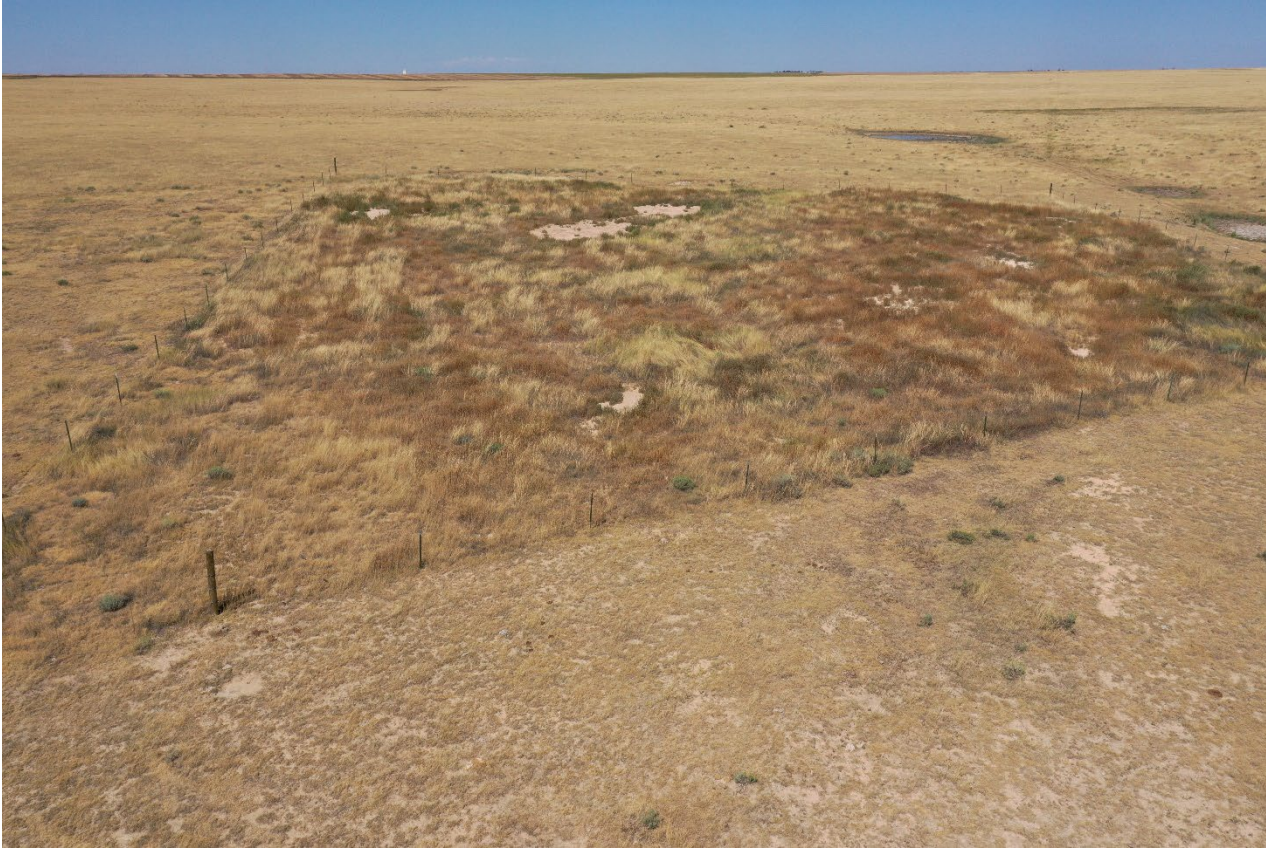
**Photo 1.** Drone aerial photo facing west toward the location.

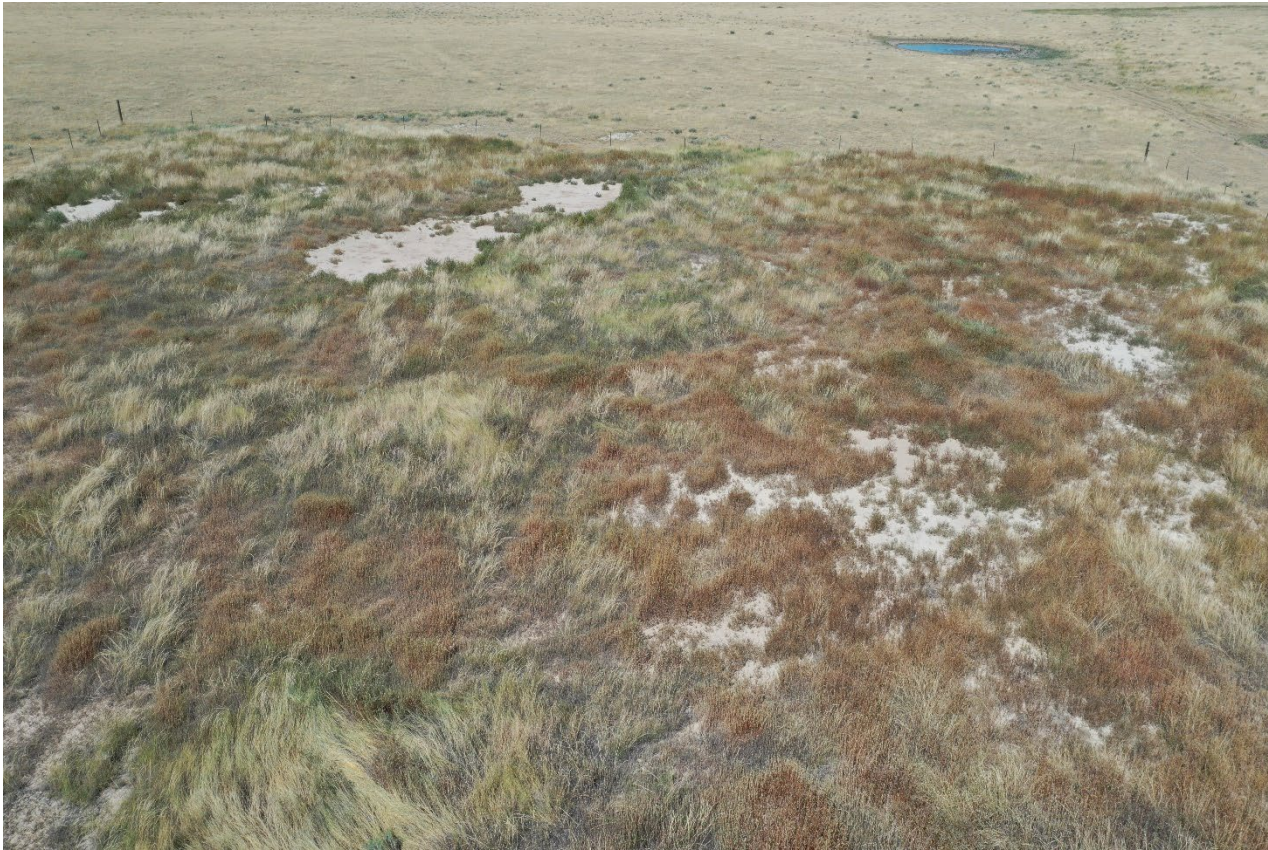
**Photo 2.** Drone aerial photo facing west down toward the location. The reddish brown vegetation is undesirable weeds (Kochia). The desirable vegetation has not re-established and there are bare areas with no vegetation.

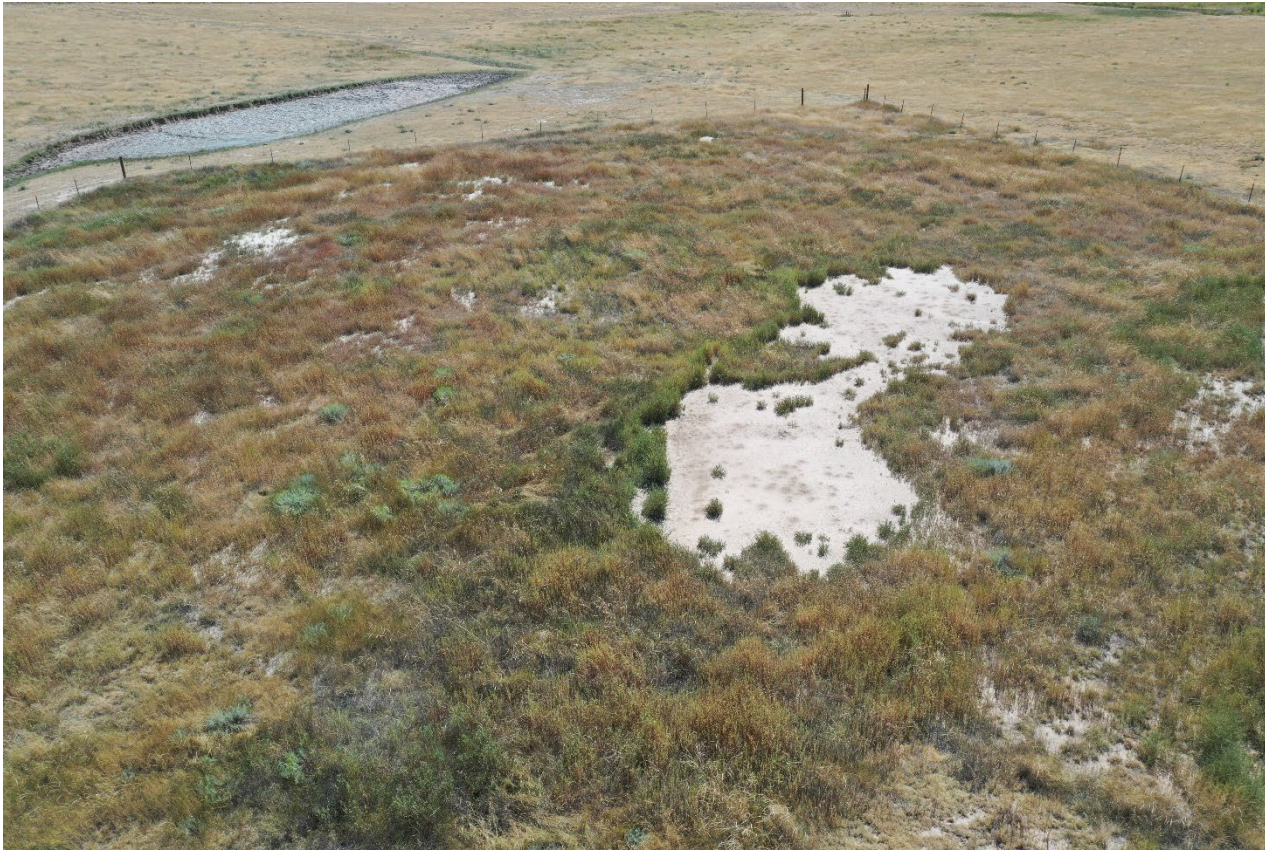
**Photo 3.** Drone aerial photo facing east down toward the location. The reddish brown vegetation is undesirable weeds (Kochia). The desirable vegetation has not re-established and there are bare areas with no vegetation. The bare area appears to be impacted soil from the well site.

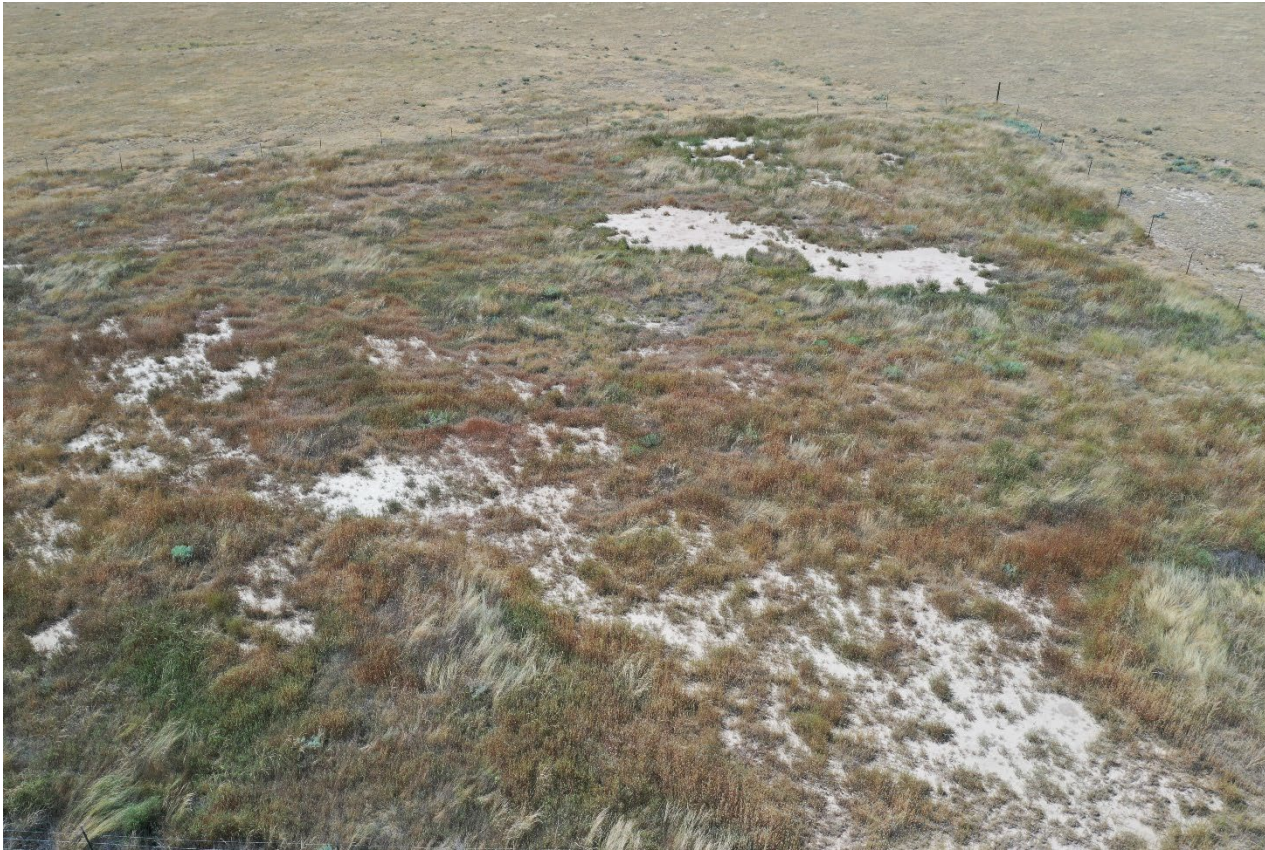
**Photo 4.** Drone aerial photo facing south toward the location. The reddish brown vegetation is undesirable weeds (Kochia). The desirable vegetation has not re-established and there are bare areas with no vegetation.

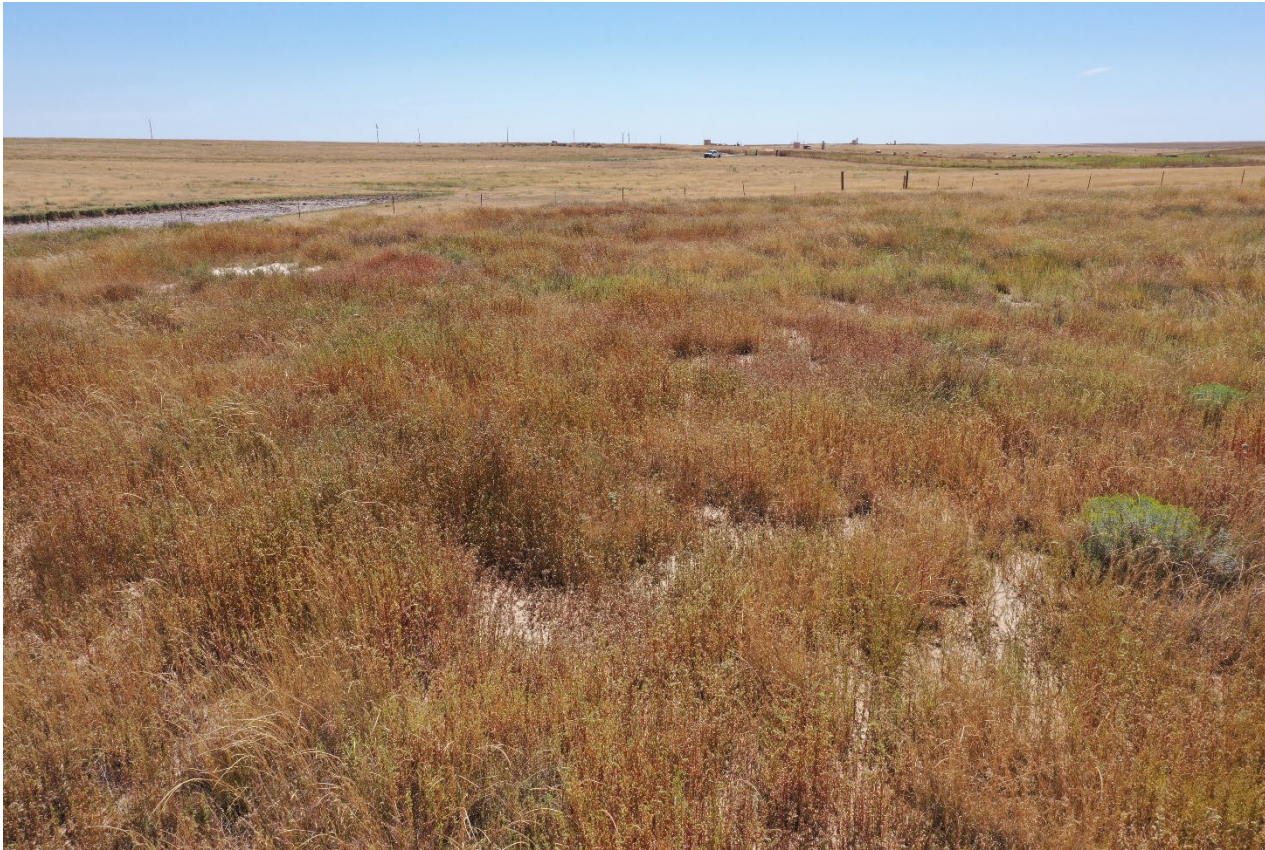
**Photo 5.** Closer view of the location facing west. The tall undesirable weeds (Kochia) which needs to be controlled.

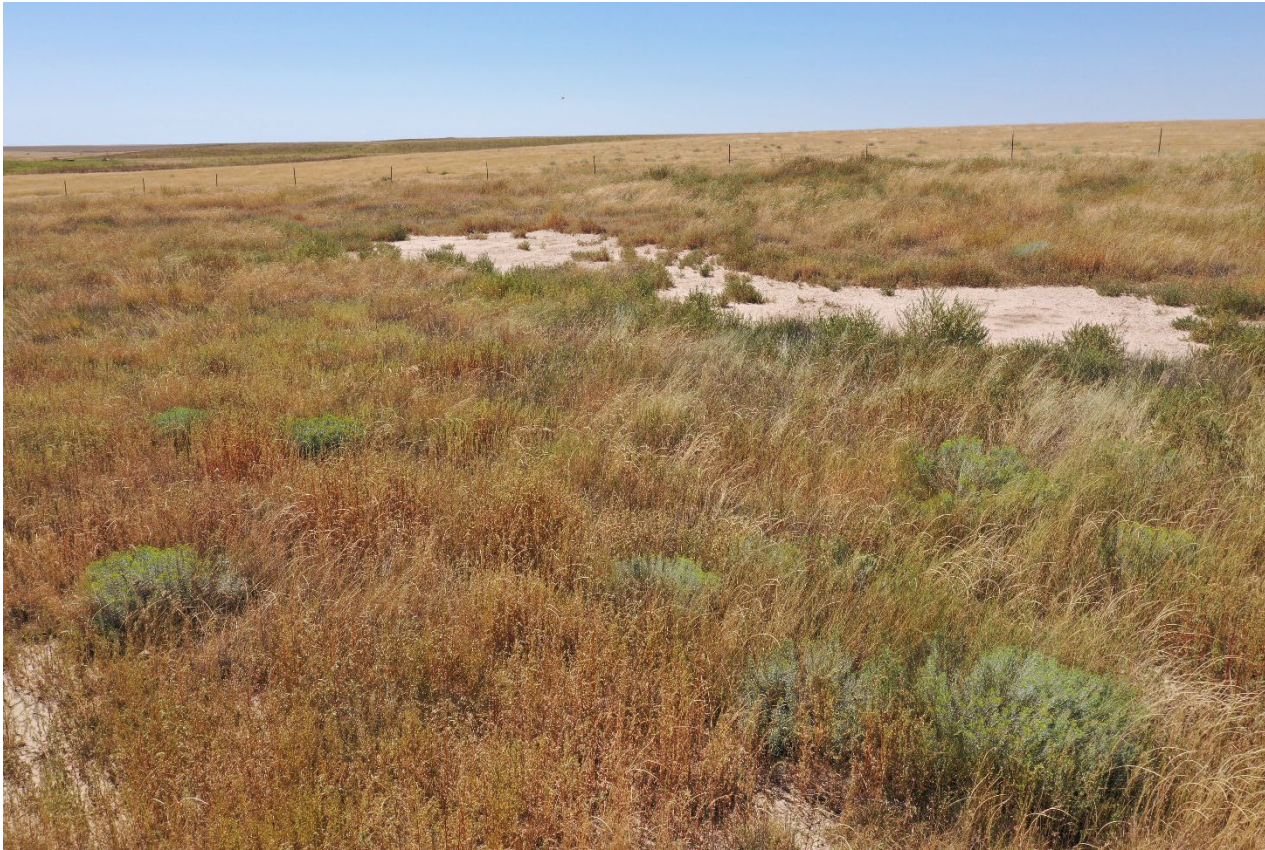
**Photo 6.** Closer view of the location facing south. The tall undesirable weeds (Kochia) which needs to be controlled.
