Inspection Photos

API: 061-06366

Operator: SAMSON OIL COMPANY

Inspection Date: 8/24/2023

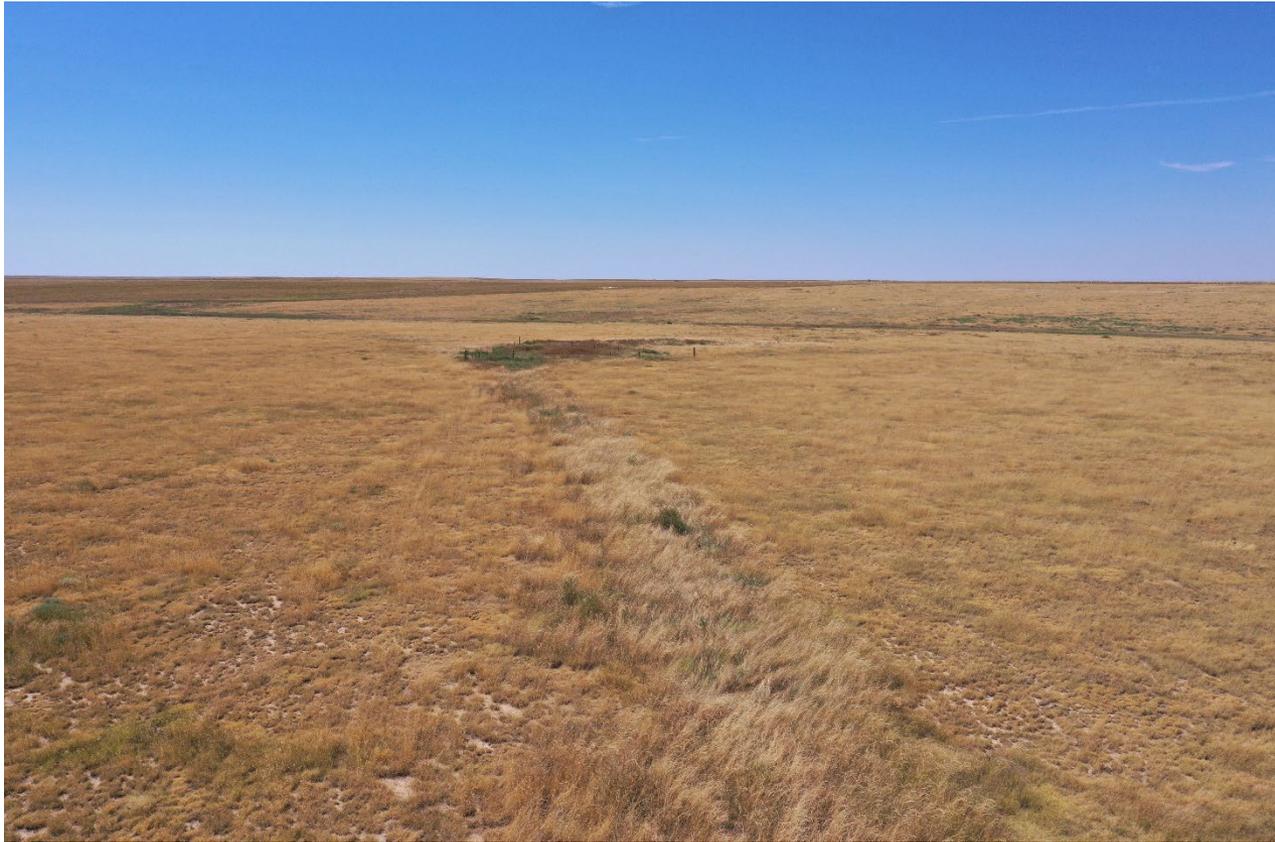
Photo 1. Drone aerial photo facing south toward the former access road and location. The perennial vegetation along the access road has re-established.

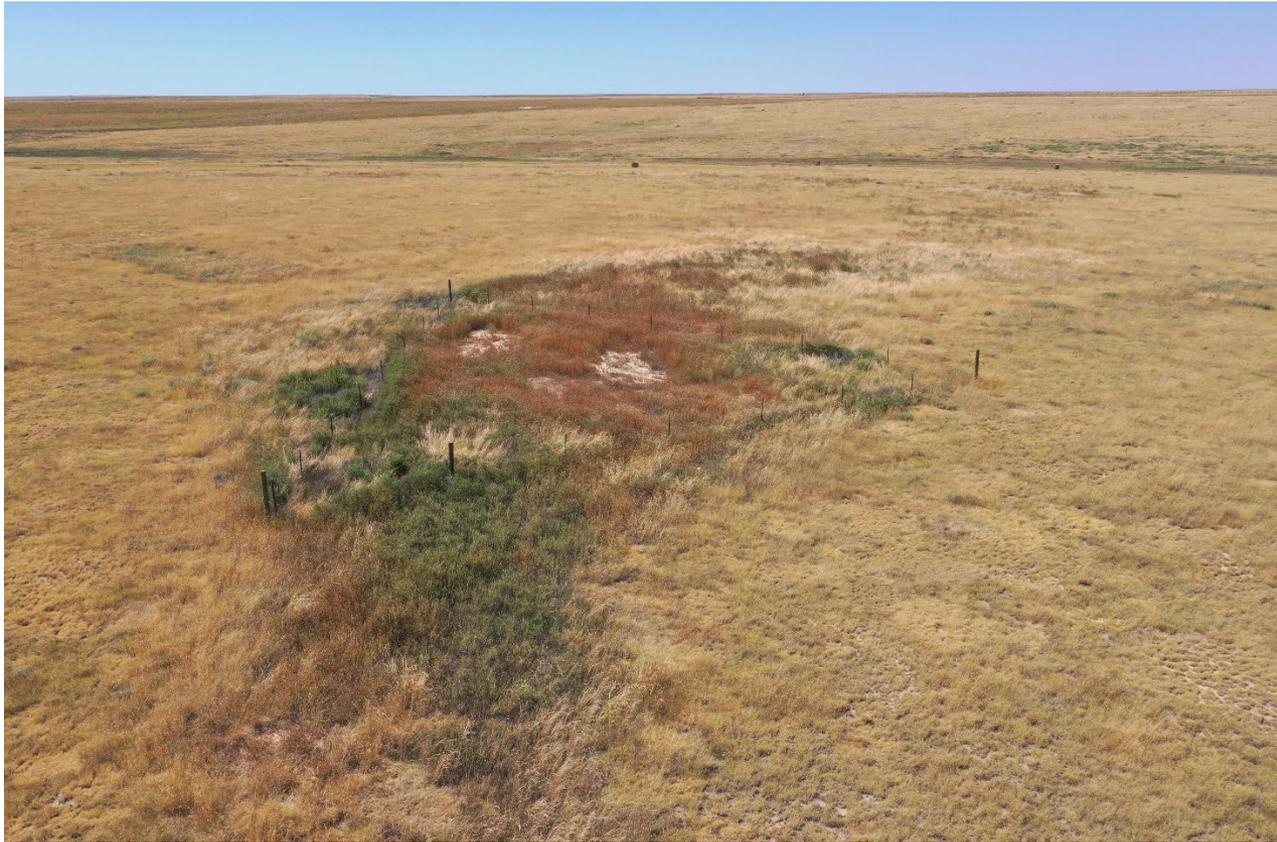
Photo 2. Drone aerial photo facing south toward the location. The green and reddish vegetation is undesirable weeds (Kochia) The desirable vegetation has not re-established.

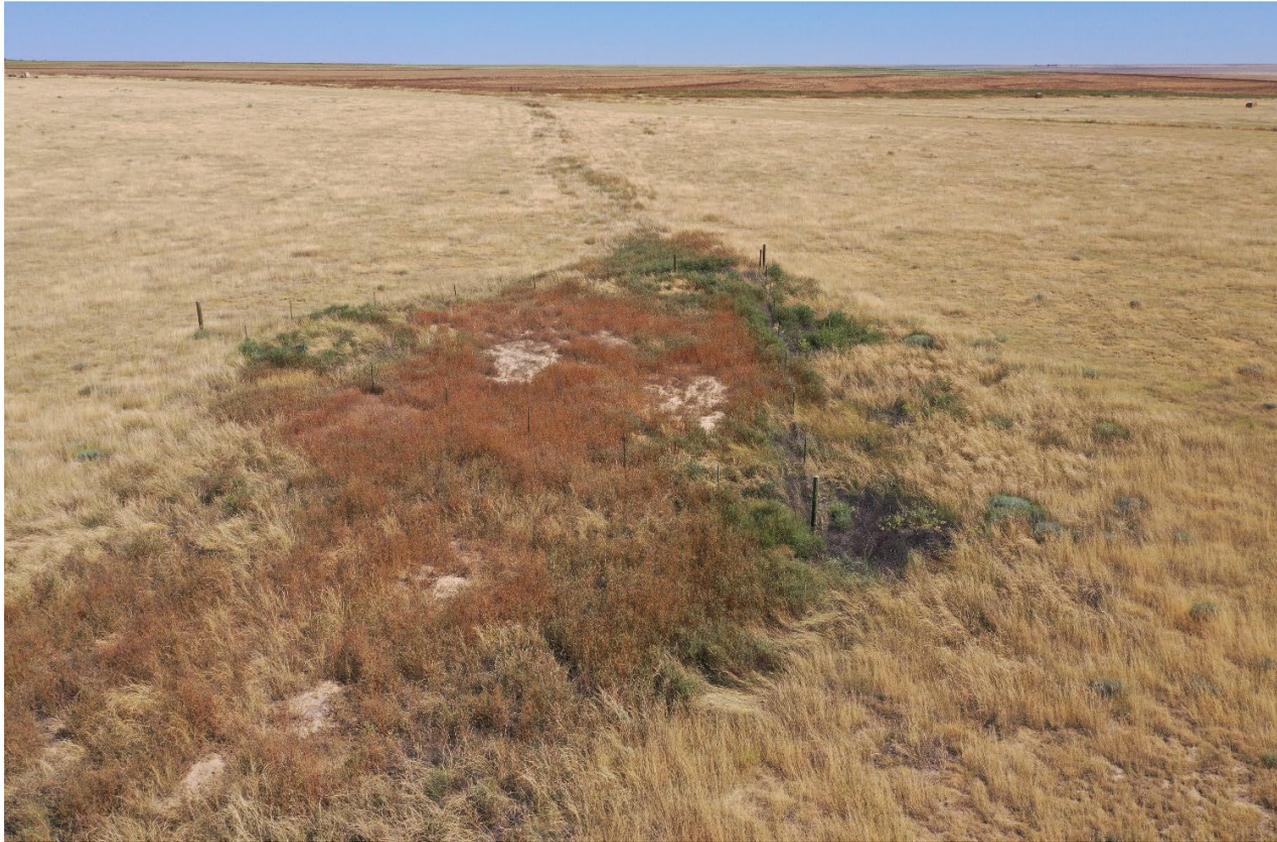
Photo 3. Drone aerial photo facing north toward the location. The green and reddish vegetation is undesirable weeds (Kochia) The desirable vegetation has not re-established.

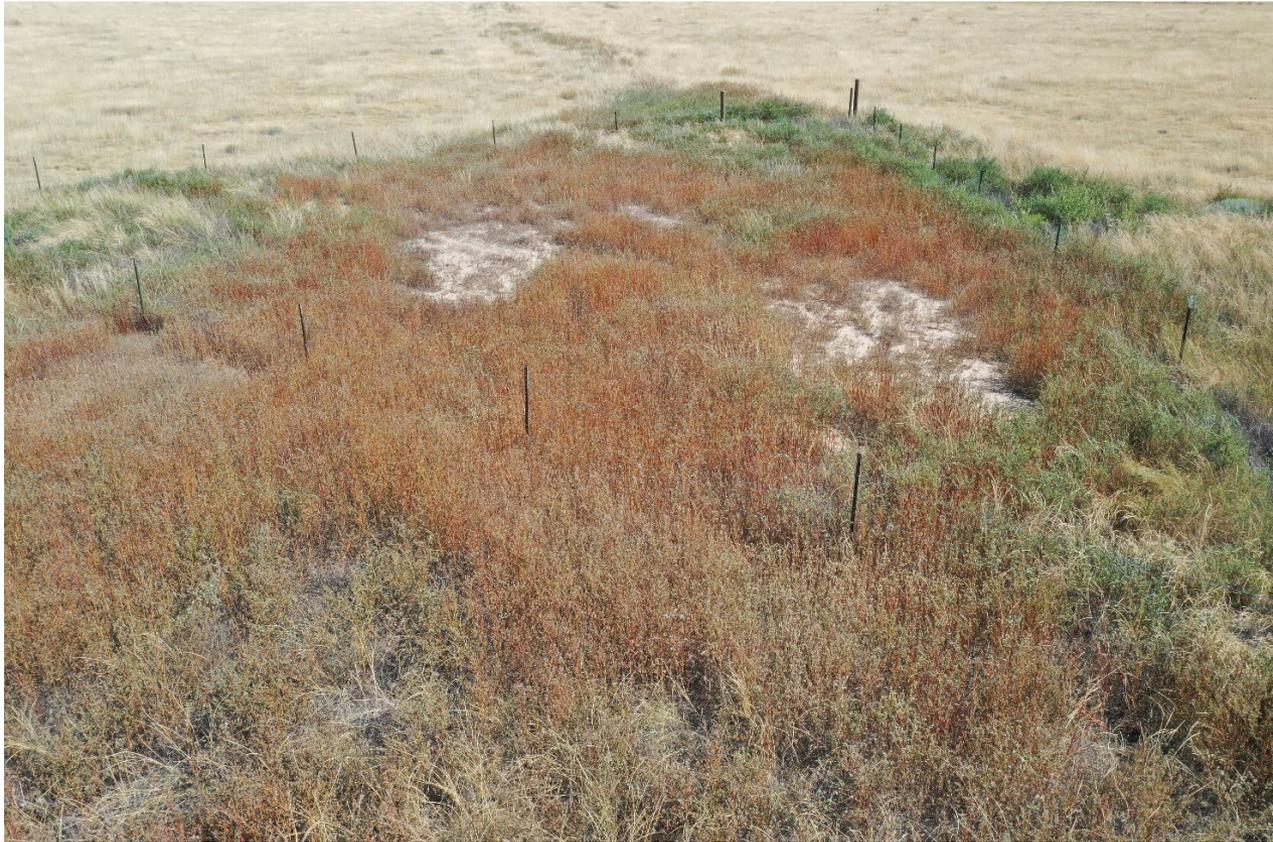
Photo 4. Closer view of the location and tall undesirable weeds (Kochia) which needs to be controlled. The fence installed does not completely surround the entire location.
