# Inspection Photos

Loc: 324498

Operator: **OXY USA INC**

Inspection Date: 10/11/2023

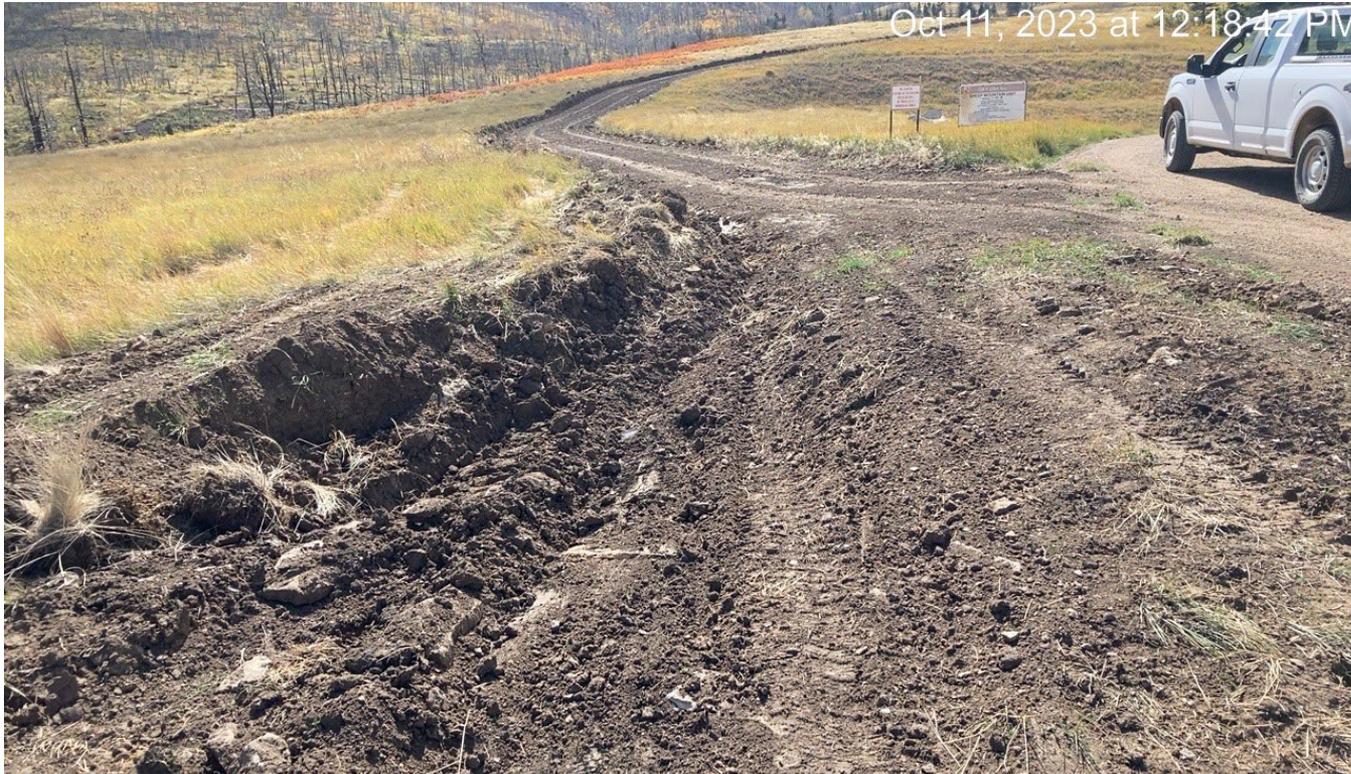
**Photo 1.** Facing southwest along the access road near the SMU #1-12-B . This area was bladed and sediment was pushed further out creating disturbance. Grading activities as the only BMP is not sufficient to stabilize the road.

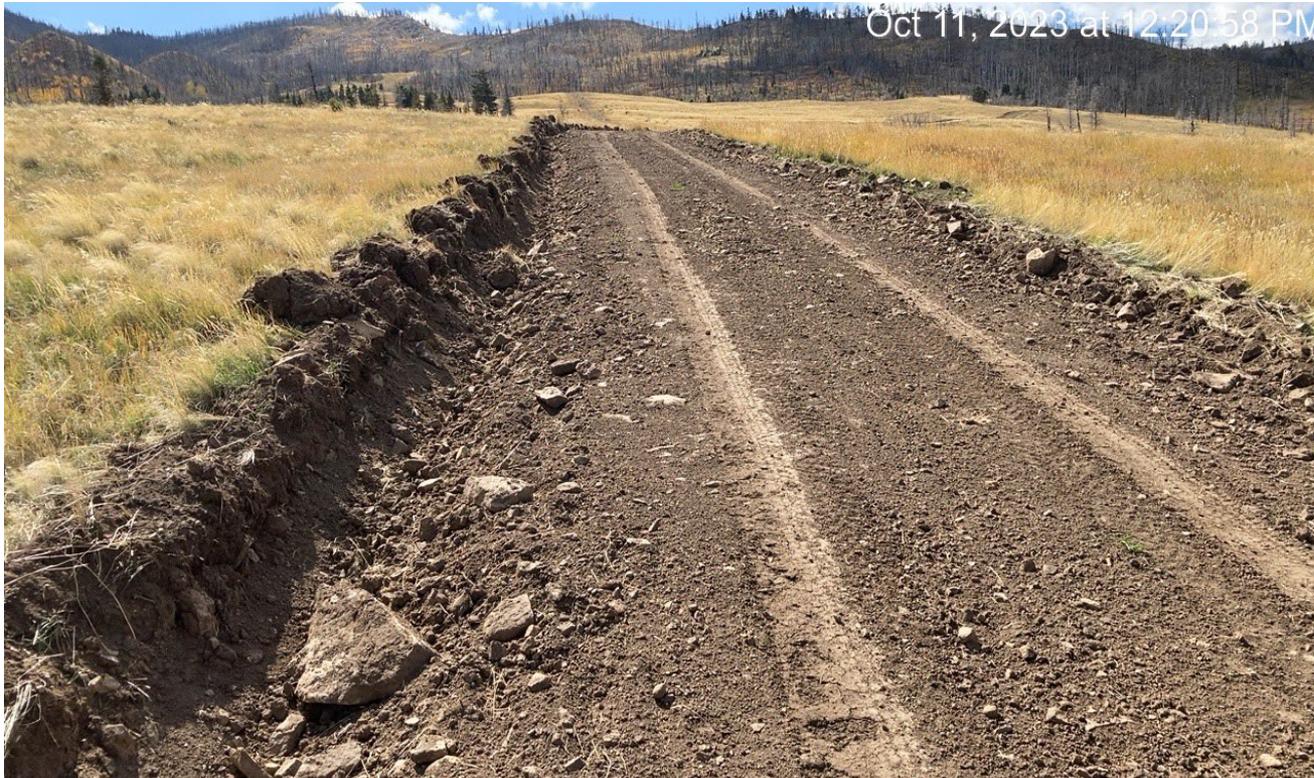
**Photo 2.** Facing southwest along the access road. The road has recently been graded however, no other BMP's have been installed.

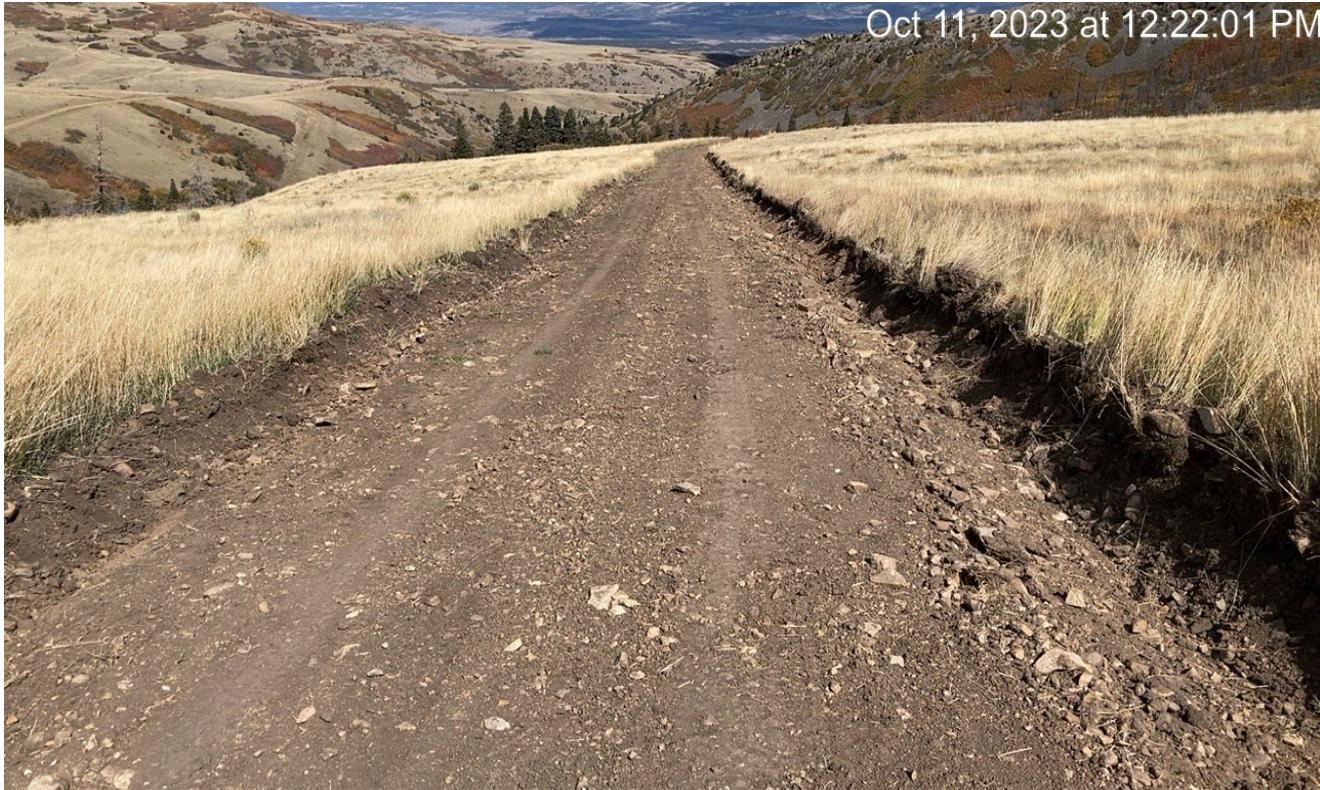
**Photo 3.** Facing northeast back down the access road. Grading activities as the only BMP is not sufficient to stabilize the road and prevent stowmwater erosion issues of the road.

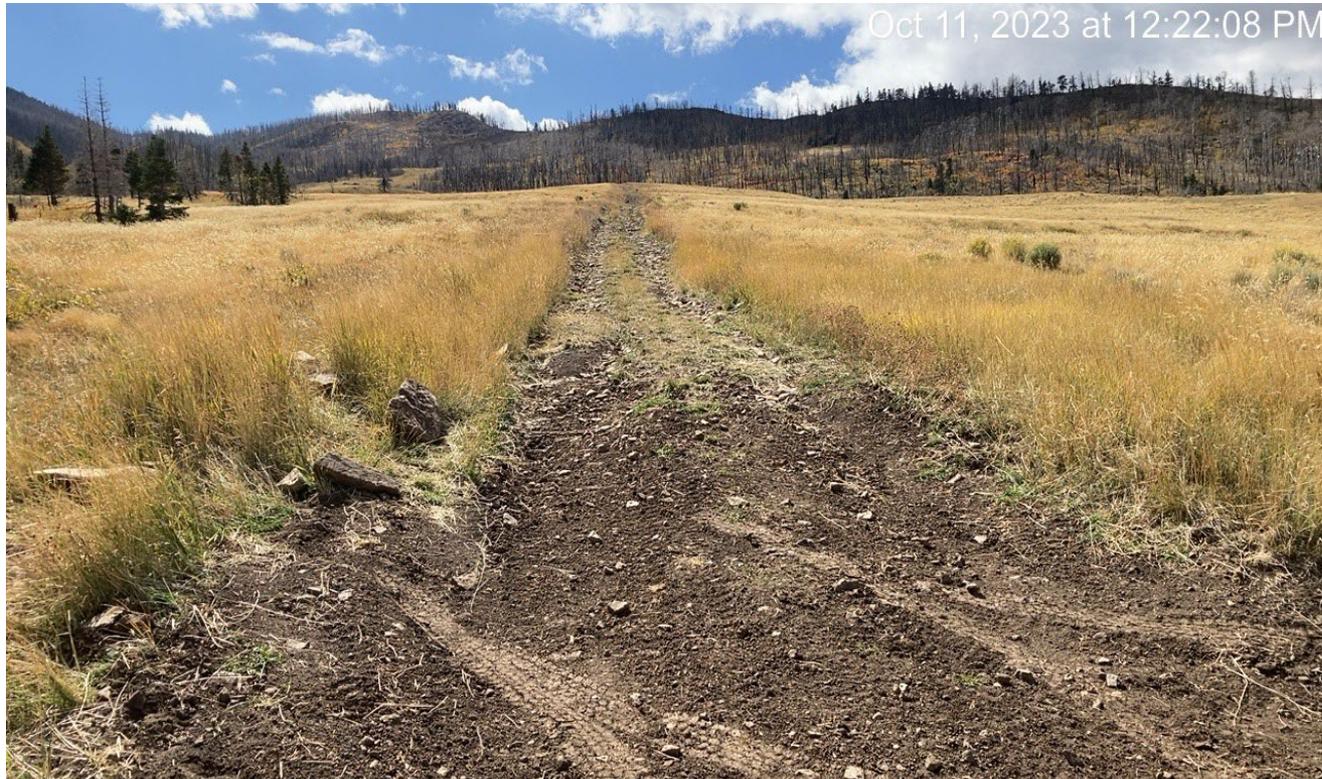
**Photo 4.** Facing southwest along the access road. Grading of the road stopped at this point and the remainder of the road remains eroded with insufficient BMP maintenance.

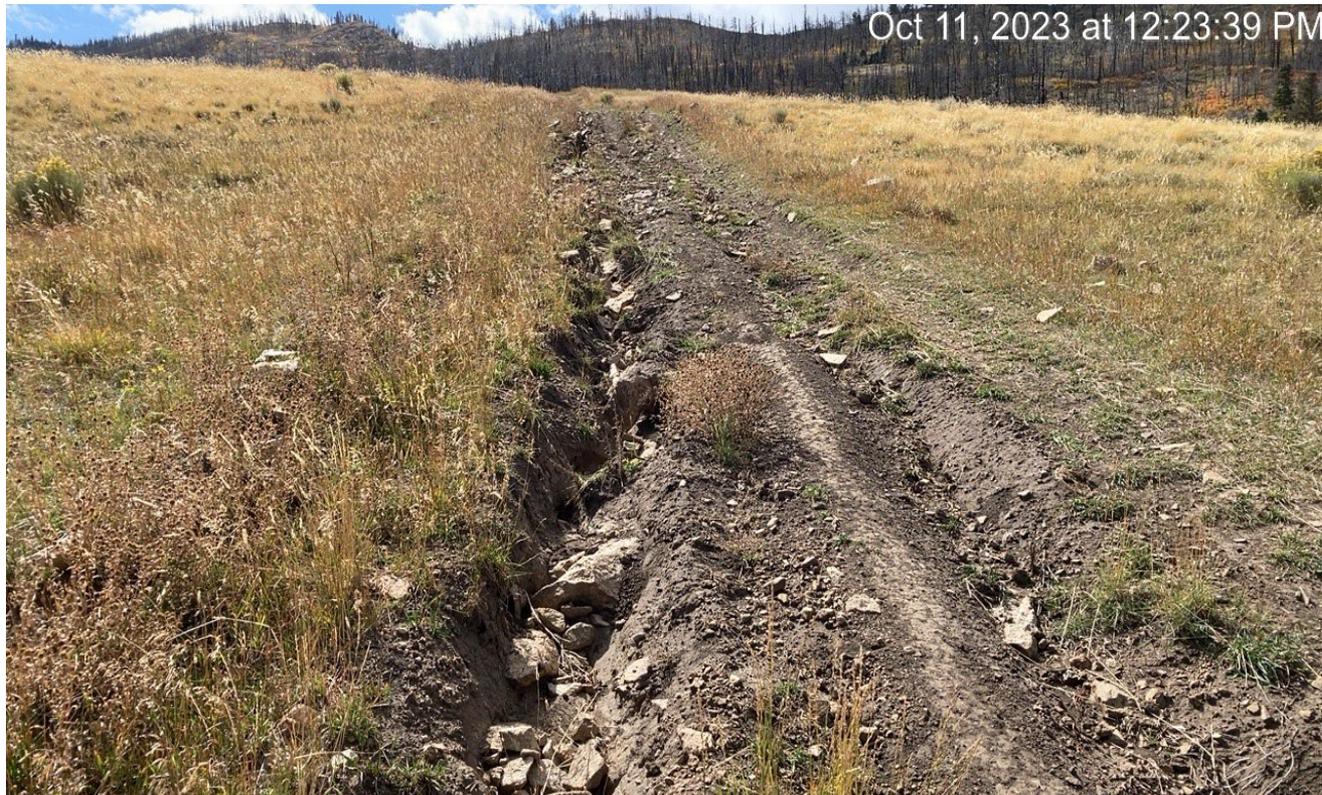
**Photo 5.** Facing southwest further along the access road. There are areas of erosion occurring which need to be repaired and stabilized.

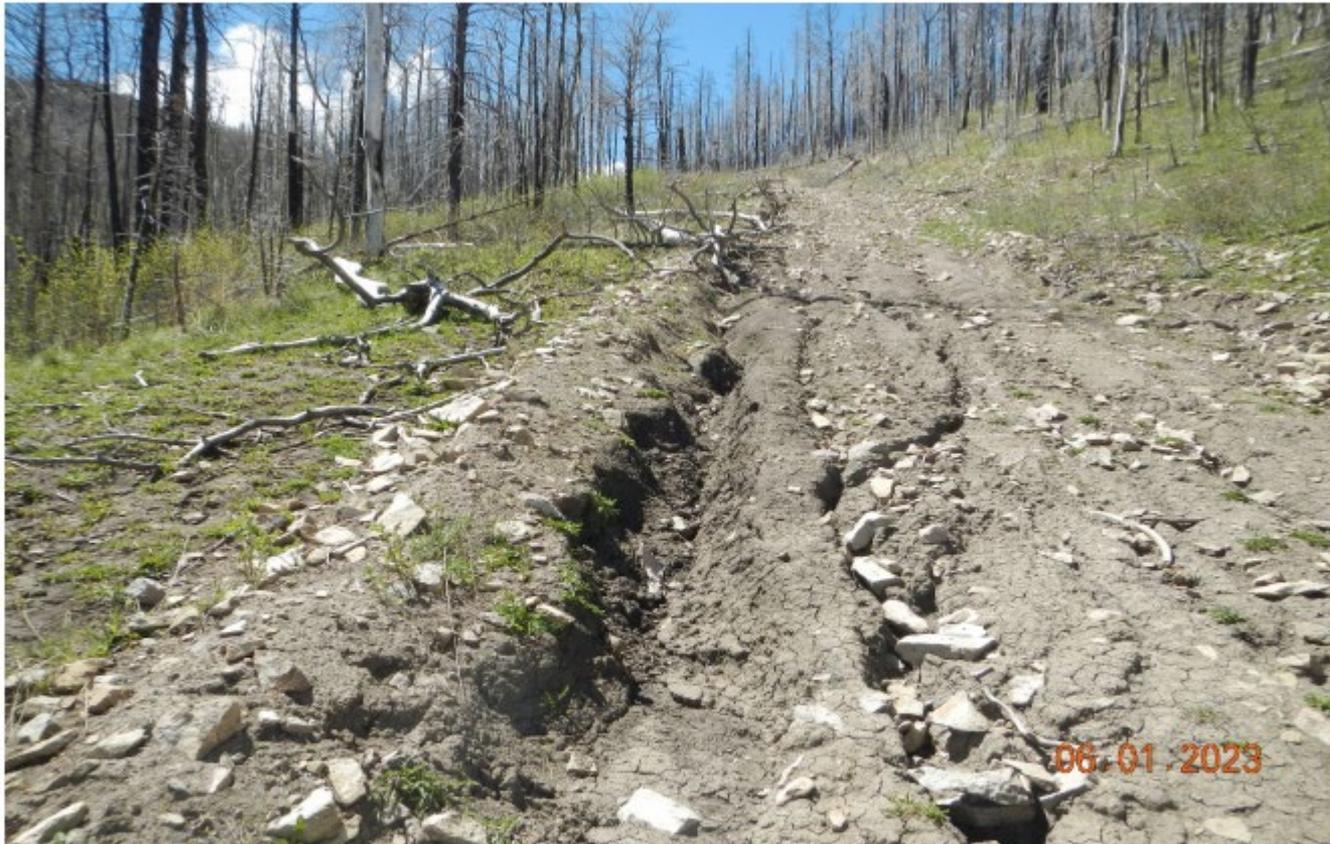
**Photo 7.** Facing southwest further along the access road. There are areas of erosion occurring which need to be repaired and stabilized. Previous corrective action has not been completed.

Photo taken from previous inspection 6/1/2023.

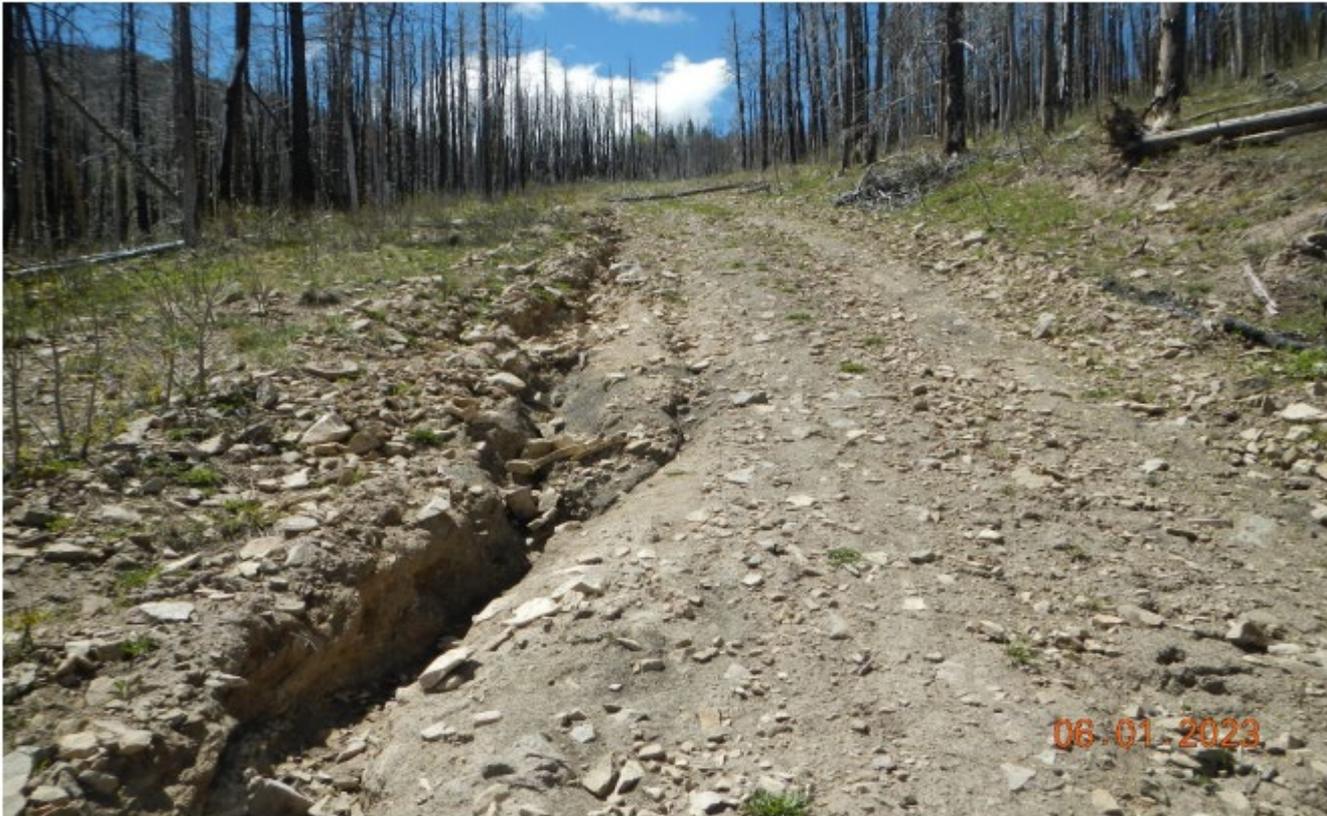
**Photo 8.** Facing southwest further along the access road. There are areas of erosion occurring which need to be repaired and stabilized. Previous corrective action has not been completed.

Photo taken from previous inspection 6/1/2023.
