# Interim and Stormwater Inspection

October 9, 2023

Operator: Investment Equip. LLC, #10330

Location Name: Clifford Causey #20

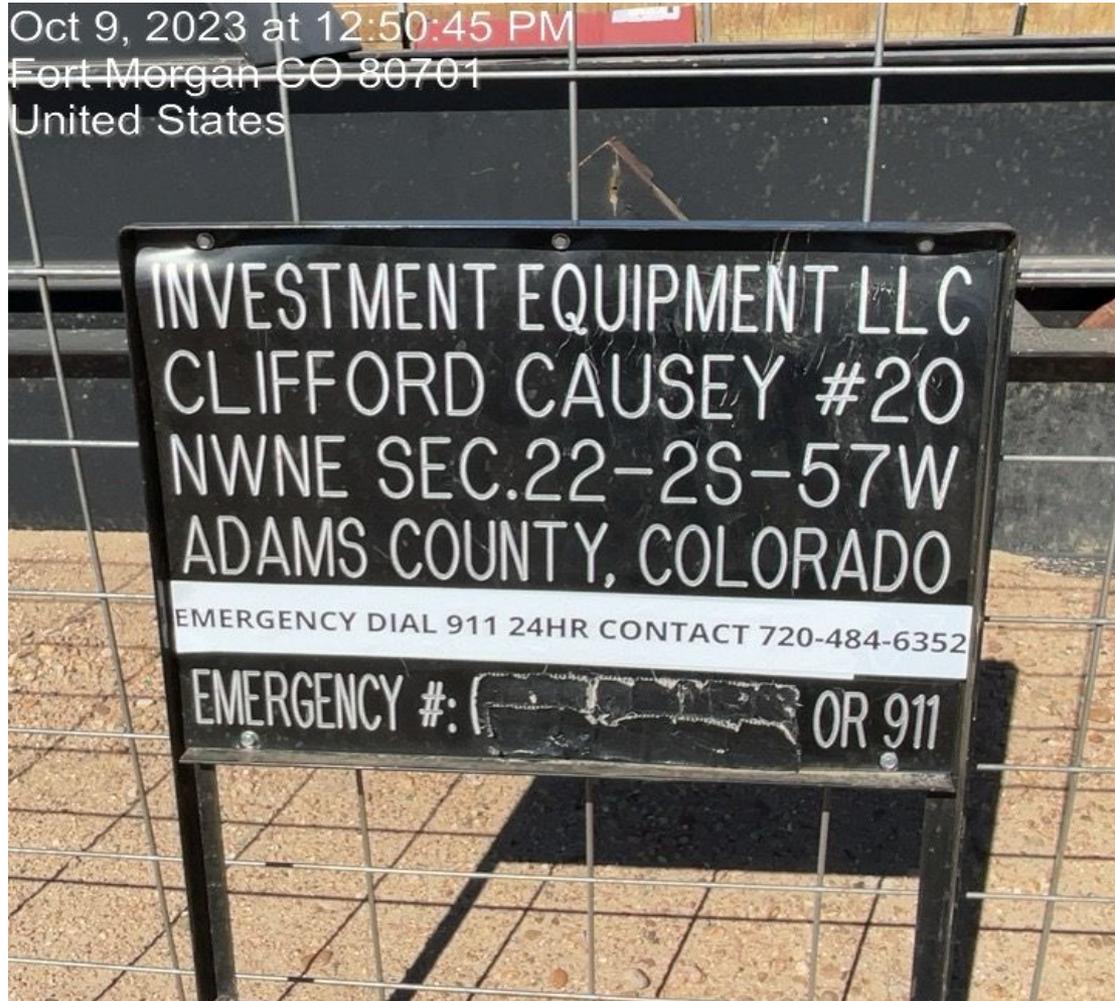
Photo 1. Photo taken facing west, of wellhead location sign.

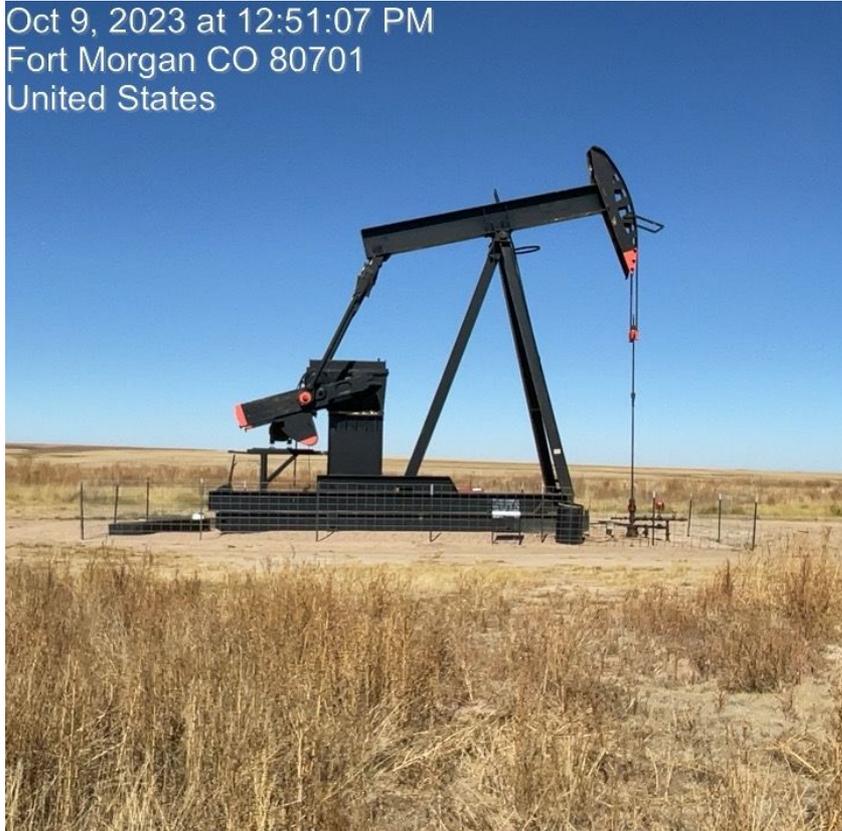
**Photo 2. Photo taken facing west of well head.**

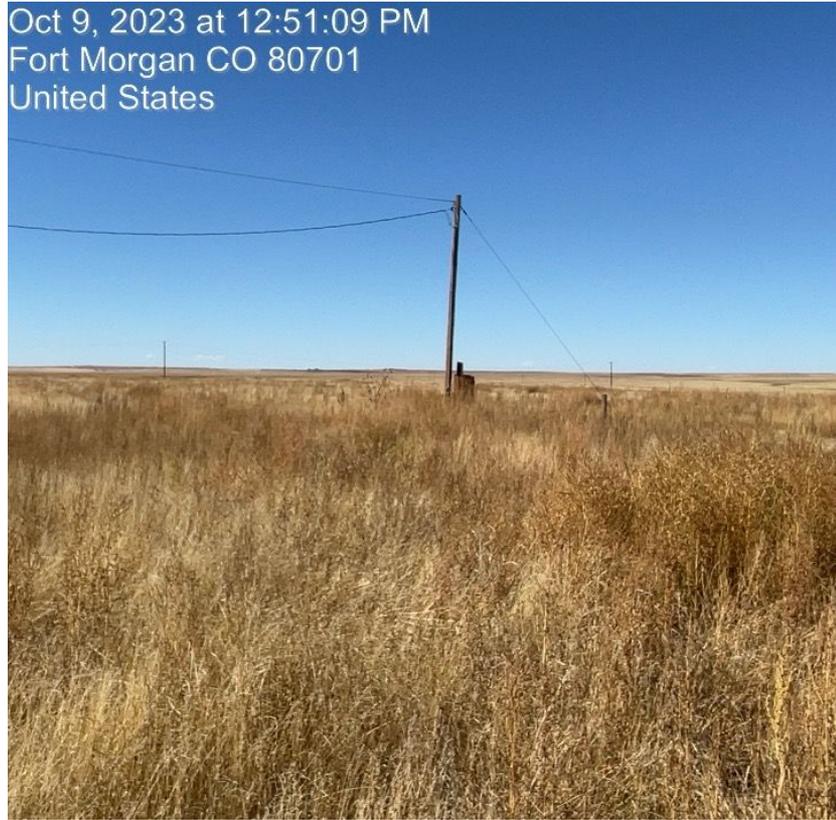
**Photo 3. Photo taken facing west of perennial grasses and weeds (kochia) on working pad perimeter and in reclaimed area.  
Inspection**

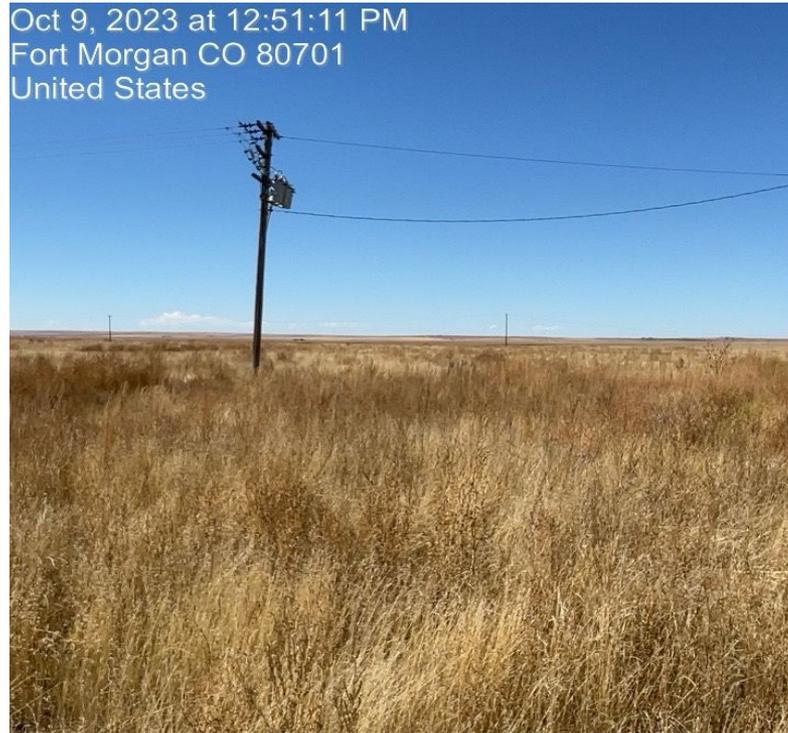
**Photo 4. Photo taken facing east of weeds (kochia) on working pad perimeter.**

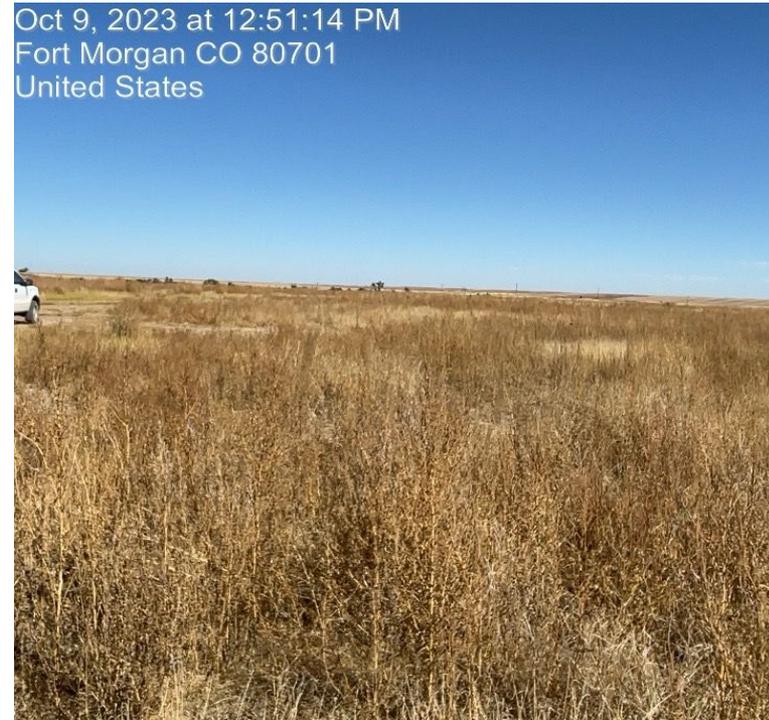
**Photo 5. Photo taken facing north, of weed (kochia) on working pad perimeter and in reclaimed area.**

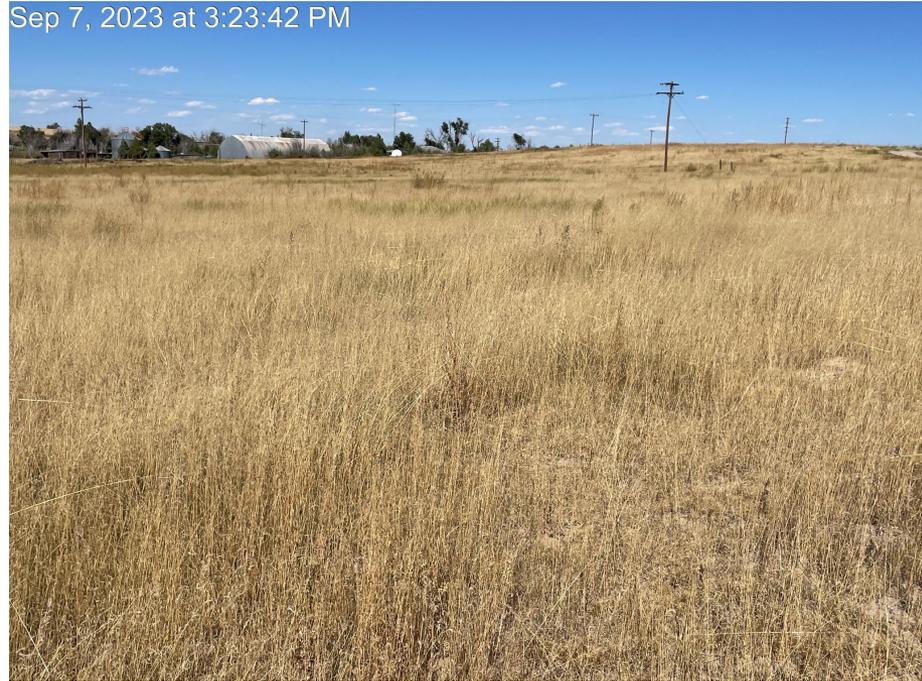
Photo 6. Photo taken facing east, of perennial grasses outside of reclaimed area, for reference vegetation.

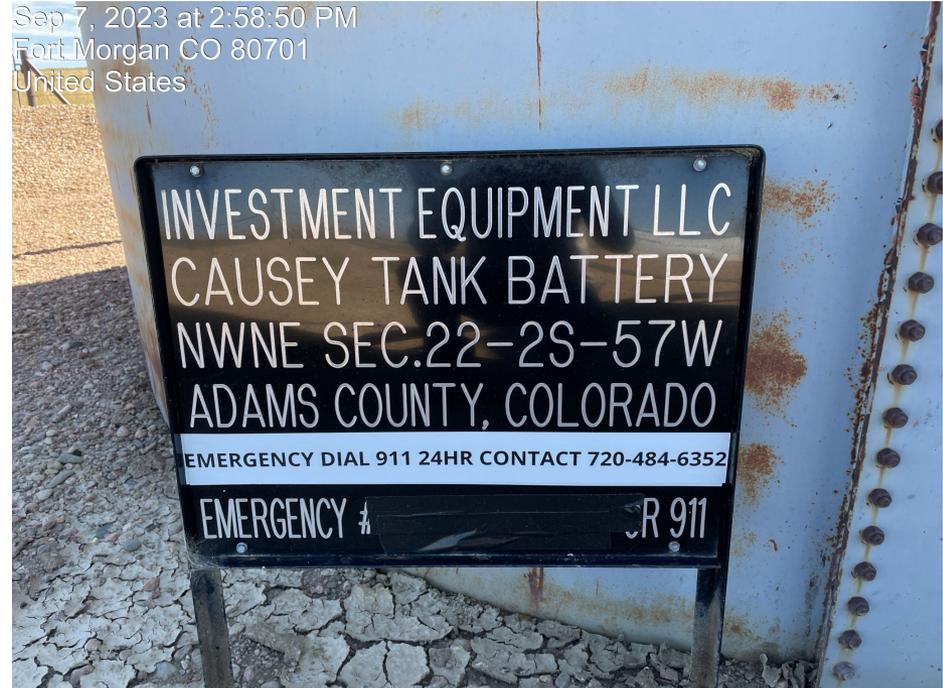
Photo 7. Photo taken of location sign.  
Tank battery ID 319632.

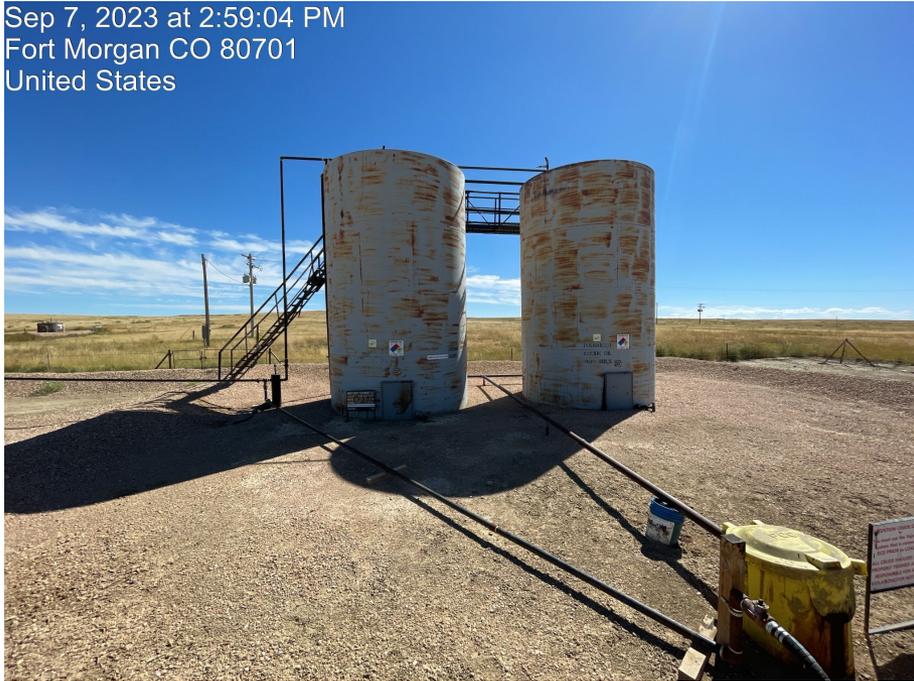
**Photo 8.** Photo taken of battery, facing south. This is an off location tank battery.

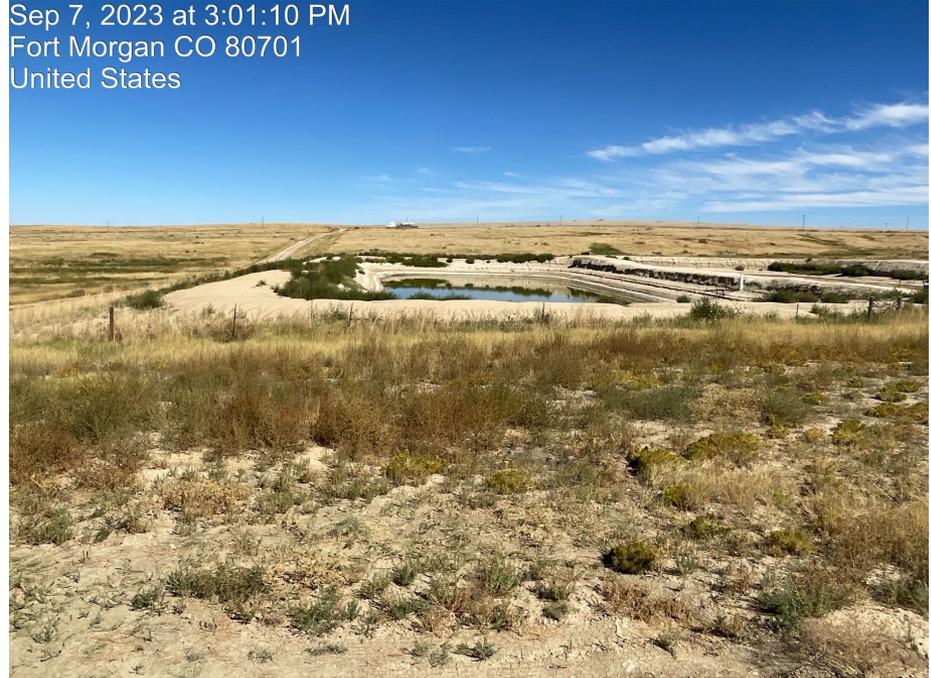
**Photo 9.** Photo taken facing north of vegetation and weeds (kochia & russian thistle) between tank battery and pits on location.

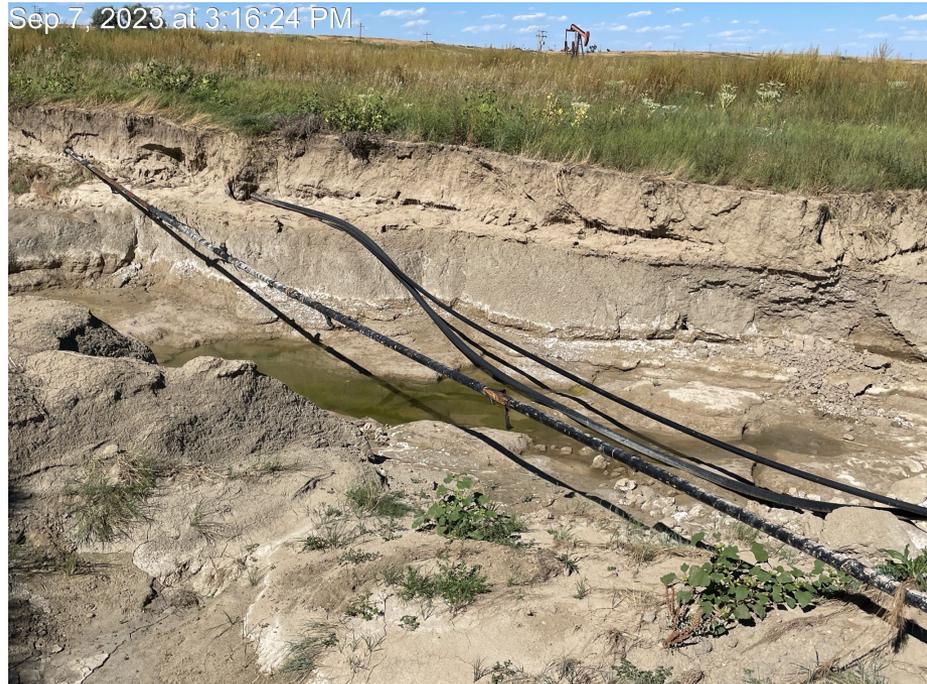
**Photo 11. Photo taken facing north, of large gully with exposed un-stabilized flowlines**

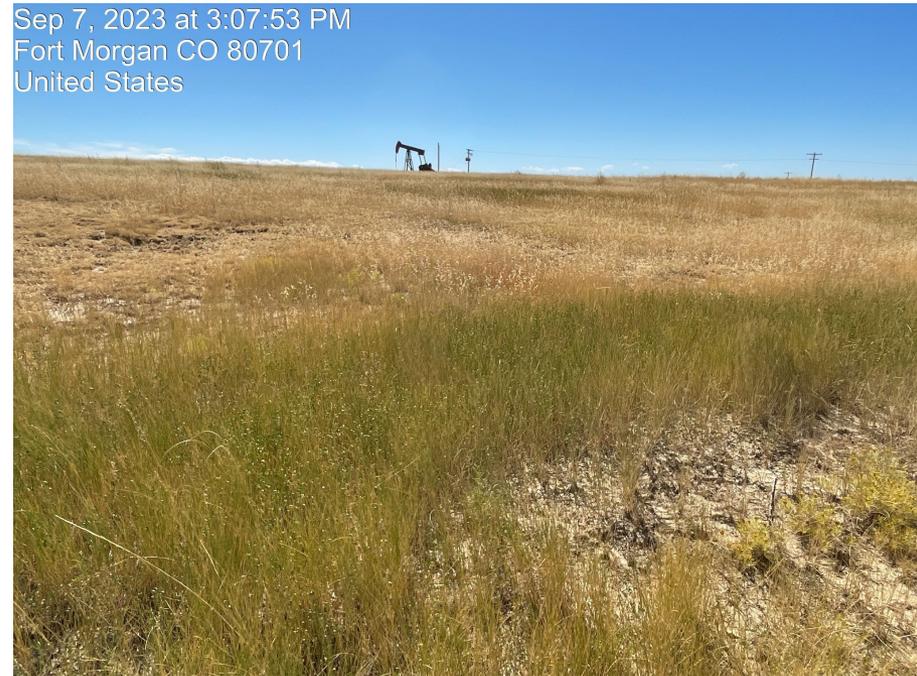
**Photo 11. Photo taken facing southwest, of perennial grasses outside of reclaimed area, for reference vegetation**
