# Inspection Photos

API: 061-06166

Operator: RENEGADE OIL & GAS COMPANY

Inspection Date: 10/23/2023

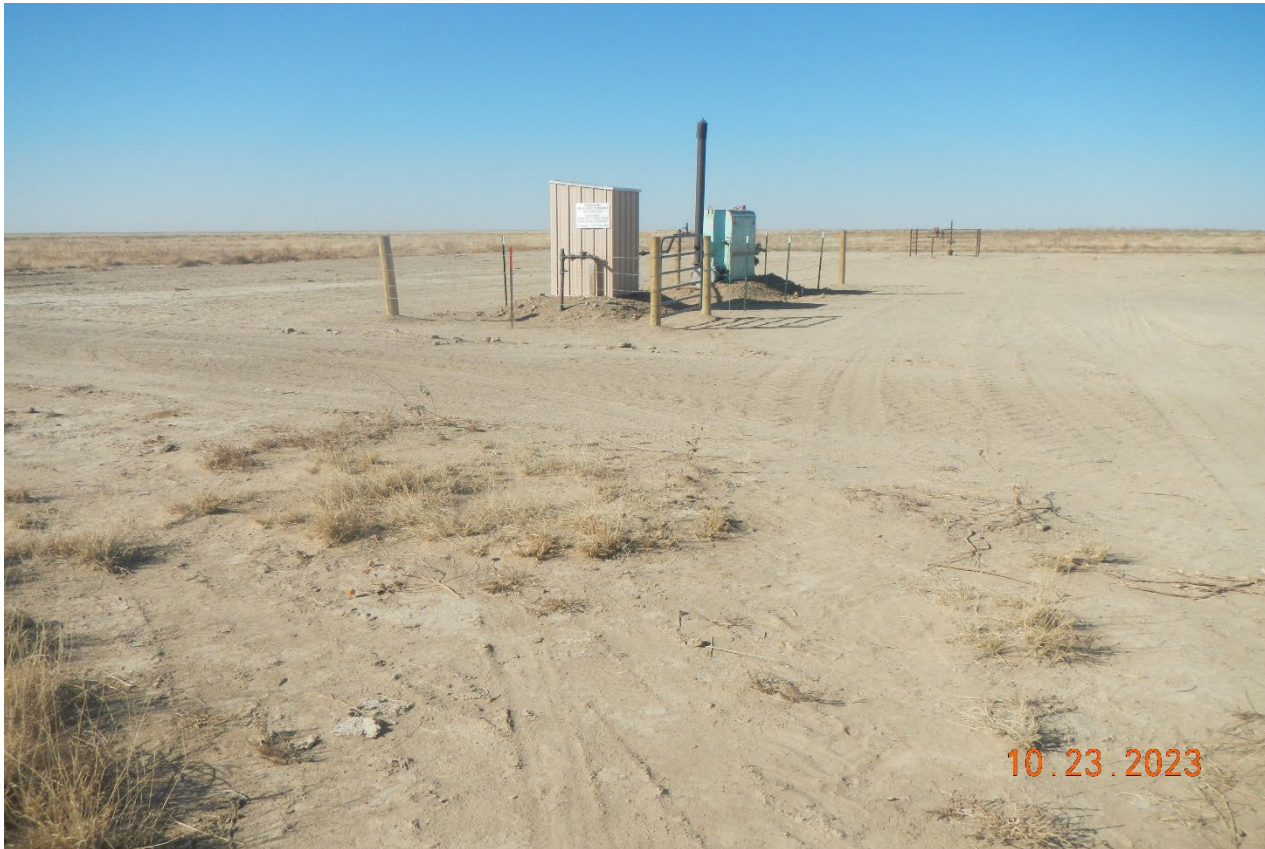
**Photo 1.** Facing southwest toward the location. The location fence has been removed and a new fence was installed around the equipment.

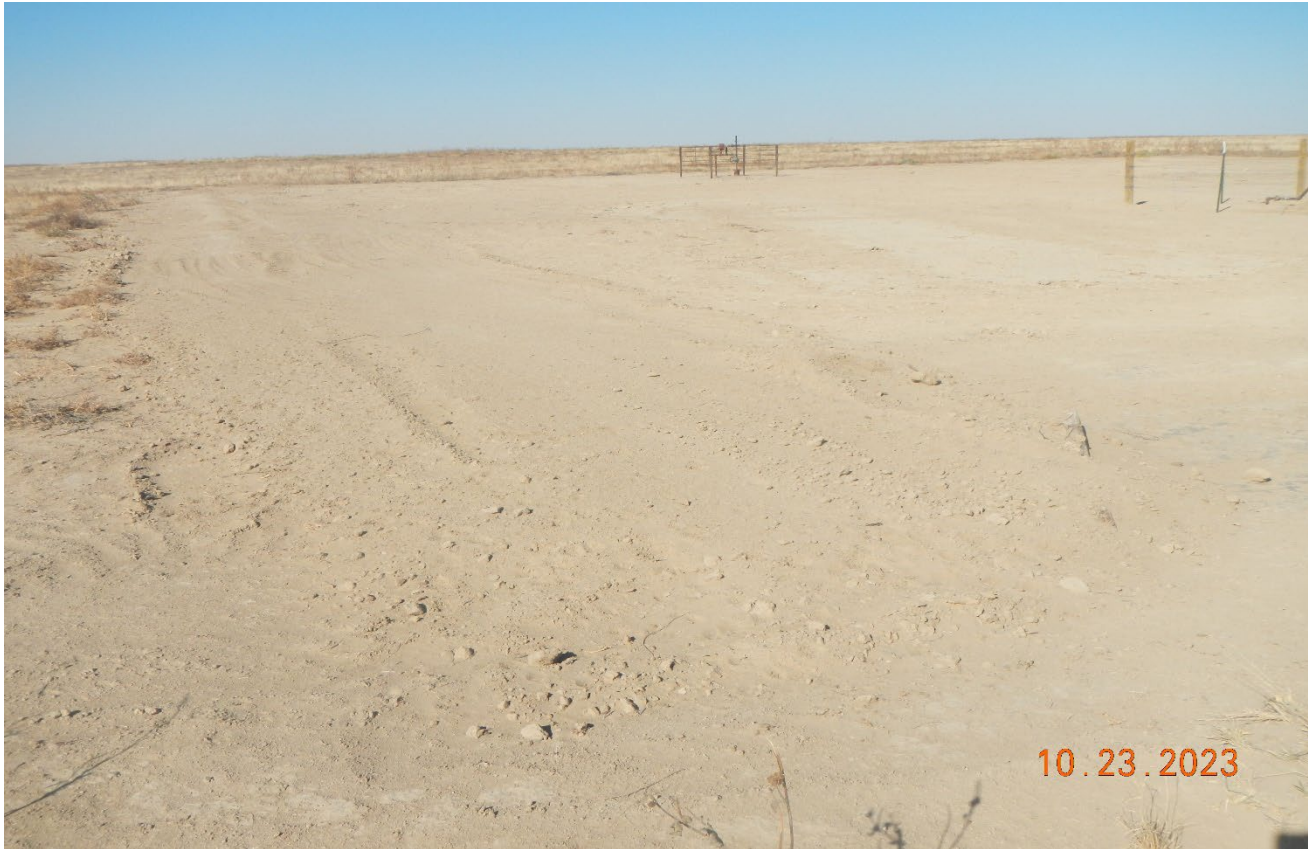
**Photo 2.** Facing northwest toward the location. There are unused areas of the location that must be reclaimed.

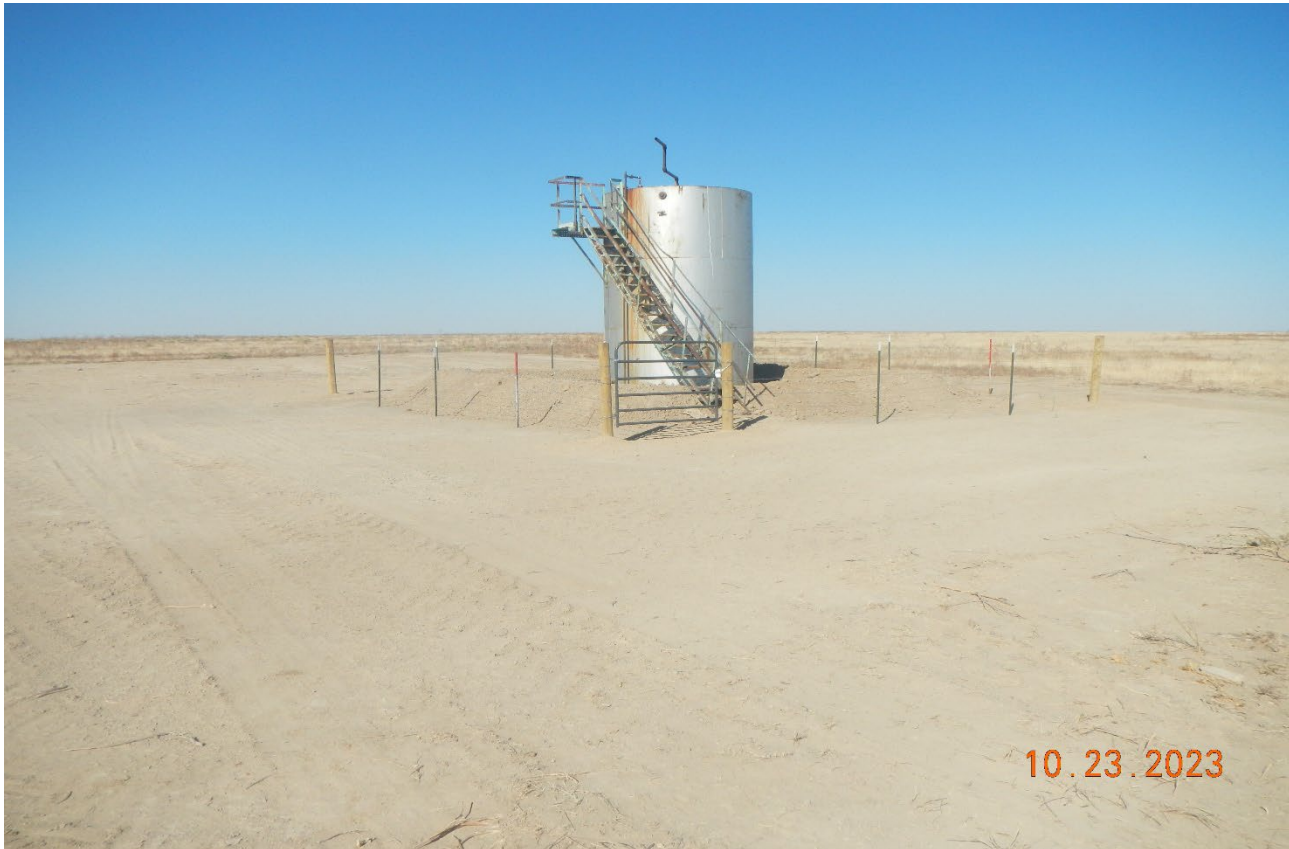
**Photo 3.** Facing northwest toward the tank battery.

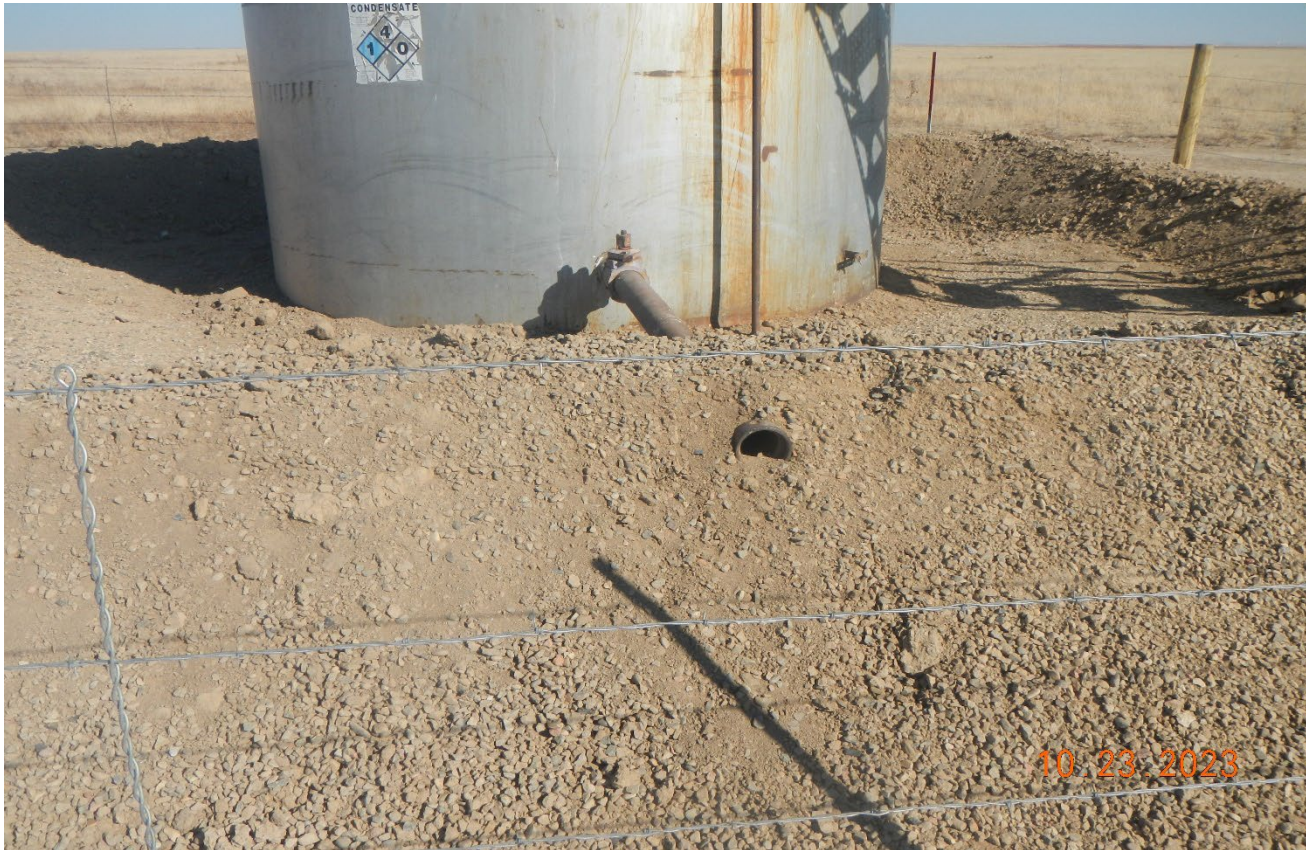
**Photo 4.** This pipe is exposed on the outside of the tank battery and is not contained inside containment,.

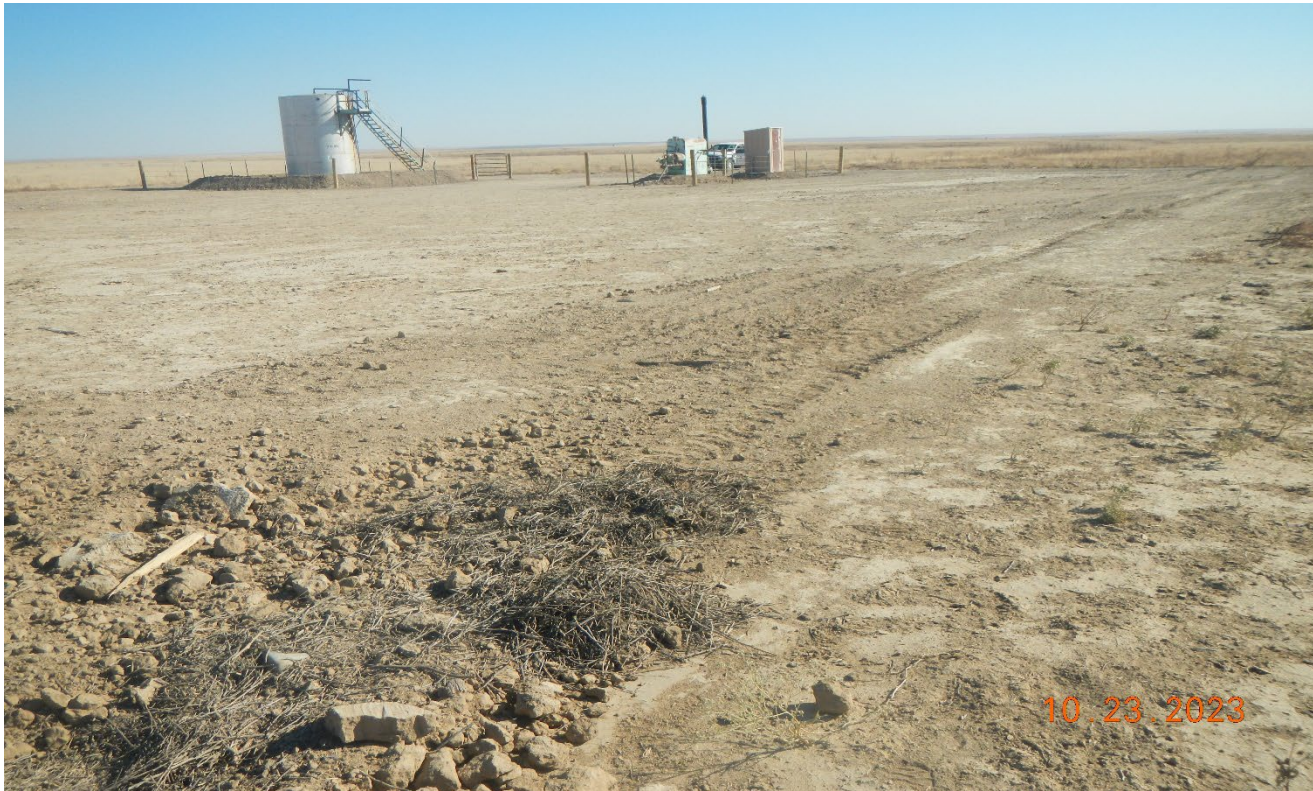
**Photo 5.** Facing northeast toward the location. There are unused areas of the location that must be reclaimed.

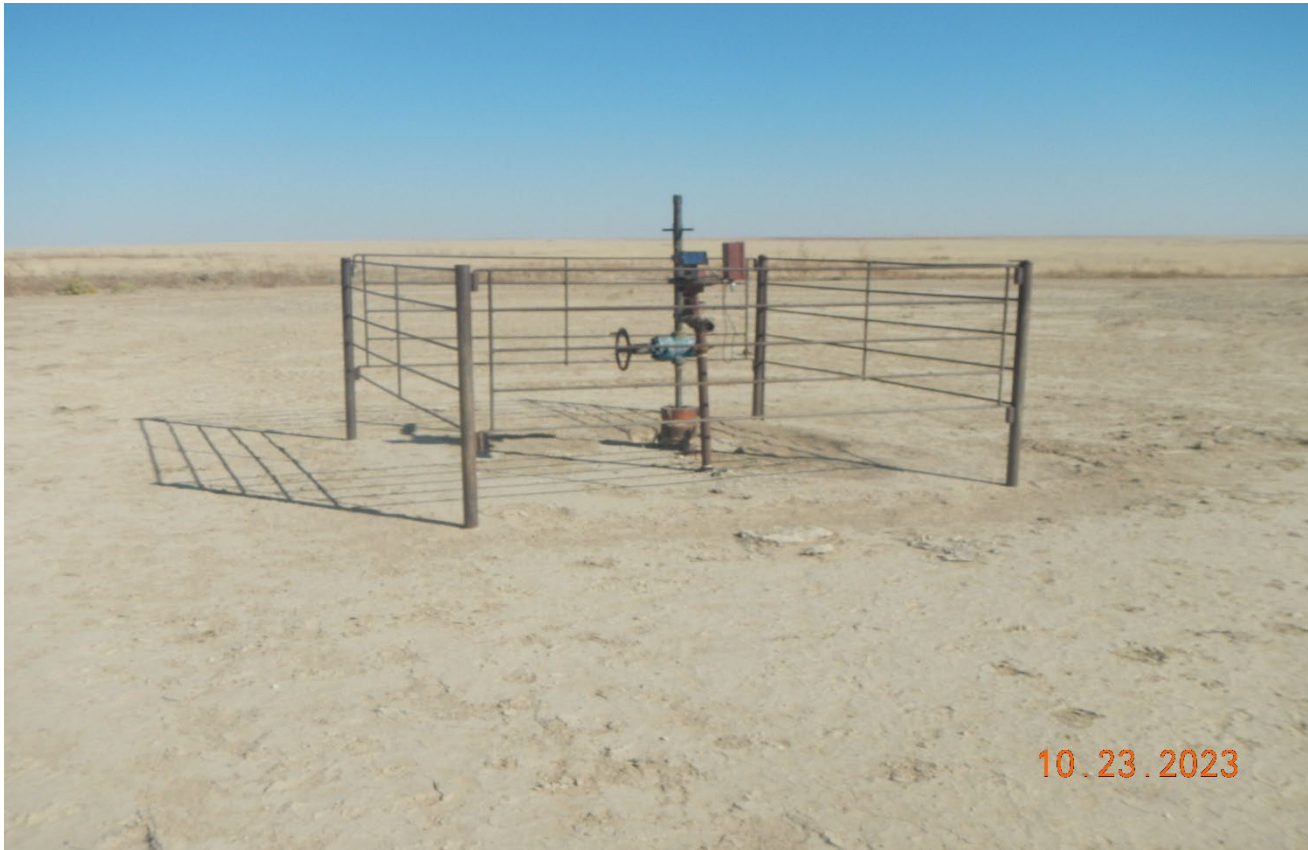
**Photo 6.** Facing toward the wellhead.
