Inspection Photos

API: 061-06163

Operator: RENEGADE OIL & GAS COMPANY

Inspection Date: 10/23/2023

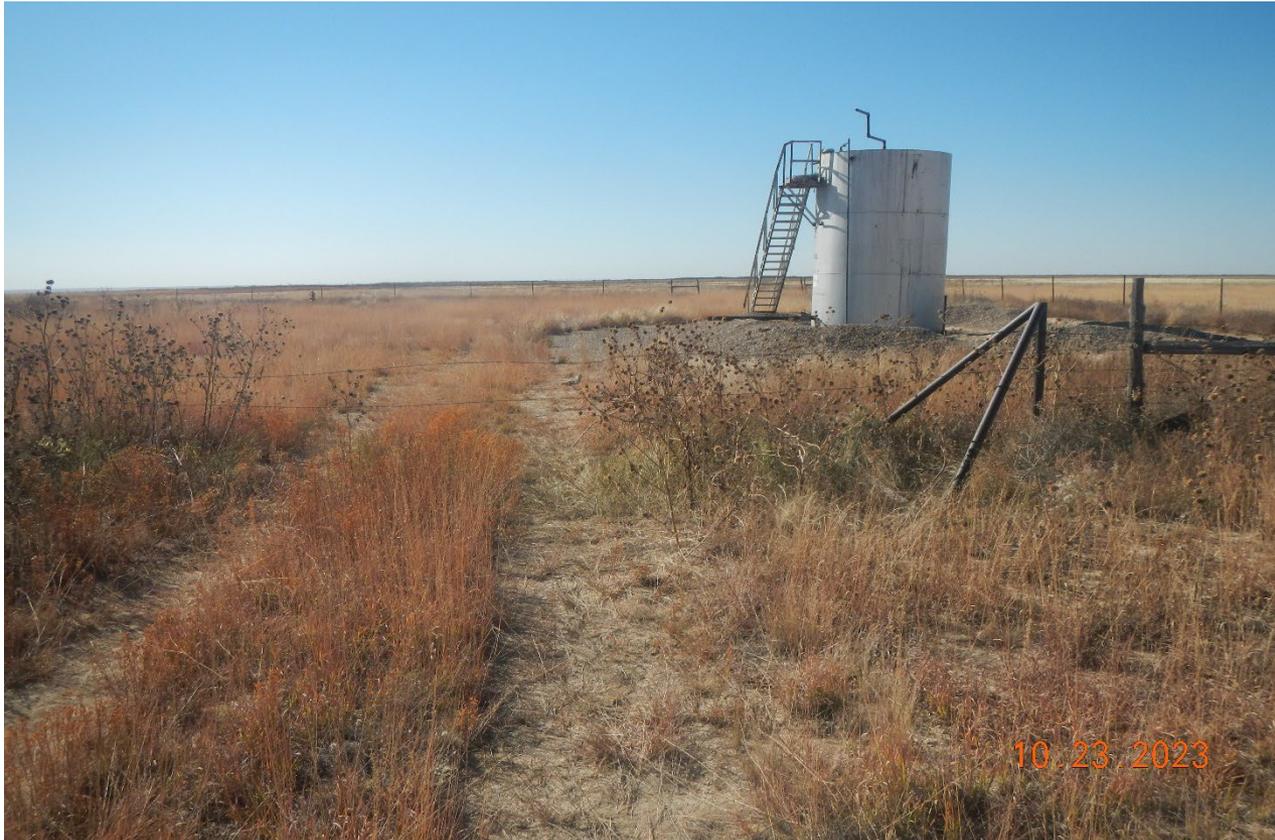
Photo 1. Facing south toward the location.

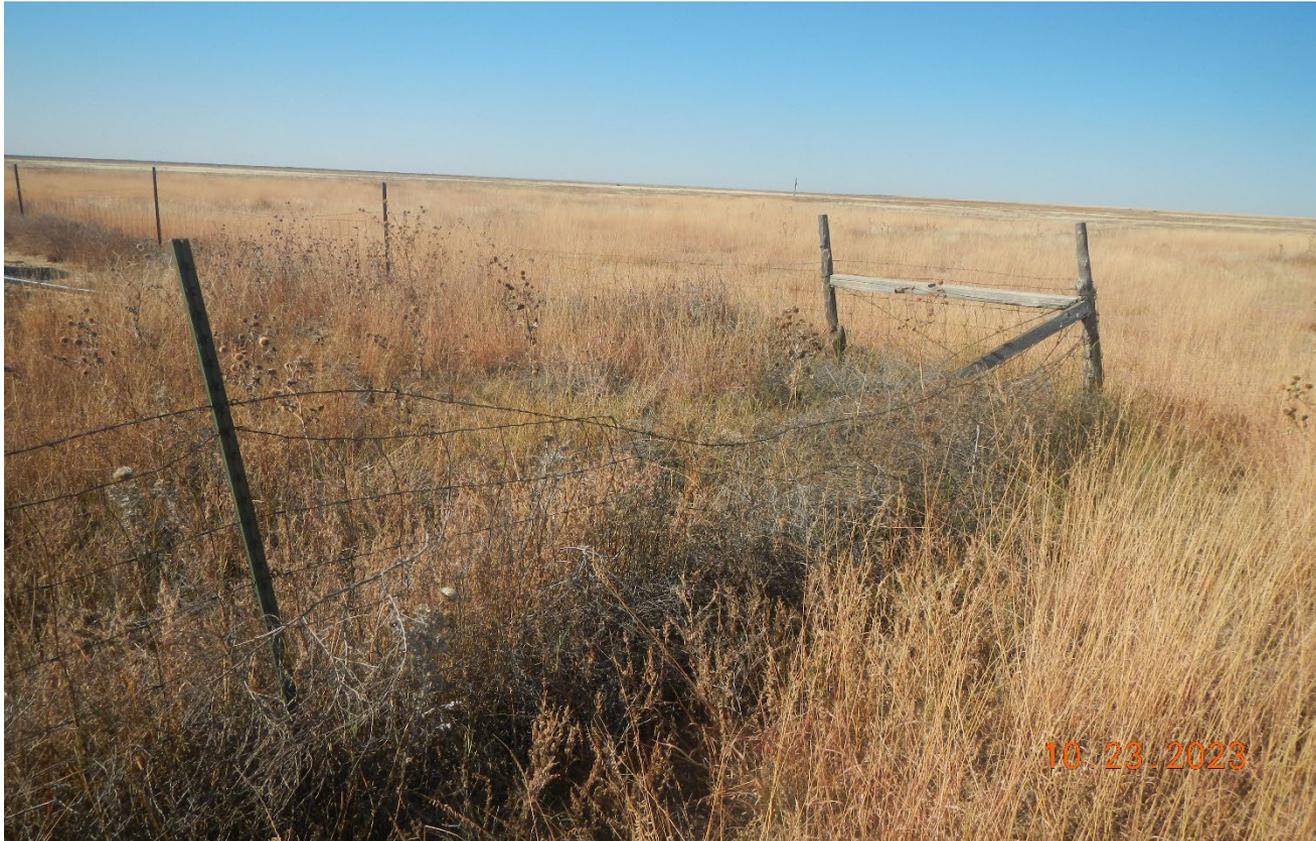
Photo 2. The fence at the northwest corner needs maintenance.

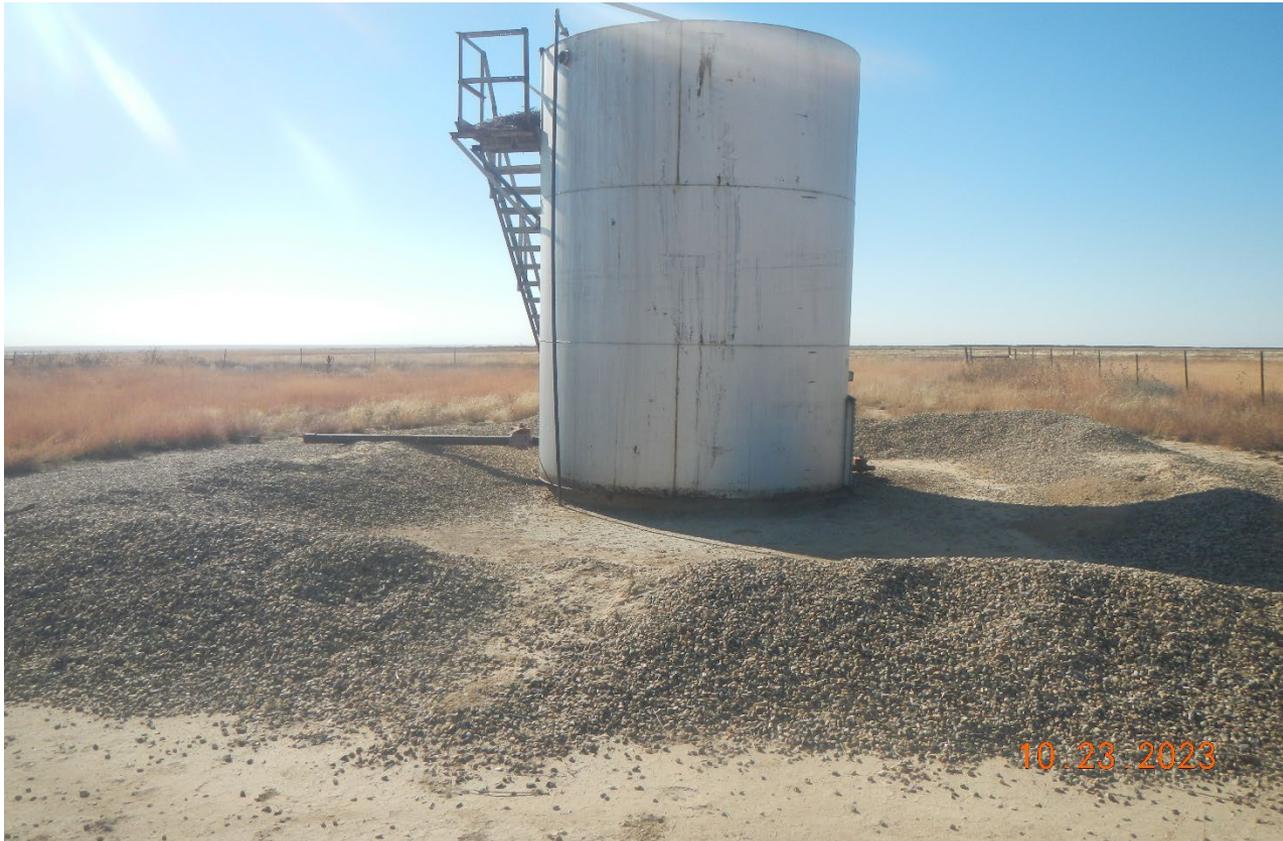
Photo 3. The berm around the tank battery is insufficient to contain a spill. If the tank is not in use then it should be removed..

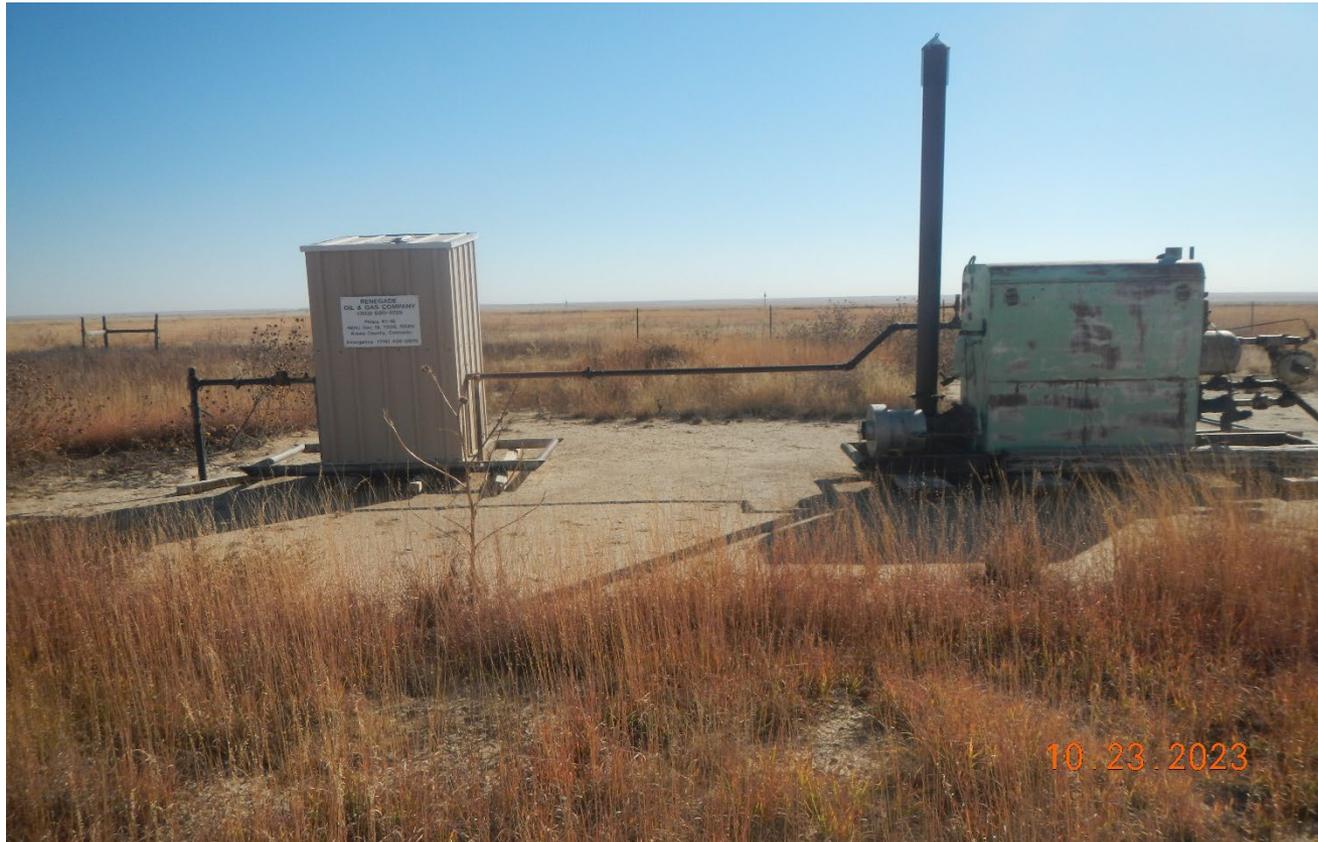
Photo 4. Facing toward the meter run.

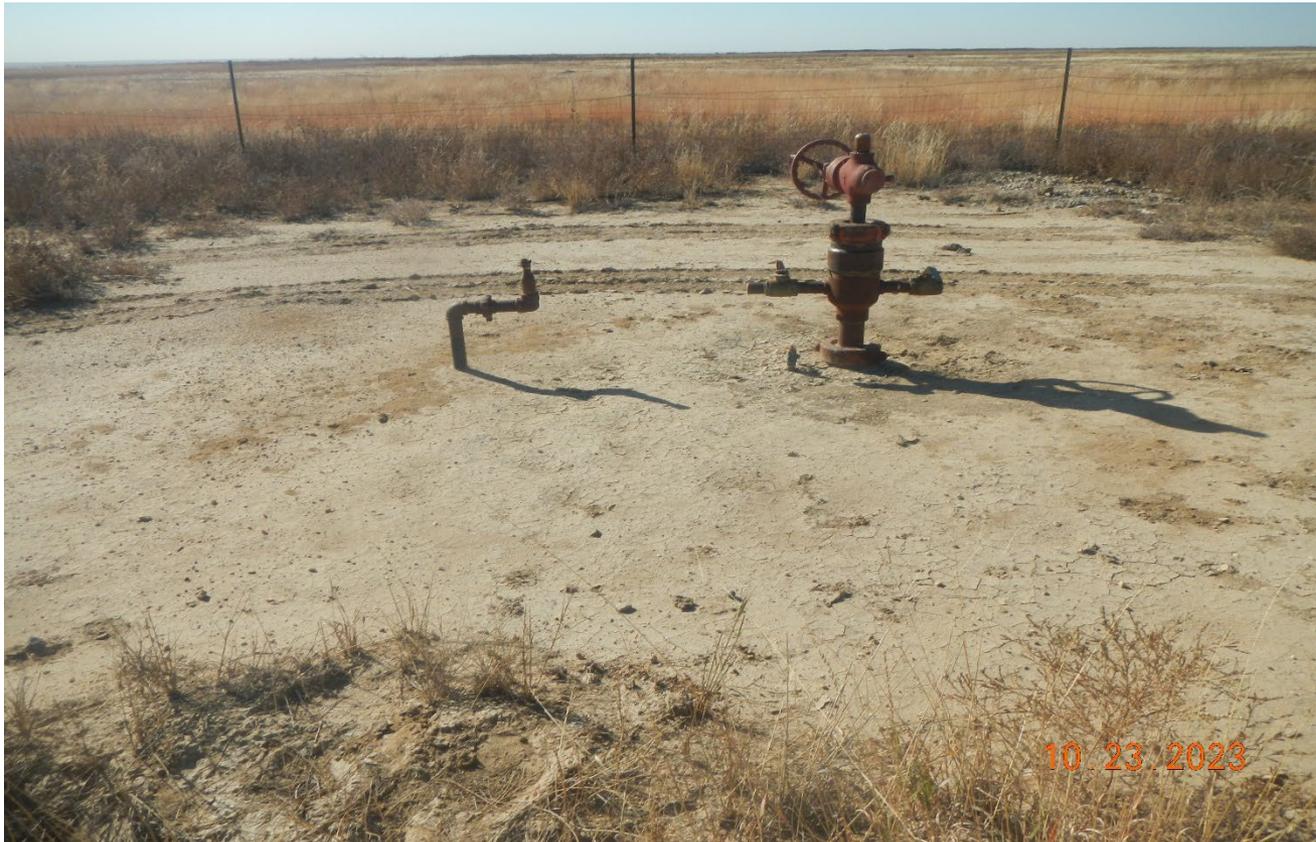
Photo 5. Facing toward the wellhead. There is a pipe riser with no OOSLAT.
