Inspection Photos
Location: Drill Site 2
Facility ID: 334549

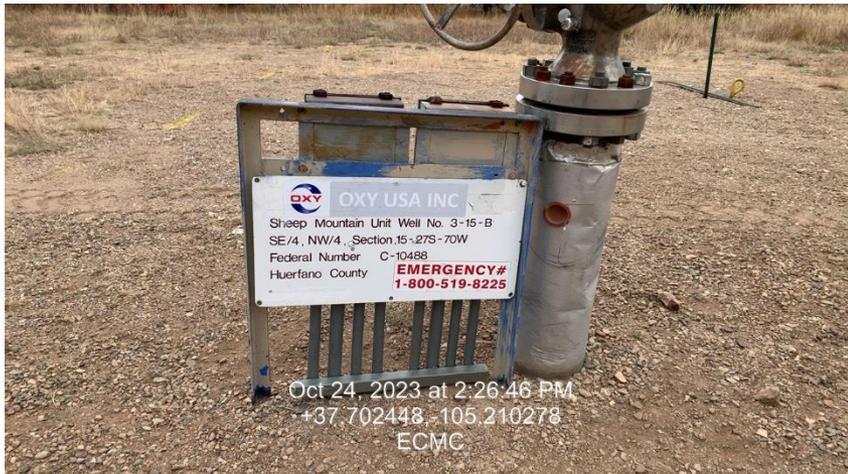
Photo 1 –Wellhead Placard SMU 3-15-B P&A Wellhead

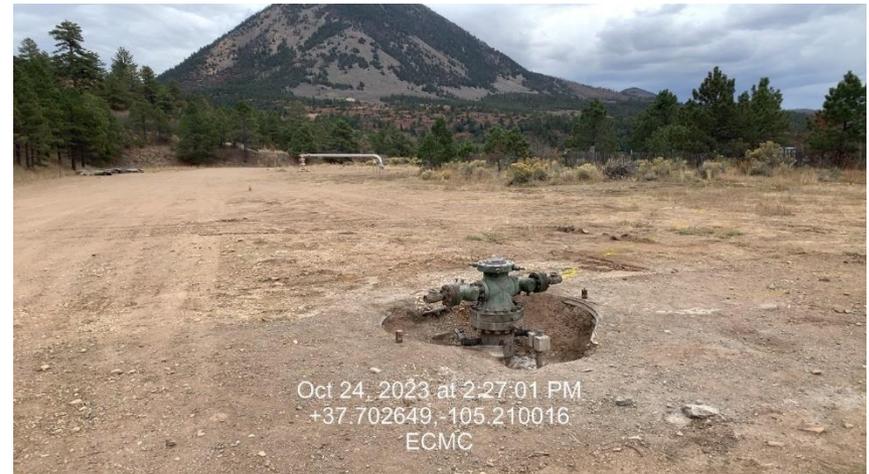
Photo 2 – SMU 3-15-B Cemented Wellhead, Remediation # 23900

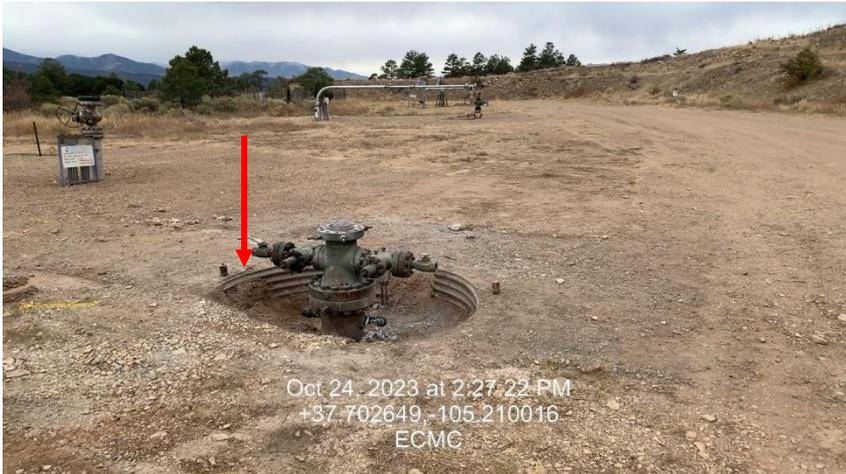
**Photo 3 – SMU 3-15-B Cemented Wellhead,
Remediation # 23900**

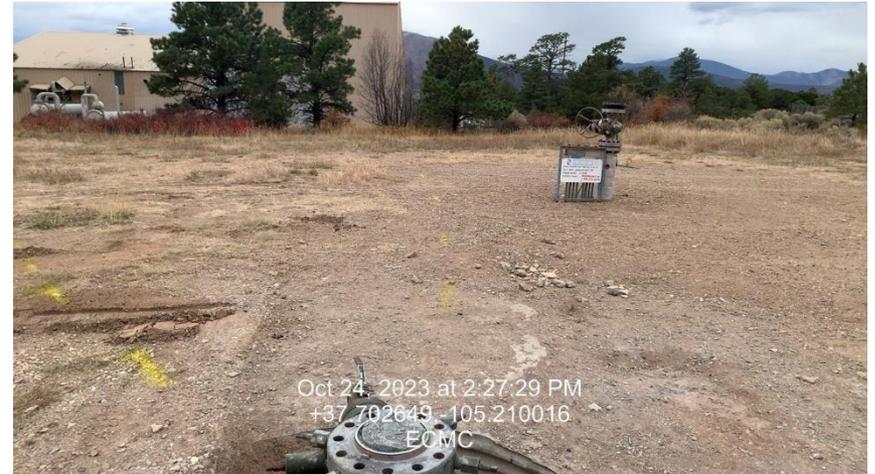
**Photo 4 – SMU 3-15-B Cemented Wellhead,
Remediation # 23900**

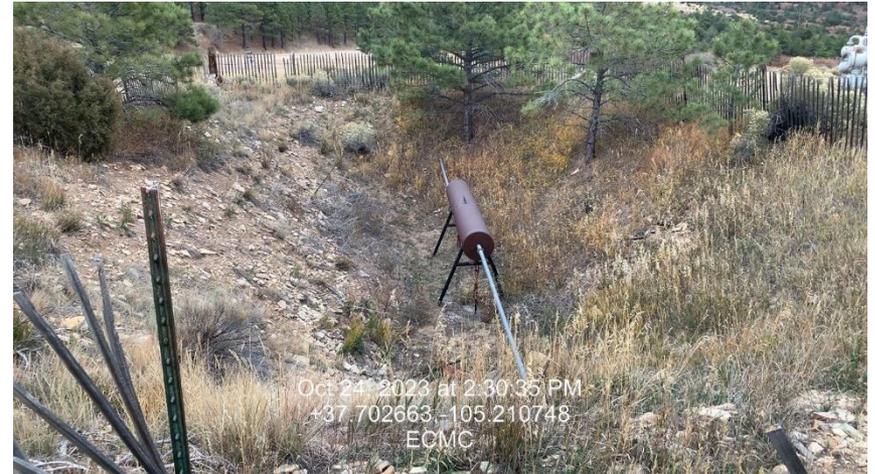
Photo 6 – Drill Site # 2, Pit ID 115234; Remediation # 28884

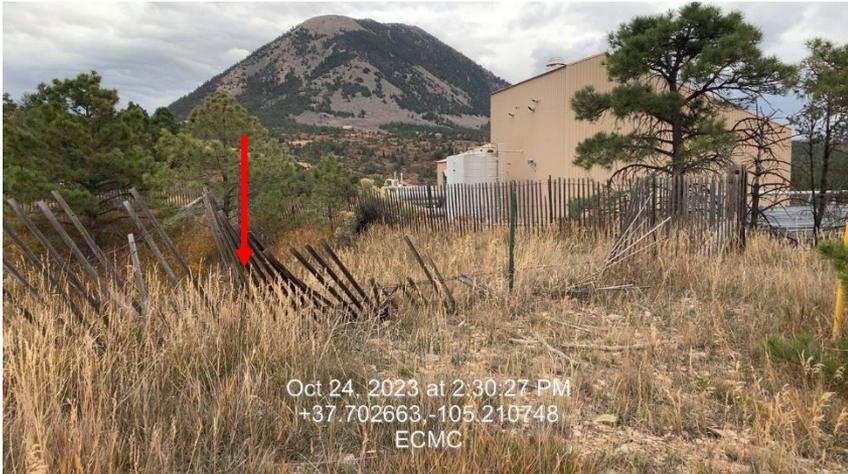
Photo 7 – Drill Site # 2, Pit ID 115234; Remediation # 28884

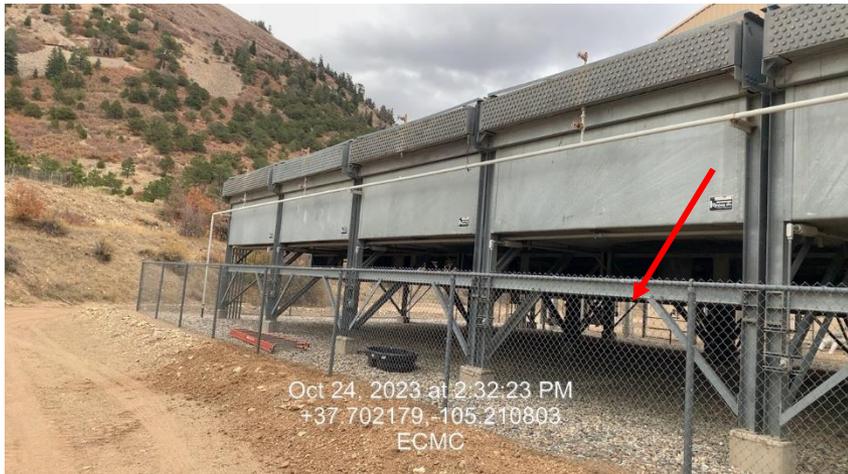
Photo 9 – Glycol Spill identified in Inspection Doc # 713600296 has been cleaned

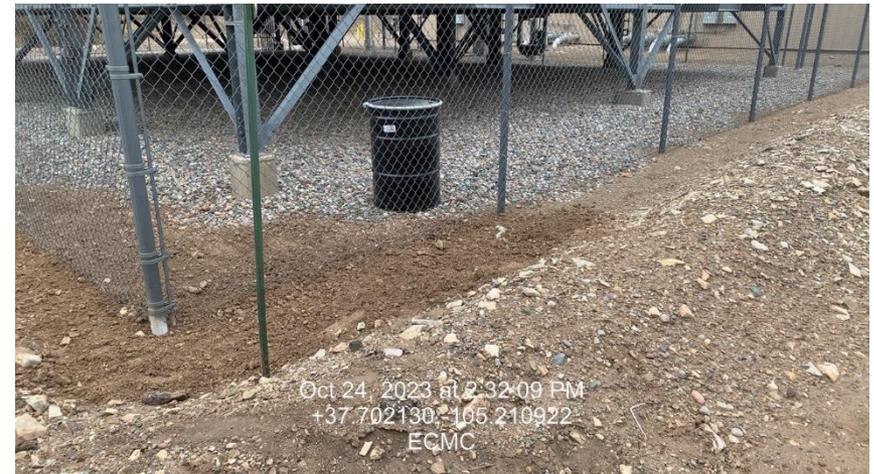
Photo 10 – Glycol Spill identified in Inspection Doc # 713600296 has been cleaned
