# Inspection Photos

Loc: 441082

Operator: **DOVER ATWOOD CORPORATION**

Inspection Date: 10/31/2023

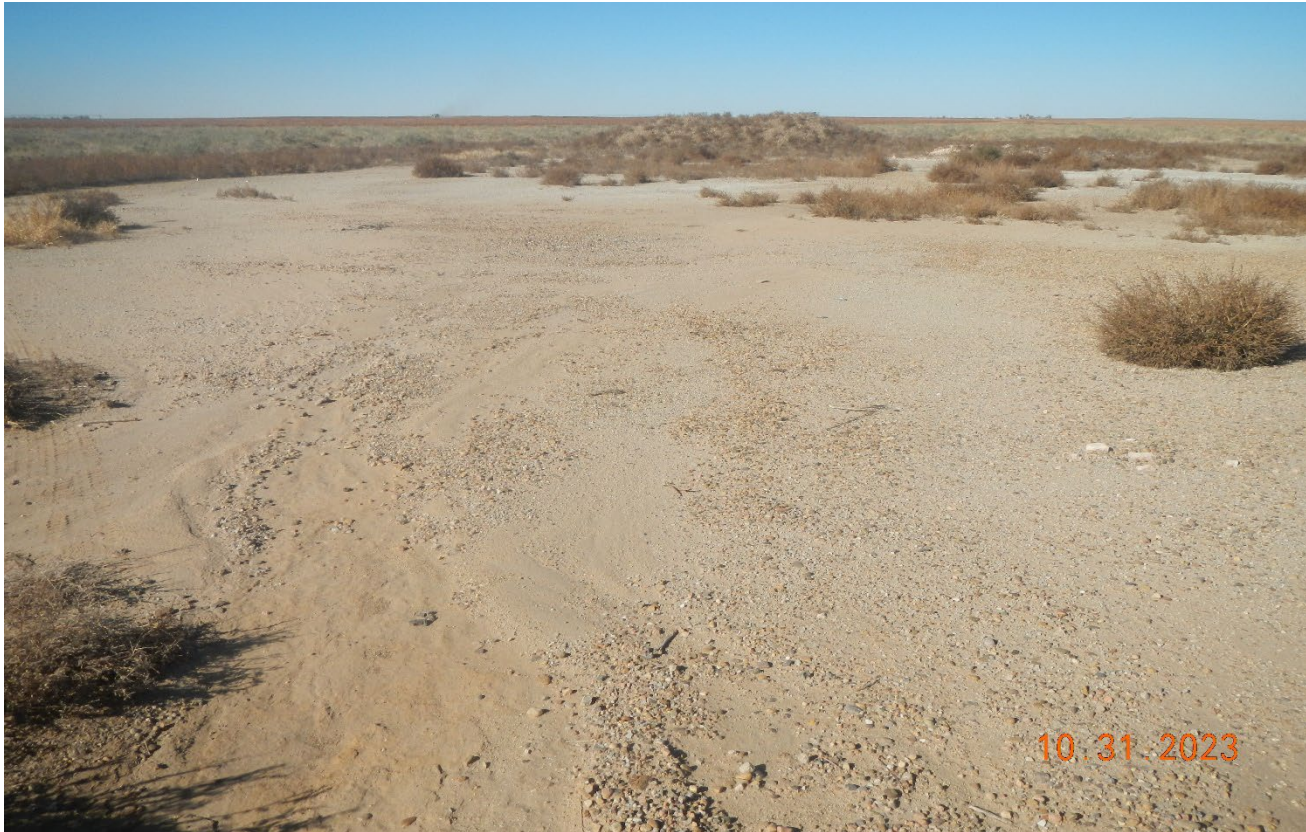
**Photo 1.** Facing north toward the location. The disturbed location has not been reclaimed. Previous corrective actions are not completed.

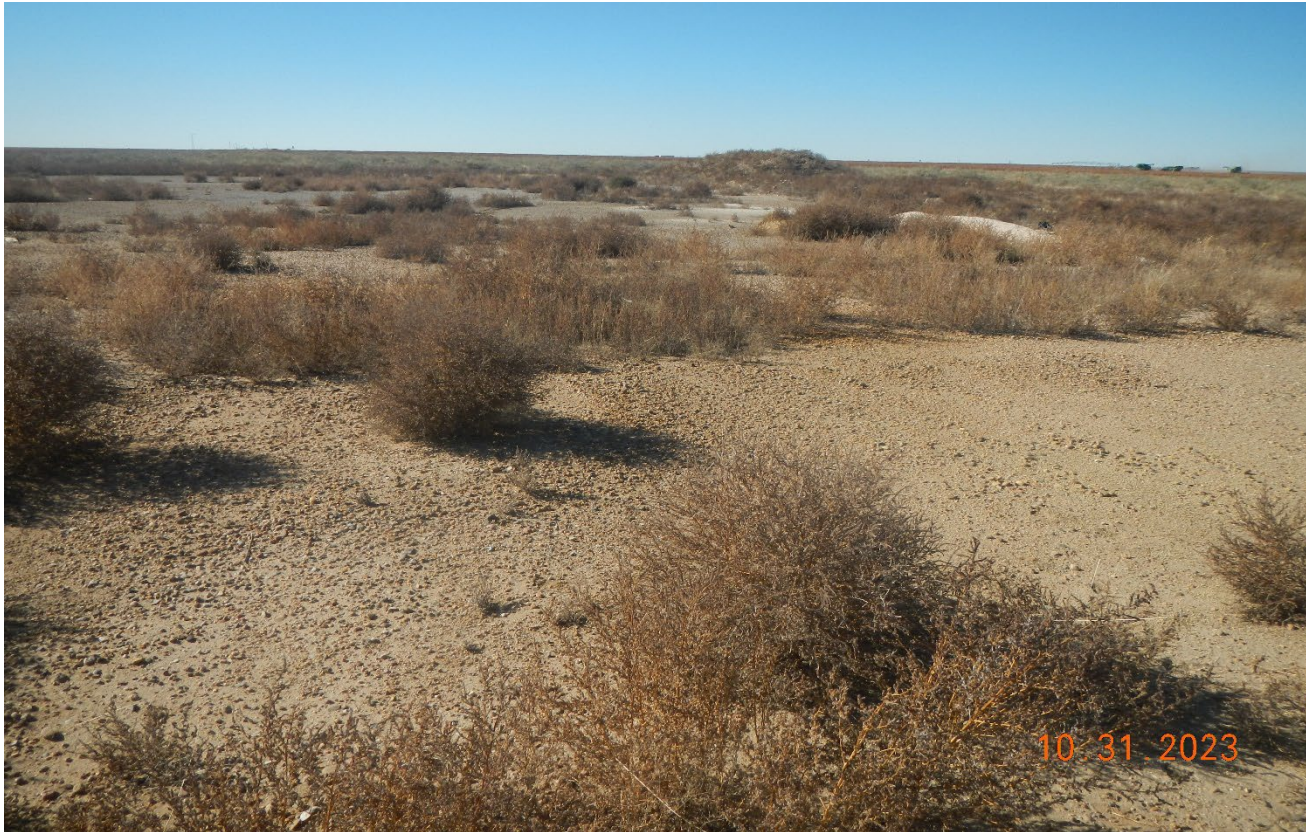
**Photo 2.** Facing northwest at the location. Soils are compacted and the location has not been reclaimed. Previous corrective actions were not performed. Soils must be decompacted by cross ripping to a depth of 18 inches.

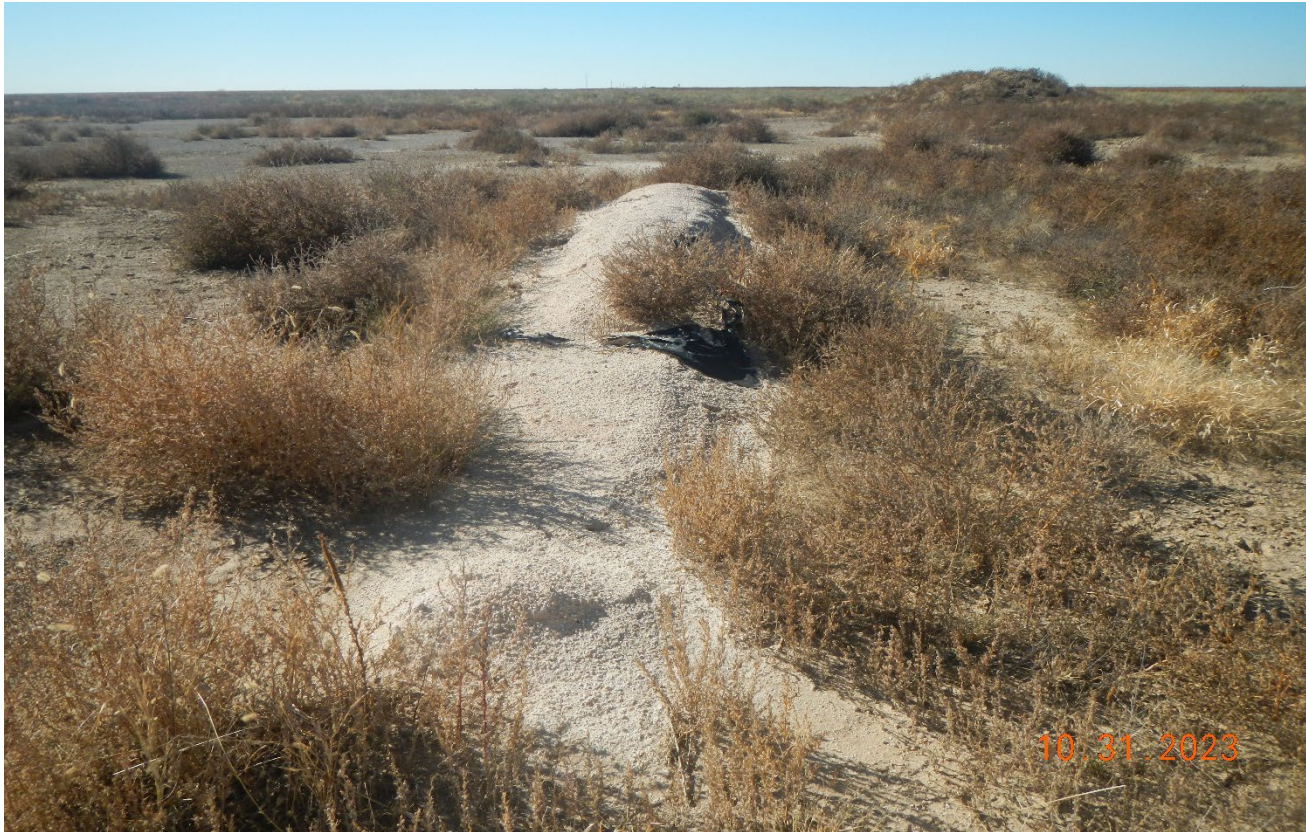
**Photo 3.** Facing east at the location. There are piles of manure and material left on the location. There are undesirable weeds throughout the location.

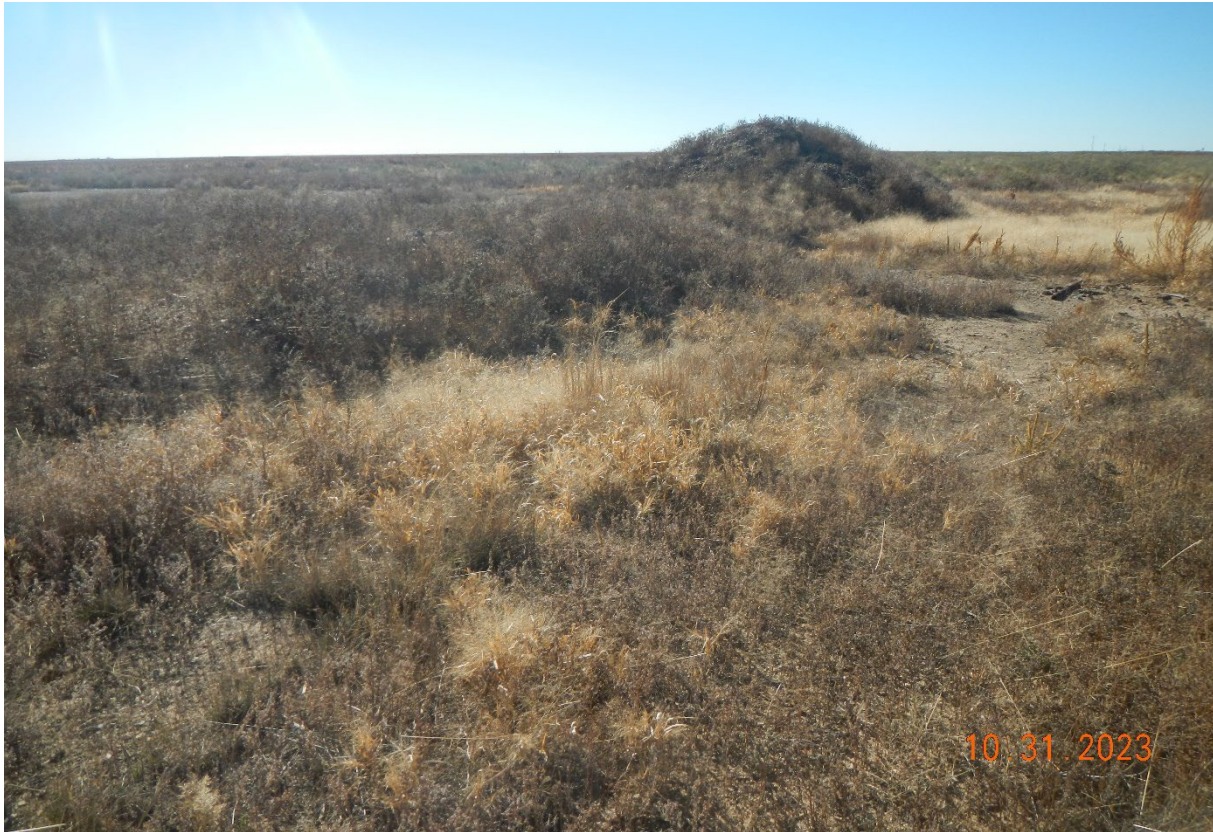
**Photo 4.** There are gravel and soil piles that remain at the north side of the location. The piles need to be removed. There are undesirable weeds on the piles.

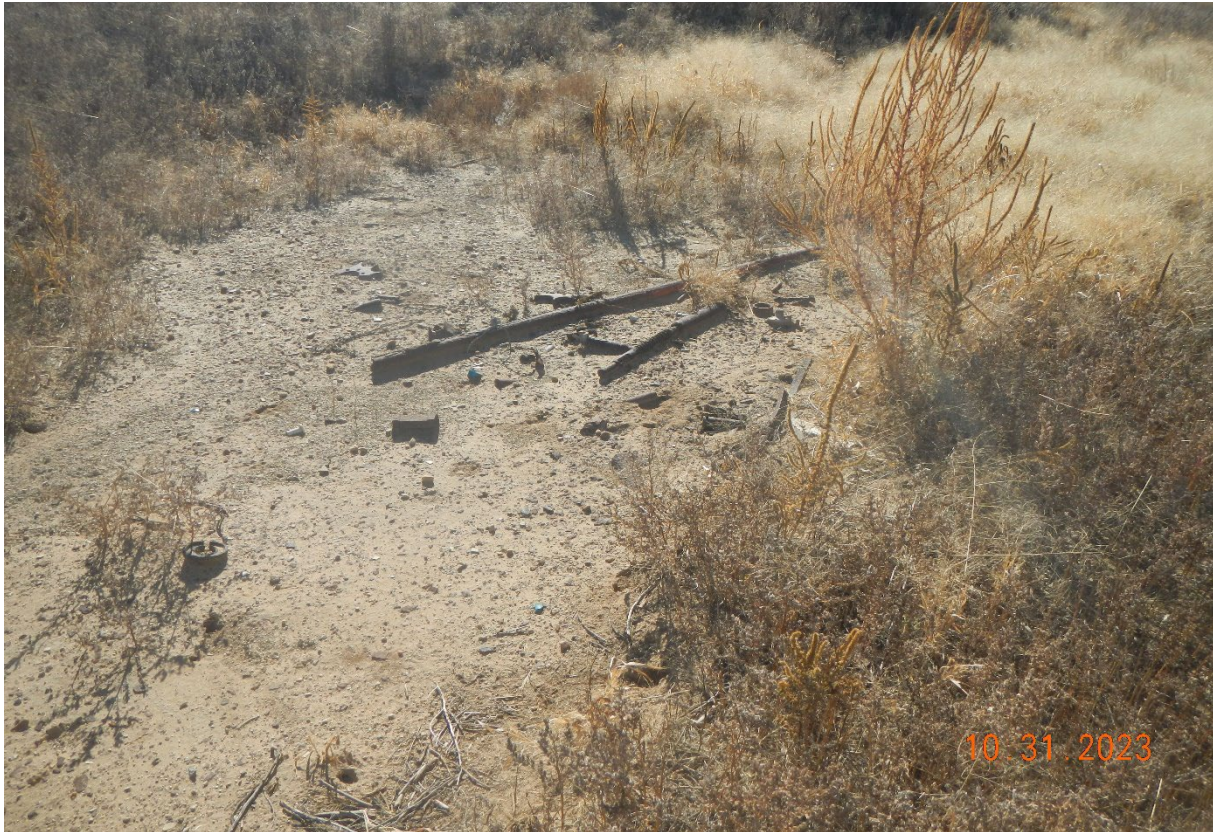
**Photo 5.** Facing southwest at the north side of the location. There is metal debris which has not been removed.

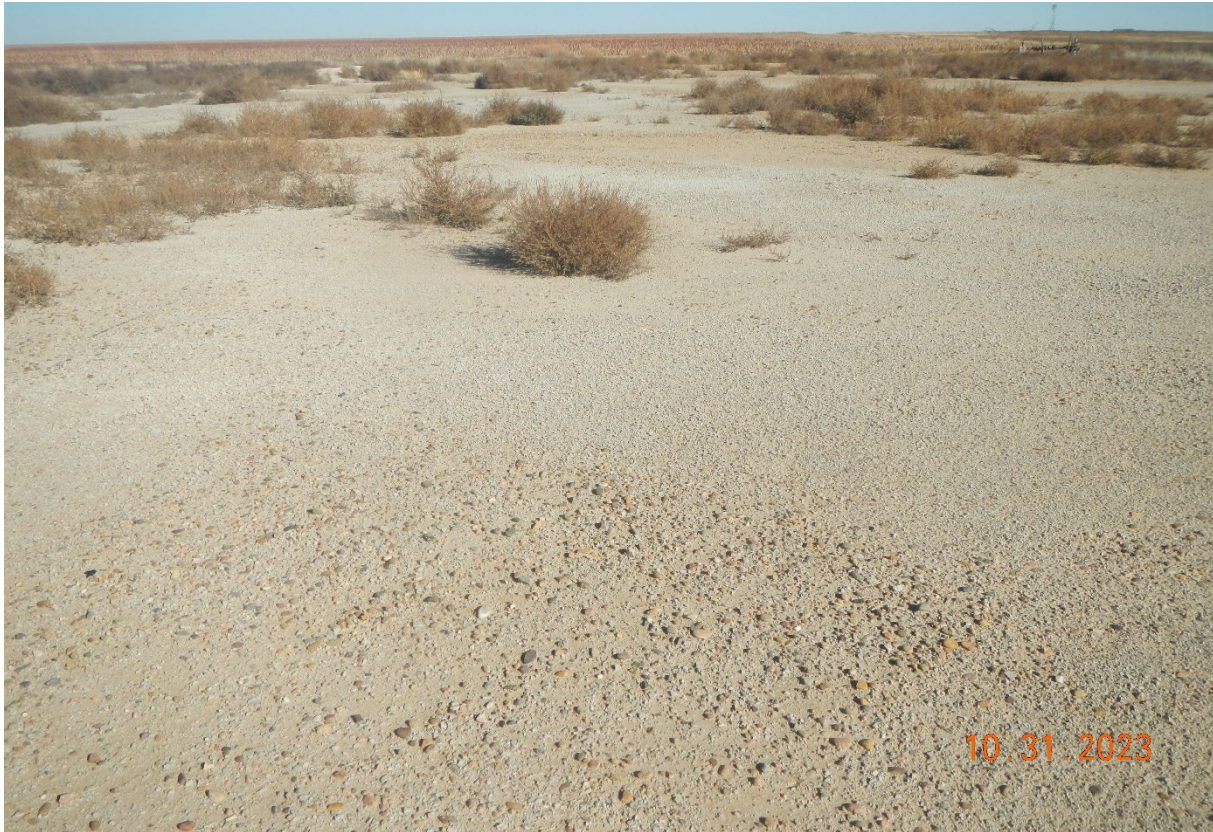
**Photo 6.** Facing east at the location. Soils are compacted and the location has not been reclaimed.

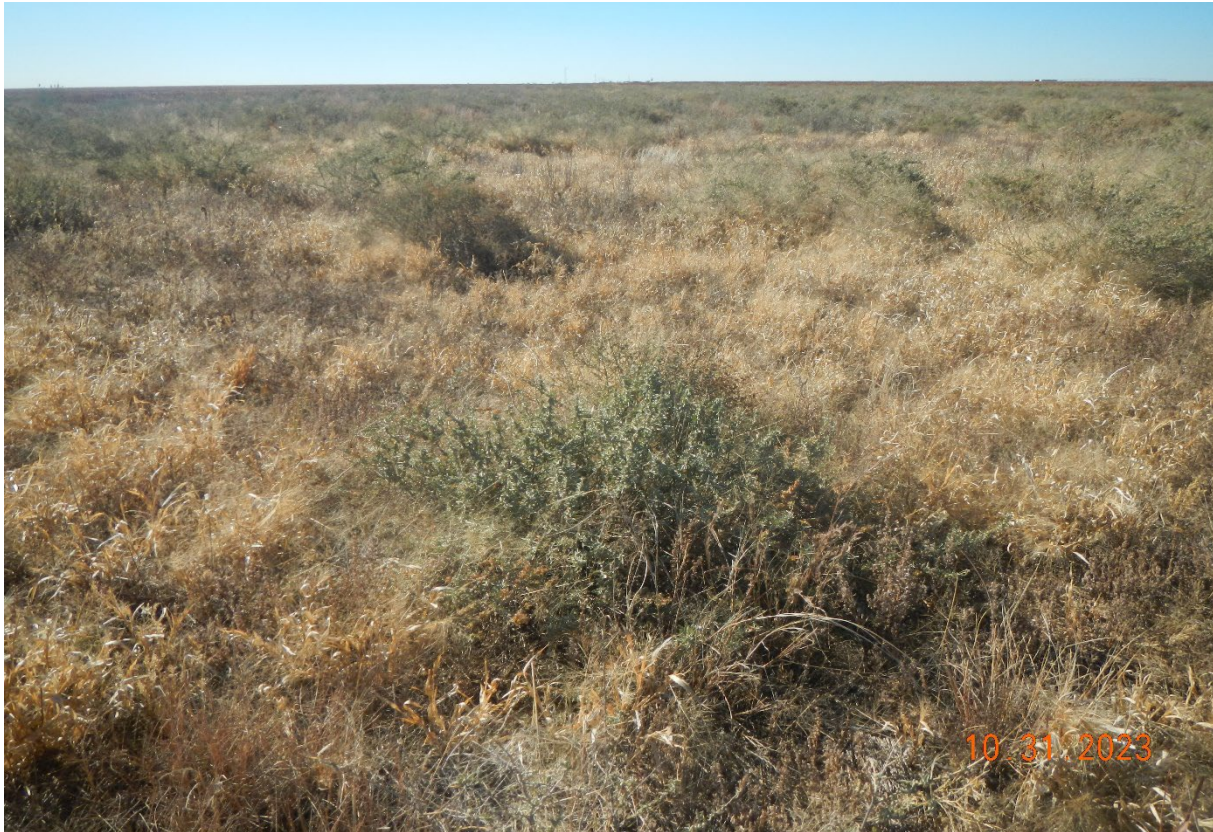
**Photo 7.** Facing west at the location. Soils are compacted and the location has not been reclaimed.

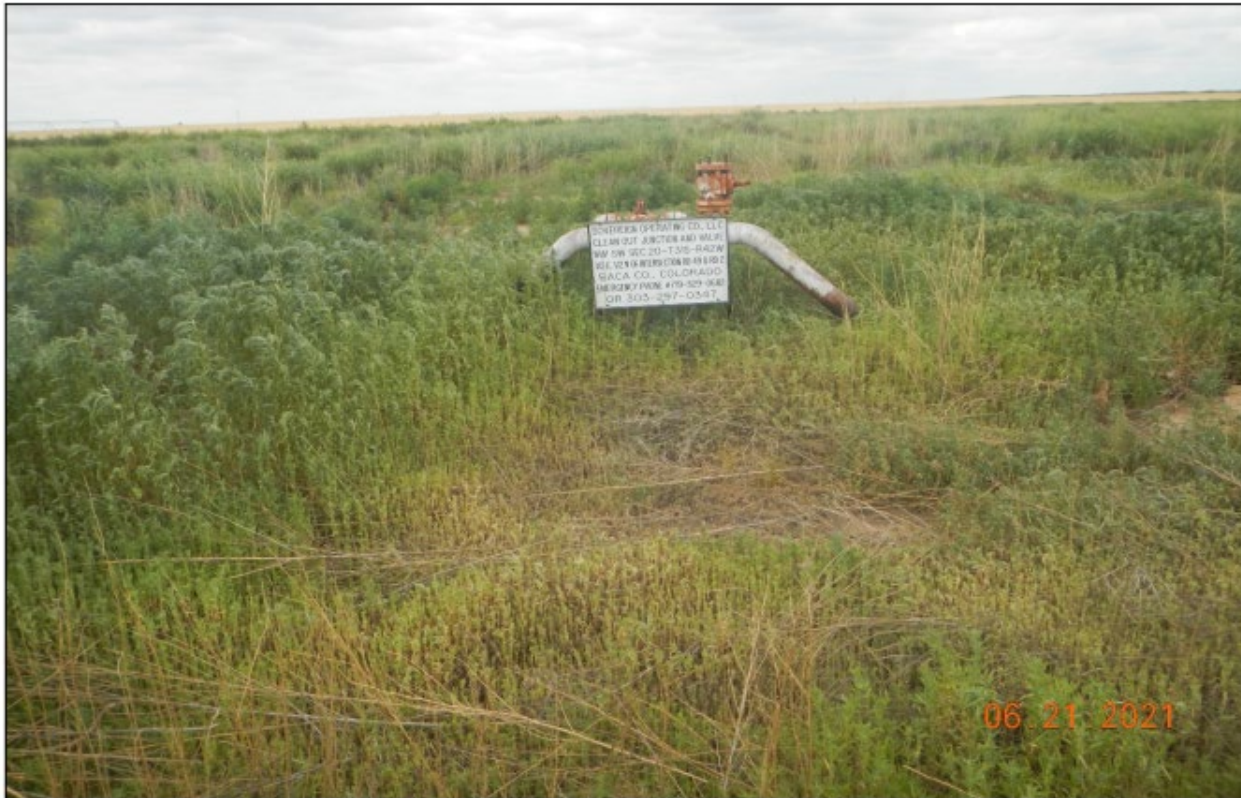
**Photo 7.** There is a cleanout junction 1850 ft. north of the pipeline which is associated with the former gas compressor station and must be removed. Photo taken from previous inspection.
