Interim Reclamation and Stormwater Inspection

Date: 01/24/2024

Operator: WESTERN OPERATING COMPANY - 95620

Location ID: 312292

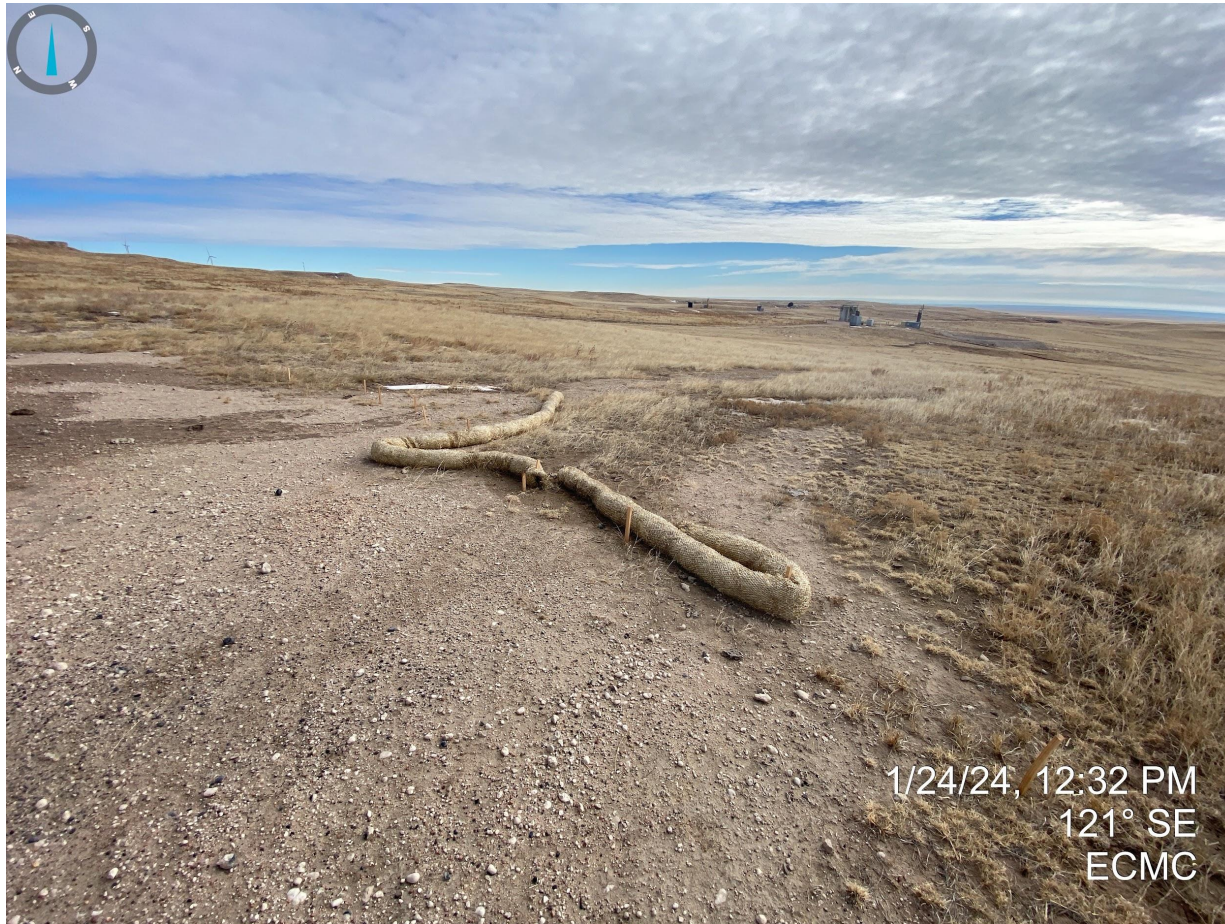
Photo 1. Taken near the vertical heater treater. Photo illustrates that straw wattles are not properly installed and bare/exposed soils are not properly stabilized.

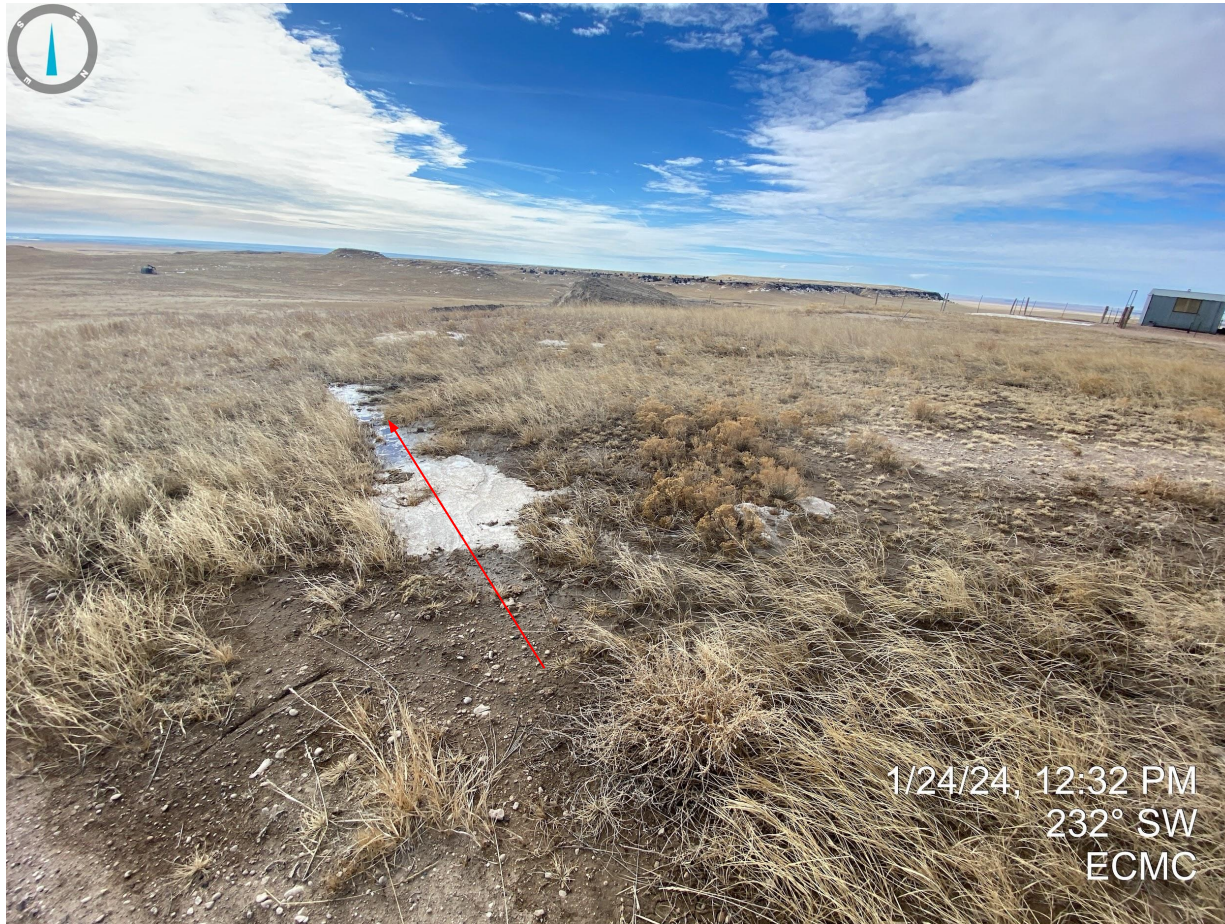
Photo 2. Taken near the vertical heater treater. Photo illustrates that erosion degradation is occurring.

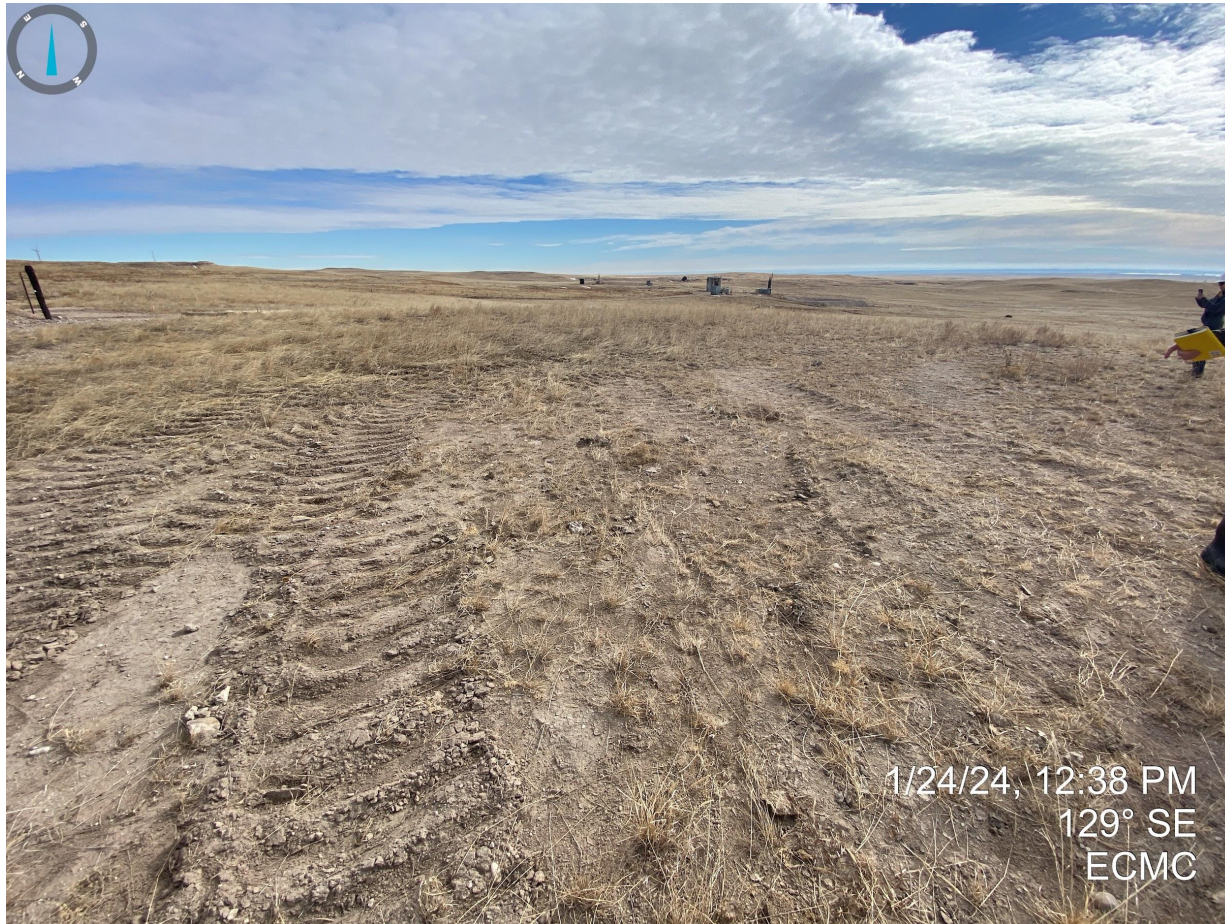
Photo 3. Taken between the vertical heater treater and pumpjack. Photo illustrates that the bulldozer has been removed from the location, and any disturbances resulting in bare/exposed or unstabilized soils will need to be properly stabilized with appropriate BMPs.

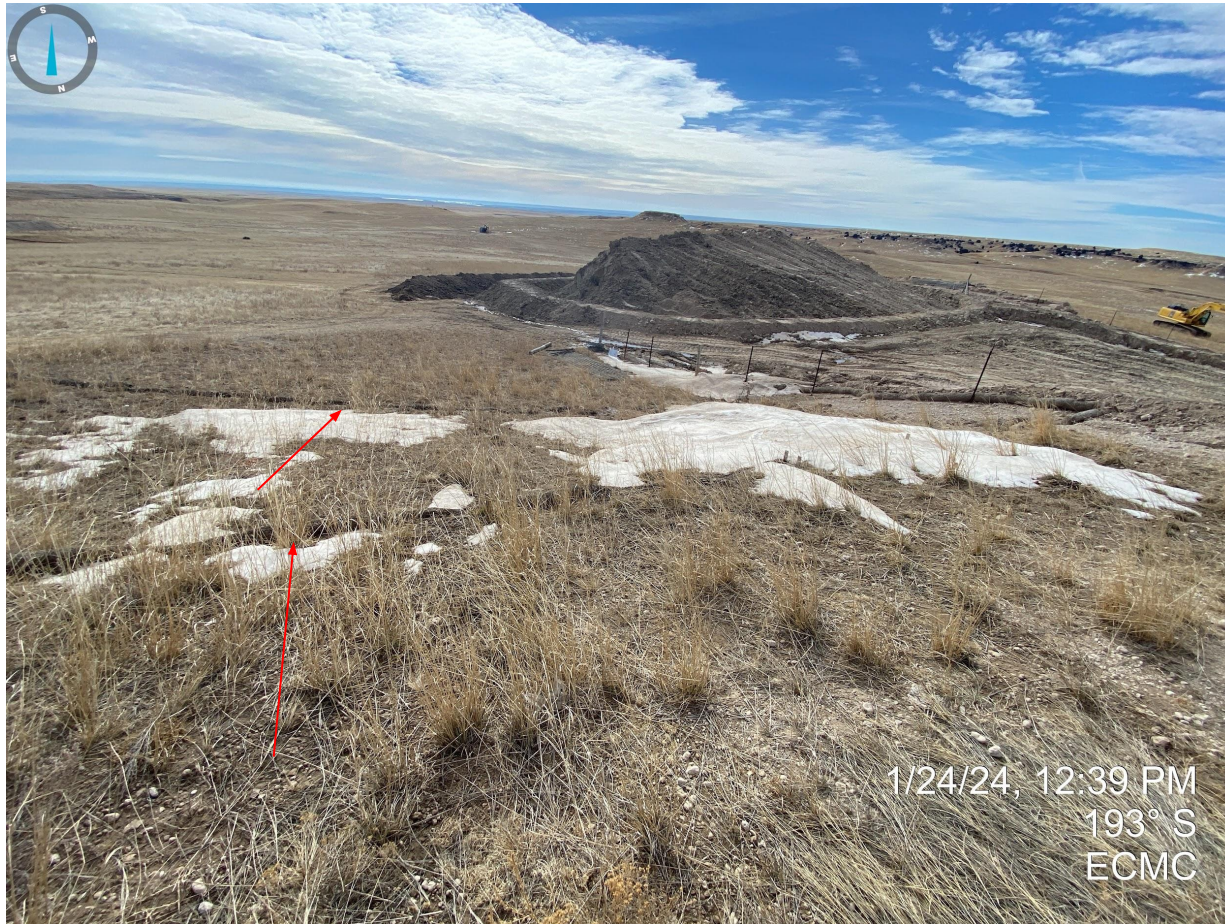
Photo 4. Taken south of pumpjack. Photo illustrates stockpile from pit in the background of the photo which is approximately 4,000 CY of material that has been placed outside of the location (approximately 0.5 of an acre of new disturbance). Straw wattle BMPs (red arrow) pictured in the foreground are degraded and now considered debris.

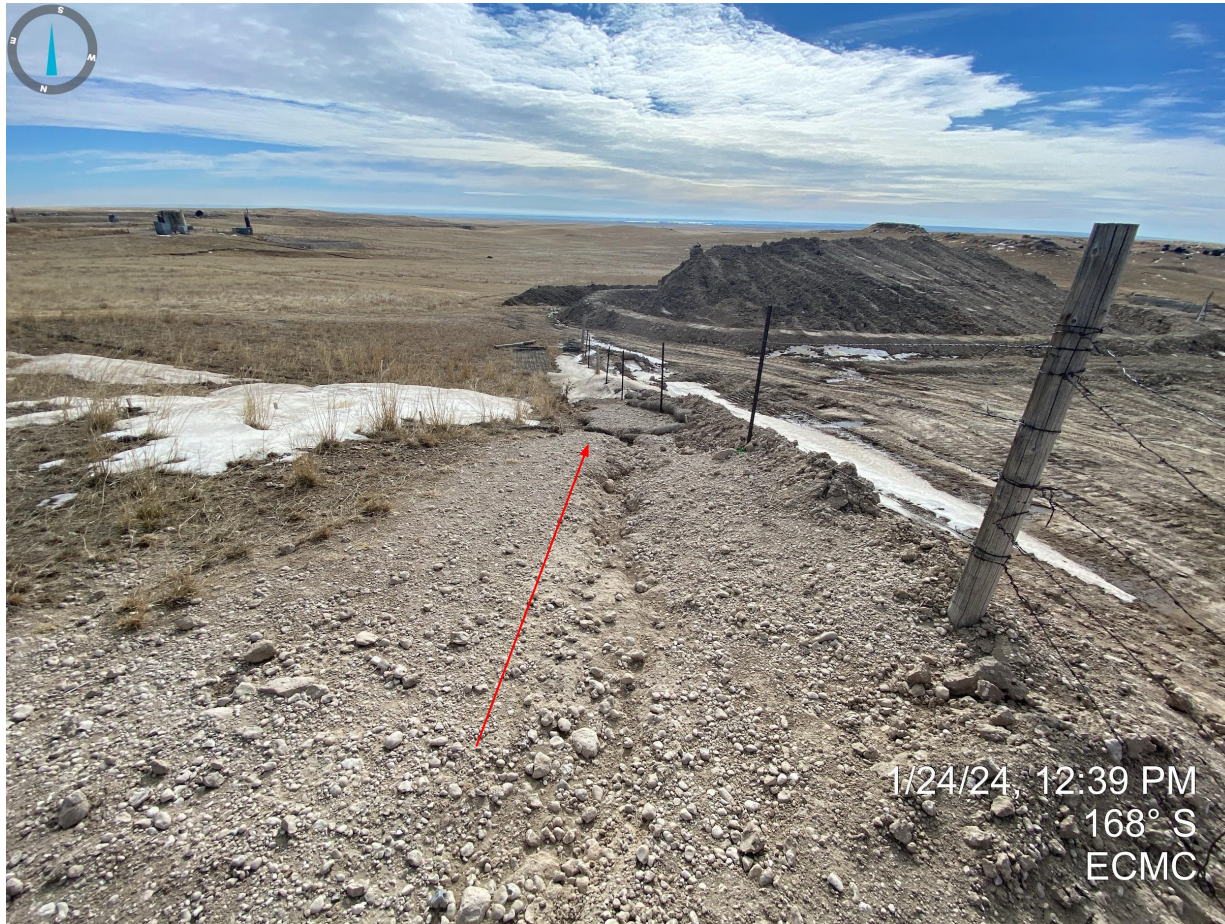
Photo 5. Erosion degradation on the east side of the pit. No stormwater control measures observed.

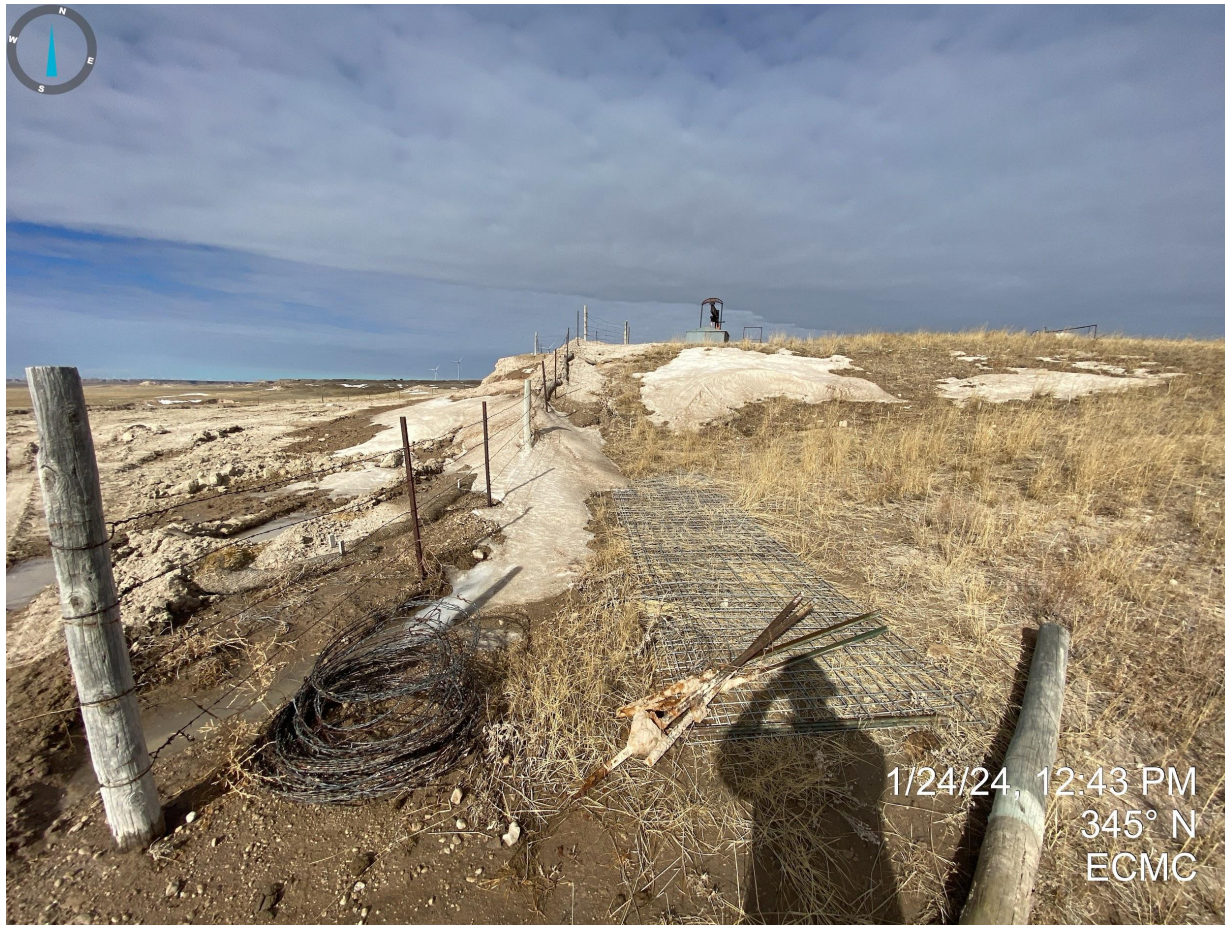
Photo 6. Unused equipment observed on the southeast corner of the pit.

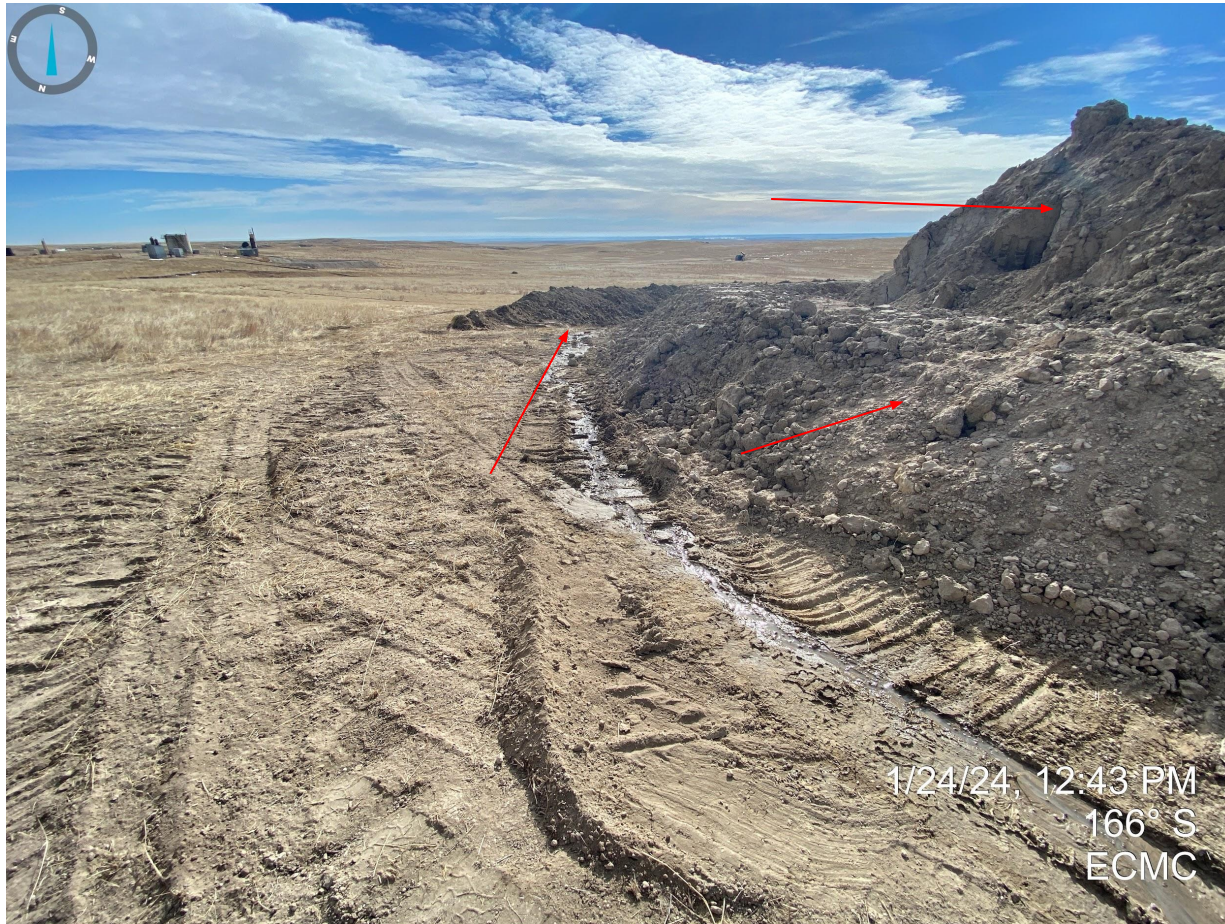
Photo 7. Northeast side of stockpiled pit soils. Photo illustrates that both the stockpile and berms have been left unconsolidated. Unconsolidated materials can become a potential pollution source as it is not properly stabilized. Also pictured, stormwater running off location into berms.

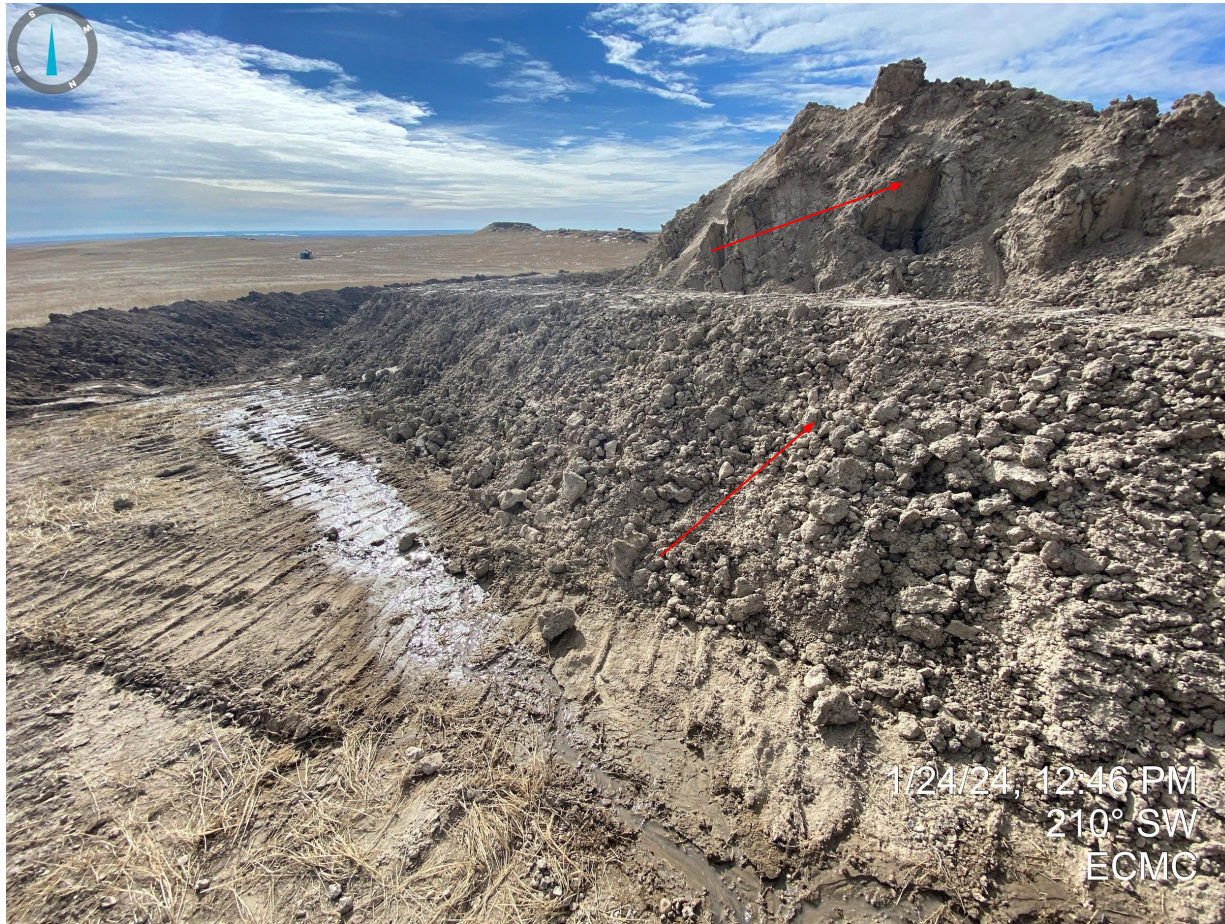
Photo 8. East side of stockpile; see comments in Photo 7.

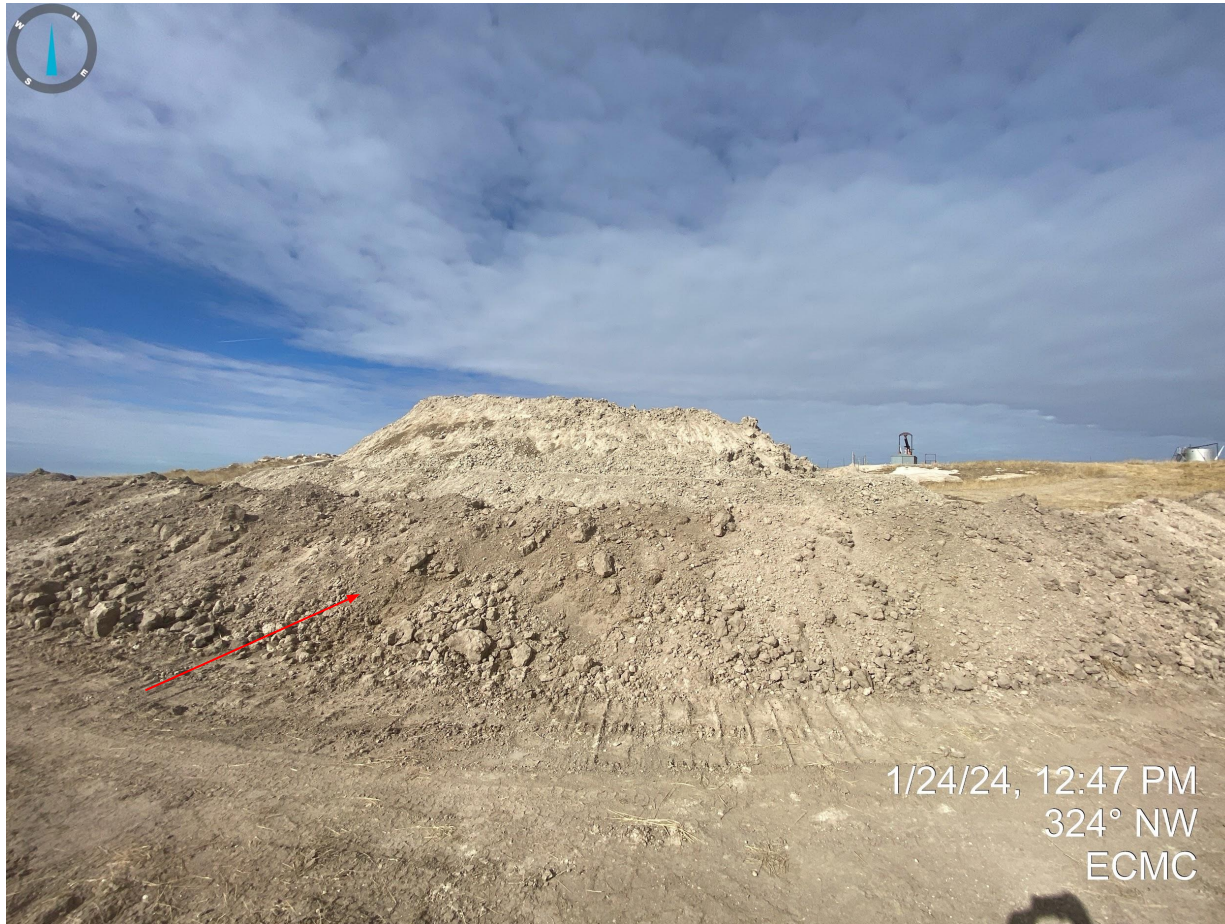
Photo 9. South side of stockpile form the pit; see comments in Photo 7.

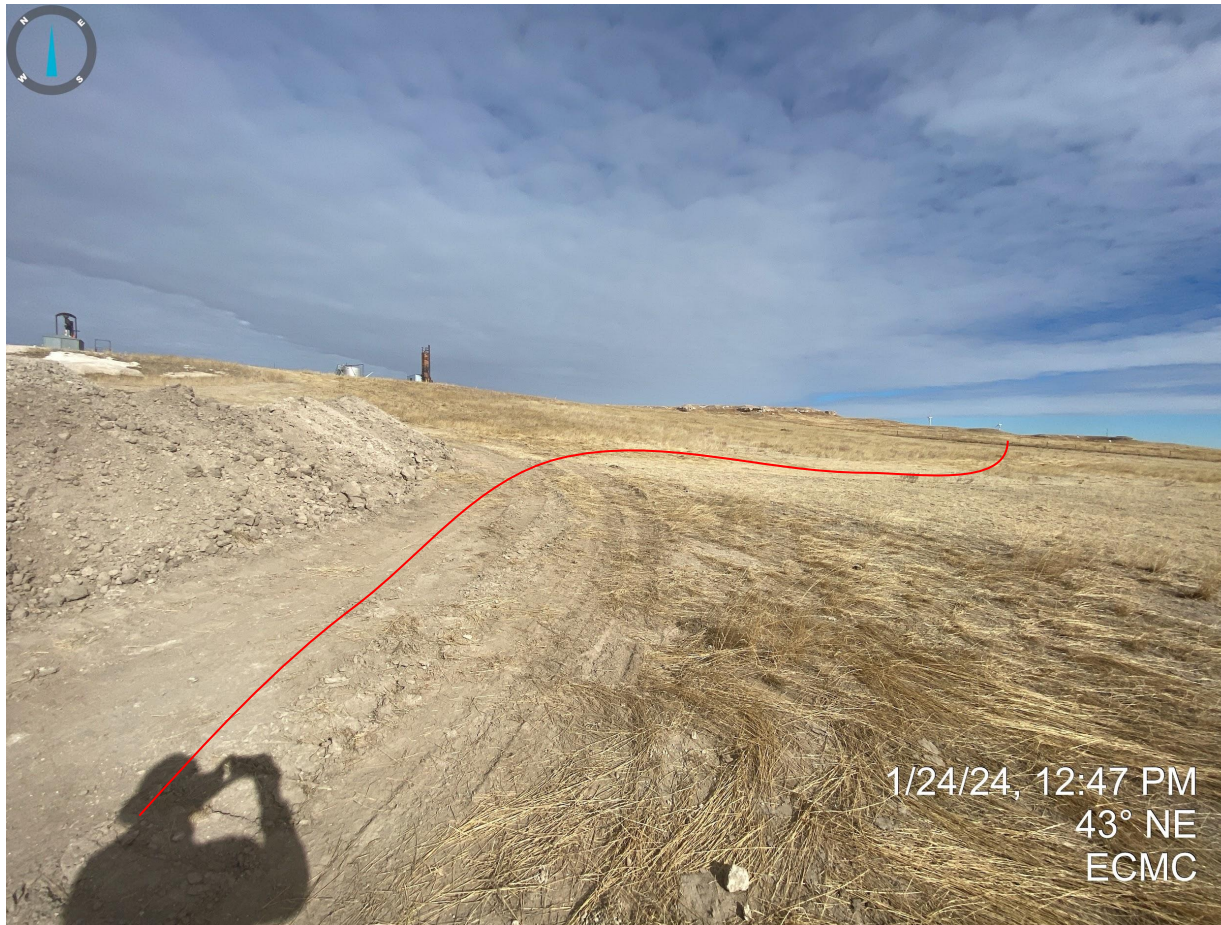
Photo 10. South side of stockpiled pit material. Red line illustrates vehicle traffic occurring outside of the lease roads; any additional disturbance will need to be reclaimed per the reclamation rules.

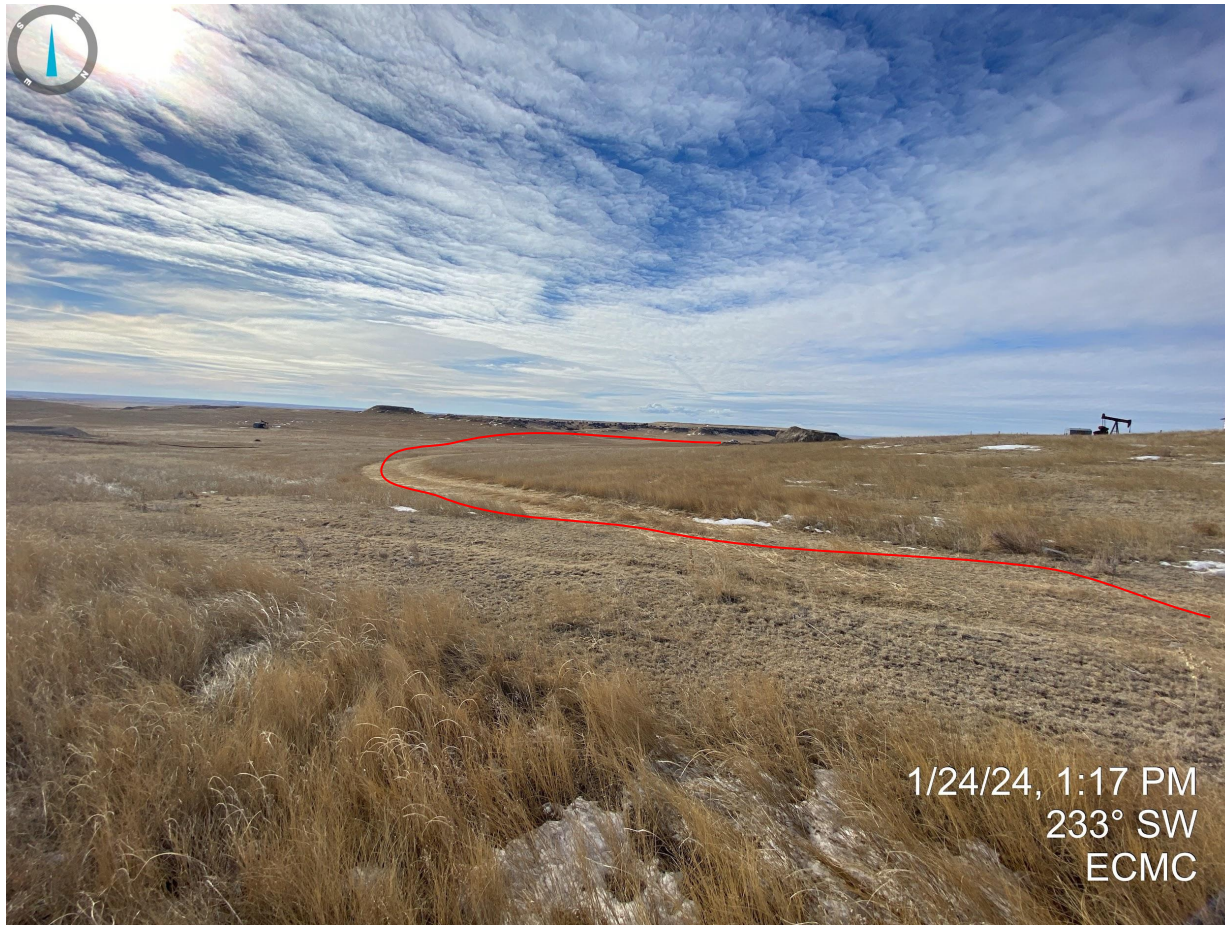
Photo 11. Continued from Photo 10; taken from eastern access road leading to the Propst B3X location. Photo illustrates additional disturbance (e.g. vehicle traffic in red line) occurring outside of the lease roads.

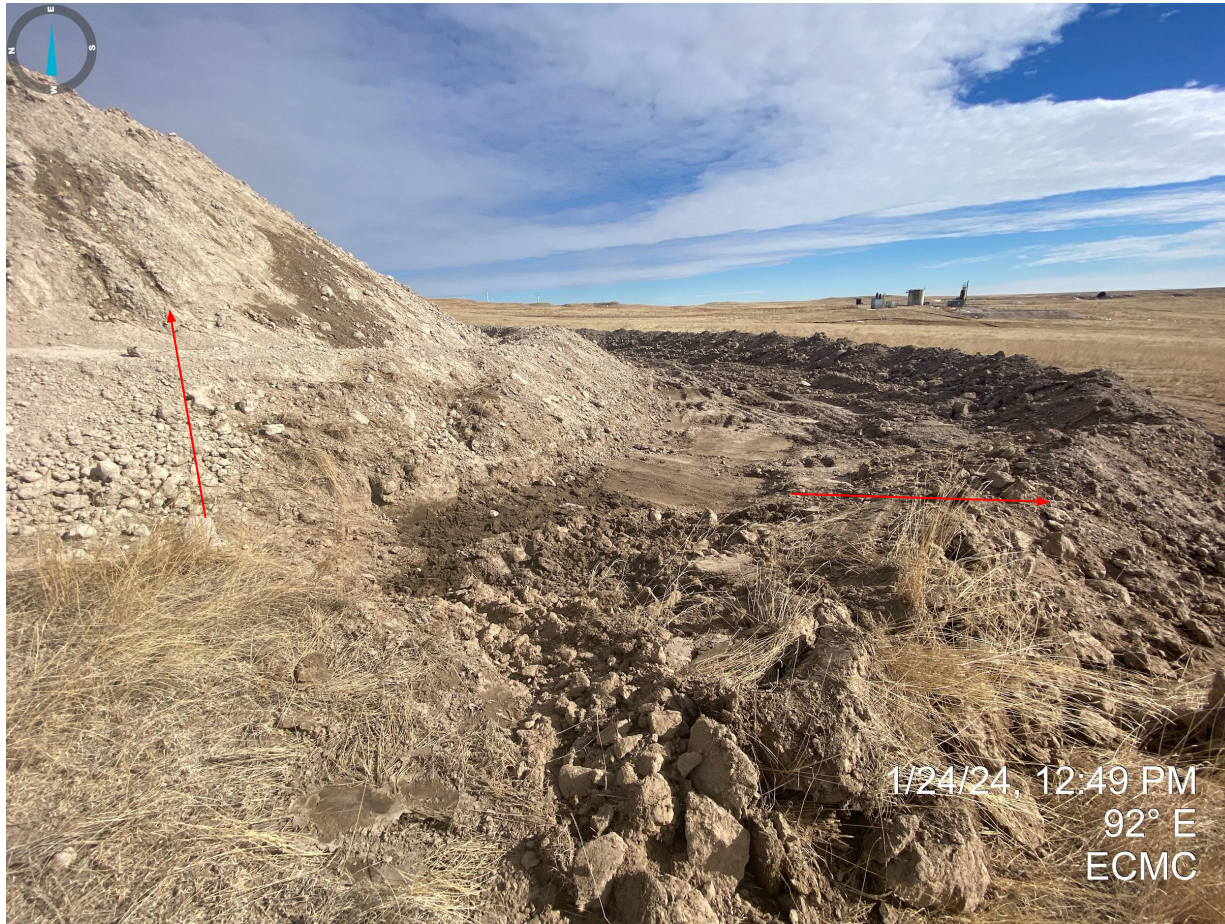
Photo 12. West side of stockpile form the pit; see comments in Photo 7.

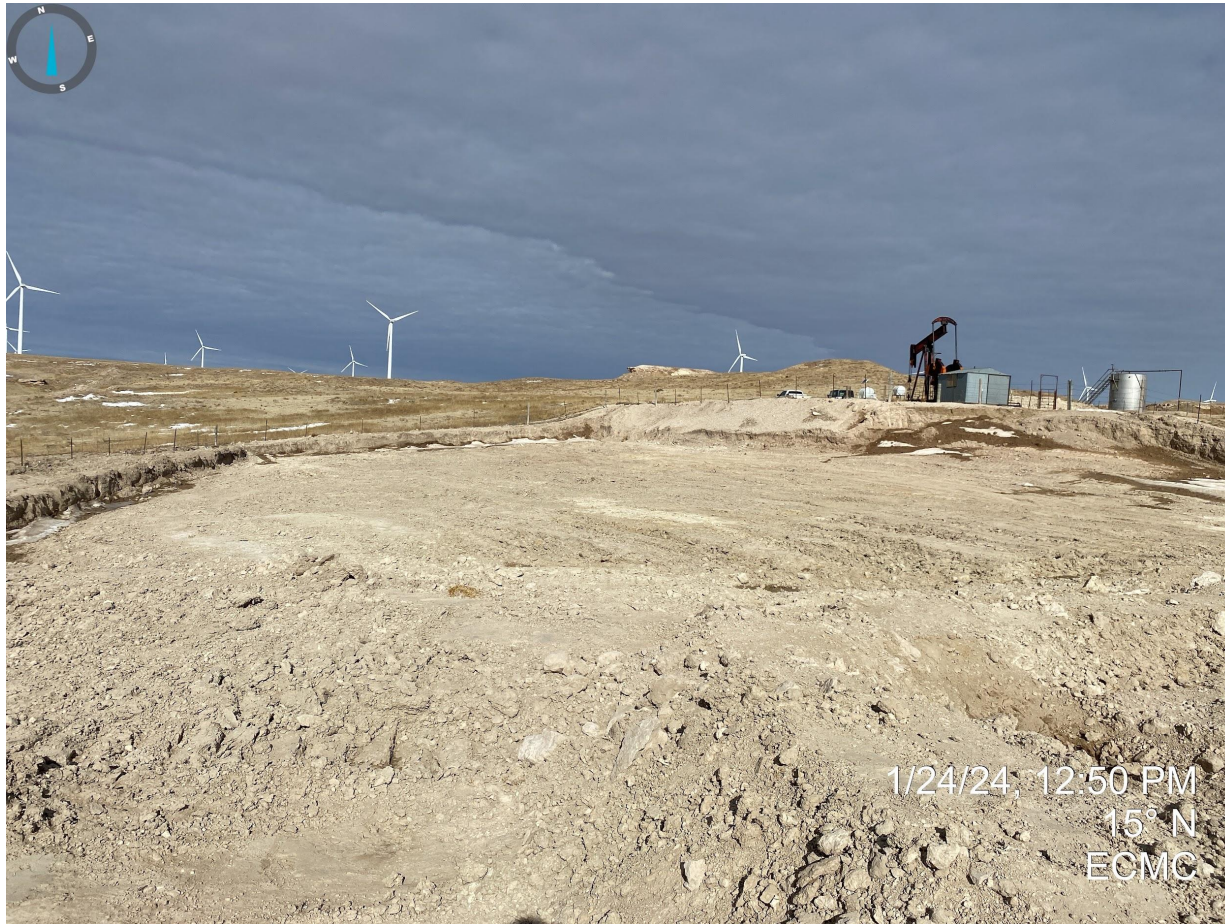
Photo 13. South side of excavated pit area. Soils do not appear to be properly stabilized as they have been left unconsolidated.

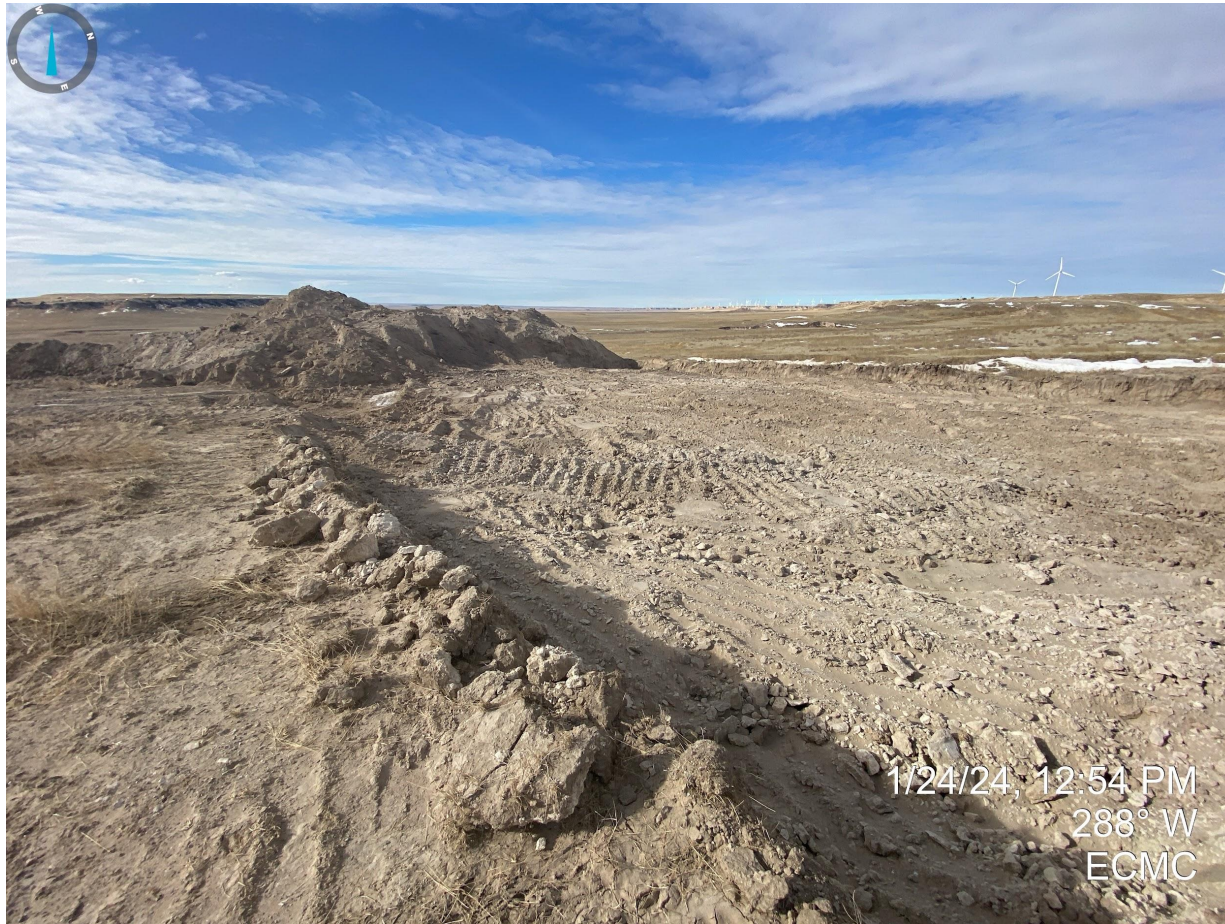
Photo 14. Excavated area west of the pit is approximately 0.5 acre in size and the stockpile is approximately 4,000 CY. Operator will need to submit an updated Form 2A as this disturbance is occurring outside of the original disturbance area. Soils do not appear to be properly stabilized from wind and water erosion.

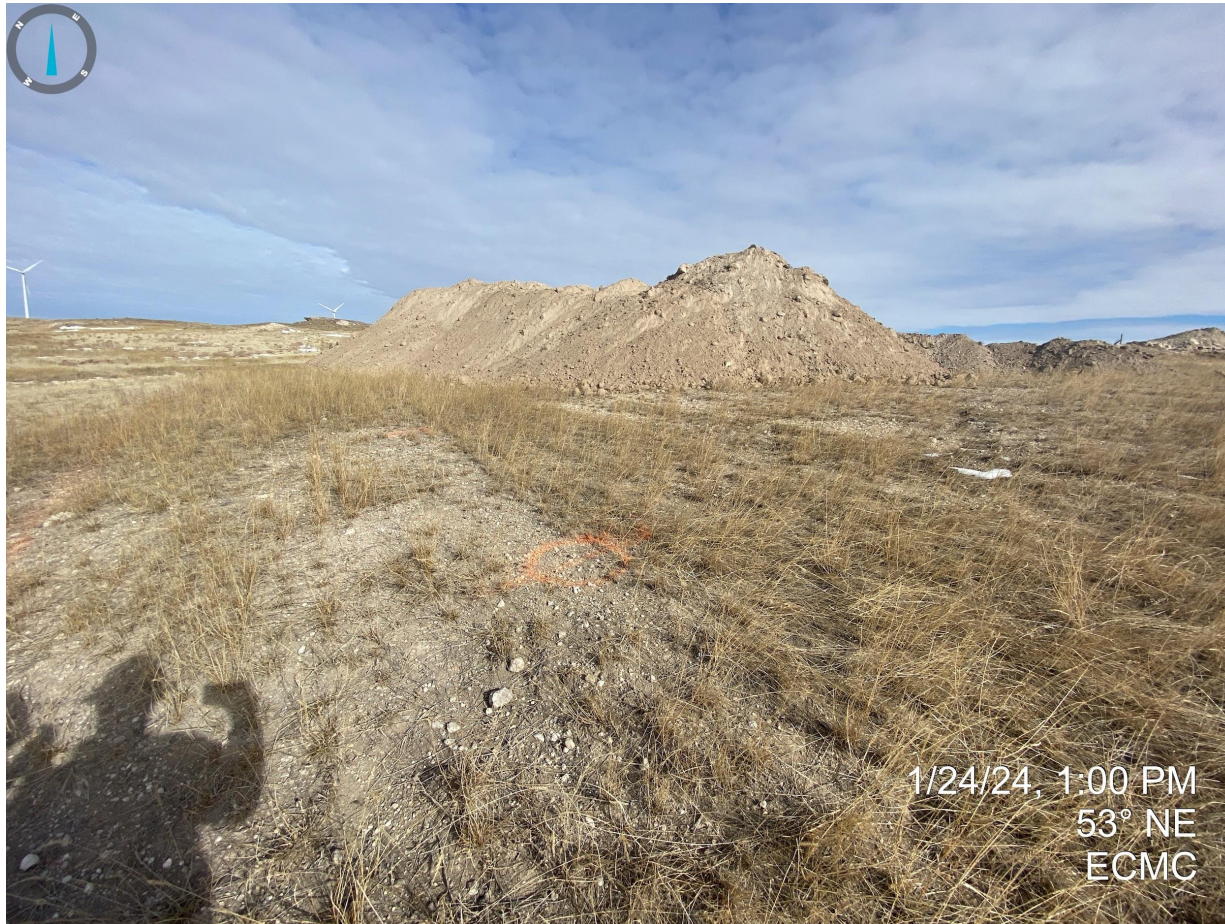
Photo 15. Southwest of the western salt kill excavation. No apparent stormwater control measures/BMPs were observed at the time of this inspection. Stockpiled material is not properly stabilized as it has been left unconsolidated.

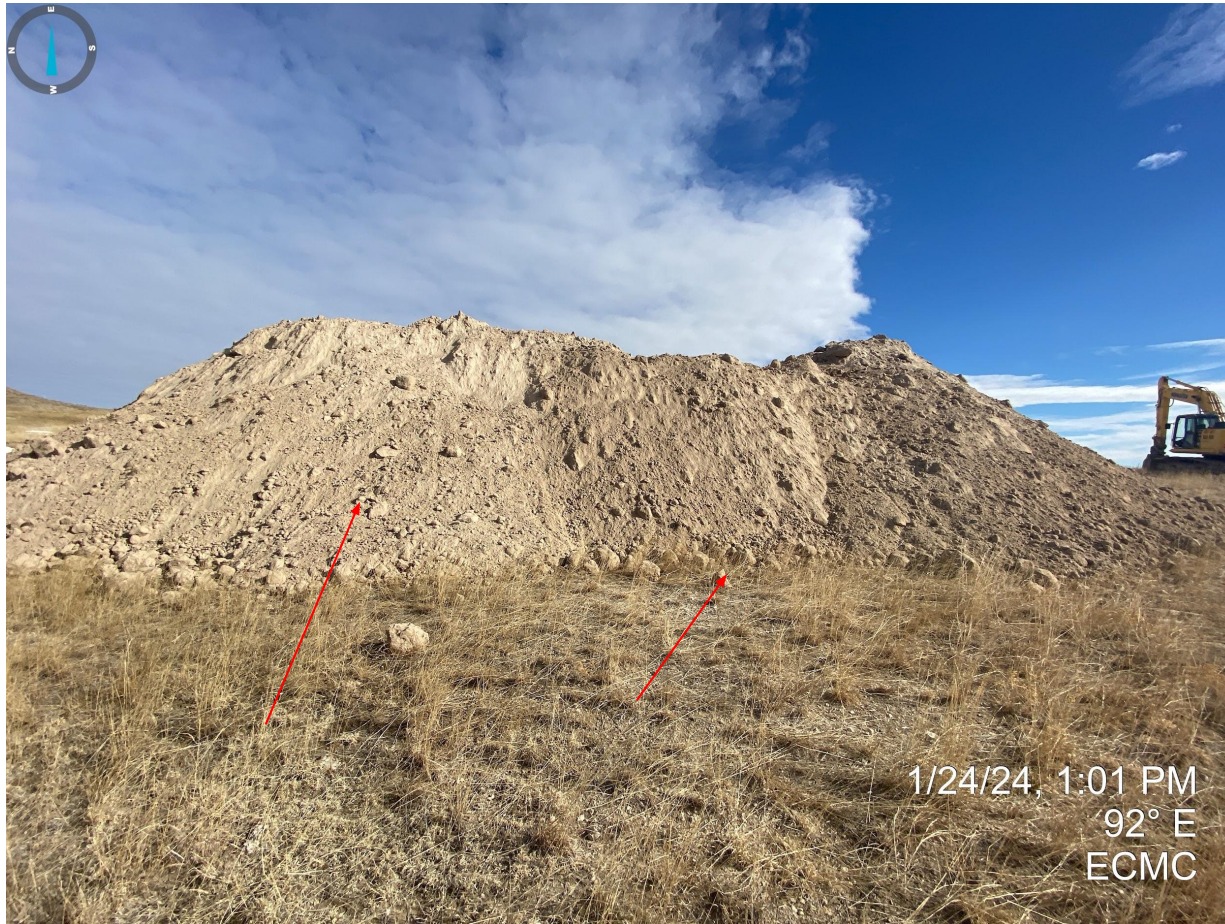
Photo 16. West side of stockpile; see comments in Photo 15.

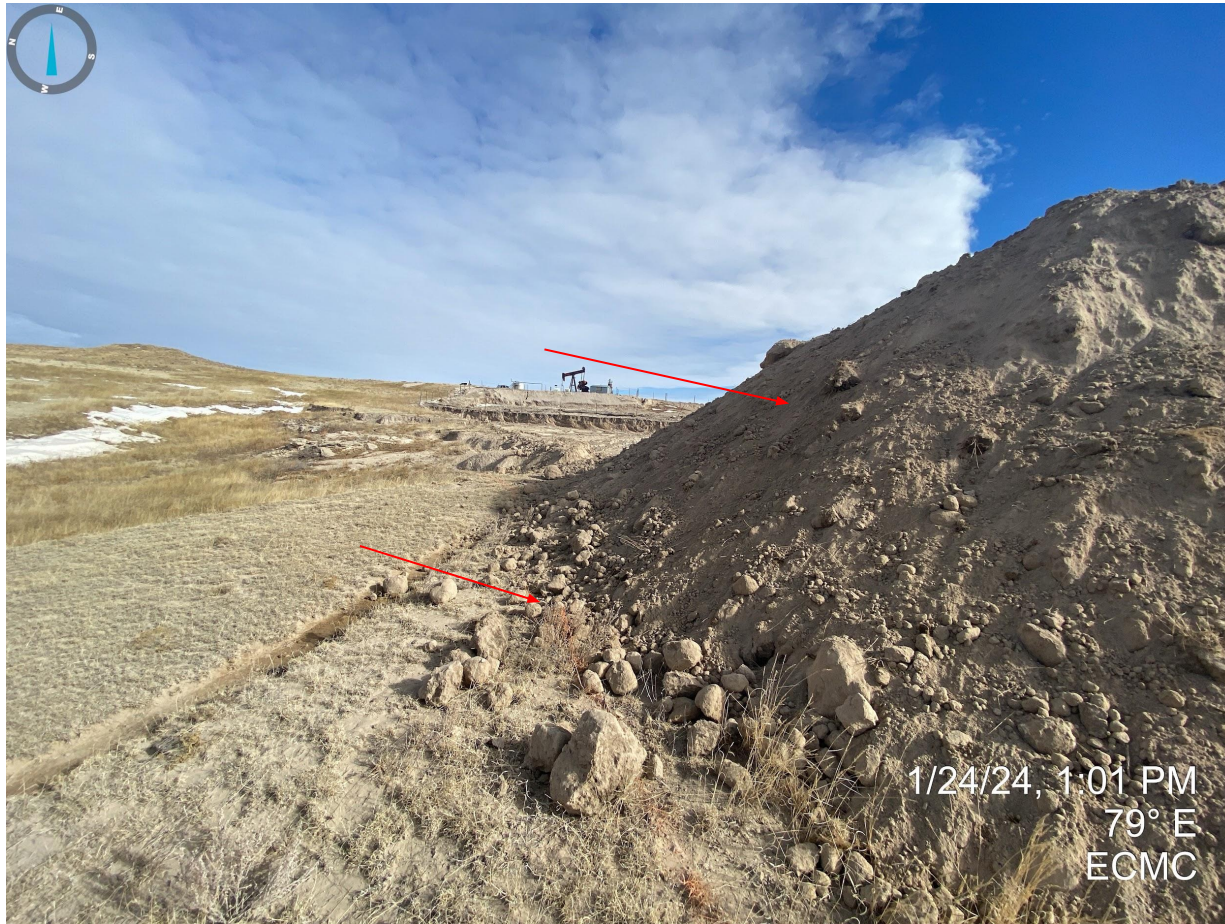
Photo 17. North side of stockpile; see comments in Photo 15.

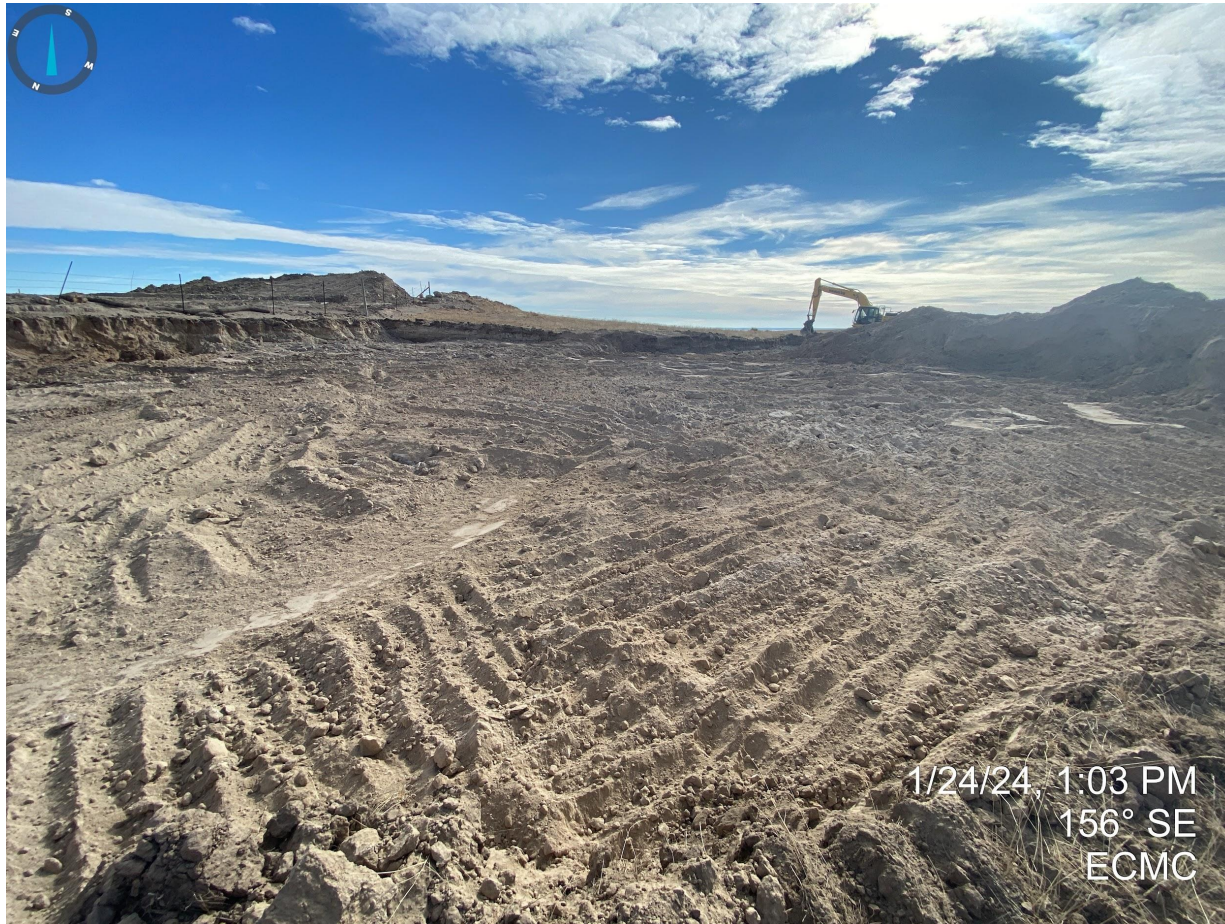
Photo 18. North side of salt kill excavation; see comments in Photo 14.

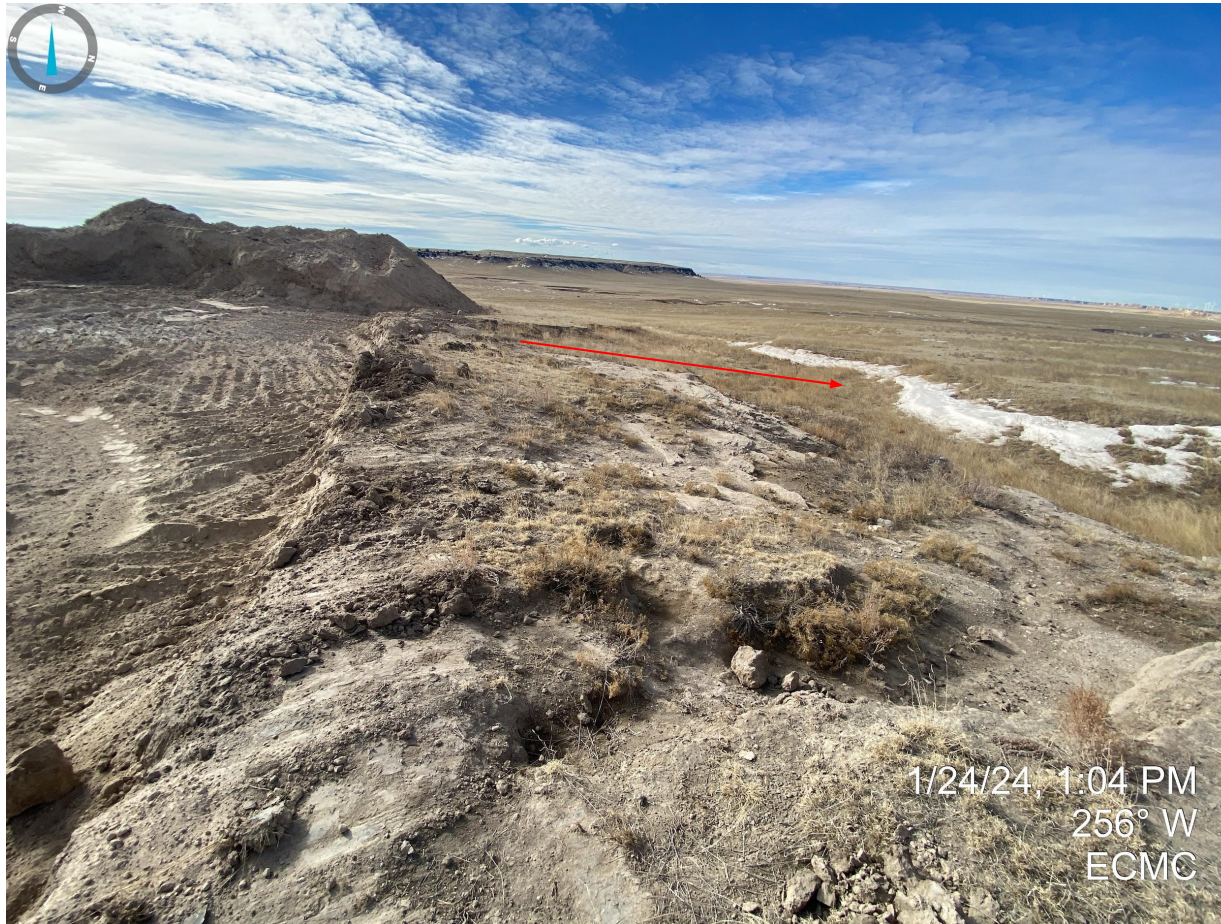
Photo 19. North side of salt kill excavation. No apparent stormwater control measures/BMPs observed that would prevent impacted material from the salt kill areas, or sediment laden stormwater, from entering adjacent drainage.
