Interim Reclamation and Stormwater Inspection

Date: 01/24/2024

Operator: WESTERN OPERATING COMPANY - 95620

Location ID: 312292

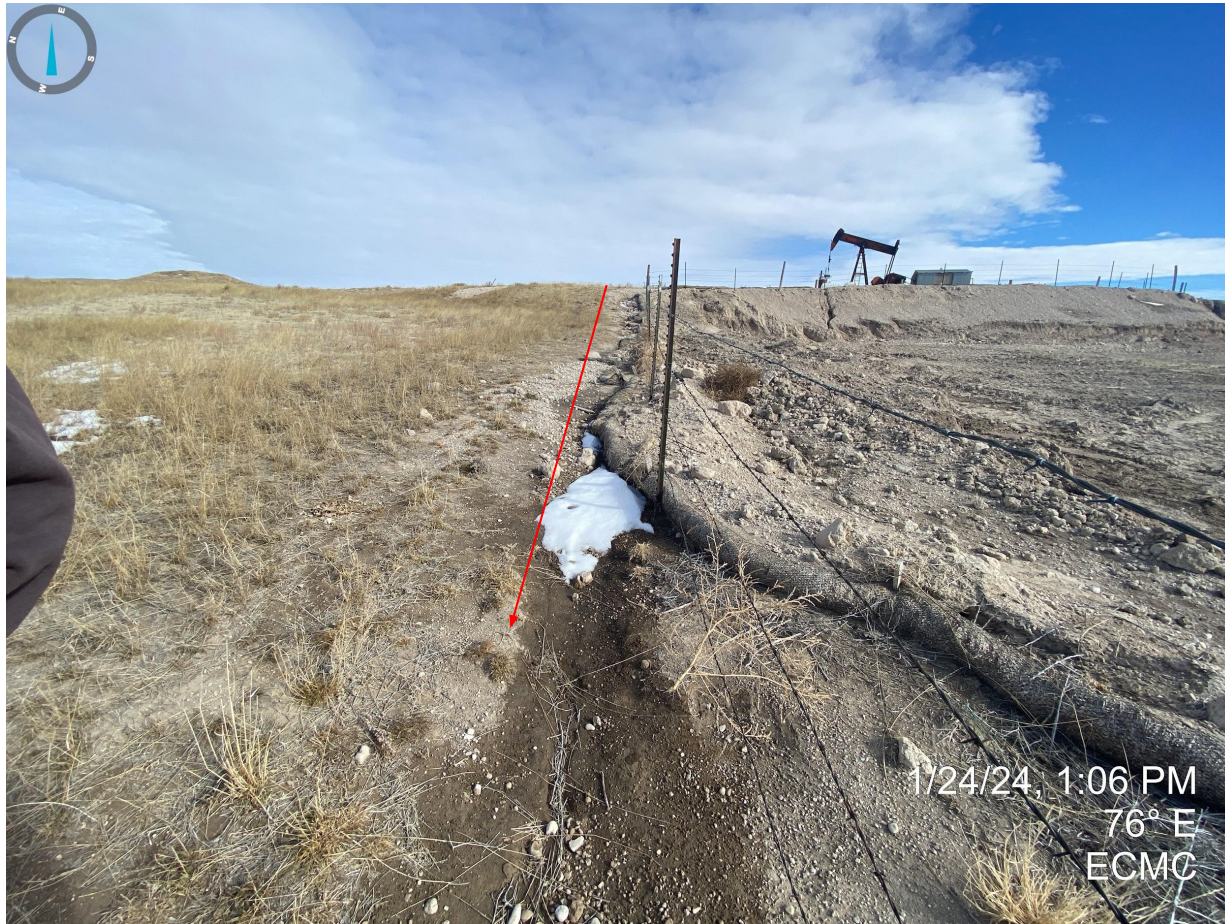
Photo 20. Erosion degradation observed on the north side of the pit does not appear to have been repaired or to have had BMPs installed.

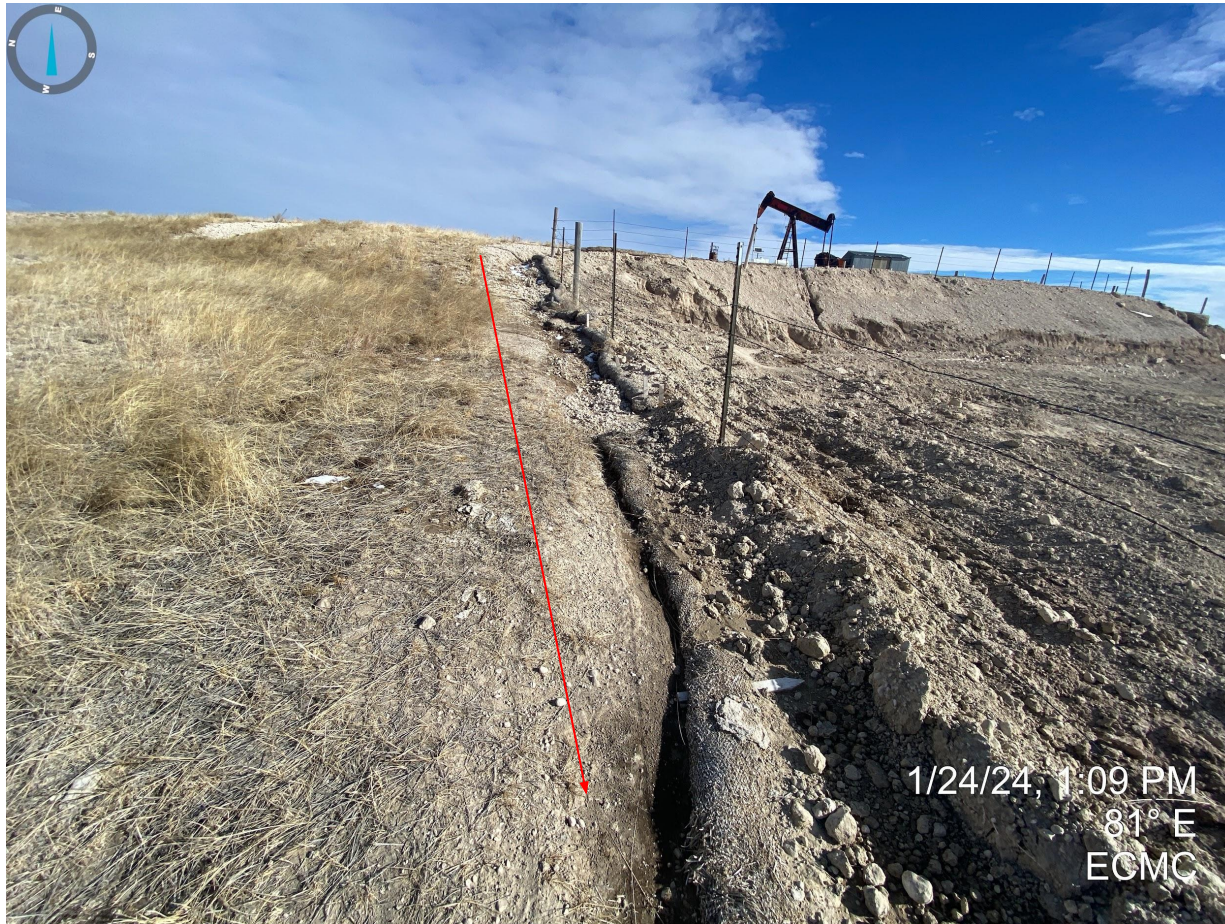
Photo 21. Continued from Photo 20.

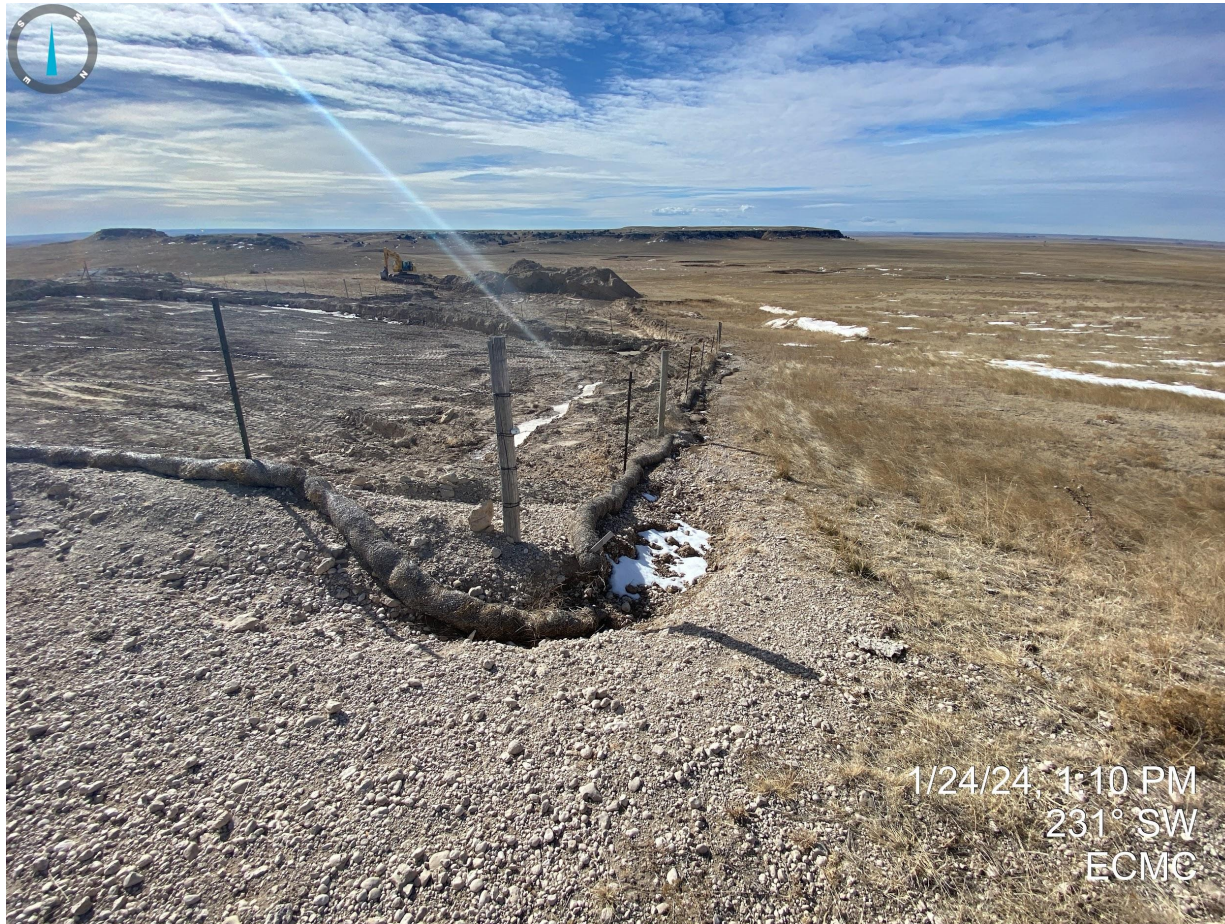
Photo 22. Northern portion of the pit; see comments in Photo 20.
