Inspection Photos
Location Name: Francis Arens 5-6-15, 34-15
Location ID: 332680

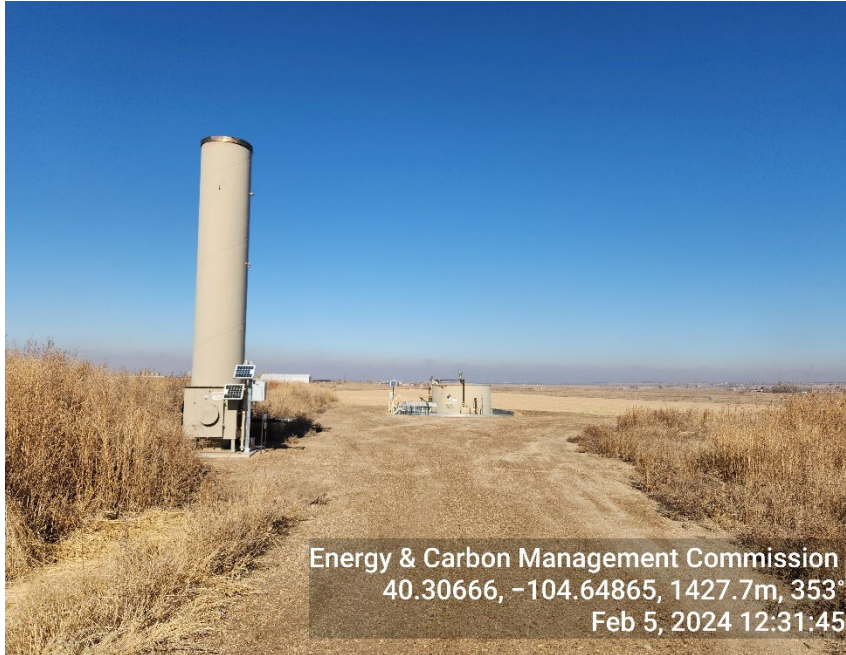
Photo 1: Location from entrance

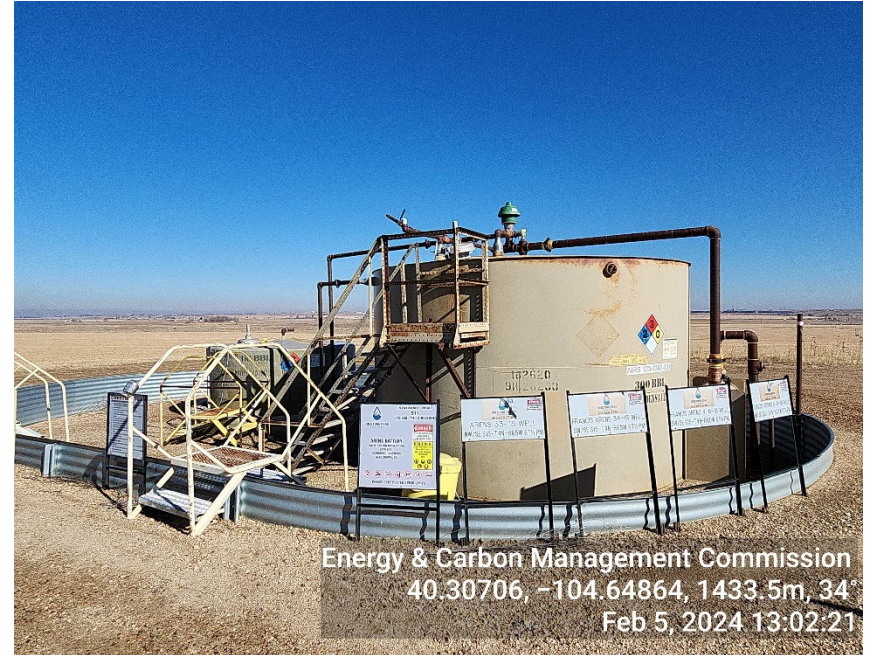
Photo 2: Centralized Tank Battery

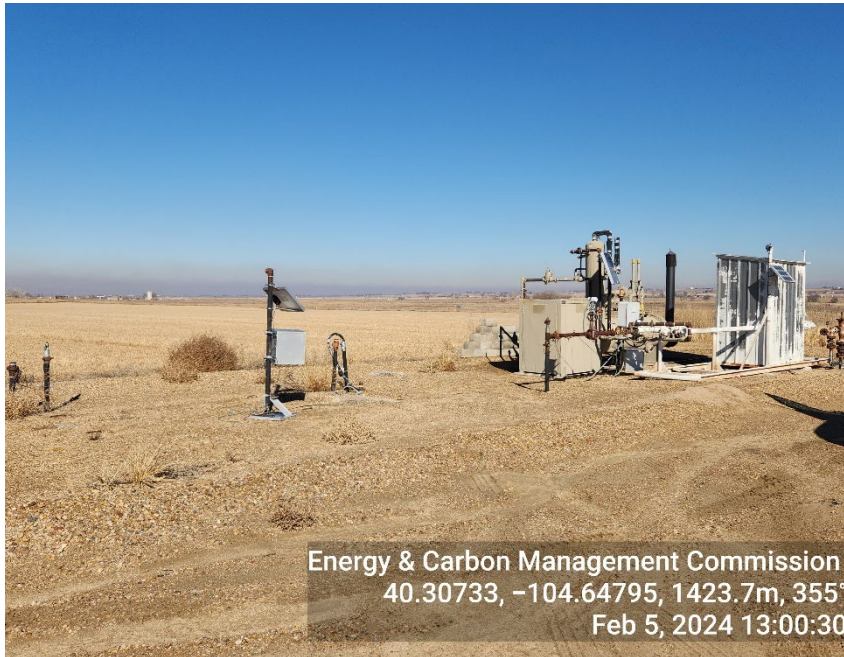
Photo 3: Equipment

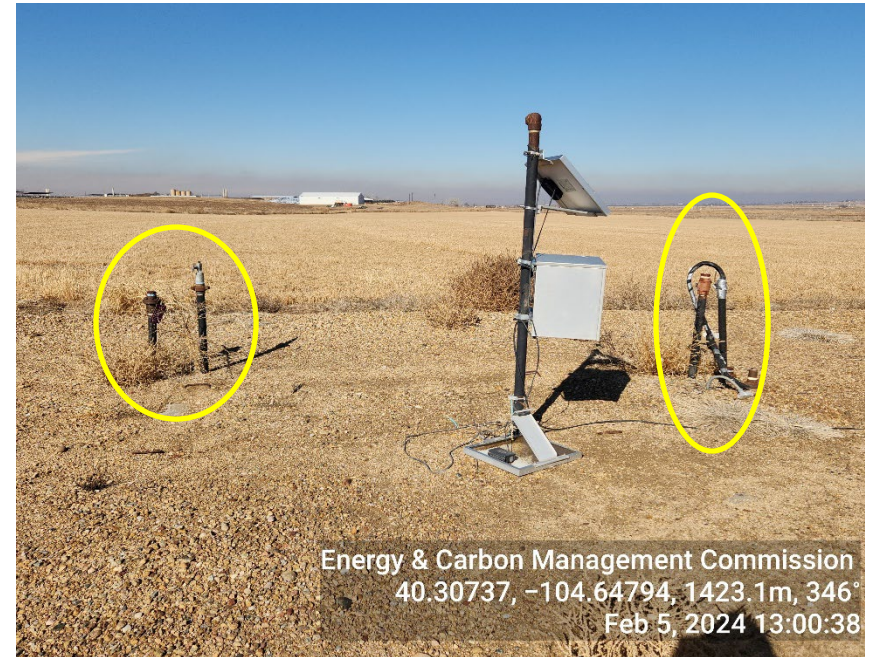
Photo 4: Unused Riser

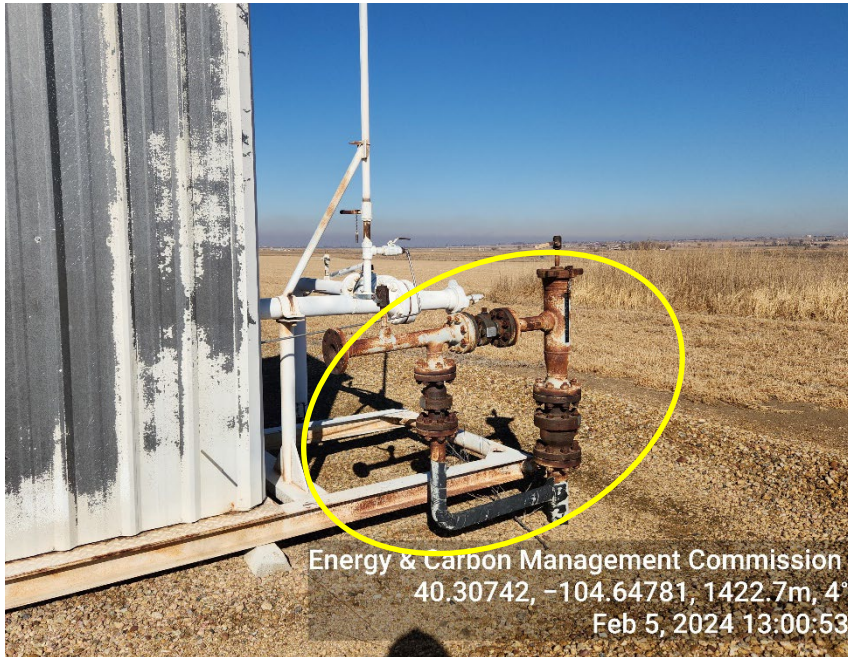
Photo 5: Unused riser

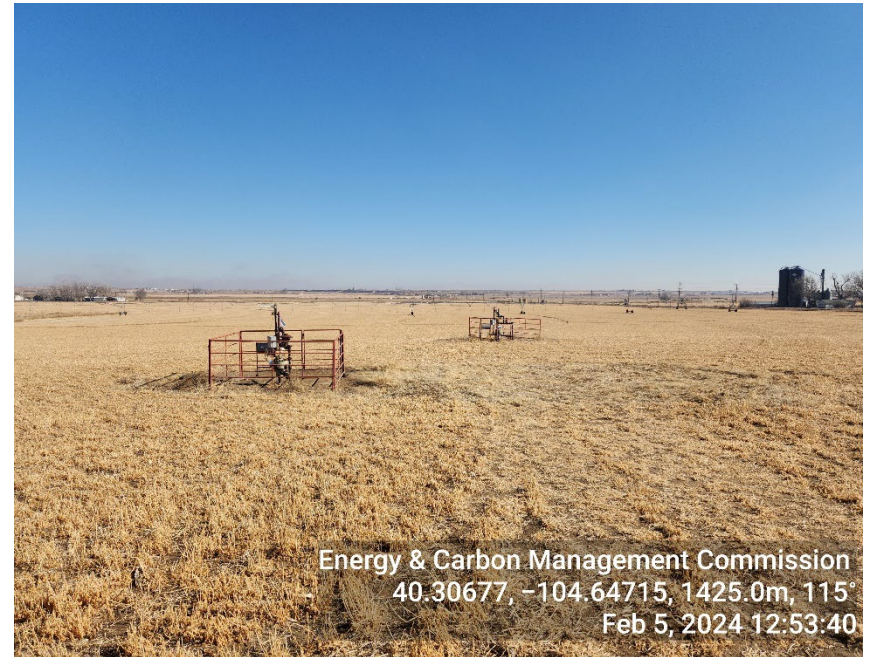
Photo 6: Location of wellheads

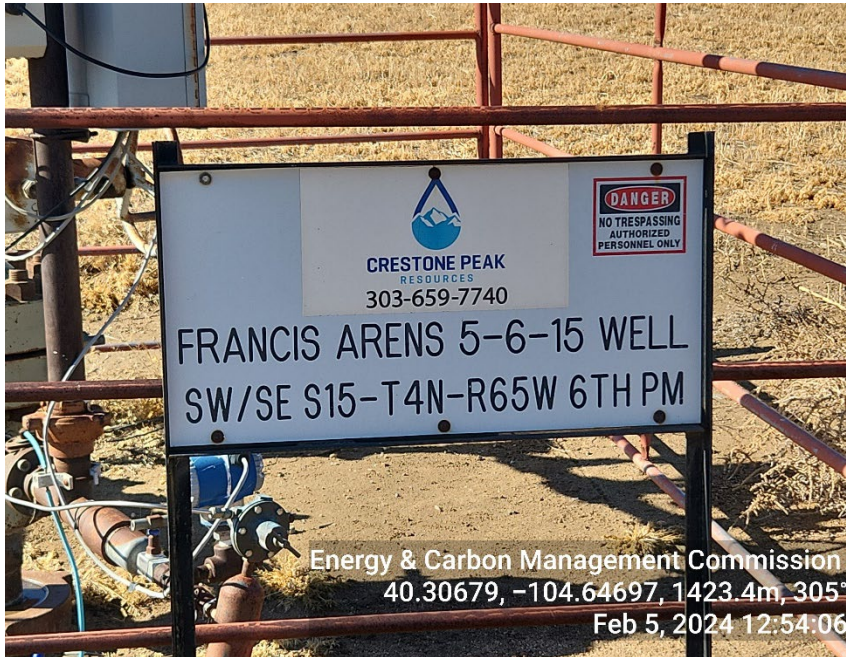
Photo 7: Wellhead Sign

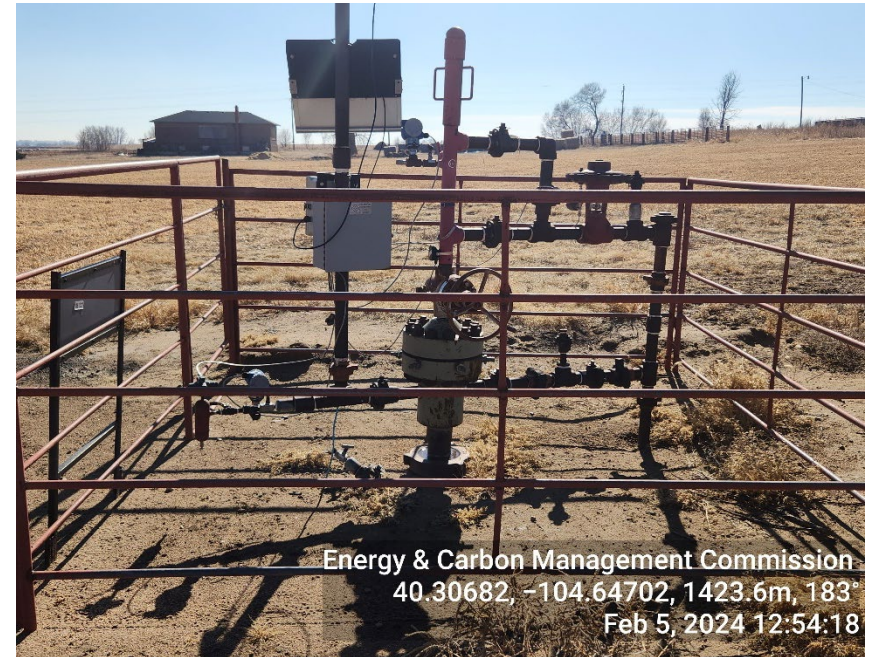
Photo 8: Wellhead

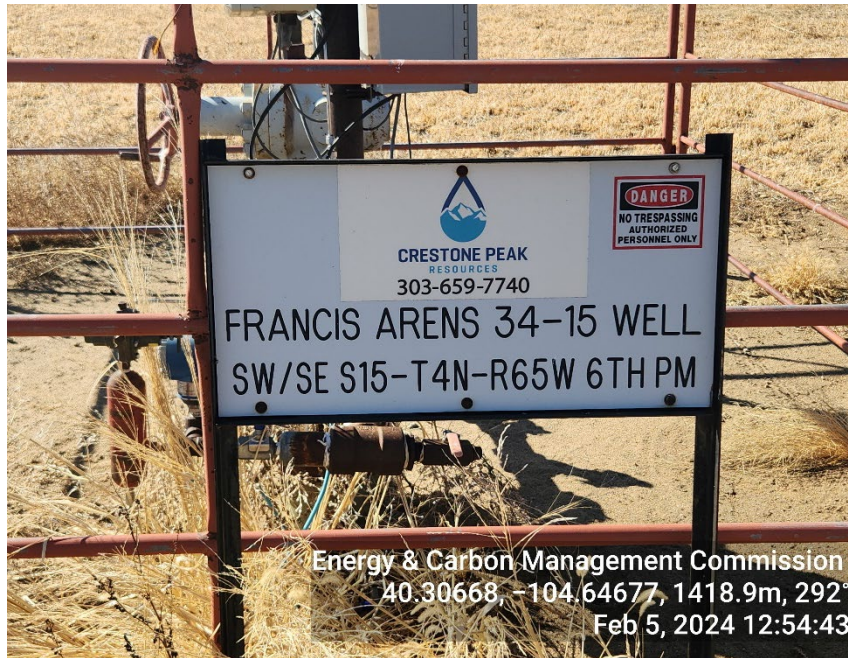
Photo 9: Wellhead Sign

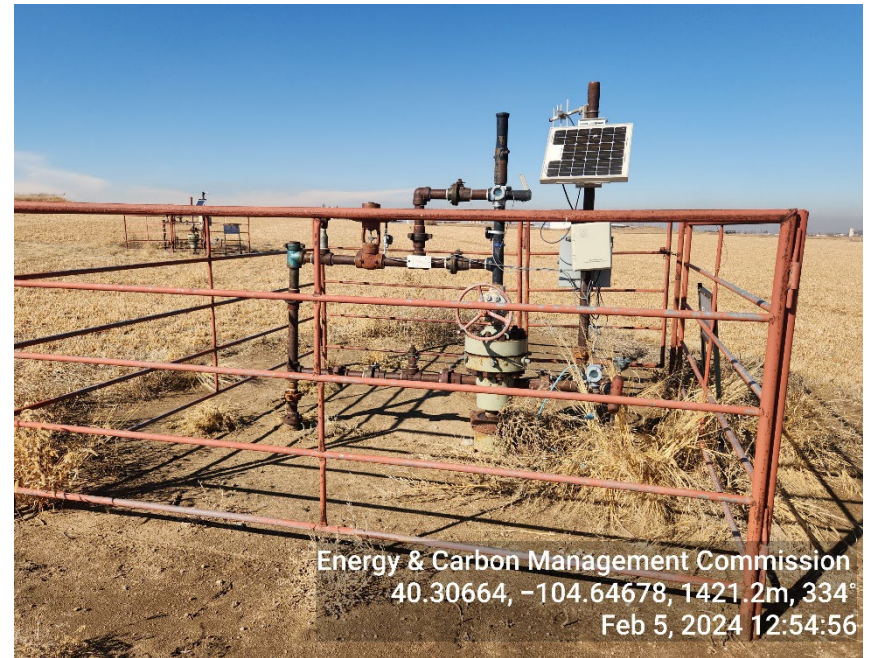
Photo 10: Wellhead

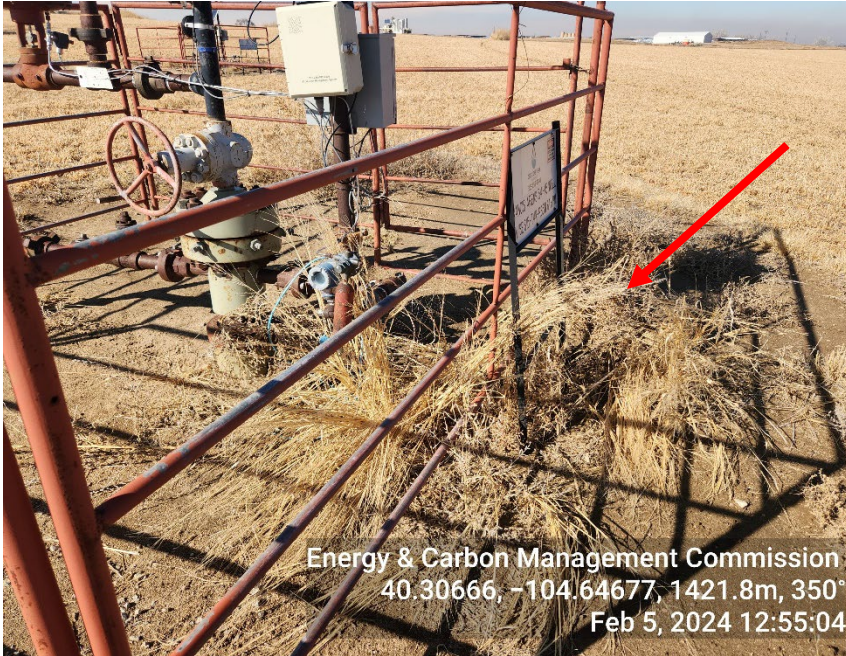
Photo 11: Weeds
