Final Reclamation Inspection

Operator: Hilcorp Energy Company - 10133

Location ID: 333494

Inspection Photos
Location Name: Argenta 34-10 32-2, 2A
Location ID: 333494

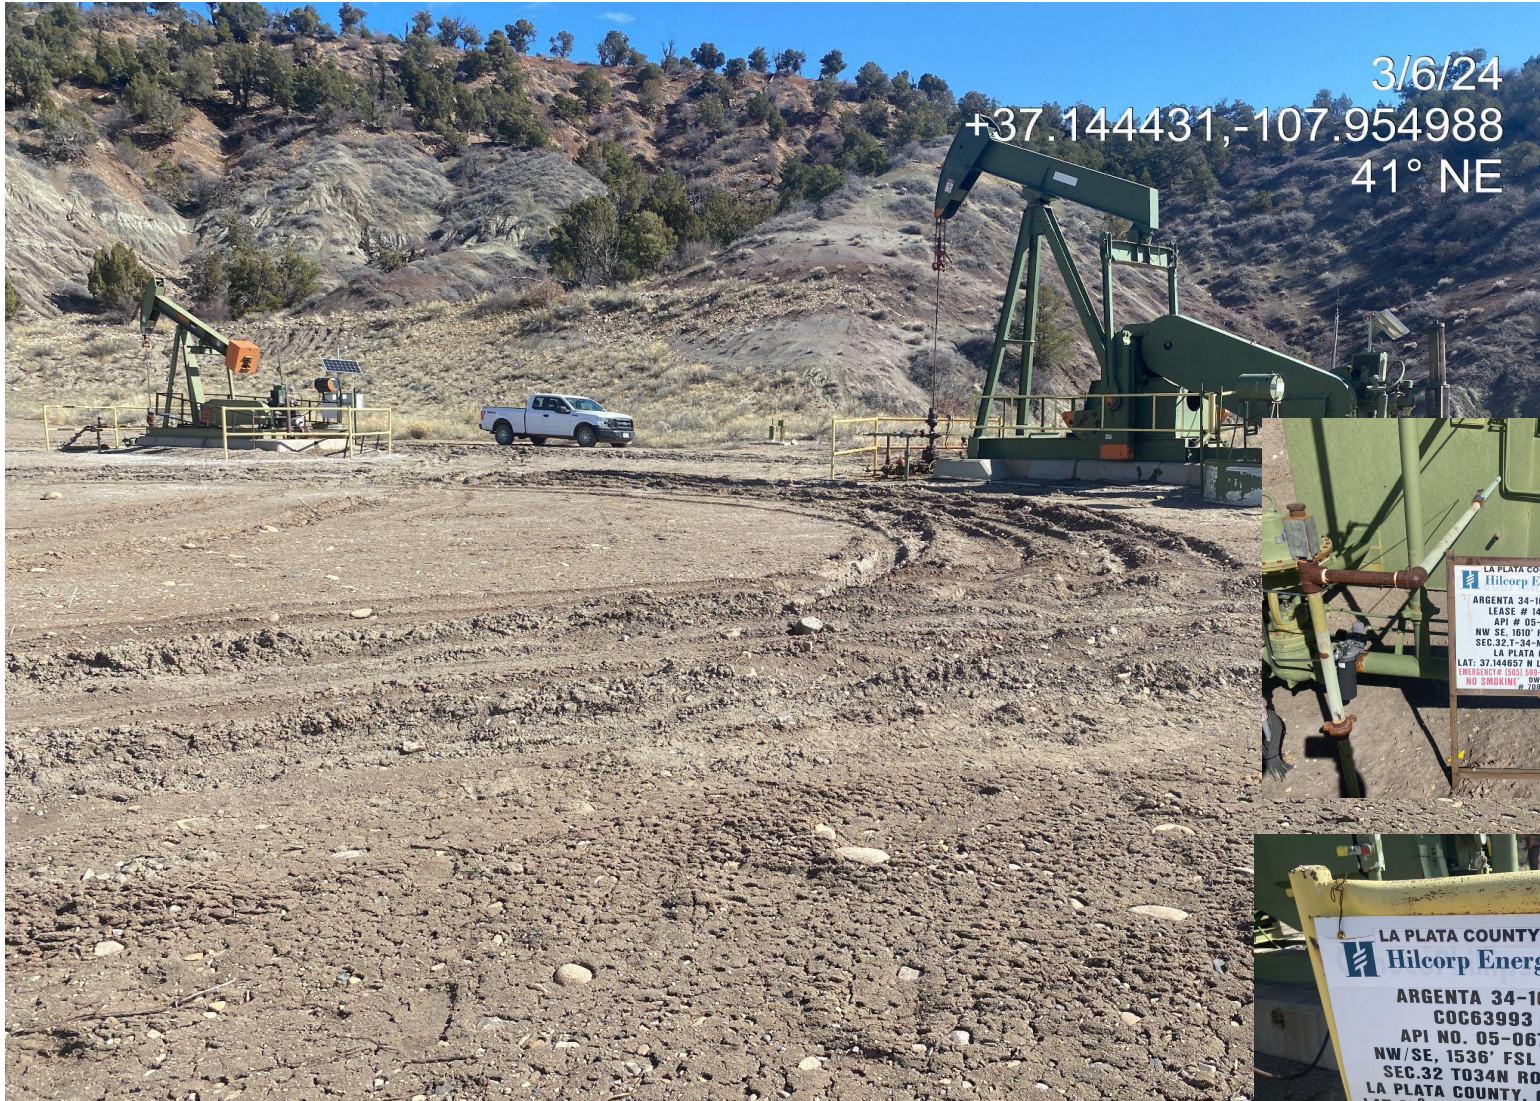
Photo 1. Overview of the disturbance taken from the entrance facing center.

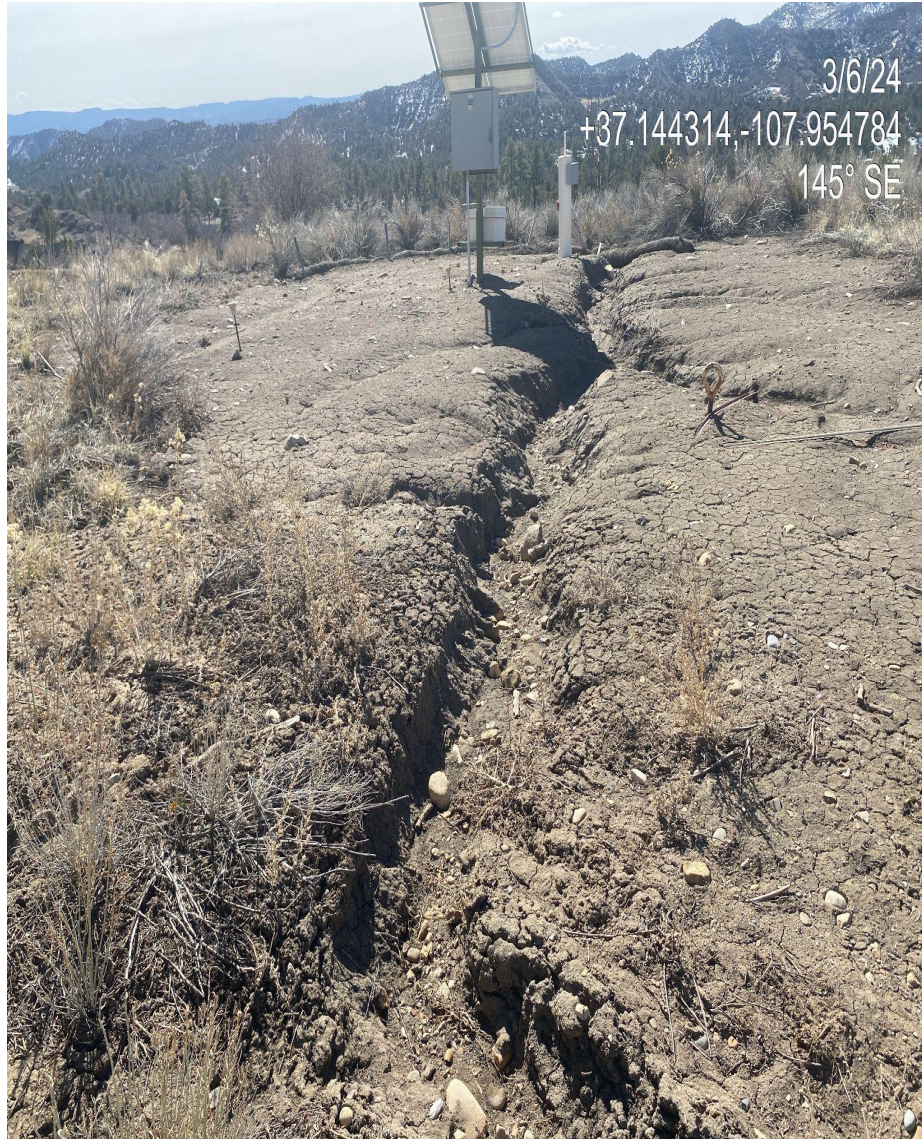
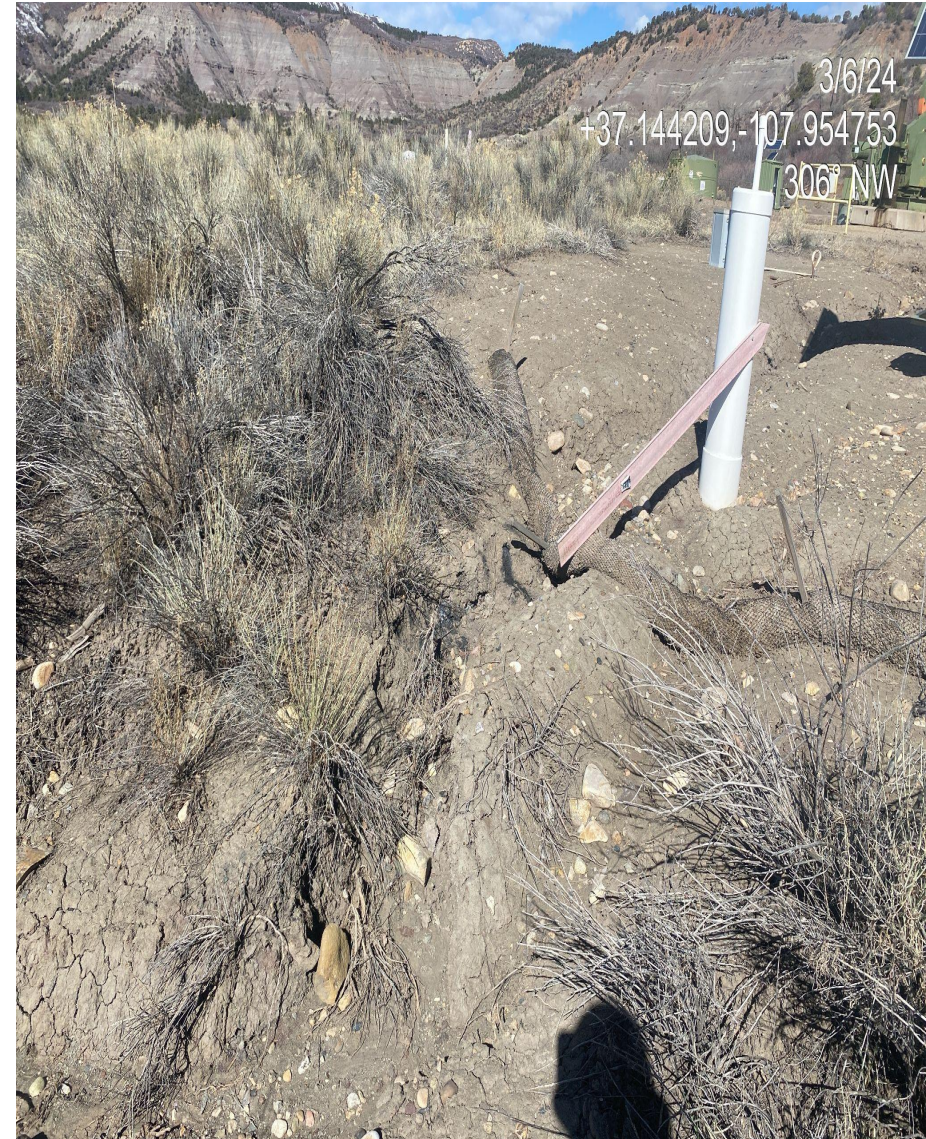
Photo 2. View of the persisting gully erosion and inadequate/failing storm water BMP issues observed in the southern interim reclamation area.

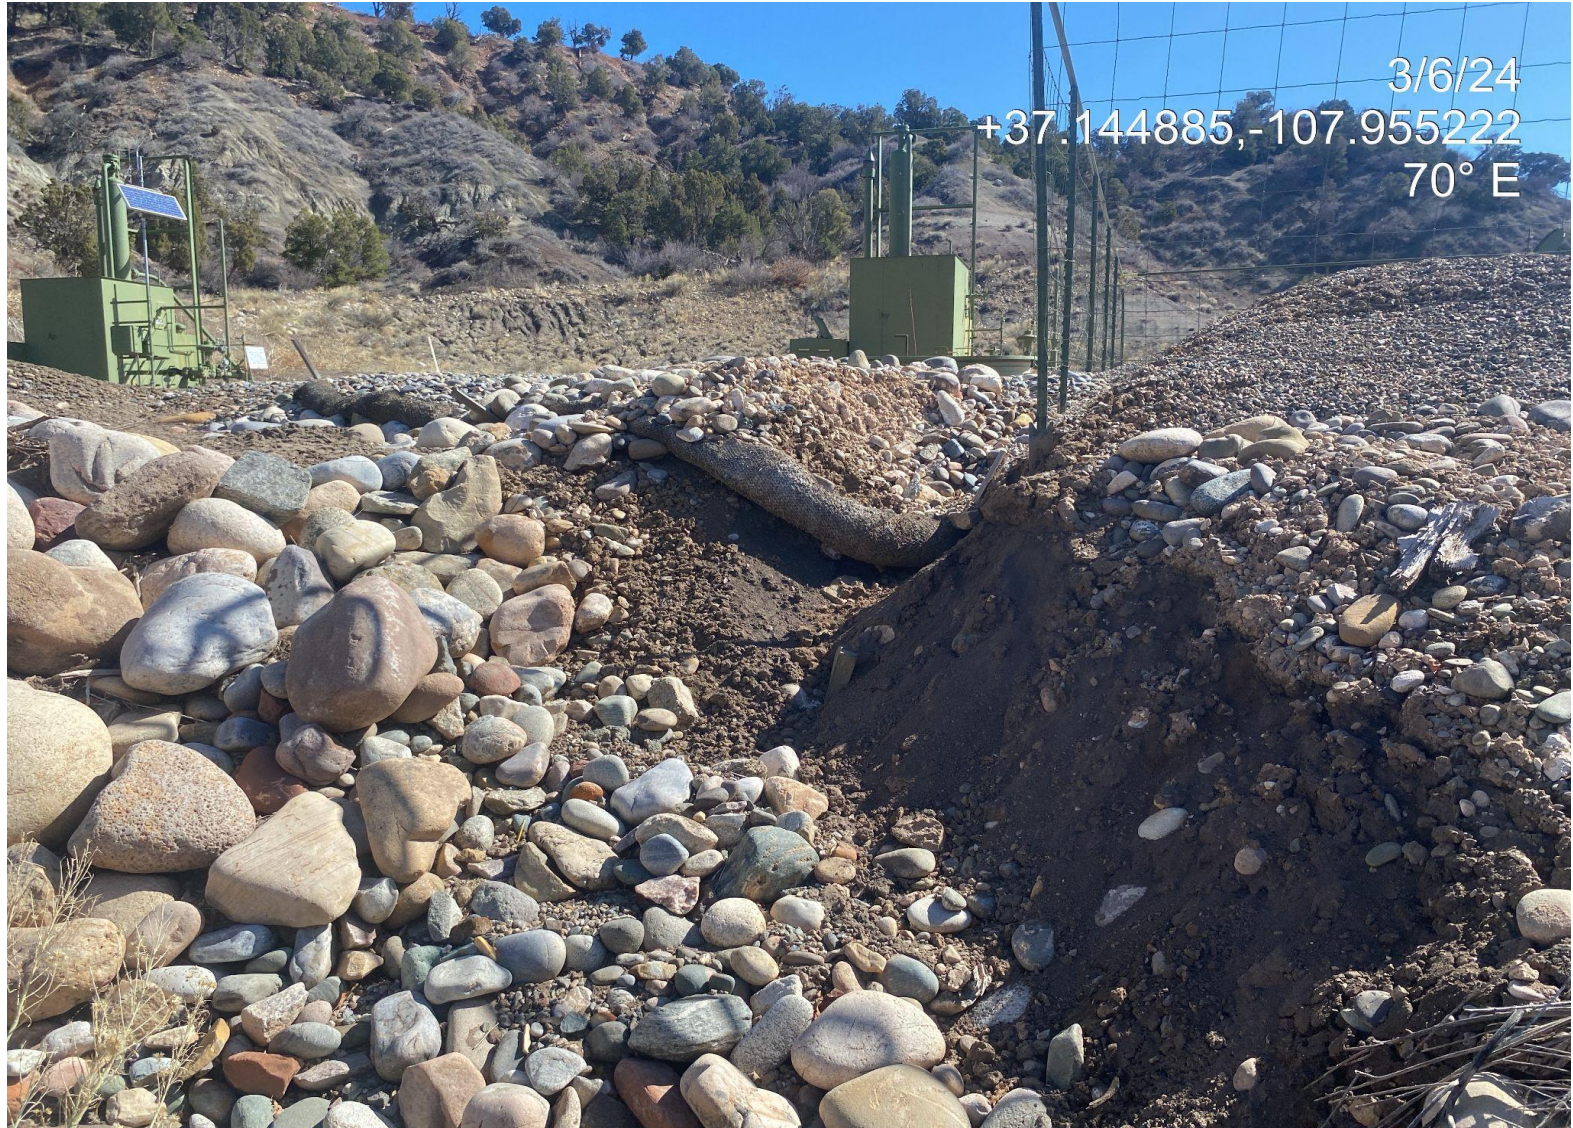
Photo 3. View of the persisting gully erosion and inadequate/failing storm water BMP issues observed in the western interim reclamation area.

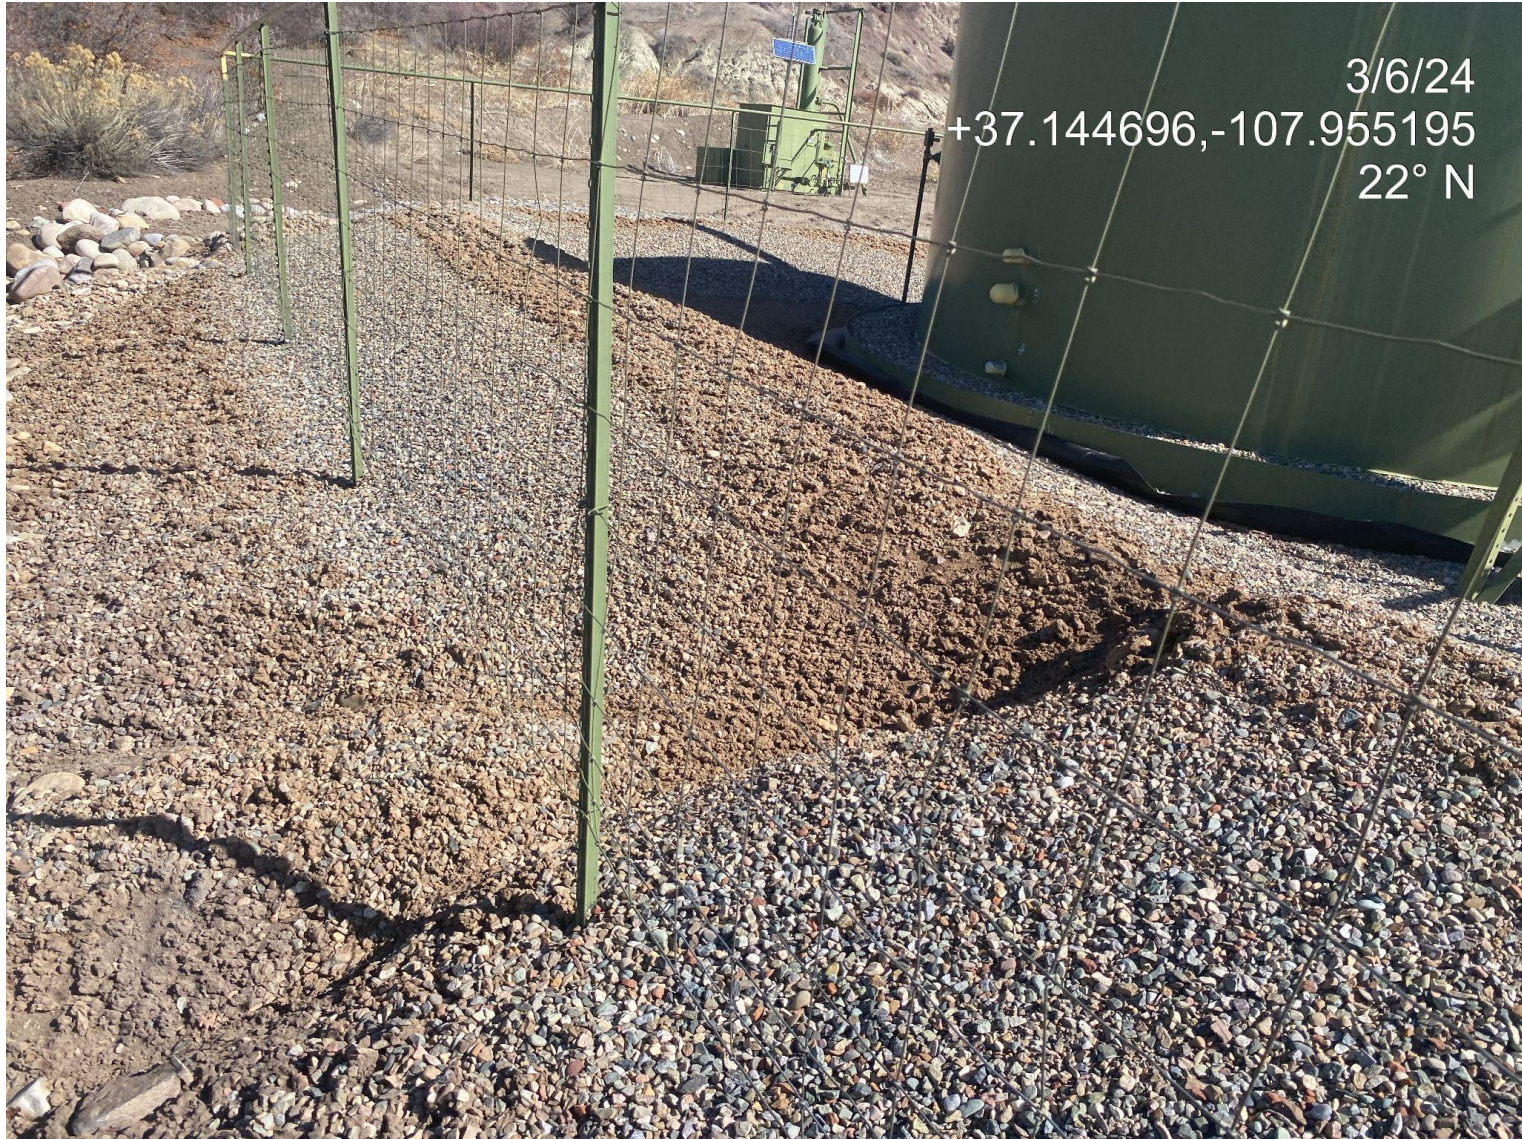
Photo 4. view of erosion impacting secondary containment around tanks.

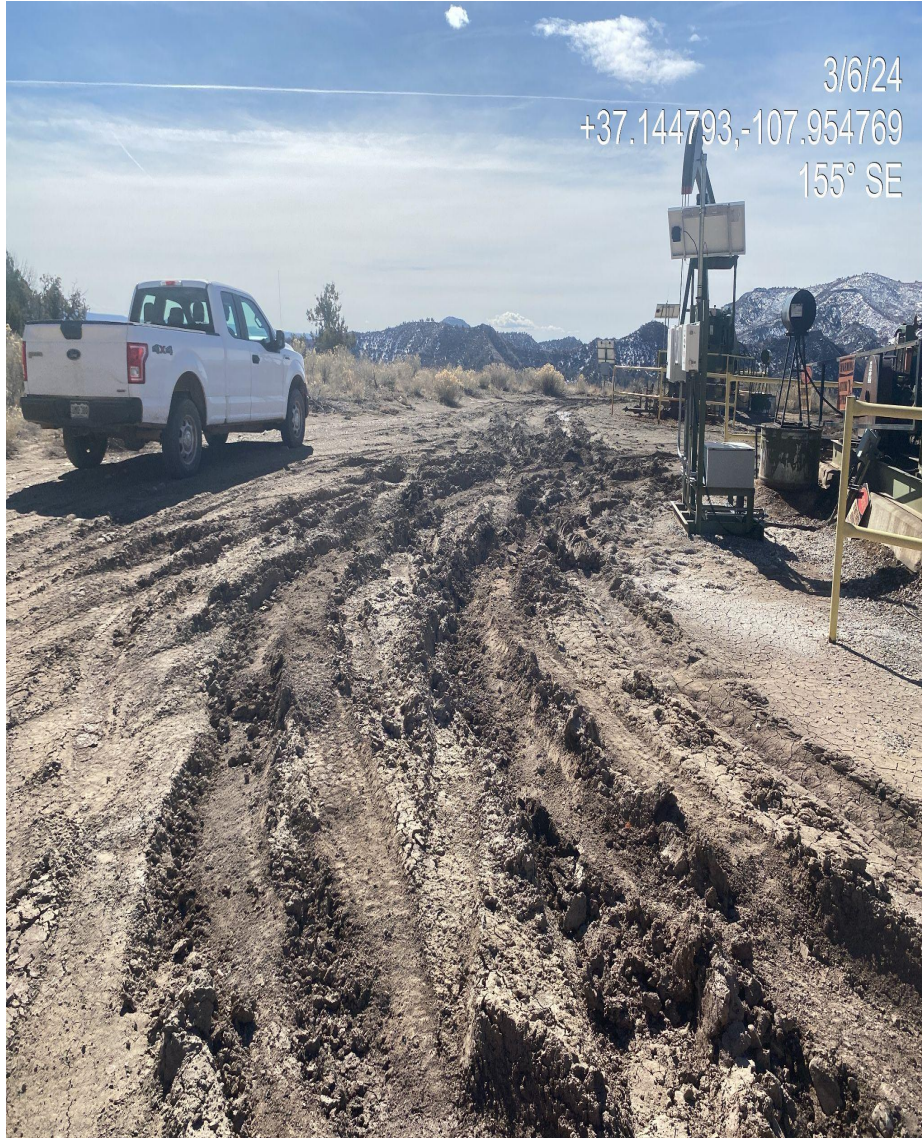
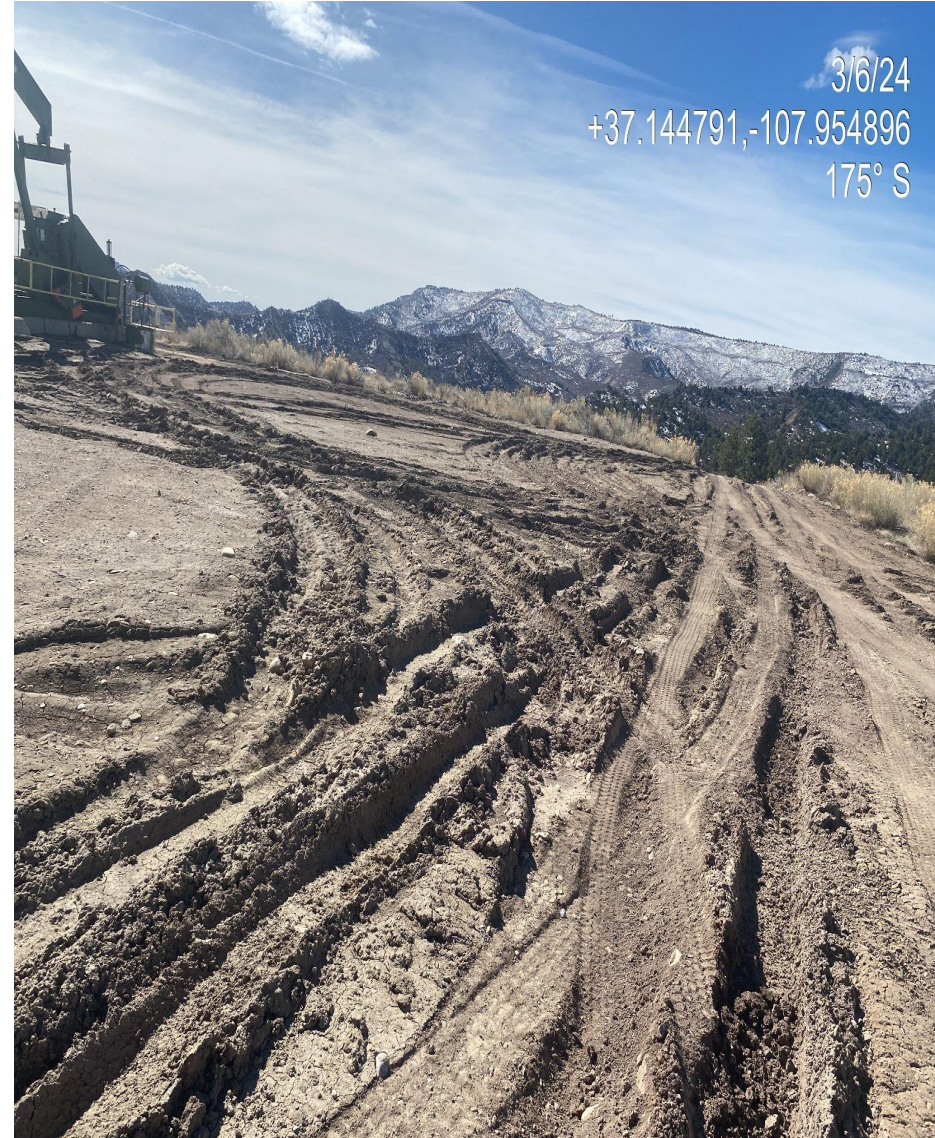
Photo 5. Rutting observed in the center of the location. Additional stabilization is needed to minimize site degradation.

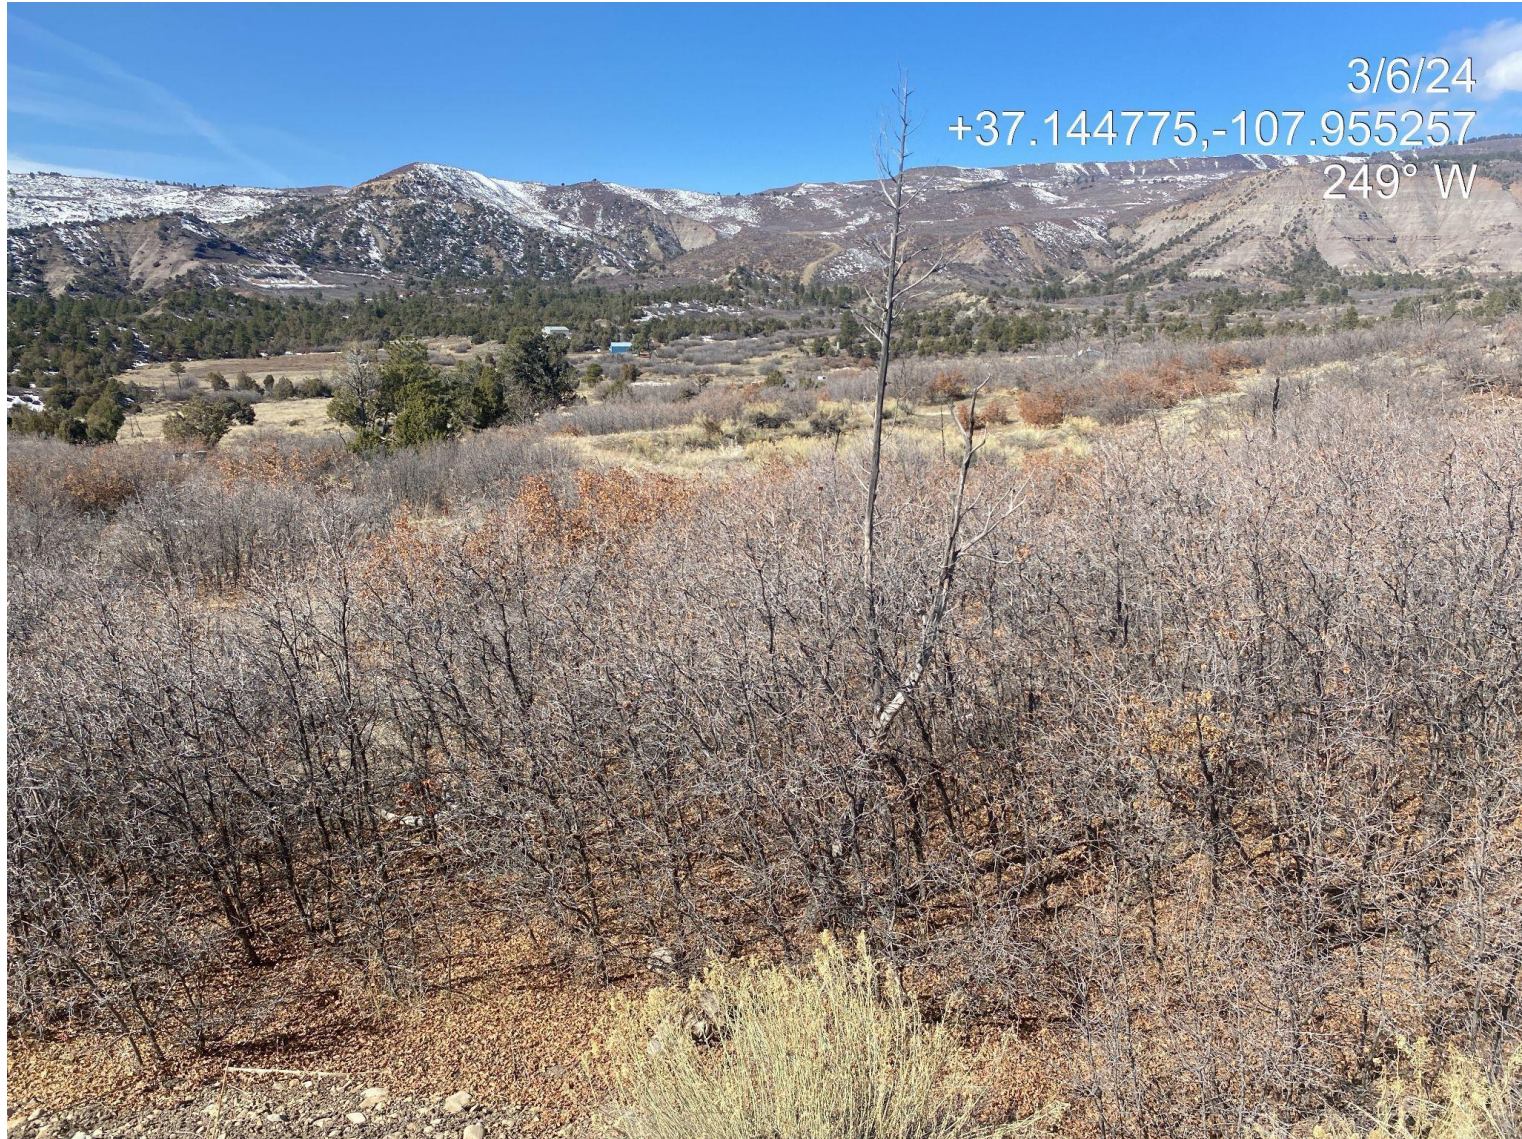
Photo 6. Reference area comprised of gambel oak and rabbitbrush.
