## Inspection Photos

Location Name: TEP ROCKY MOUNTAIN LLC, GM/41-4

Location ID: 333109

Date: 3/7/2024

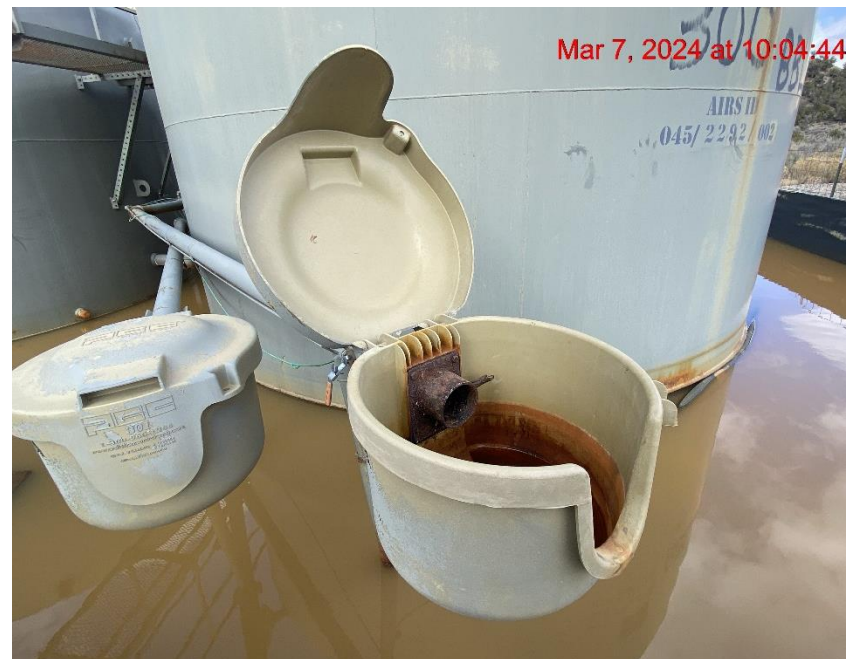
Open-Ended Load Line – Photo #09748

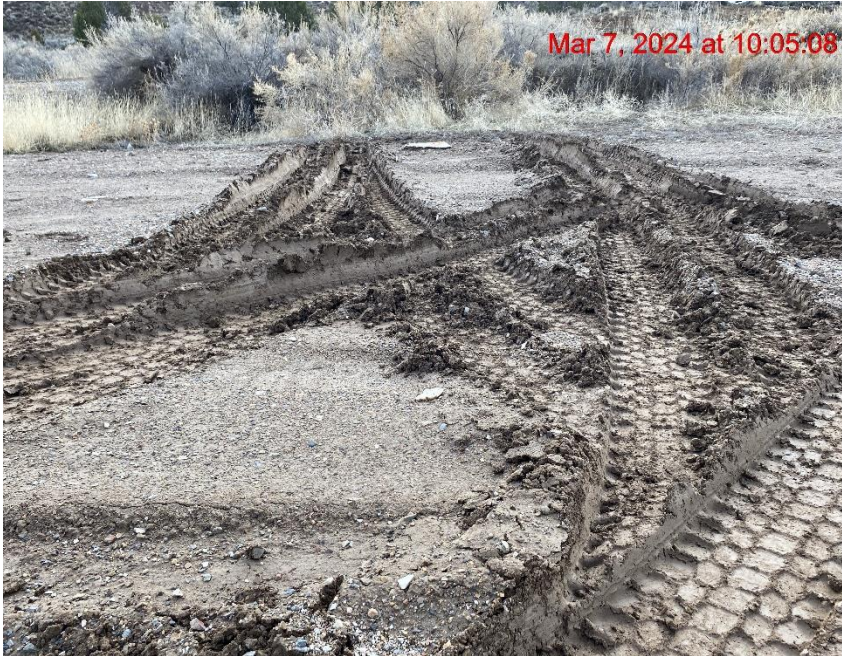
Lack of Stabilization – Photo #09749

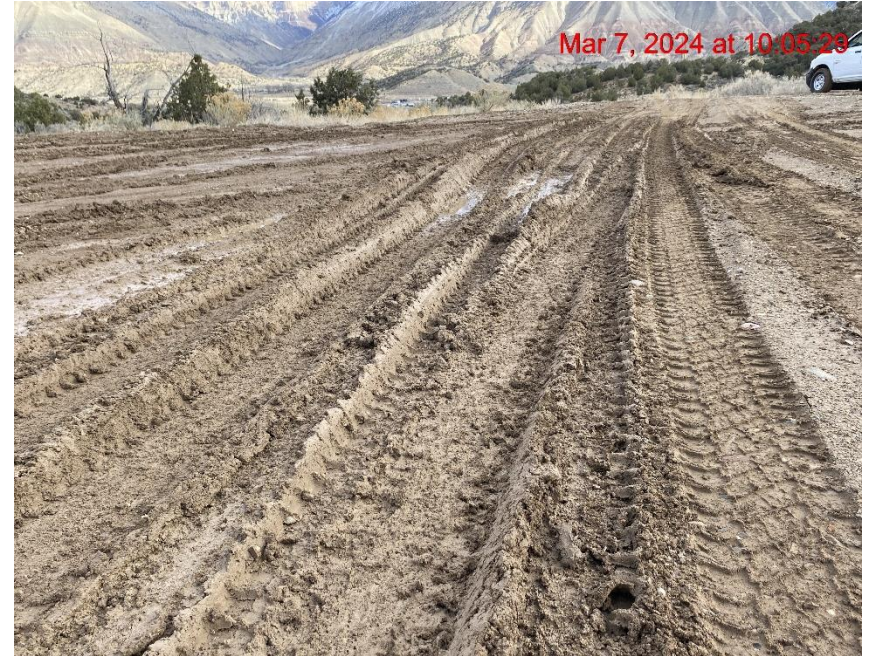
Lack of Stabilization – Photo #09750

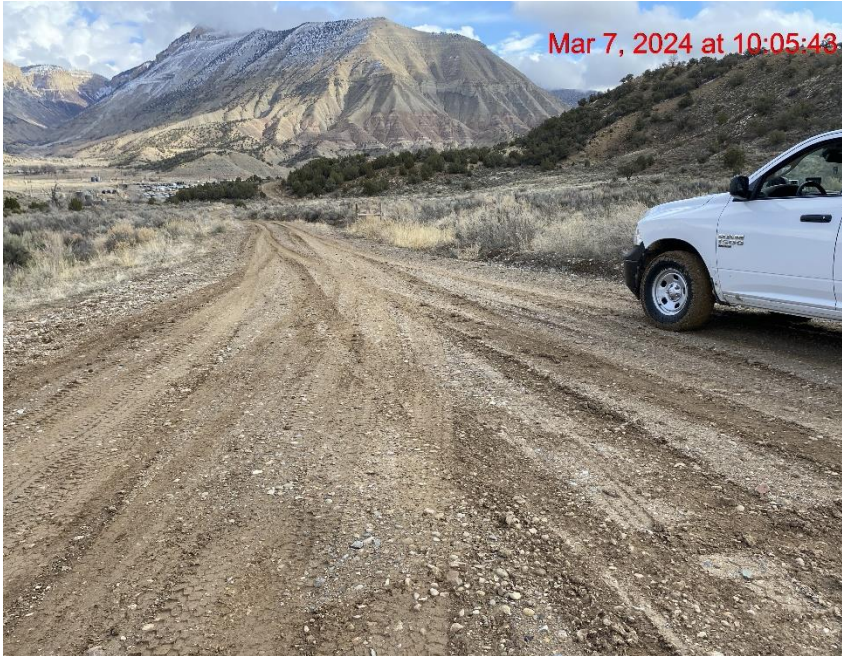
**Insufficient Vehicle Tracking BMPs at Location Entrance/Exit**  
– Photo #09751
