Storm Water Management and Erosion control
Location Name: TEP ROCKY MOUNTAIN LLC SPECIALTY # 3 Pad
Location ID: 335147

**Location Overview: Location is within High
Priority/Density/Black Bear Habitat areas.**

Section/Township/Range: 28 6S92W

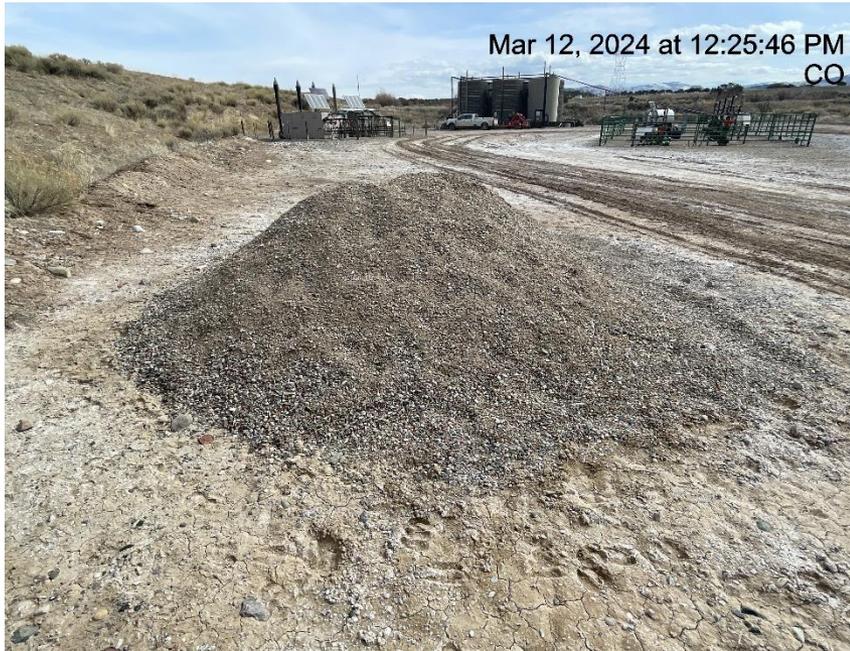
Photo # 9416 Stockpiled soils with no BMP's

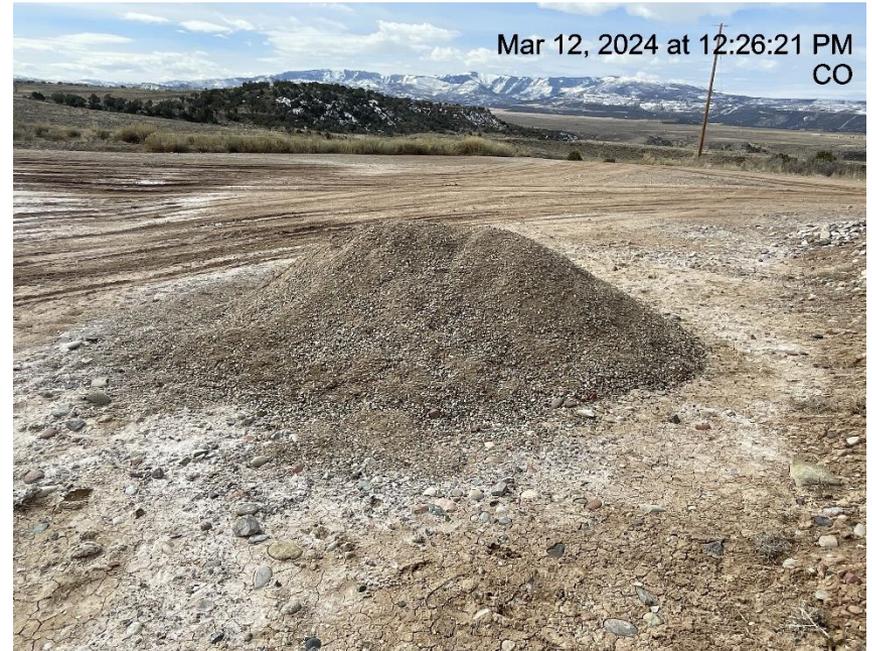
Photo # 9417 Stockpiled soils with no BMP's

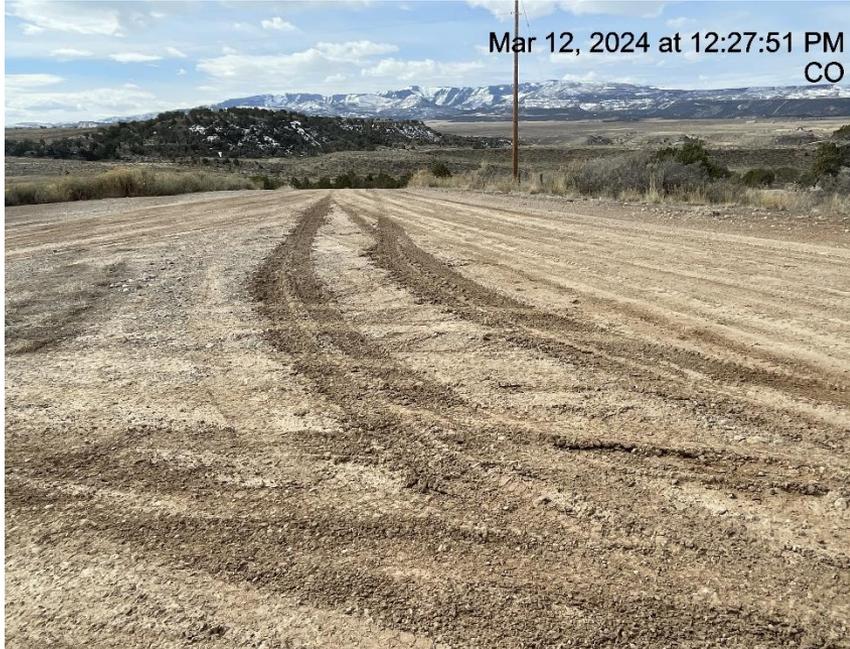
Photo # 9418 Lack of stabilization/compaction/insufficient tracking BMP's

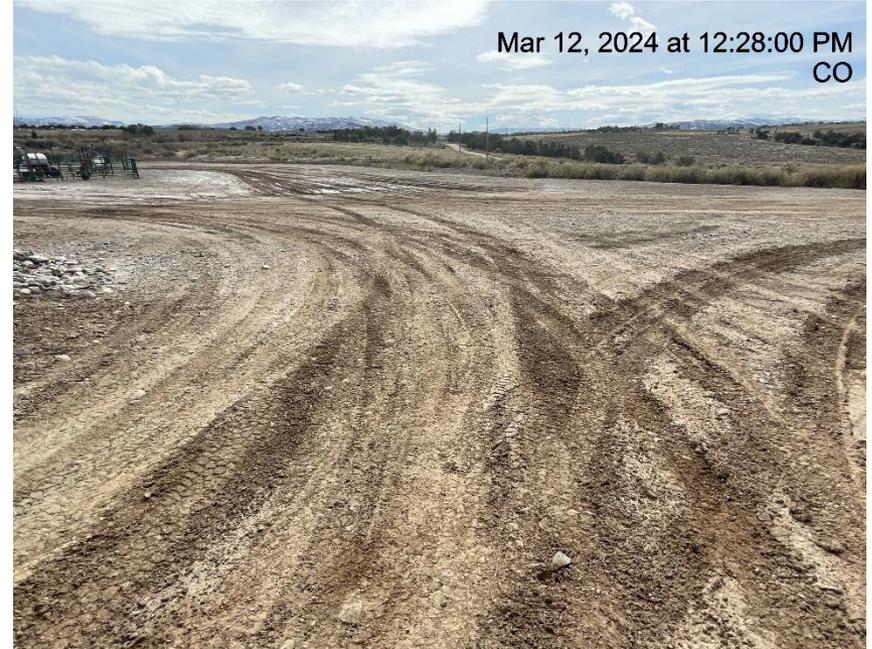
Photo # 9419 Lack of stabilization/compaction/insufficient tracking BMP's

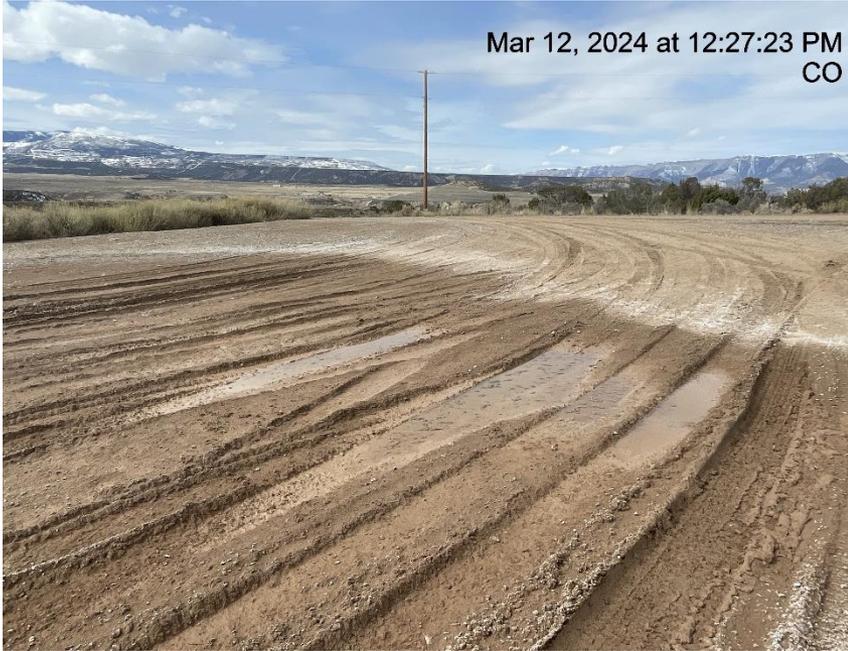
Photo # 9420 Lack of stabilization/compaction/insufficient tracking BMP's

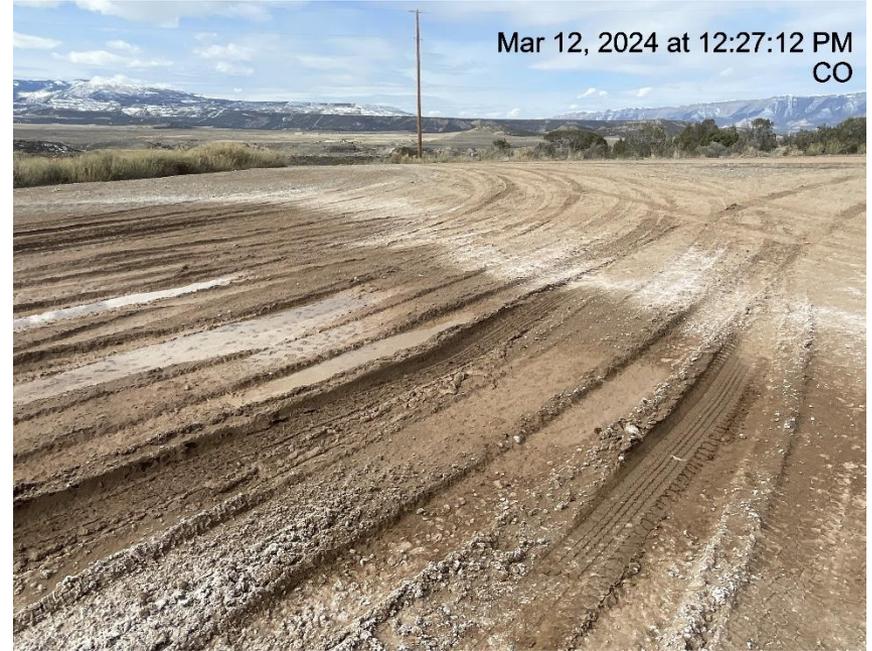
Photo # 9421 Lack of stabilization/compaction/insufficient tracking BMP's

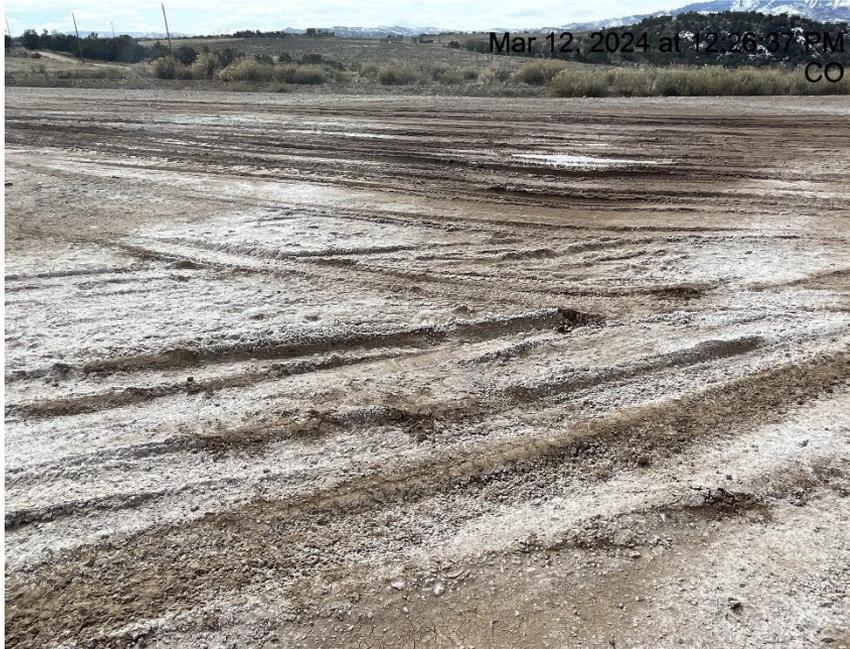
Photo # 9422 Lack of stabilization/compaction/insufficient tracking BMP's

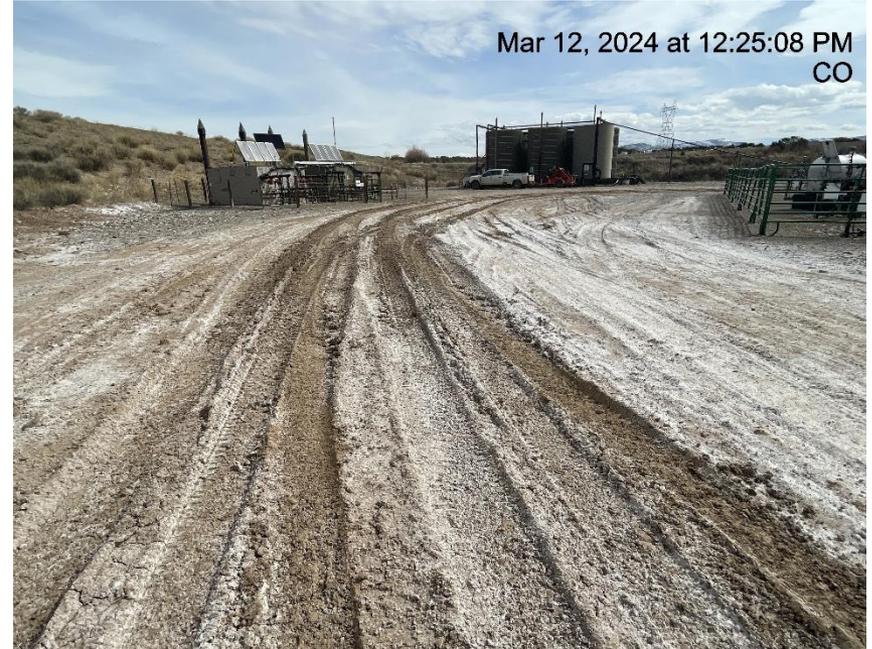
Photo # 9423 Lack of stabilization/compaction/insufficient tracking BMP's

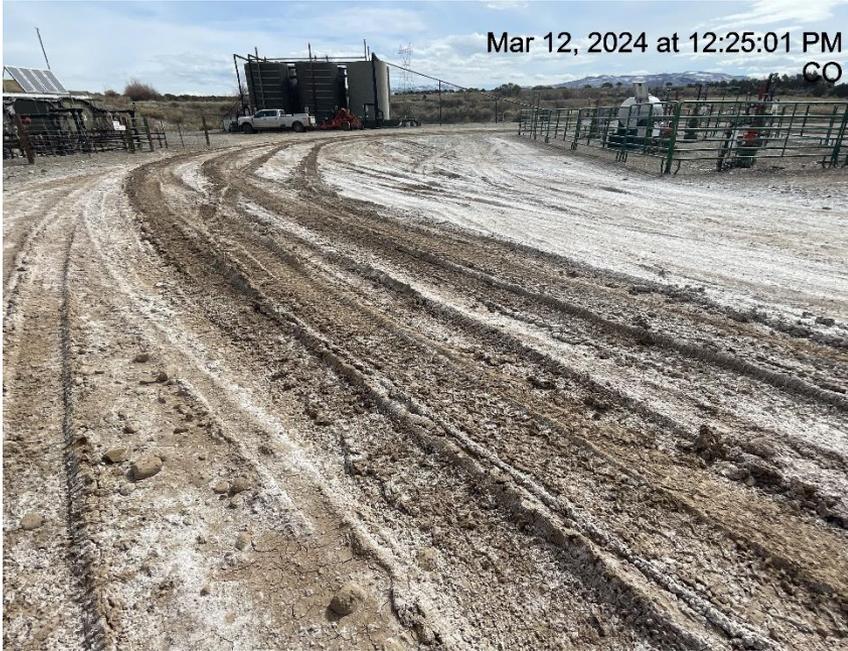
Photo # 9424 Lack of stabilization/compaction/insufficient tracking BMP's

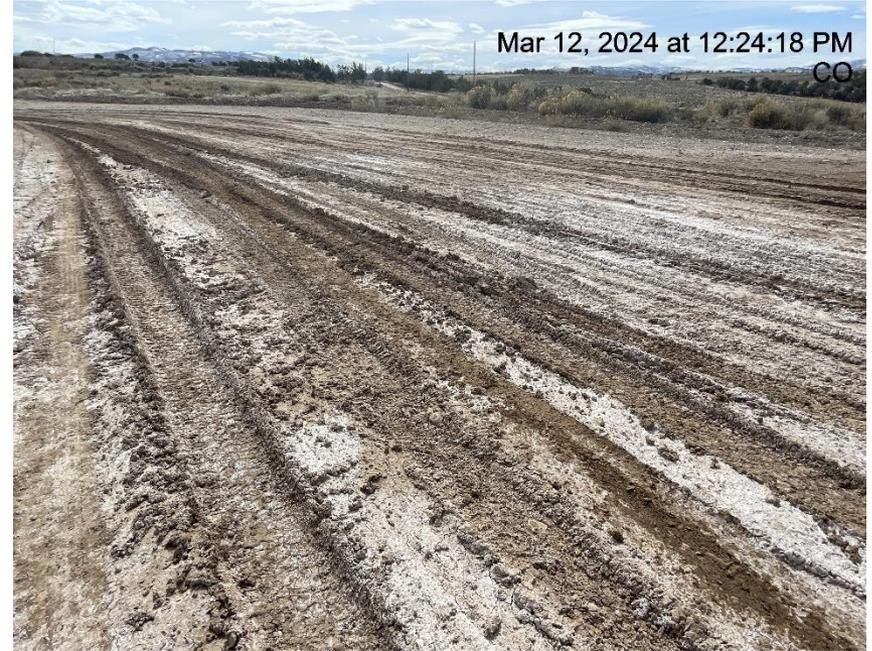
Photo # 9425 Lack of stabilization/compaction/insufficient tracking BMP's

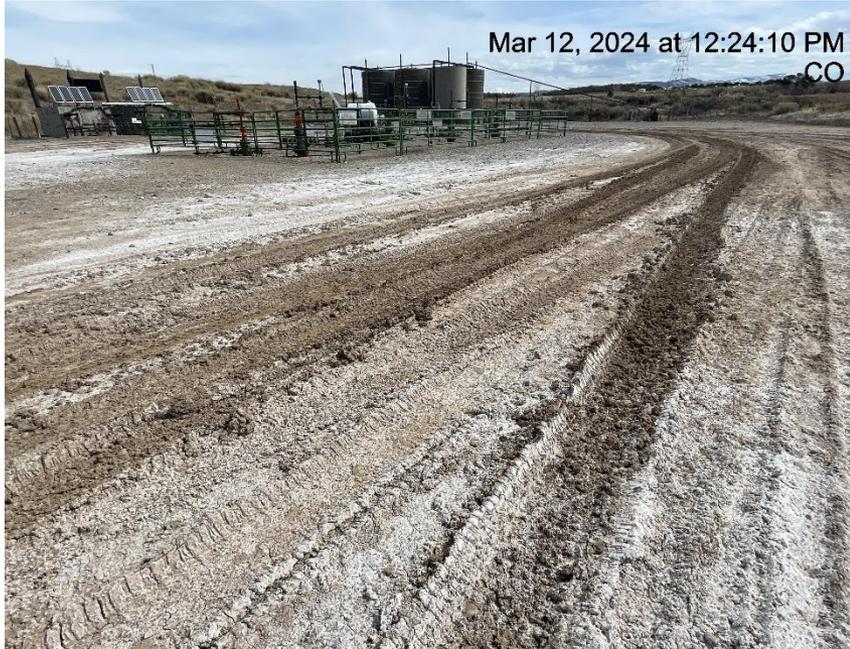
Photo # 9426 Lack of stabilization/compaction/insufficient tracking BMP's

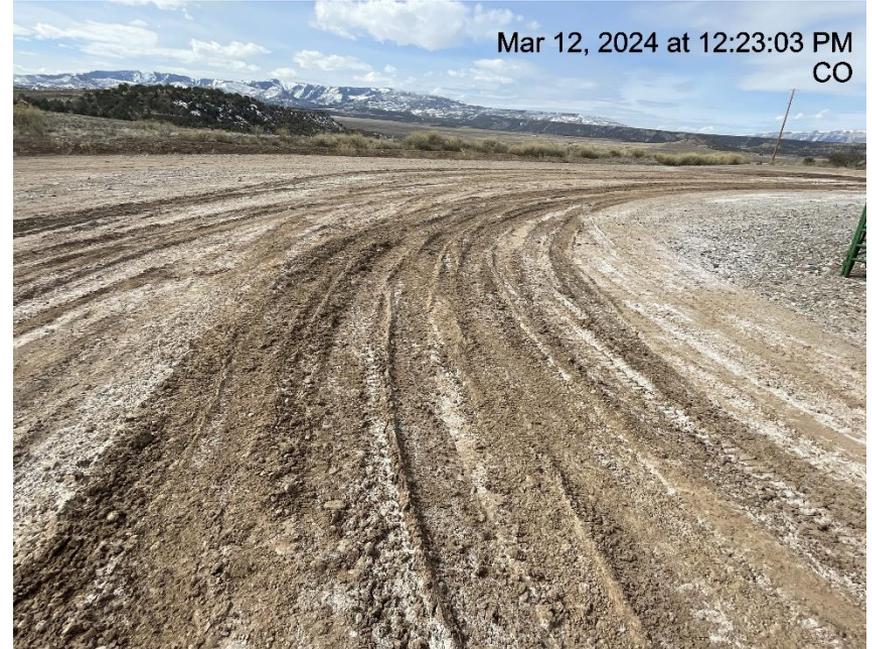
Photo # 9427 Lack of stabilization/compaction/insufficient tracking BMP's

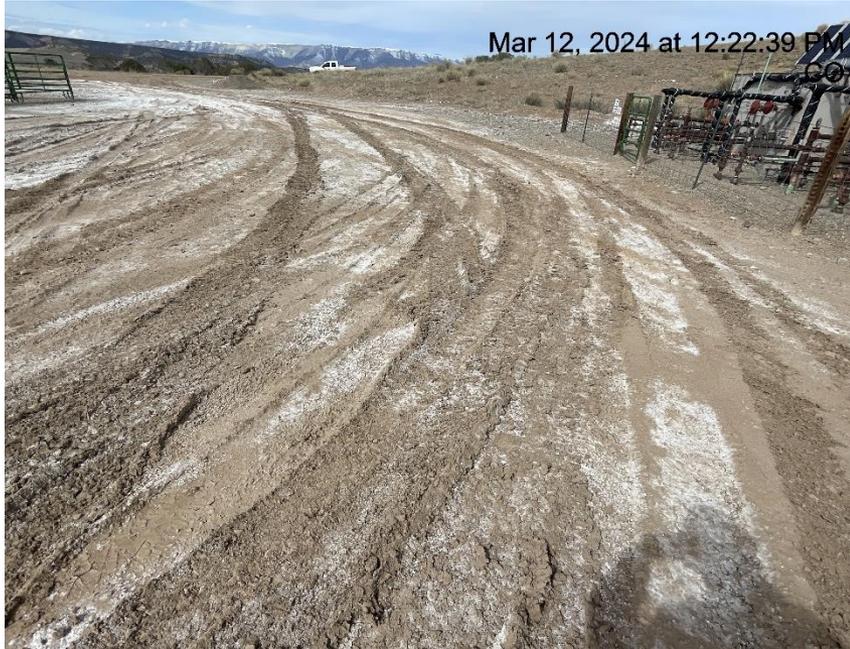
Photo # 9428 Lack of stabilization/compaction/insufficient tracking BMP's

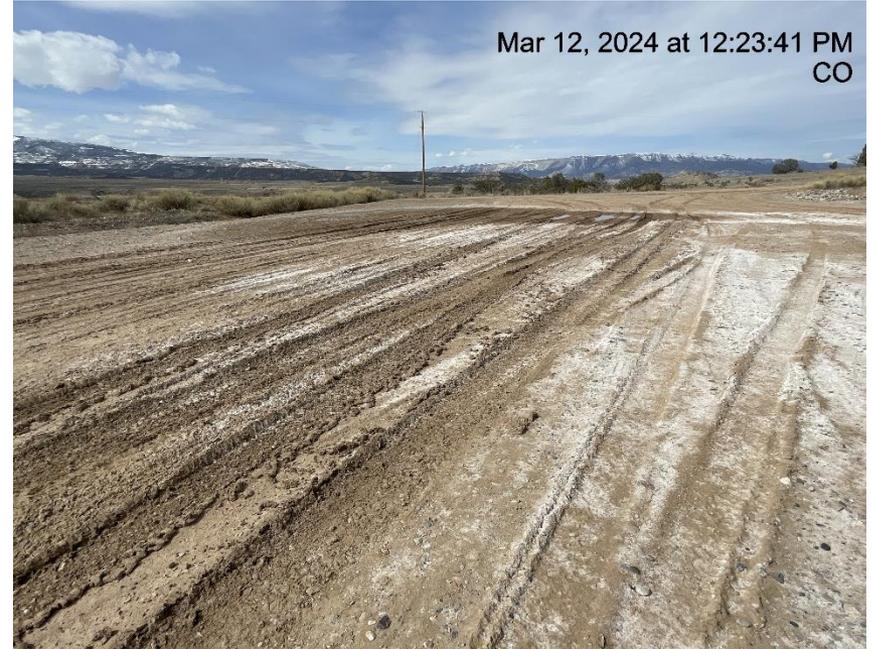
Photo # 9429 Lack of stabilization/compaction/insufficient tracking BMP's
