**From:** [Robert Chesson - DNR](#)  
**To:** [John Axelson - DNR](#)  
**Subject:** RE: Griffin Management - Tori #1 05-001-07268  
**Date:** Friday, September 18, 2015 3:19:00 PM  
**Attachments:** [image001.png](#)  
[image002.png](#)  
[image004.png](#)  
[image005.png](#)  
[image006.png](#)  
[image007.png](#)  
[image008.png](#)

05-001-07268 Tori#1

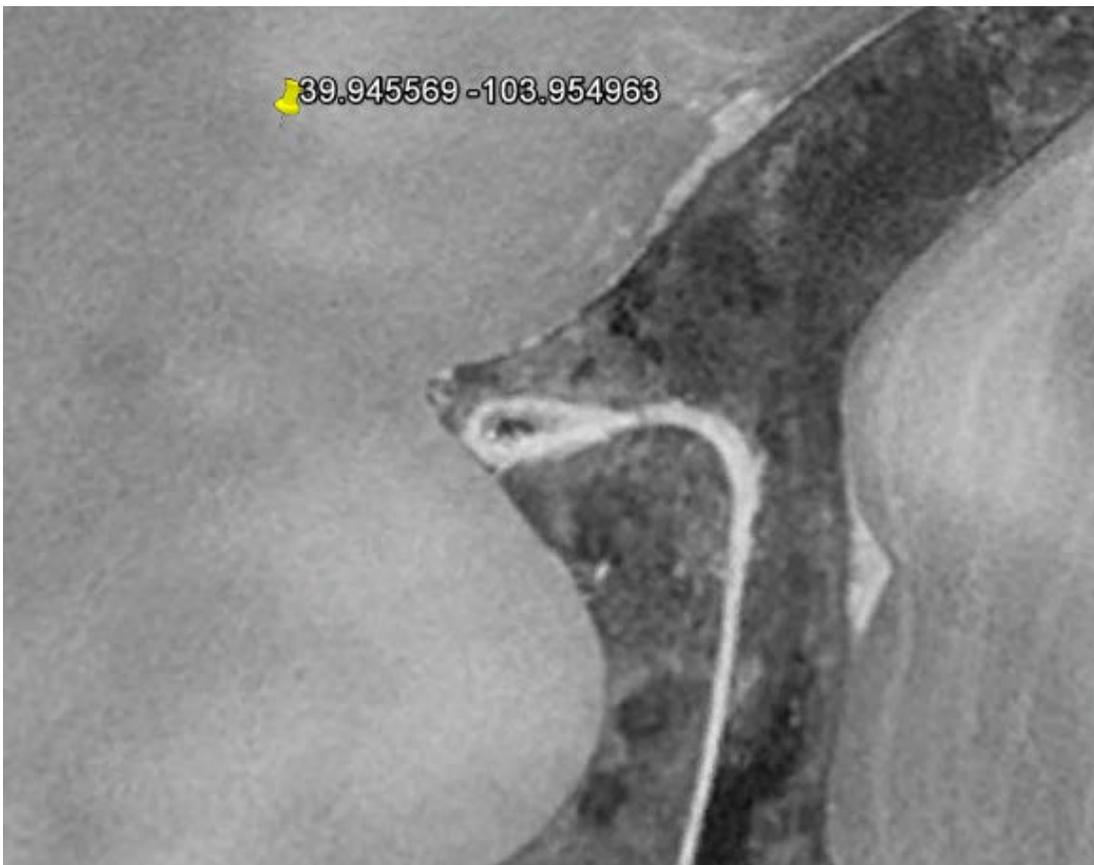
Our aerials (1993) show a TB/wellsite but there is not enough resolution to distinguish any pit(s). I checked Google Earth and they have a 1993 image which also shows a tank battery/wellsite but again not enough resolution to distinguish any skim pit(s). In fact the 1993 image doesn't really show anything that I would call a pit (skim or otherwise) although the resolution is poor.

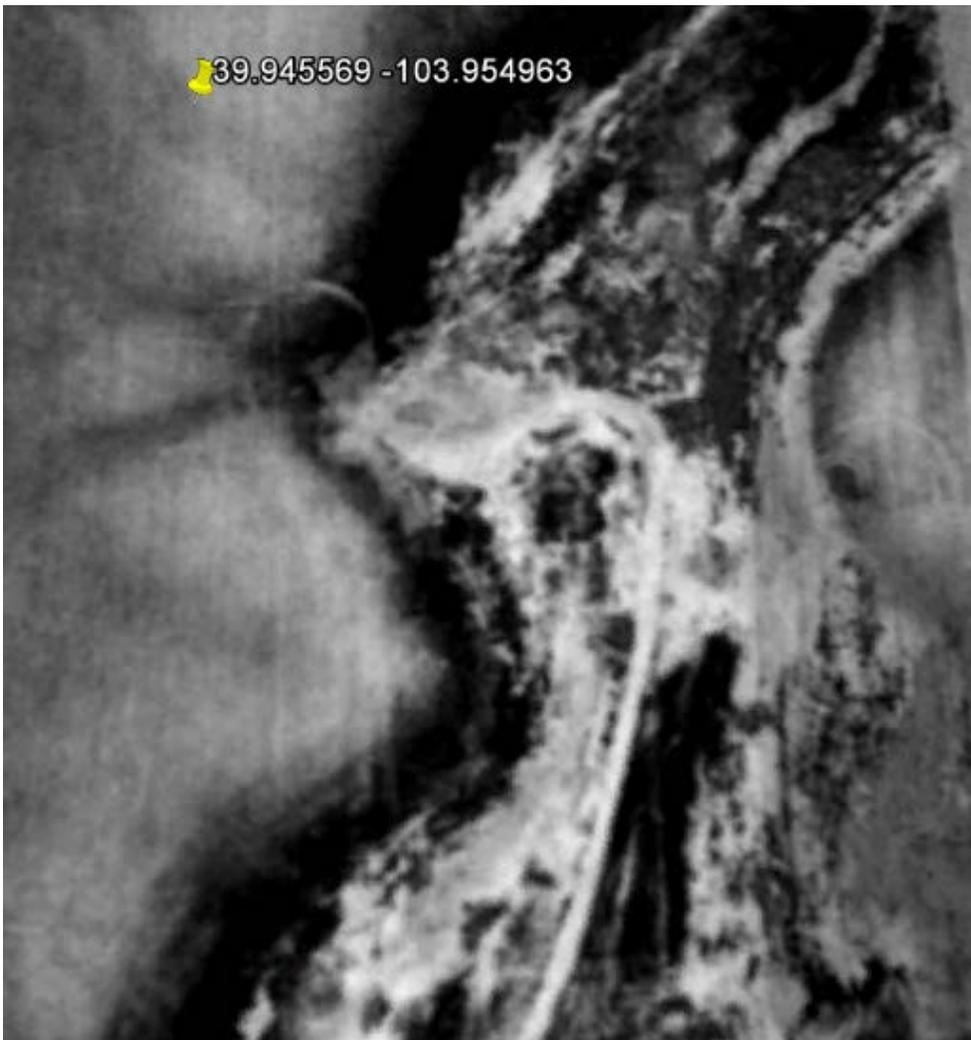
A 1998 photo seems to show the TB/wellsite with all equipment removed? and the former lease road present.
