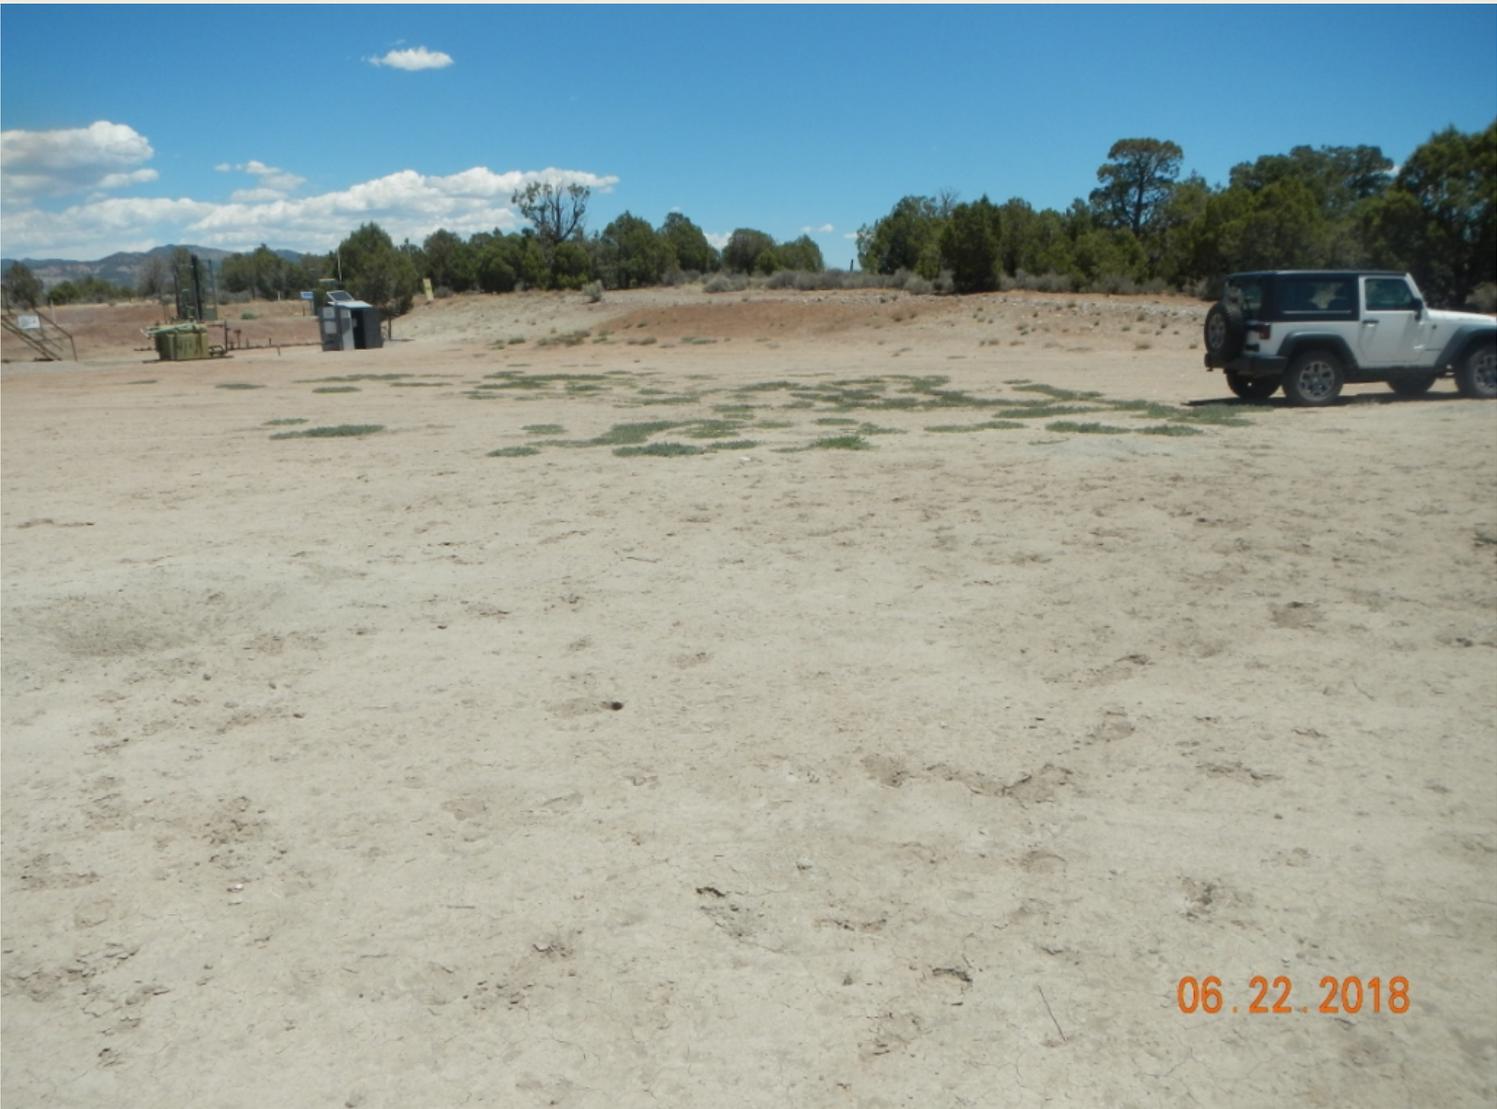
Photo 1. View of the project area from the southwestern corner facing center.

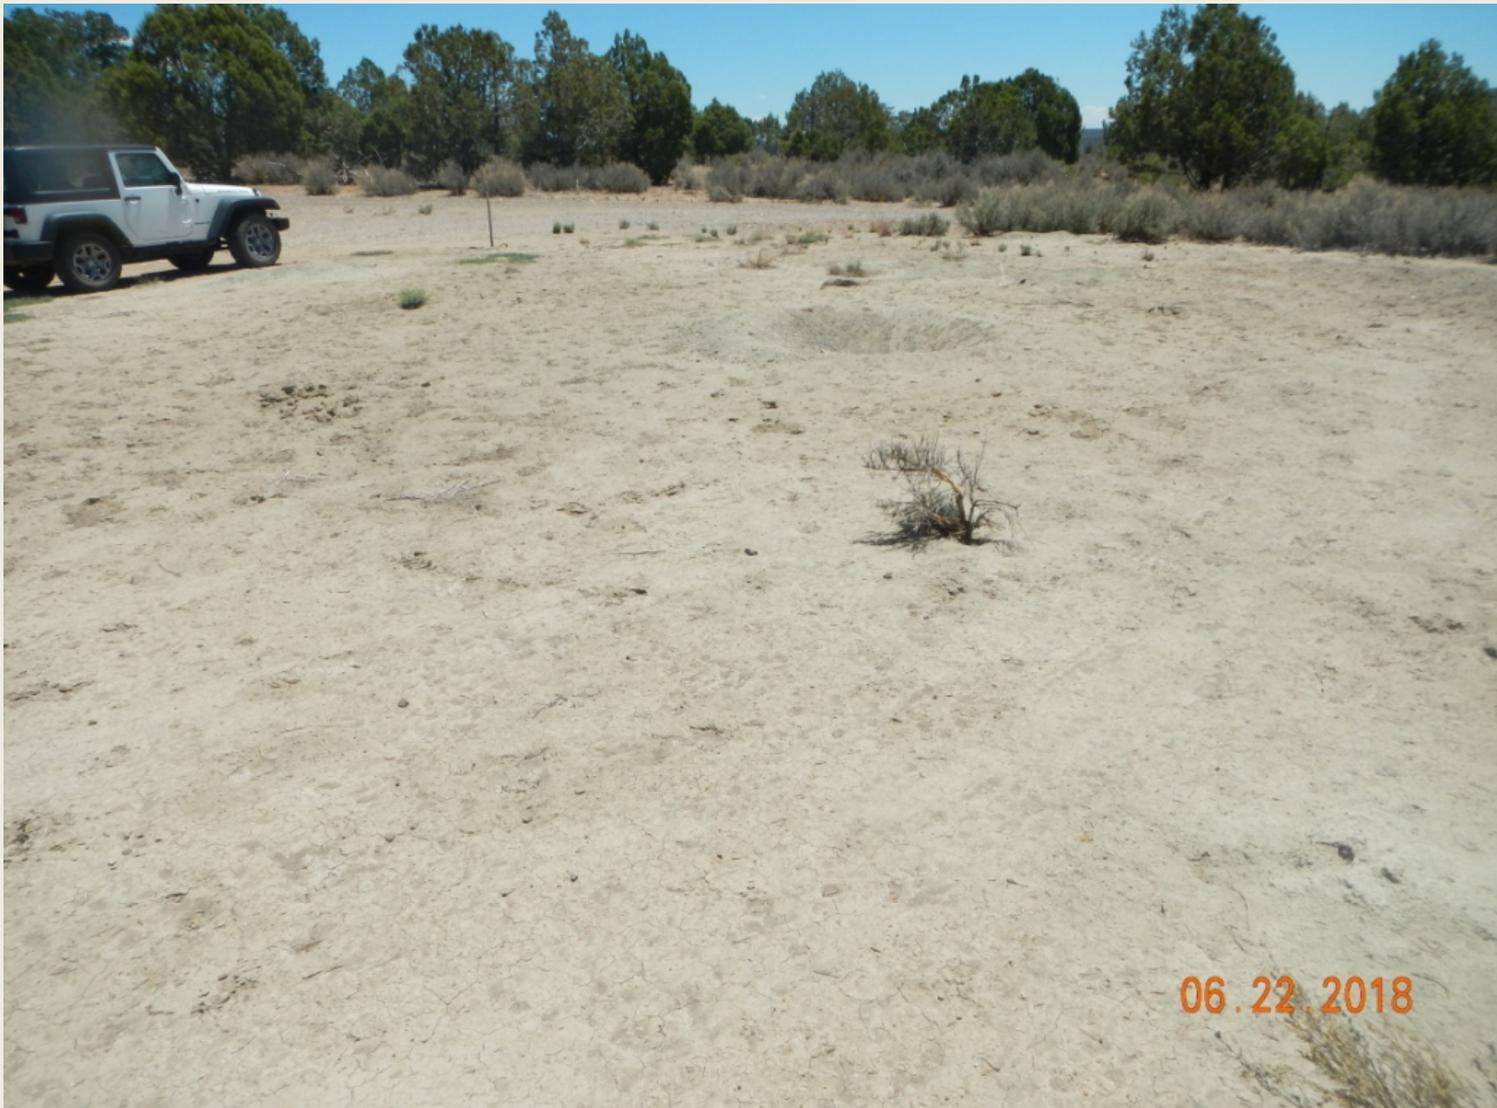
Photo 2. View of the southern portion of the project area from the southwestern corner facing eastward. Very little vegetative cover observed here.

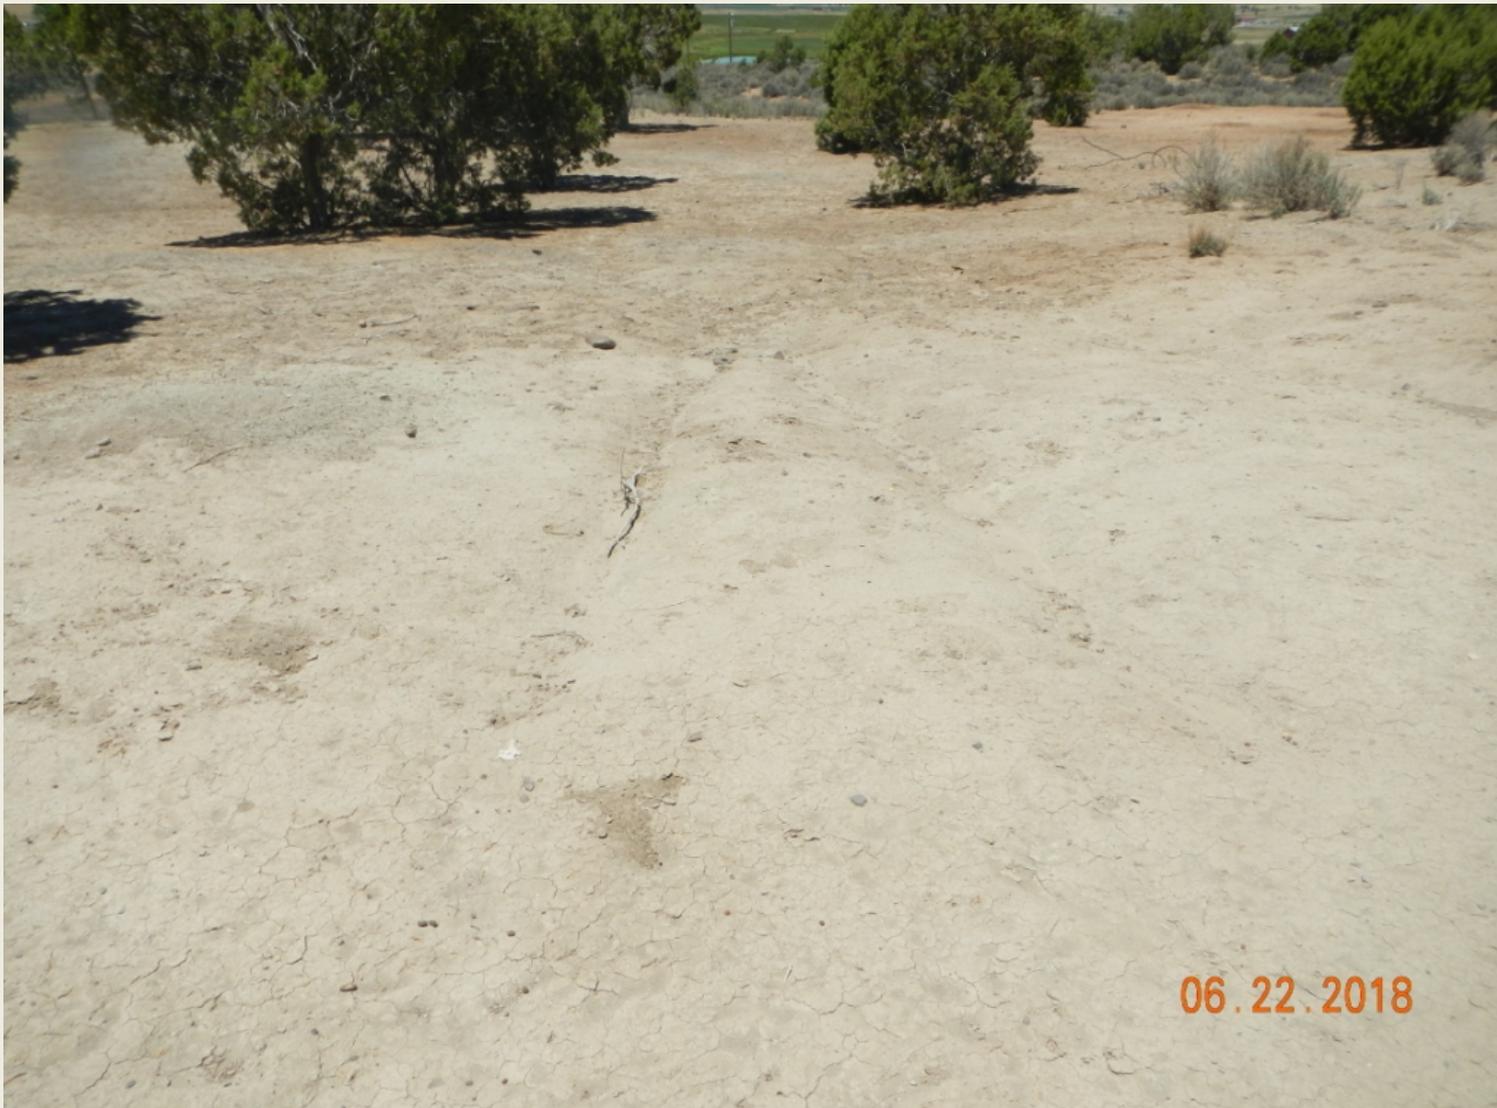
Photo 3. View of erosional channels approximately 1 foot wide and deep in the western portion of the project area.

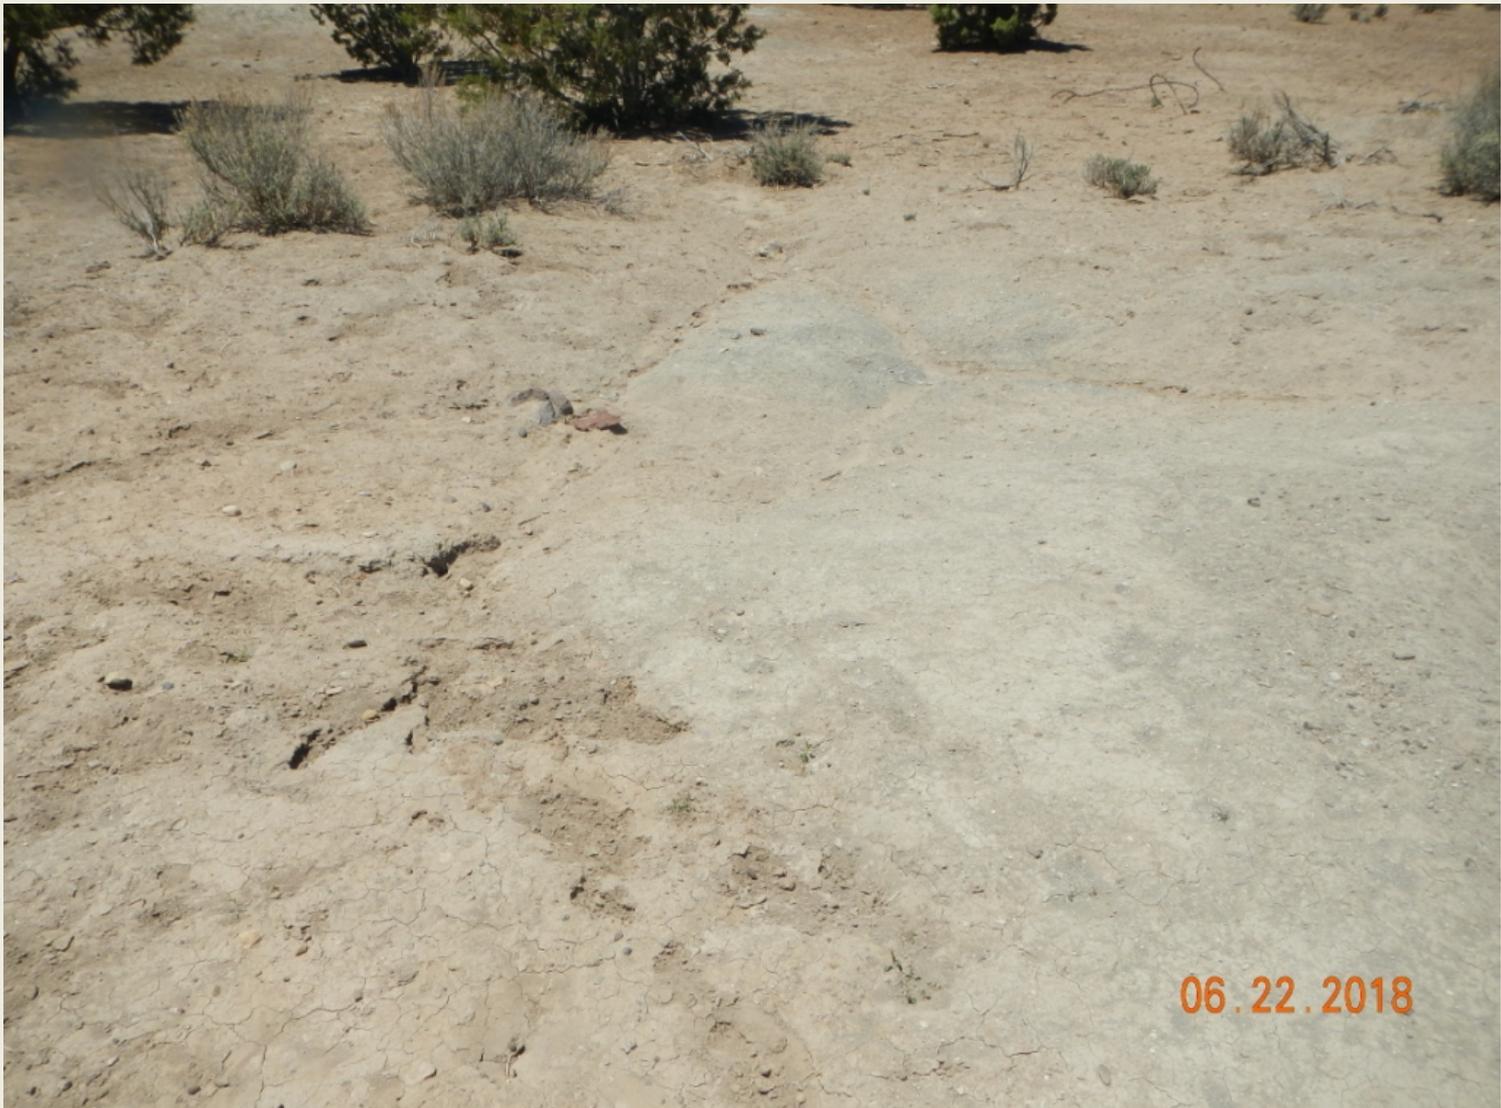
Photo 4. View of more erosional channels in the western project area.

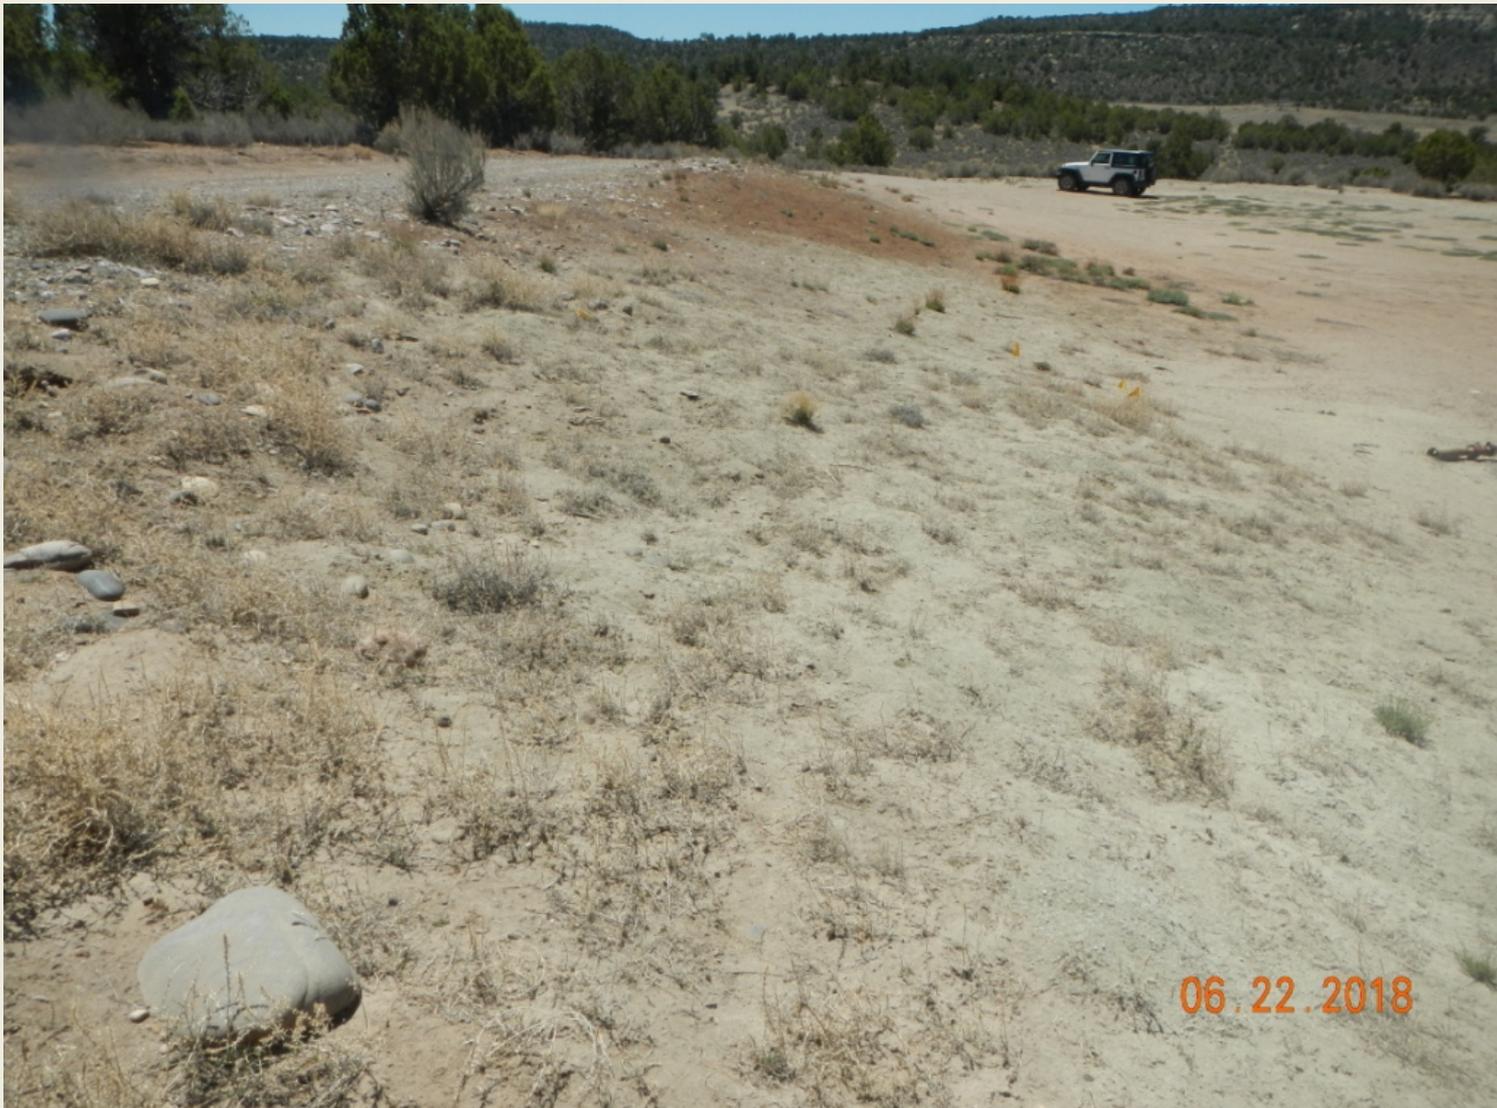
Photo 5. View of the eastern portion of the project area from the northeastern corner facing southward.
