Well ID: PA 43-34

Monitor Date: 7/17/2008

Reclamation Status as of July 2008: Reclaimed

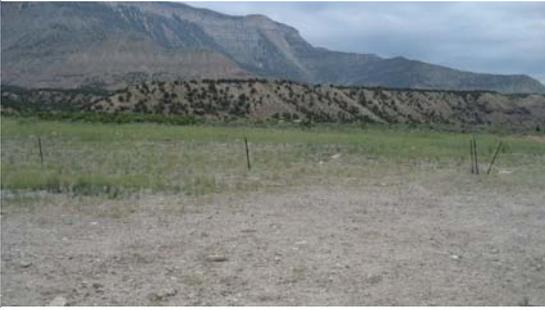
PA 43-34 North

Noxious Weeds Present? Yes Cheatgrass and erodium present on north and east sides of pad.

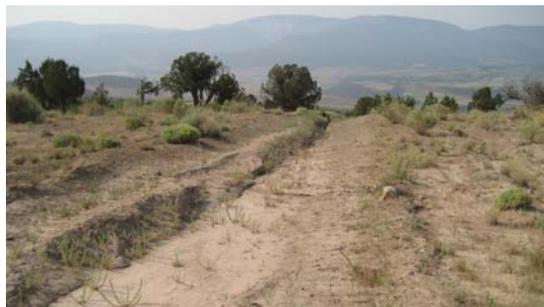
RMV 141-16 Erosion Picture 3

Rills > 3" also present. Erosion photo 1: northwest corner; Erosion photo 2: southwest edge; Erosion photo 3: southeast edge; Erosion photo 4: northeast boundary along access road; Erosion photo 5: joins and runs perpendicular to erosion 4; Erosion photo 6: minor rilling along SE edge and adjacent to fence.
