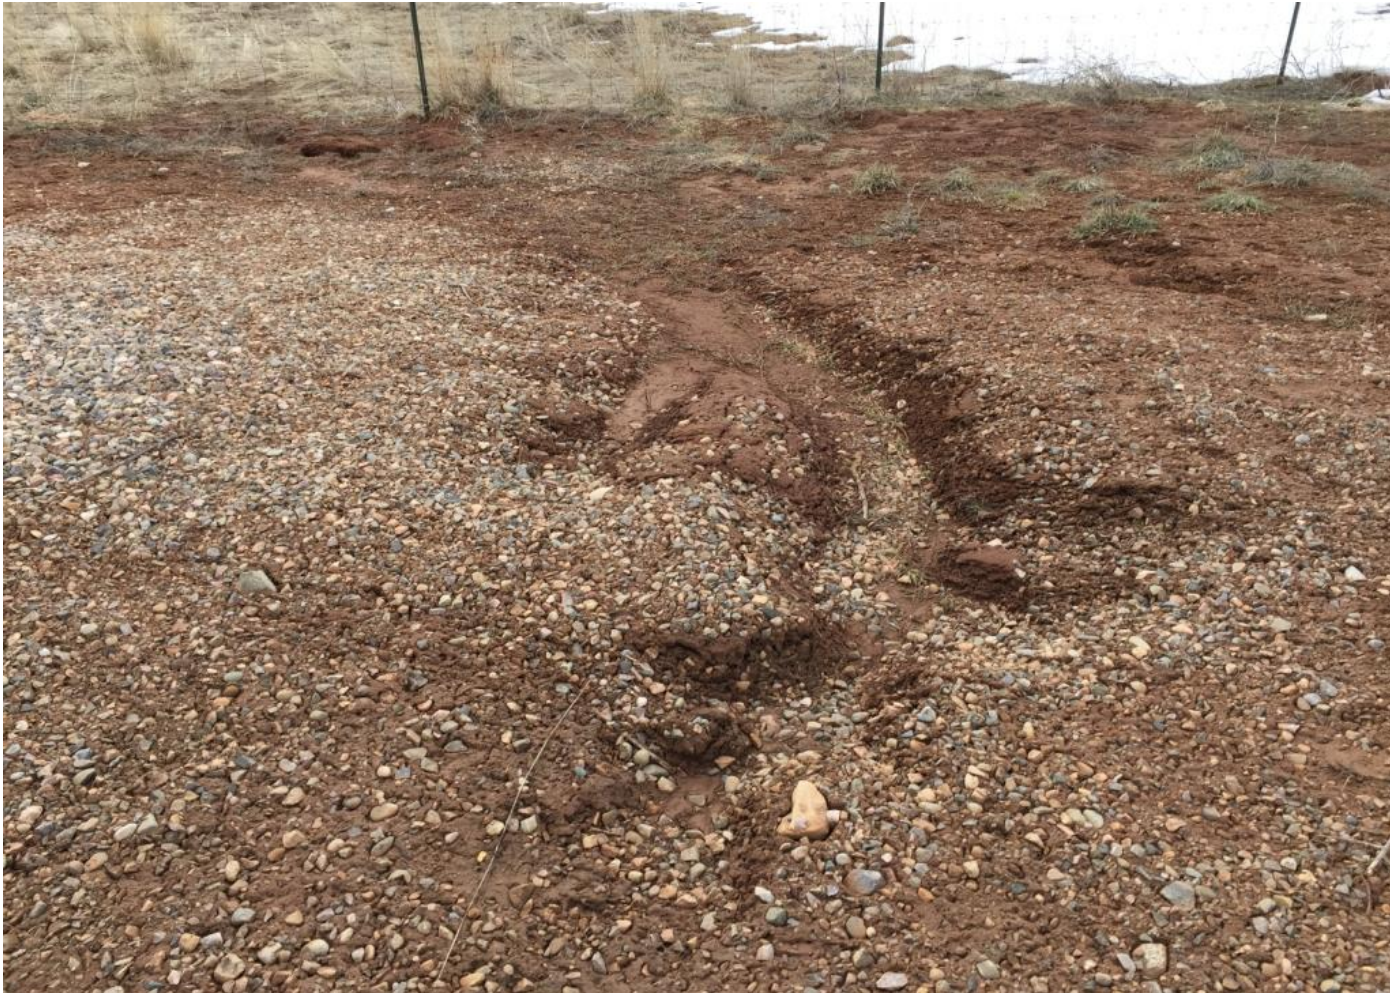
Photo 1. View of stormwater erosion channel forming in southwestern portion of the project area. Channel is approximately 12 inches wide and deep.

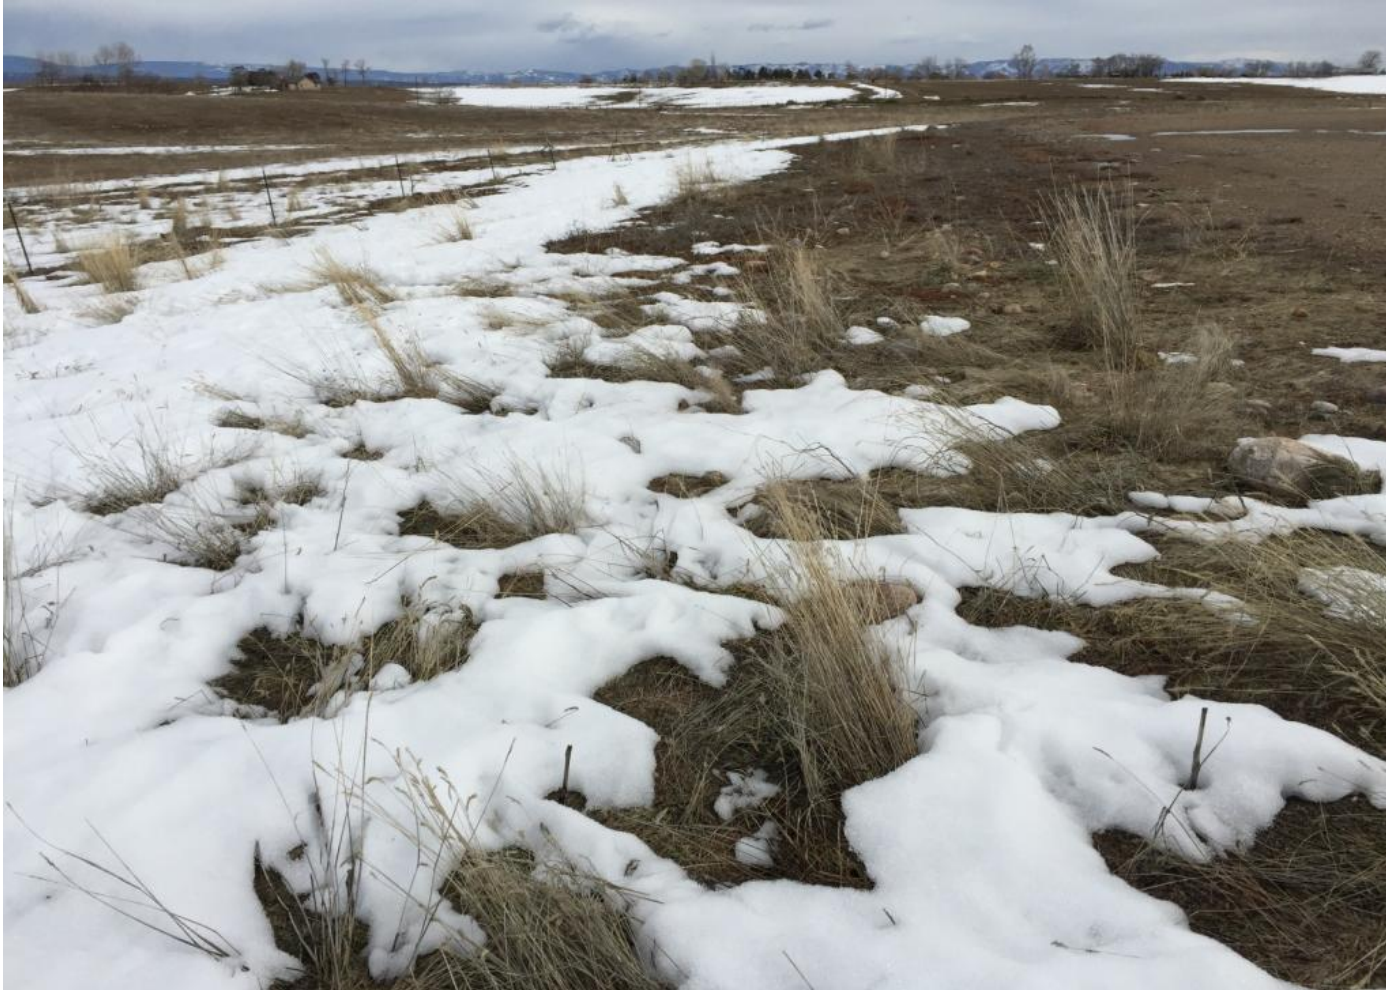
Photo 2. View of the western portion of the project area from the southwestern corner facing northward. Revegetation is comprised of grasses such as crested wheatgrass (*Agropyron cristatum*) and intermediate wheatgrass (*Thinopyron intermedium*) as well as weedy cheatgrass (*Bromus tectorum*).

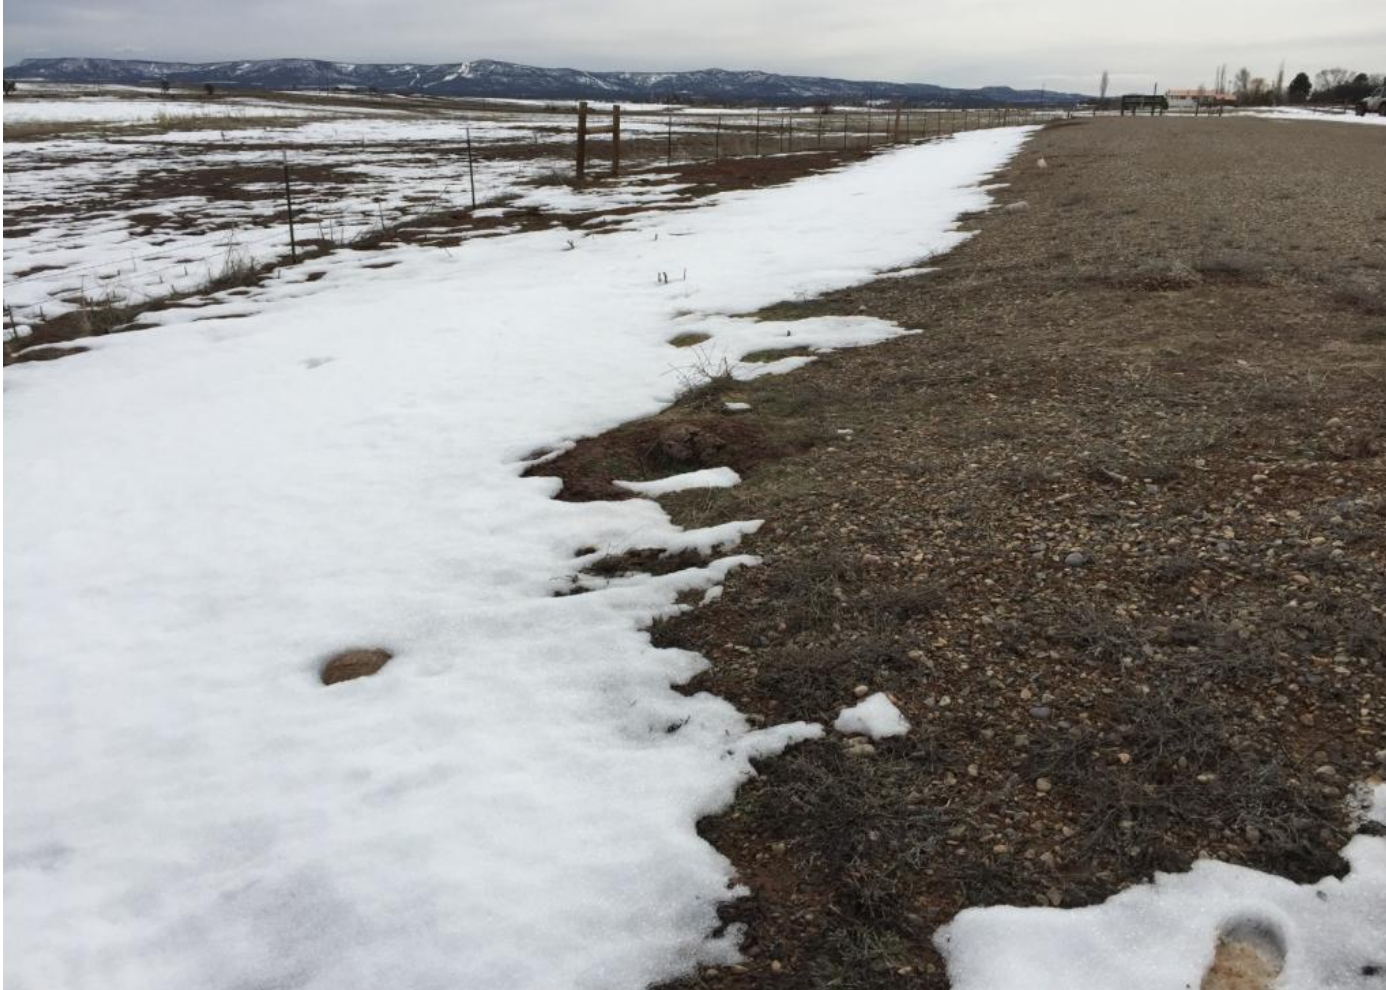
Photo 4. View of the eastern portion of the project area from the northeastern corner facing southward. Although much of this area is covered with snow, it appears that there is little vegetation in this area and it needs to be monitored and re-seeded if necessary.
