**MARATHON OIL COMPANY
NOTICE OF COMPLETION REPORT FOR
INTERIM RECLAMATION OF
596-20C**

January 20, 2012

**596-20C Pad Location
Interim Reclamation
Revegetation - Seeding**

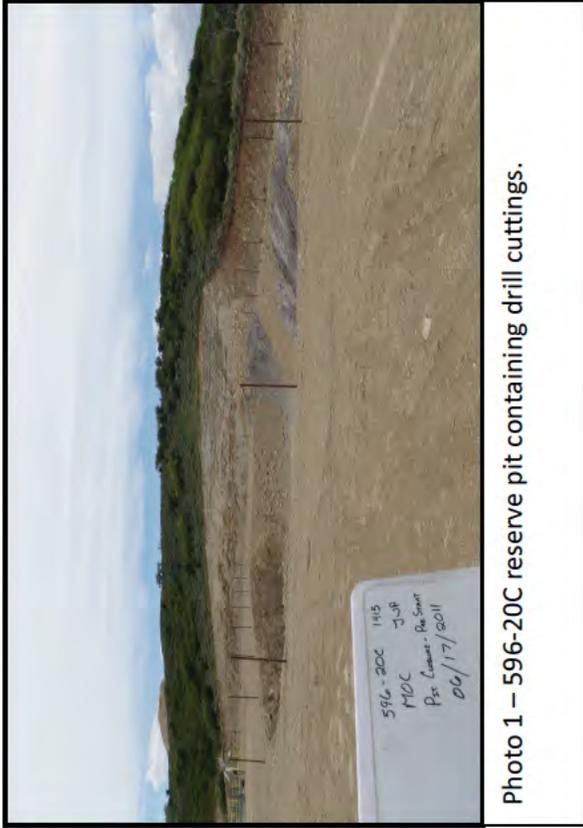
Photo 1 – 596-20C reserve pit containing drill cuttings.

This report covers the activities associated with the closure of the on-site reserve pit at Marathon Oil Company's 596-20C well pad. At the time of the initial site visit, the pit contained what appeared to be drill cuttings in an unlined pit (Photo 1, Appendix A).

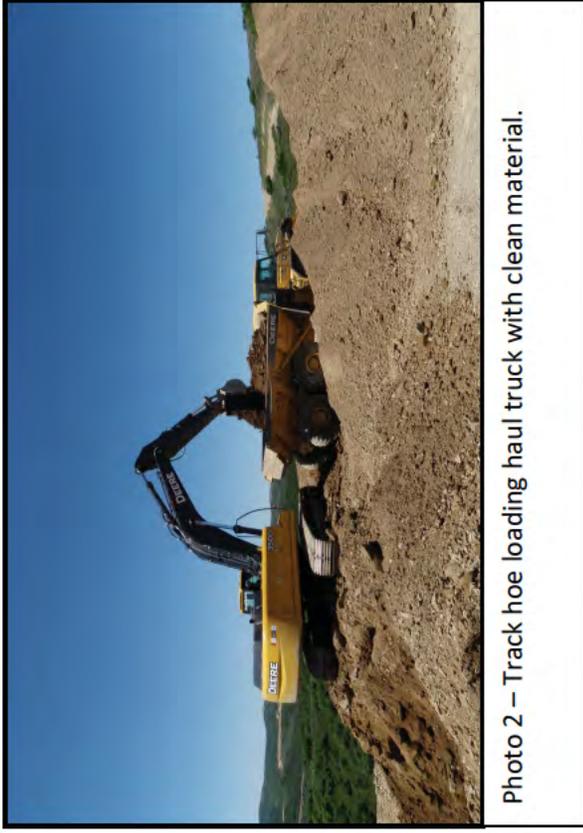
Photo 2 – Track hoe loading haul truck with clean material.

The mixing of pit contents with clean soil occurred inside of the pit. Native soil was obtained from portions of the pad slated for removal during re-contouring activities necessary for interim reclamation. A haul truck was used to transport the soil from the pad's southeast corner to the edge of the pit where it could be used as clean material for mixing with the pit's contents (Photo 2). After a pile of clean soil had been established on the pad, the clean soil was systematically added to the cuttings inside of the pit using an excavator and bulldozer to turn and mix the materials (Photos 3 and 4).

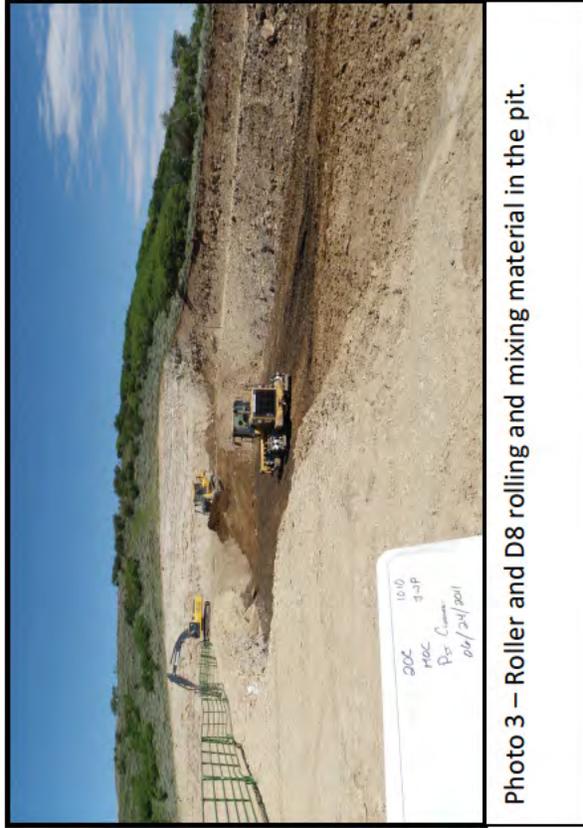
Photo 3 – Roller and D8 rolling and mixing material in the pit.

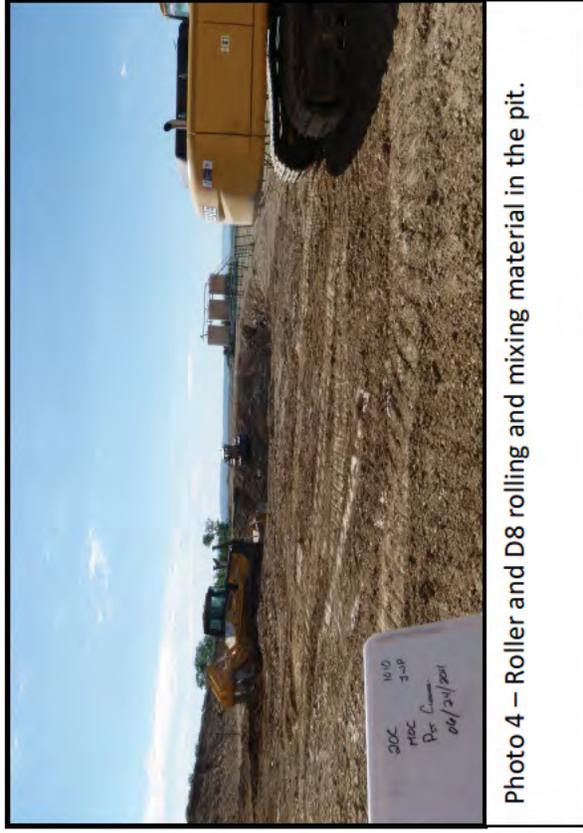
Photo 4 – Roller and D8 rolling and mixing material in the pit.

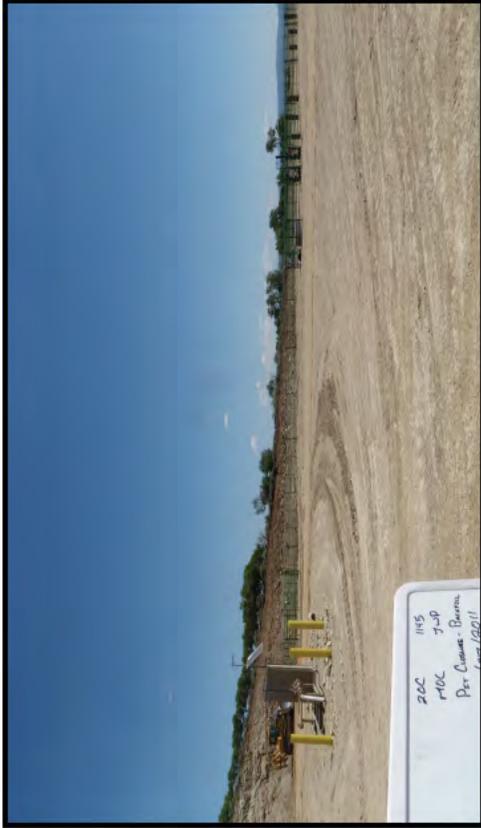
Photo 5 – D8 rolling material while backfilling to achieve homogenous mixture.

The mixing was performed within the pit in order to dry and solidify the pit material, as well as to dilute the concentrations of its COGCC Table 910-1 constituents. The mixed material was then placed on the drilling pad where a bulldozer continued the mixing process by combining additional clean soil with the extracted material and rolling the two together to reach a dry, homogenous mixture (Photo 5). Samples of the mixed soil were collected for laboratory analysis. These samples were tested only for the constituents that previously exceeded COGCC Table 910-1 limits. The final mixing ratio of clean soil to pit material was 1.5:1. The resulting analytical data indicated that the constituent concentrations of the mixture were below

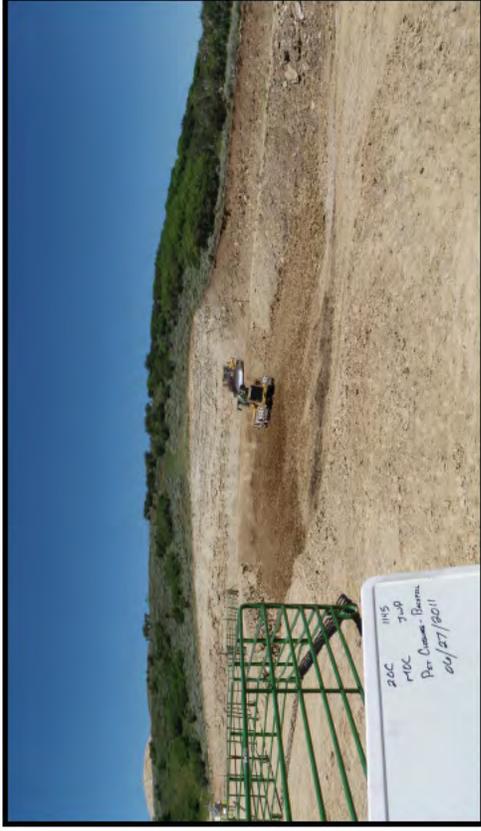
Photo 6 – Pit during backfilling operations.

Backfilling of the excavation was achieved by placing the 1.5:1 mixture of clean soil and cuttings back into the excavation (Photos 6 and 7). The mixed material was placed load-by-load into the excavation with each load being thoroughly compacted using the tracks of a dozer and a sheep's foot compactor. This process continued until the excavation was completely filled.

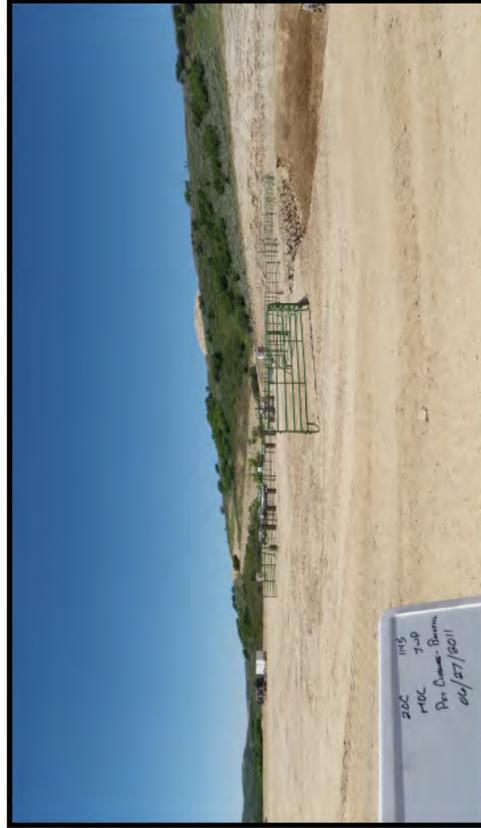
Photo 7 – Well pad during backfilling operations.

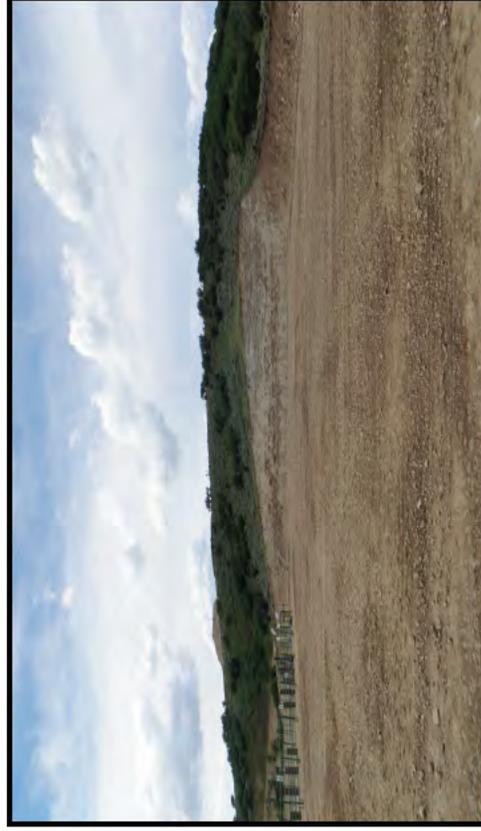
Photo 8 – Well pad after pit closure and reclamation.

Once the excavation had been backfilled, areas of the well pad no longer required for production were roughly graded to their original contour (Photo 8). These re-contoured areas were then top-soiled, thereby mitigating the potential effects of physical parameters on reclamation success. Backfilling and re-contouring operations concluded on July 10, 2011.

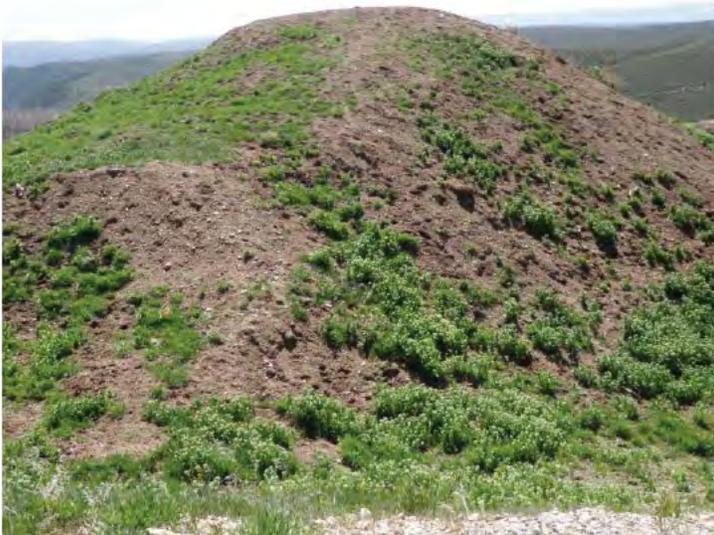
Top soil pile, southeast of pad

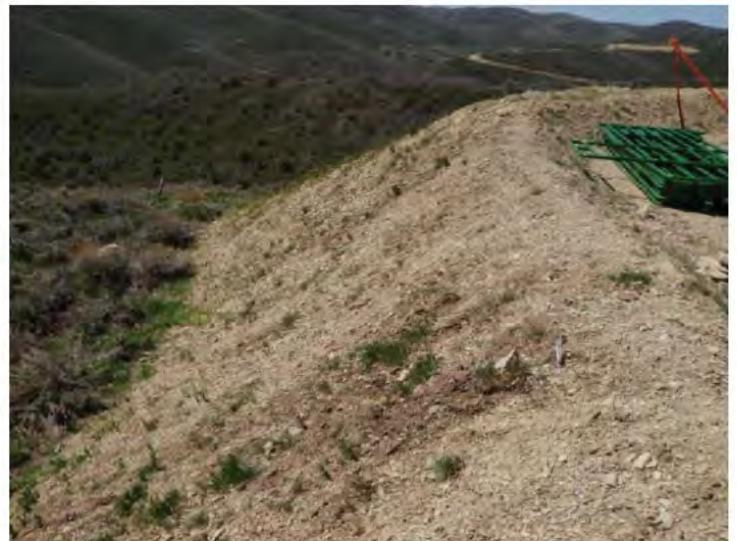
Southeastern fill slope

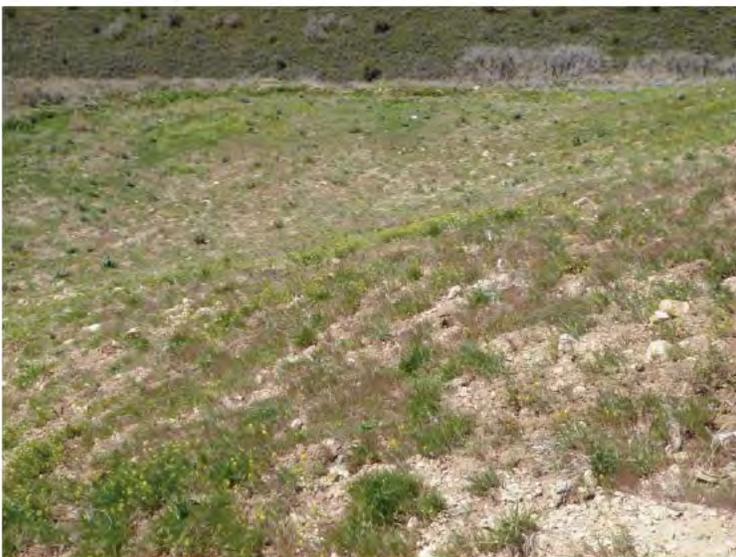
Fill slope on southeastern corner of pad

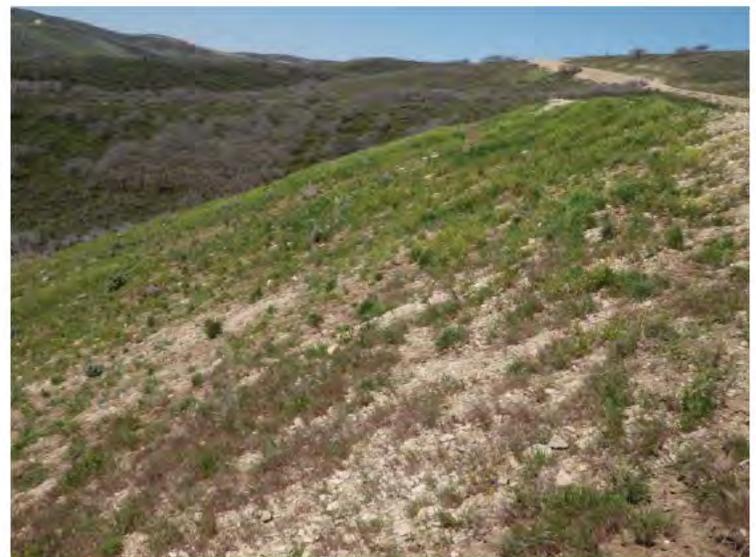
South-facing fill slope

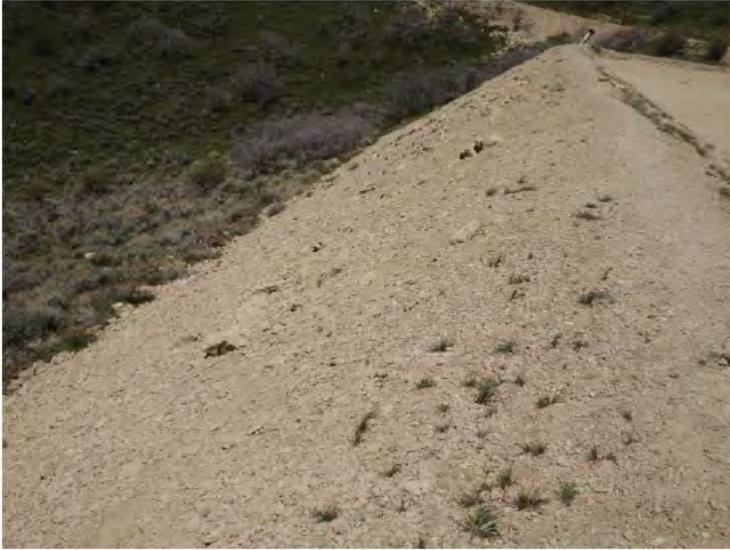
Southwestern fill slope

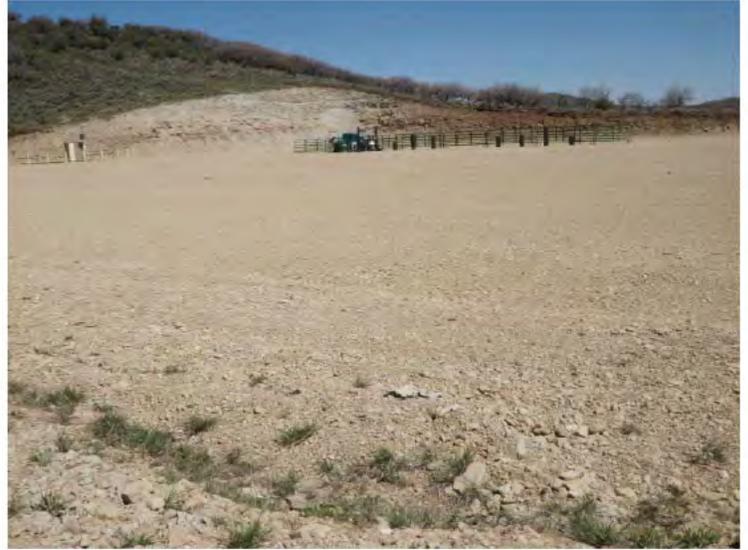
Looking northwest across pad

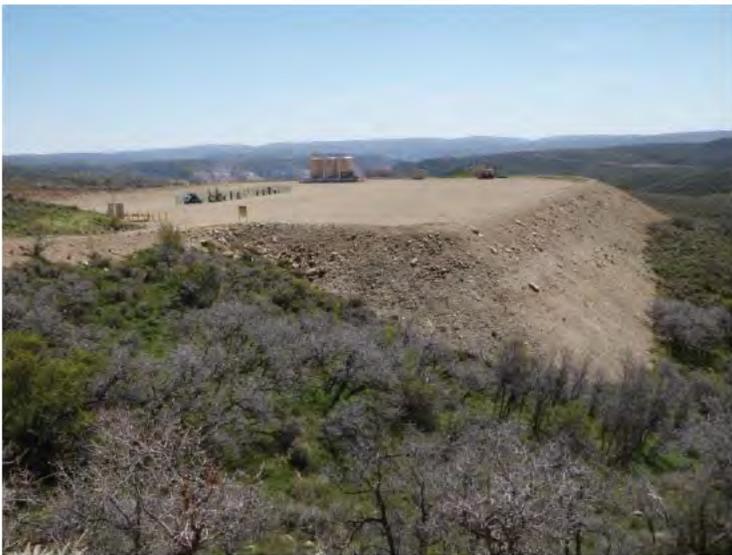
Looking east across pad from access road
