Final Reclamation Inspection

Operator: ANADARKO E&P ONSHORE LLC- 2800

API: 05-123-31711

Inspection Photos
Location Name: HUTCHISON #9-67-3-7
API: 05-123-31711

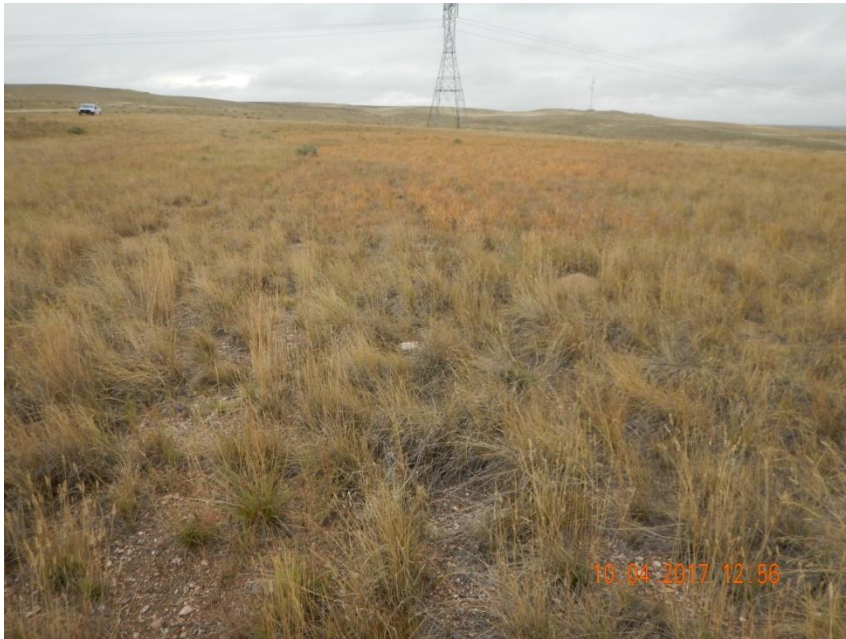
Photo 1. Photo taken from the eastern well location, facing West. Unable to find evidence of oil and gas activities and/or disturbances. Well location appears reflective of reference areas. Crested wheatgrass (*Agropyron cristatum*) does appear to be at a higher density than reference areas but Blue grama (*Bouteloua gracilis*) was observed within the reclamation area.

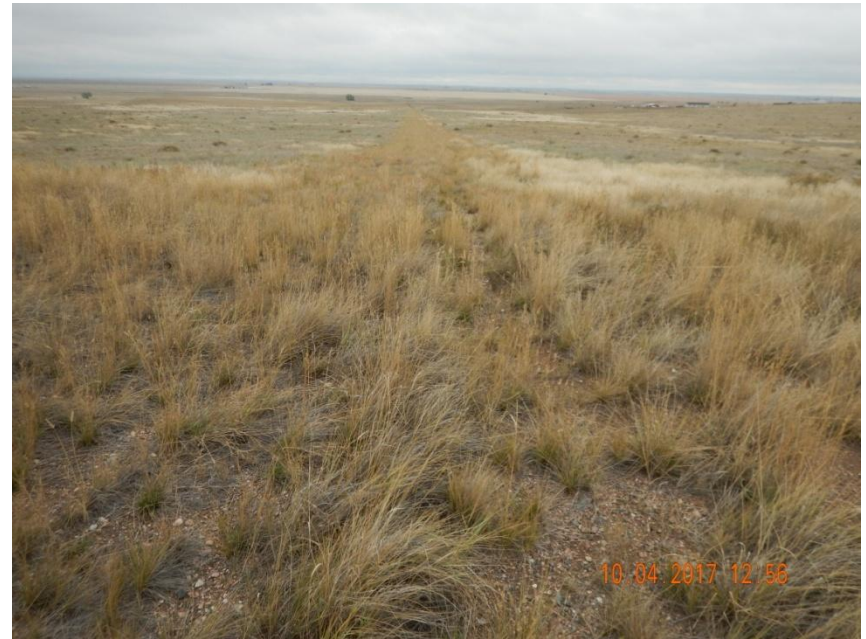
Photo 2. Photo taken from the eastern well location, facing East along the access road. Crested wheatgrass does appear to be at a higher density along the access road than reference areas but Blue grama was observed within the reclamation area.

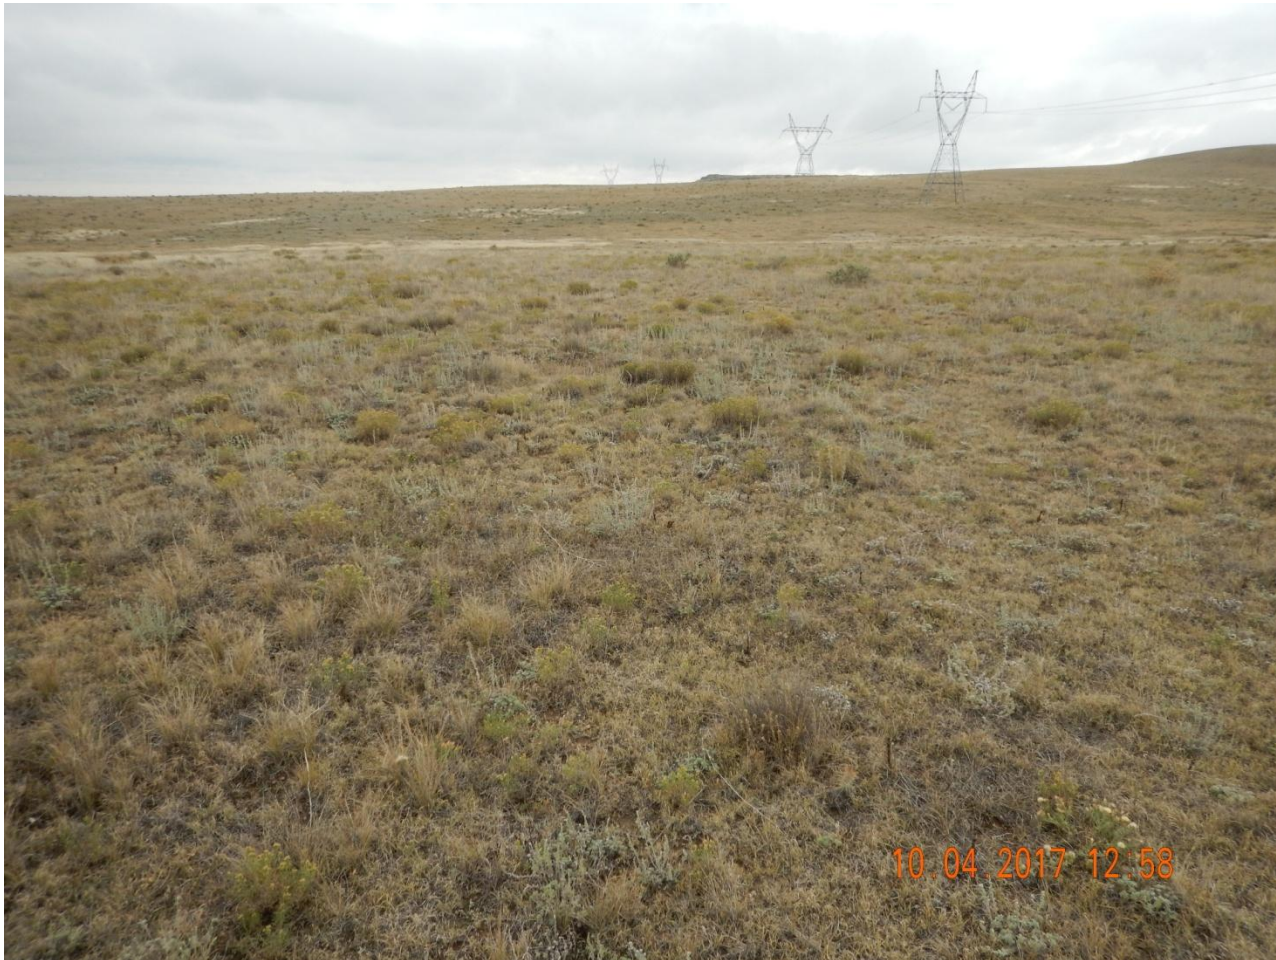
Photo 3. Reference photo taken just south of the location, facing South. Well location and access road appear reflective of reference areas. Crested wheatgrass does appear to be at a higher density within the reclamation areas but Blue grama- which is the dominant vegetative cover in reference areas- was observed within the reclamation areas.
