# Inspection Photos

Operator: WESTERN OPERATING COMPANY -  
95620

Location ID: 312292

Inspection Doc. Number: 682502714  
Logan County, CO

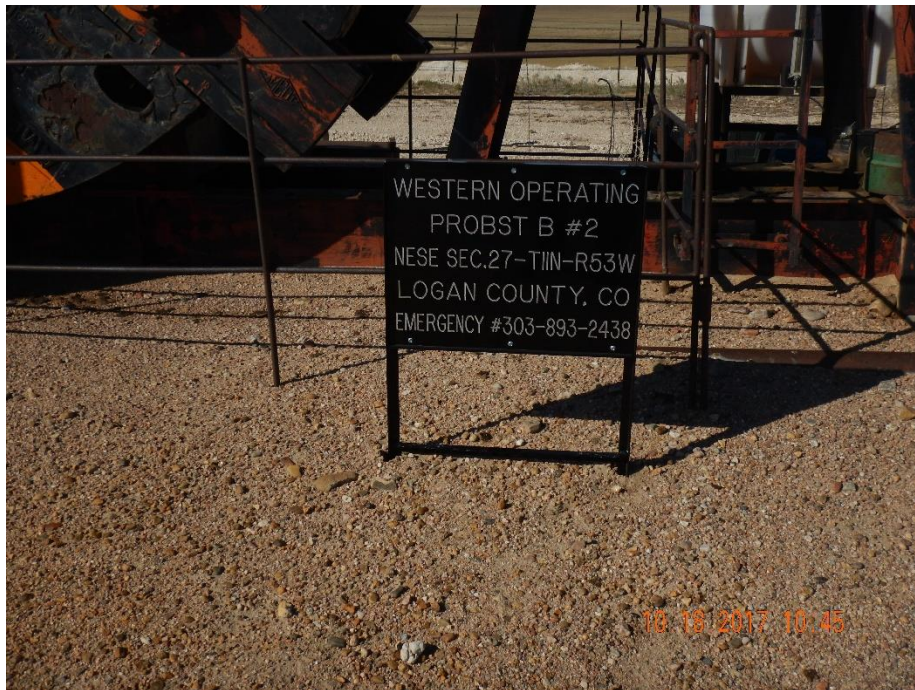
**Photo 1:** Photo taken from the east side of the well. Photo shows sign has been placed at well per the CA

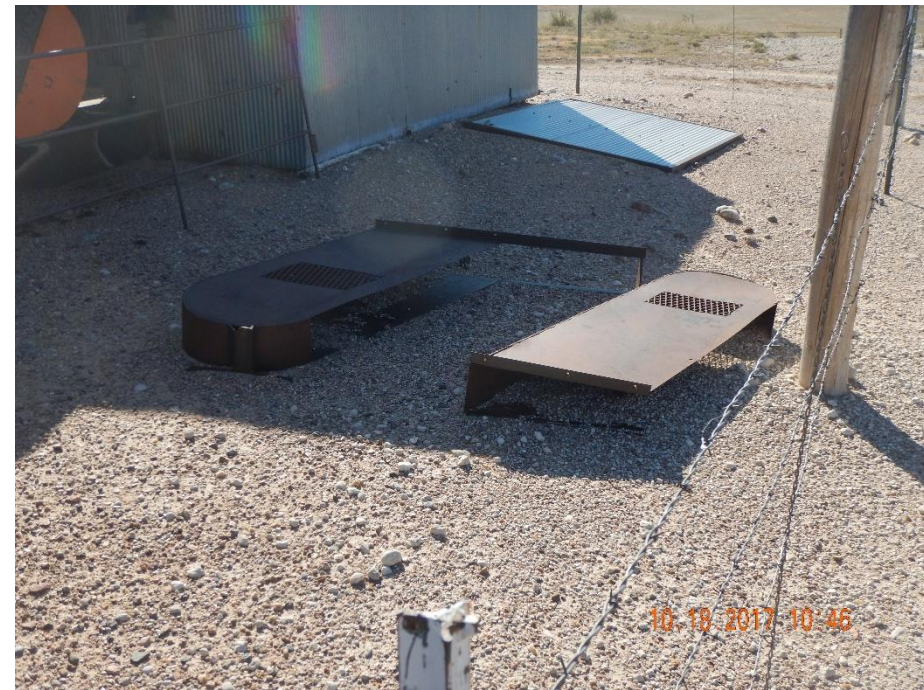
**Photo 2:** Photo taken from the west end of the well. Previous inspection required operator to properly store or remove unneeded equipment.

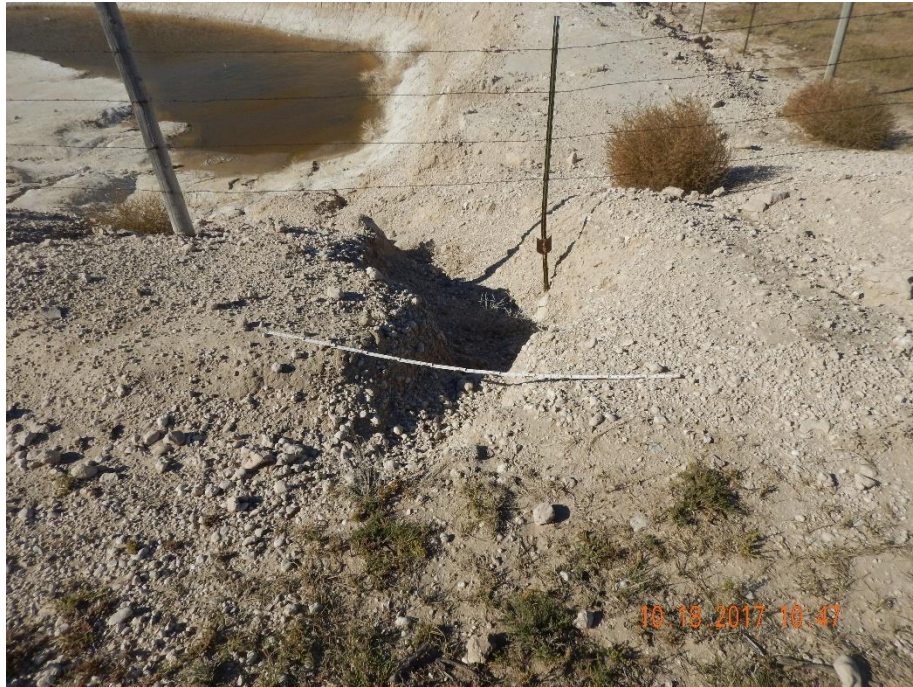
**Photo 3:** Photo taken from the northeast corner of the pit. Photo shows erosion degradation on the pit.

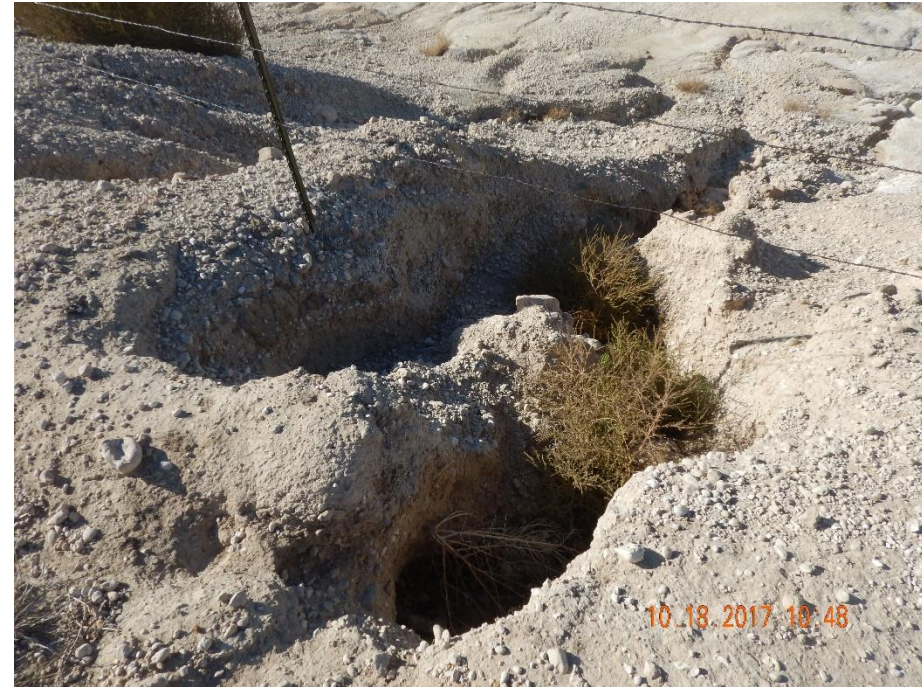
**Photo 4:** Photo taken from the northeast corner of the pit. Photo shows erosion degradation on the pit.

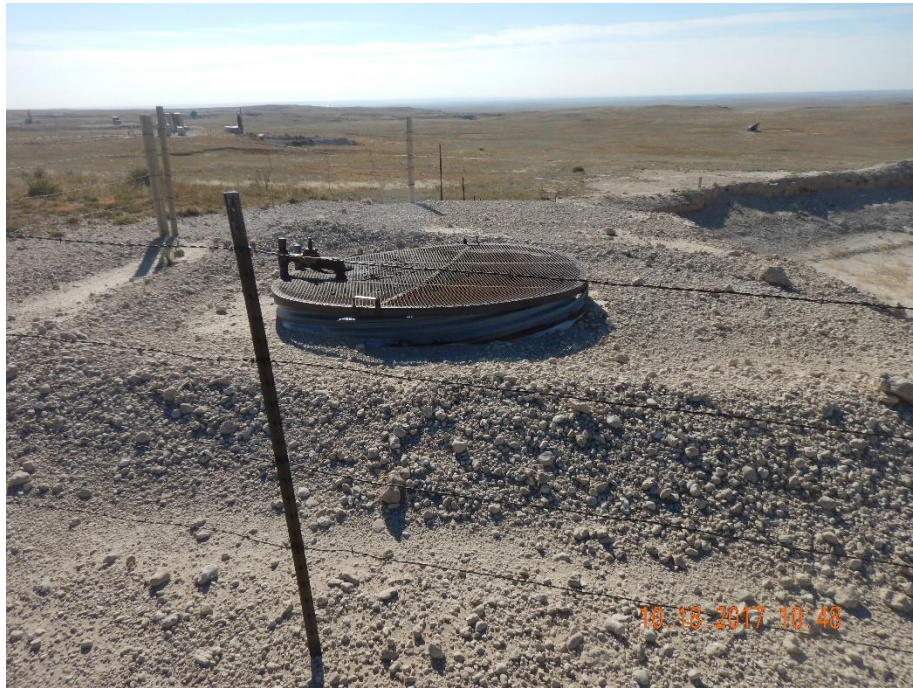
**Photo 5:** Photo shows skim pit remains.

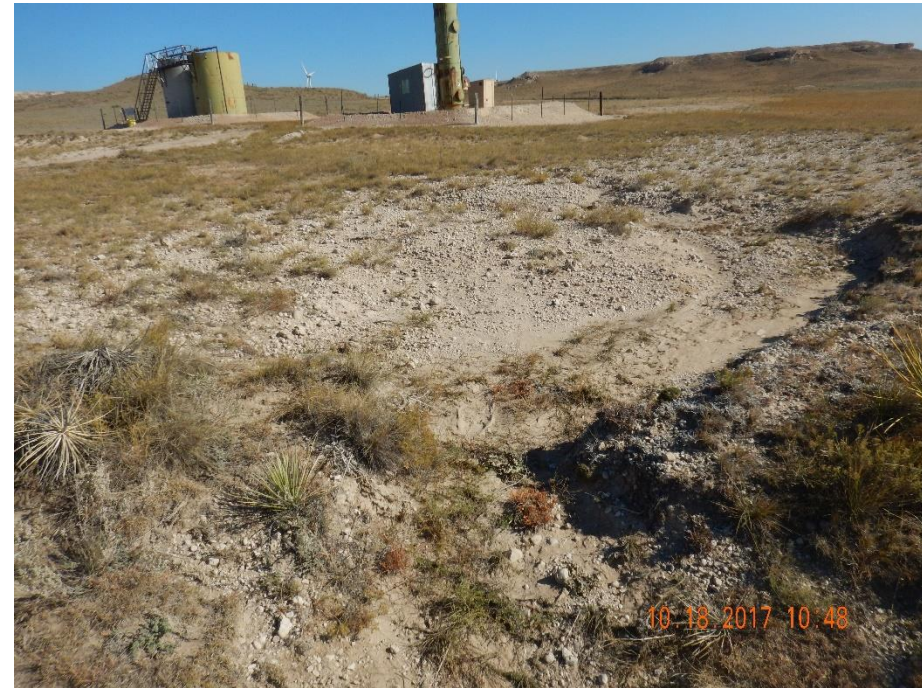
**Photo 6:** Photo taken from the south end of the location, facing northeast. Inspection #675103909 required operator to install temporary stormwater and sediment control BMPs until reclamation activities have been conducted, and more permanent stabilization controls can be implemented. Photo shows no controls have been implemented.

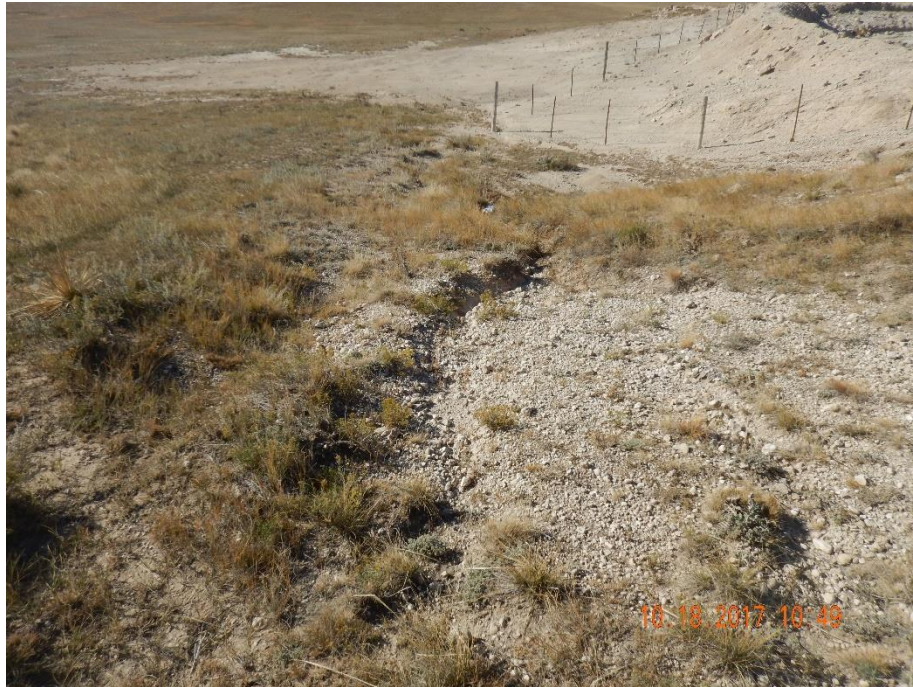
**Photo 7:** Photo taken from the south end of the location, facing west. See comments under photo 6. Photo shows no controls have been implemented.

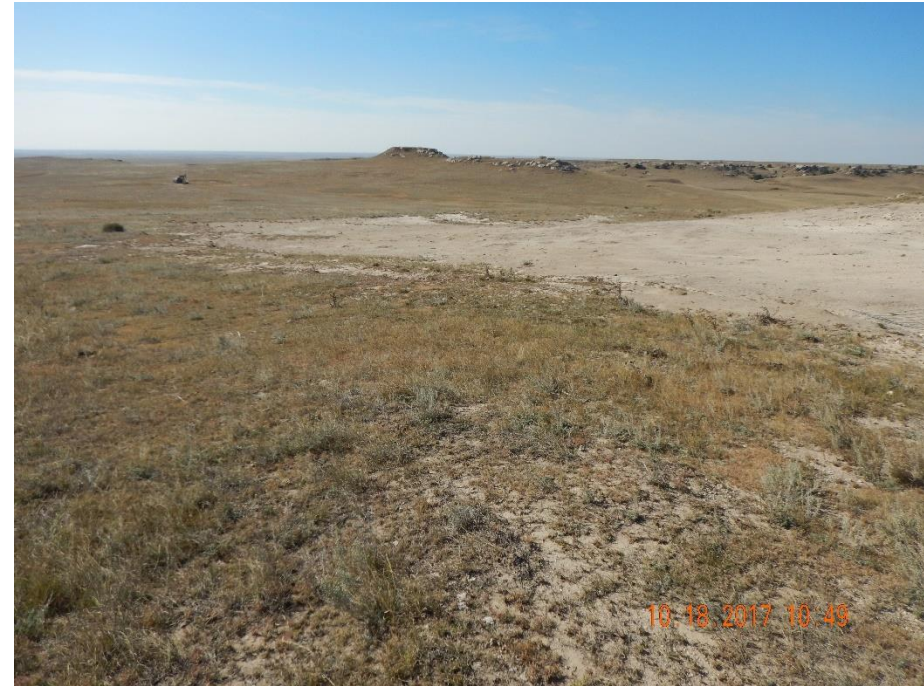
**Photo 8:** Photo taken from the north end of the location, facing south. See comments under photo 6. Photo shows no controls have been implemented.

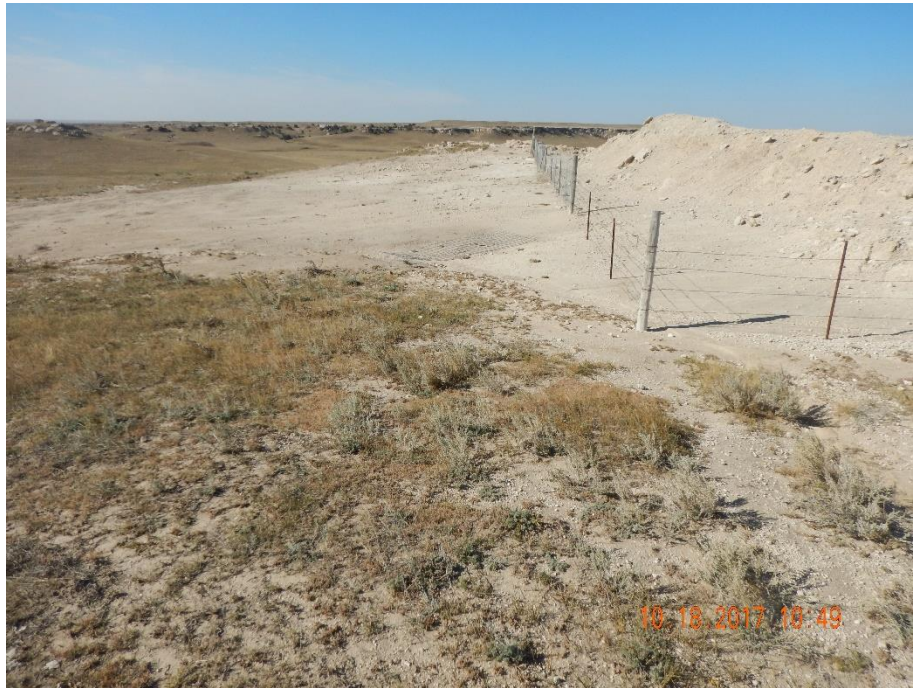
**Photo 9:** Photo taken from the southeast end of the pit, facing west. See comments under photo 6. Photo shows no controls have been implemented.

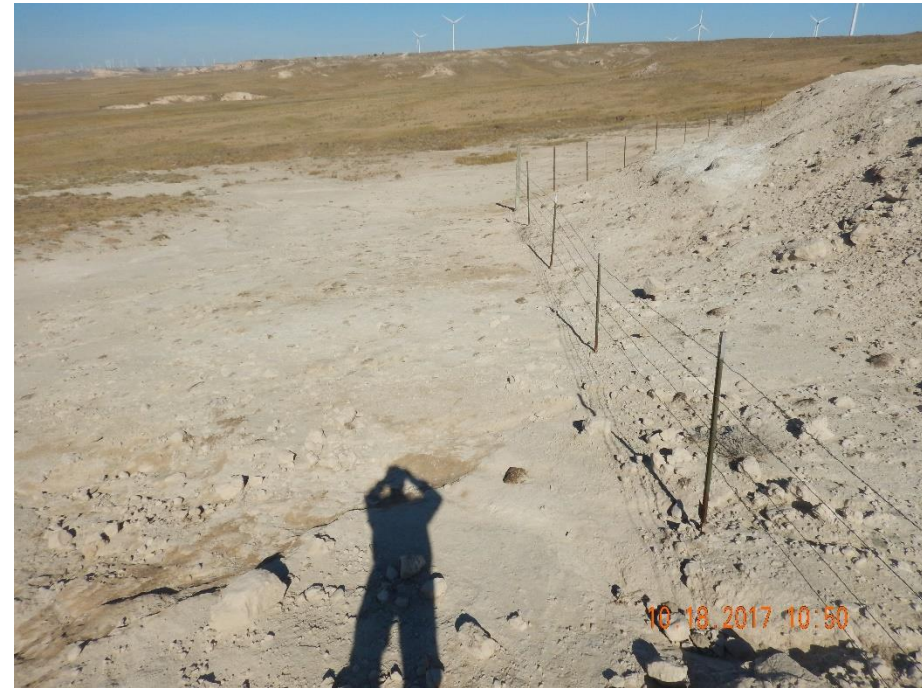
**Photo 10:** Photo taken from the southwest end of the pit, facing north. See comments under photo 6. Photo shows no controls have been implemented.

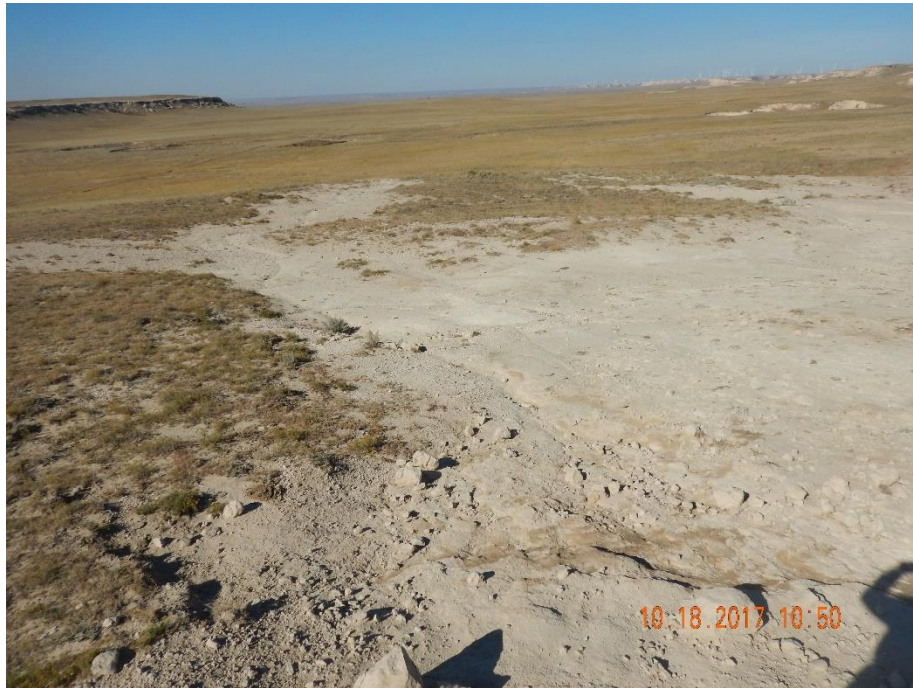
**Photo 11:** Photo taken from the southwest end of the pit, facing northwest. See comments under photo 6. Photo shows no controls have been implemented.

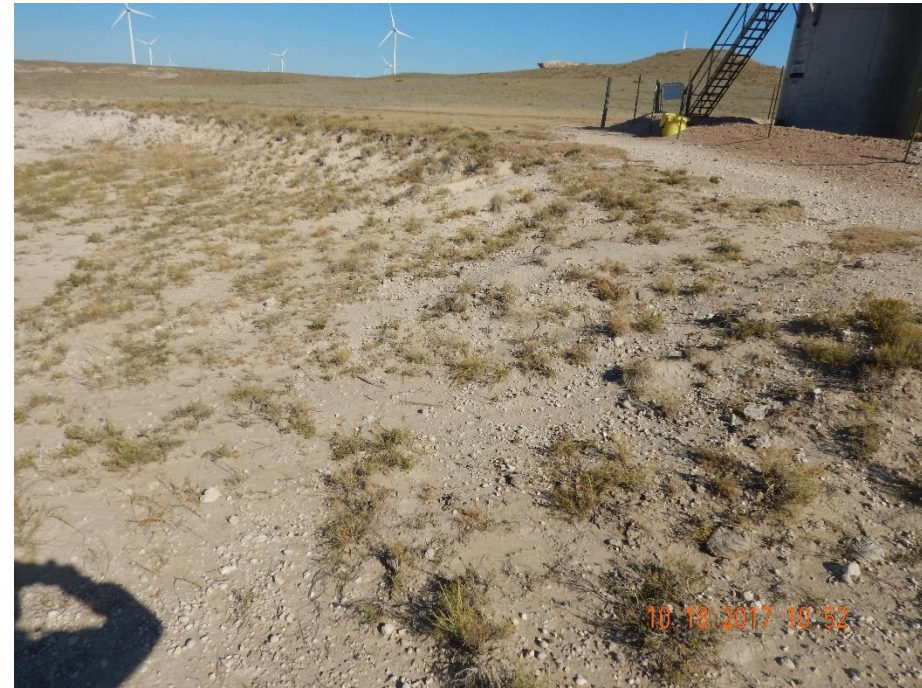
**Photo 12:** Photo taken from the location, to the west of the battery. See comments under photo 6. Photo shows no controls have been implemented.
