# Final Reclamation Inspection

November 2, 2017

Operator: KERR MCGEE OIL & GAS ONSHORE LP - # 47120

API: 05-123-10973

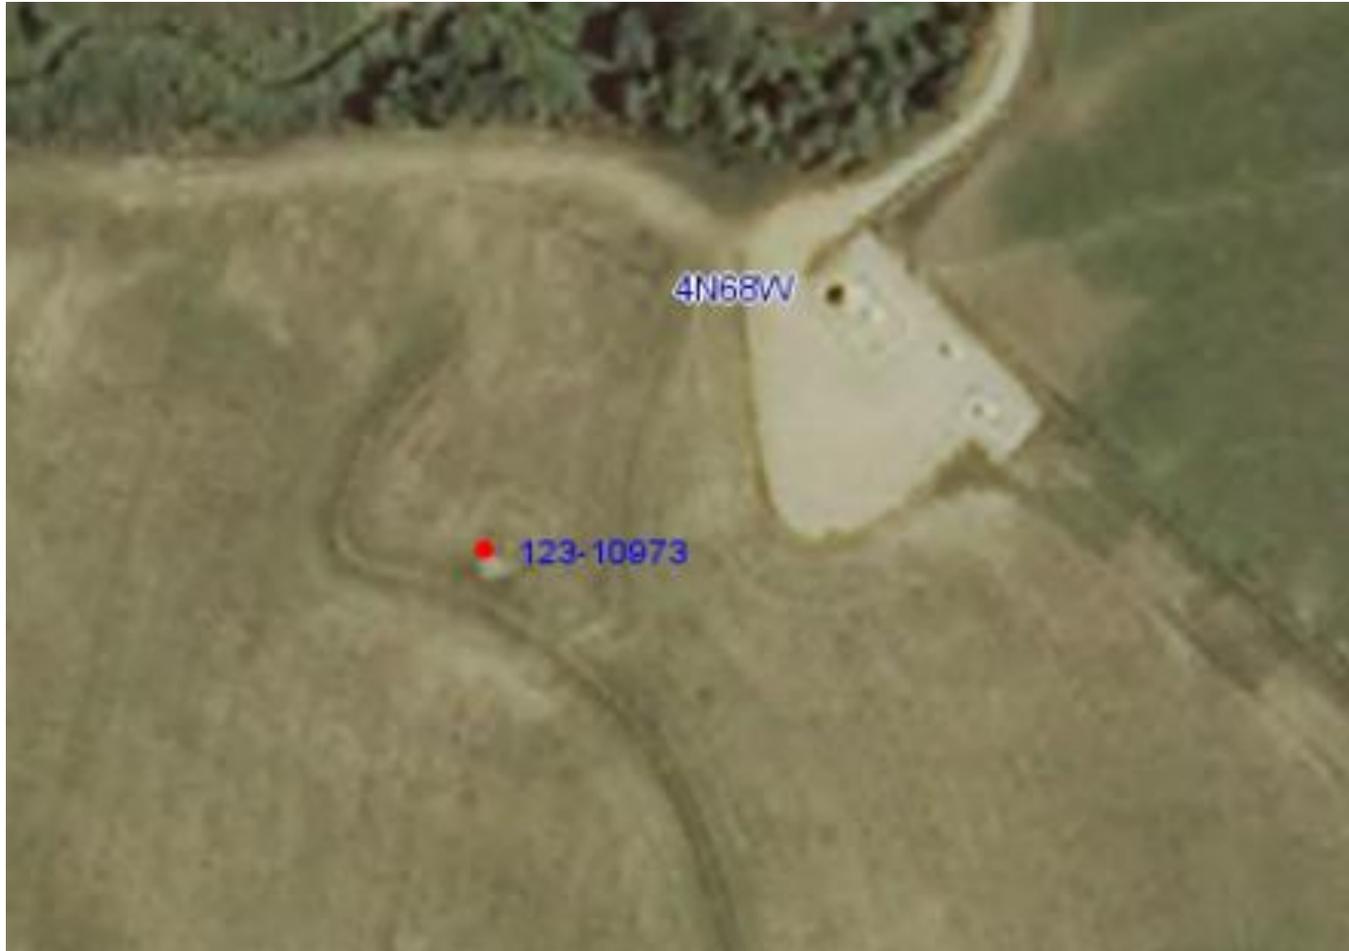
**Photo 1.** COGCC GISOnline database aerial imagery from 2013 illustrating the well and battery location during operations.

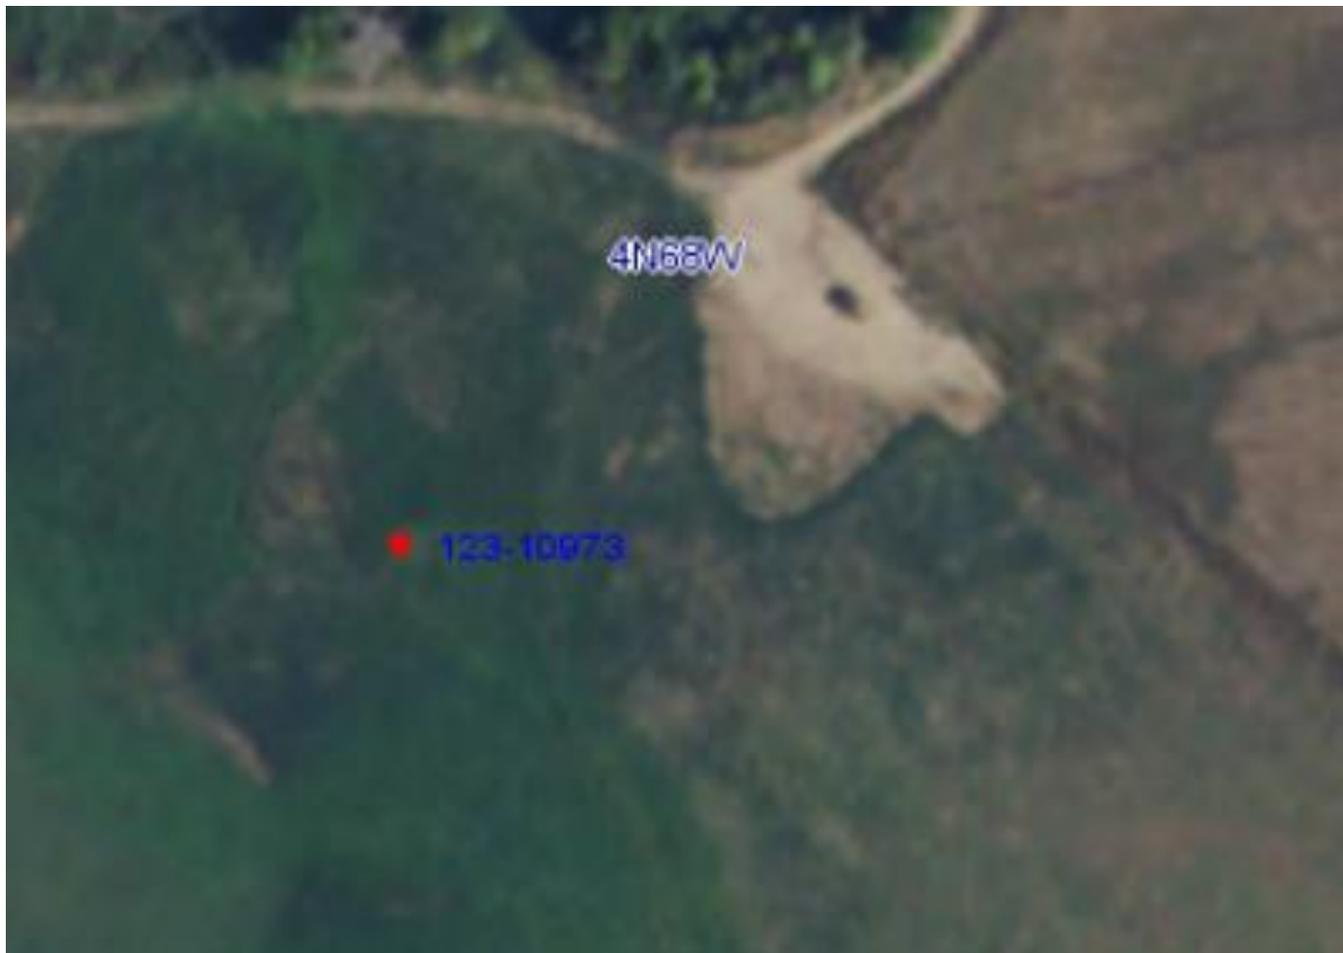
**Photo 2.** COGCC GISOnline database aerial imagery from 2015 illustrating the well and battery location. The well location appears to meet Rule 1004 standards but the tank battery location does not meet Rule 1004 standards. Refer to the following photos for more detail.

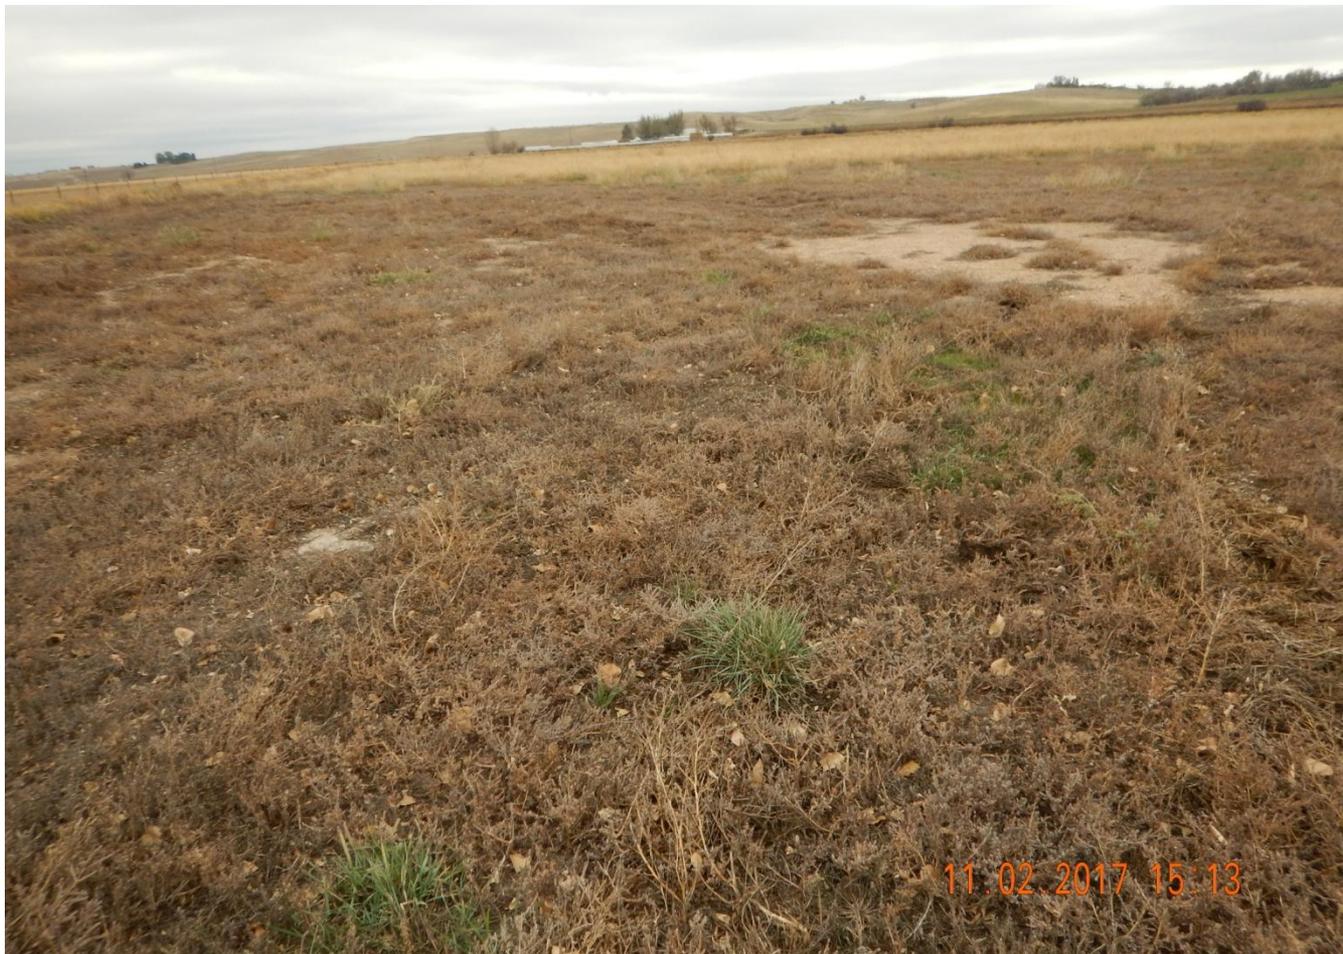
**Photo 3.** Photo taken from the approximate center of the battery location, facing South. Disturbance areas are not reflective of reference areas. Location mainly consists of weedy, annual vegetation and appears gravel material may have been left at location.

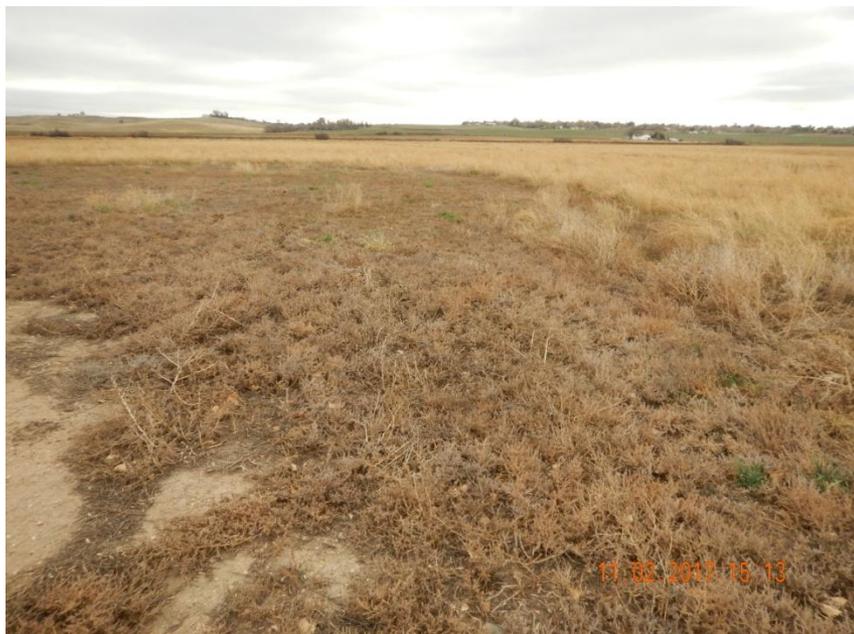
**Photo 4.** Photo taken from the western battery location, facing South. See comments under Photo 3.

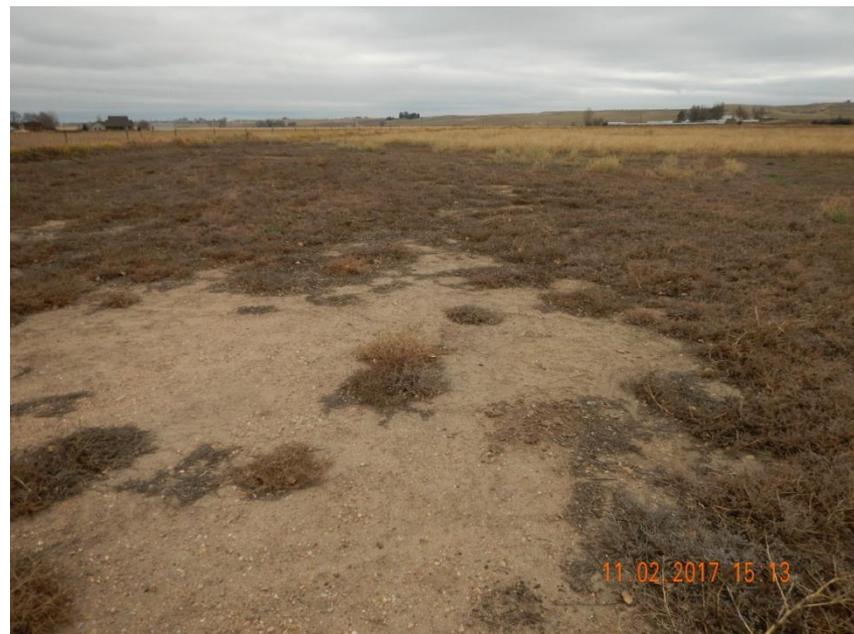
**Photo 5.** Photo taken from the approximate center of the battery location, facing Southeast. See comments under Photo 3.

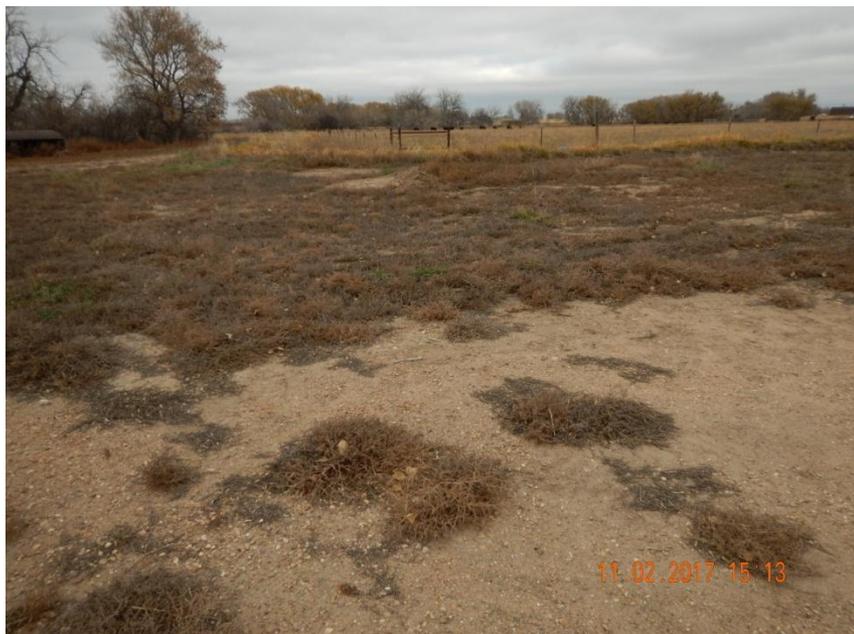
**Photo 6.** Photo taken from the approximate center of the battery location, facing East. See comments under Photo 3.

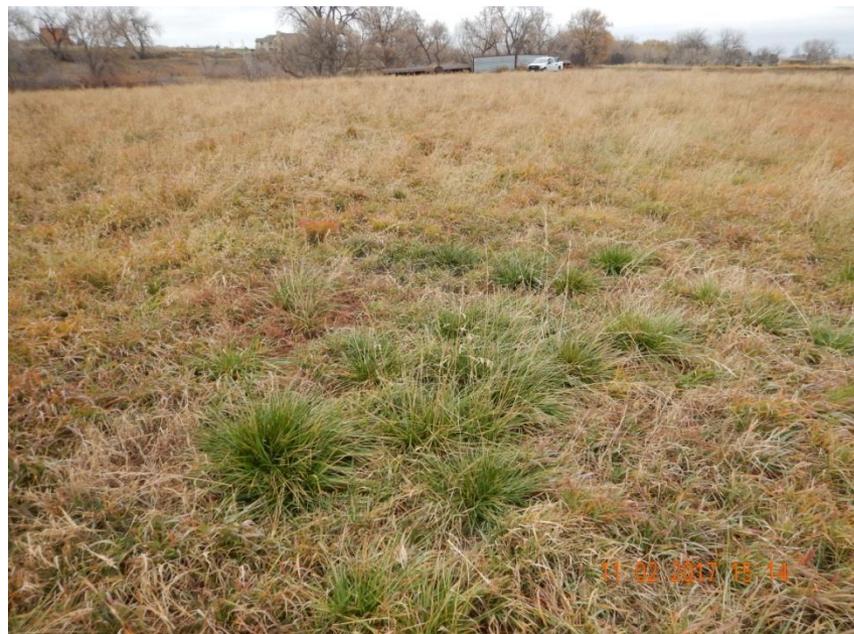
**Photo 7.** Photo taken from the approximate center of the well location, facing East. The well location appears to meet Rule 1004 standards.

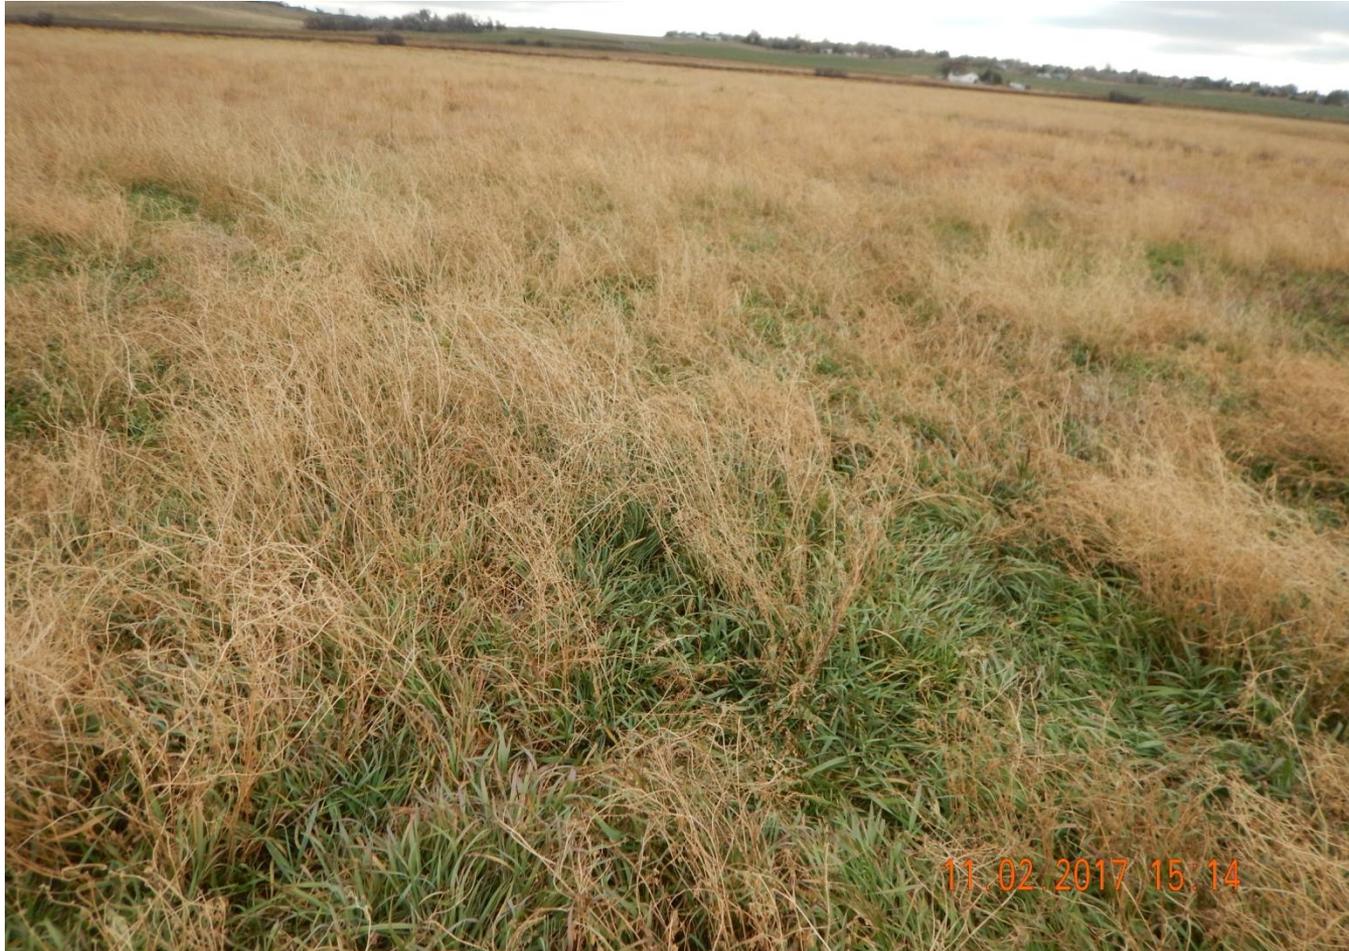
**Photo 8.** Reference photo taken south of the battery location, facing South.
