Final Reclamation Inspection

December 12, 2017

Operator: MAGPIE OPERATING, INC- # 52530

API: 05-069-06159

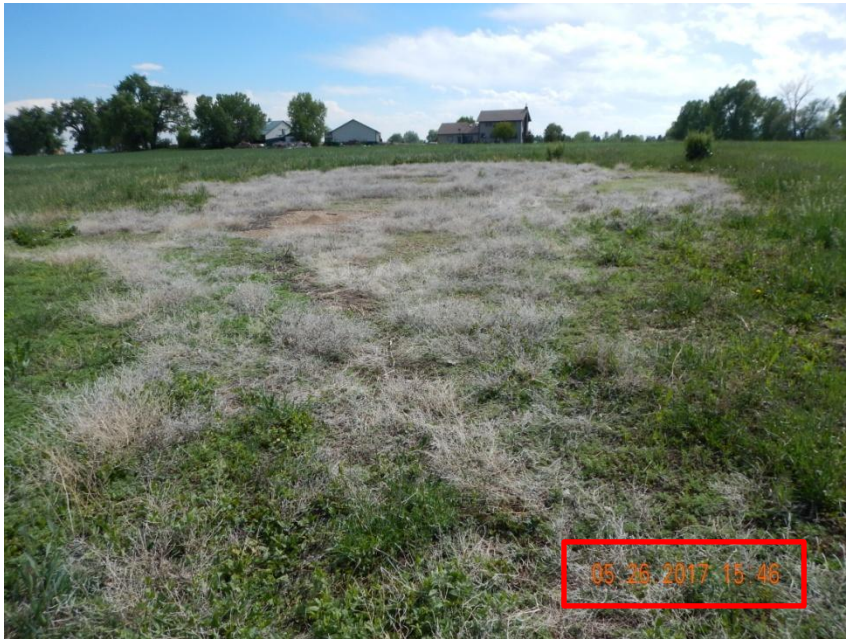
Photo 1. Photo taken on May 26, 2017 from the well location, facing South. Gravel has not been removed from location. Operator has failed to perform reclamation activities per Rule 1004.a.

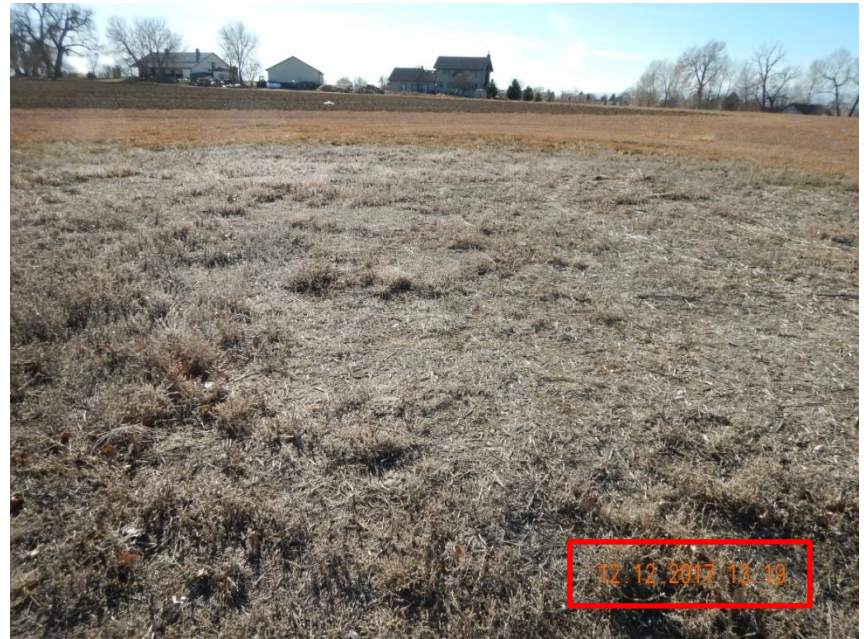
Photo 2. Photo taken on December 12, 2017 from the well location, facing South. Operator has failed to perform reclamation activities per Rule 1004.a. and has failed to respond to the previous corrective action inspection.

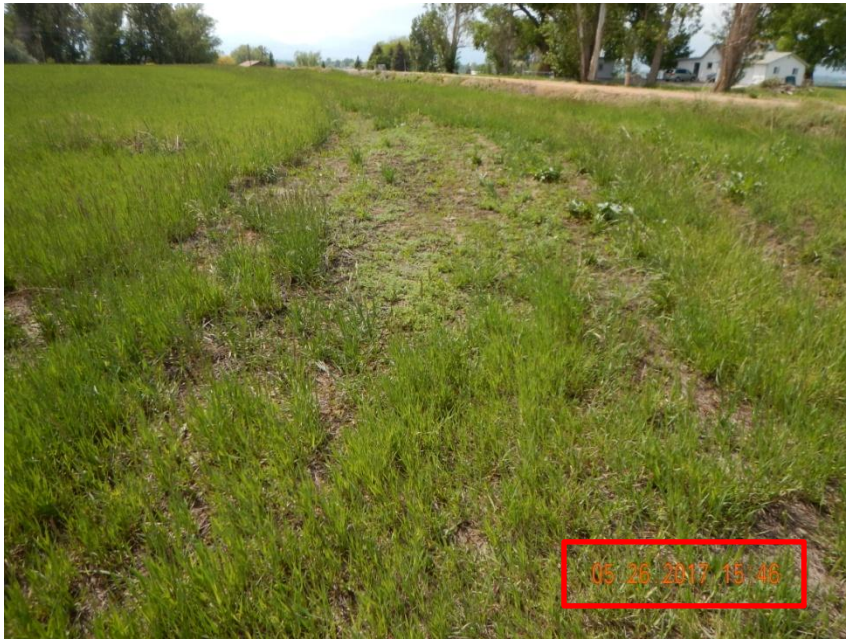
Photo 3. Photo taken on May 26, 2017 from a portion of the access road, facing West. Operator has failed to perform reclamation activities per Rule 1004.a. Along the access road.

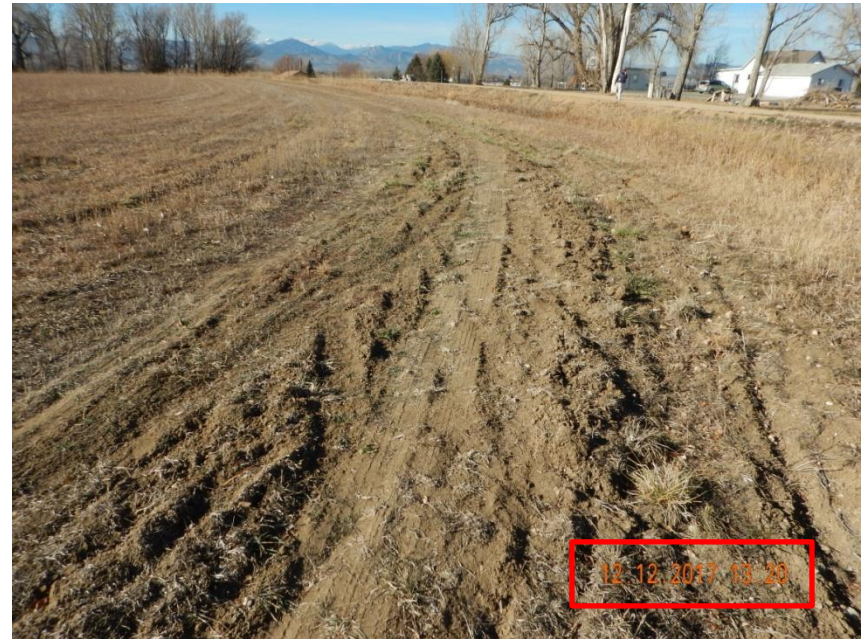
Photo 4. Photo taken on December 12, 2017 from a portion of the access road, facing West. Operator has failed to perform reclamation activities per Rule 1004.a. and has failed to respond to the previous corrective action inspection.
