# Inspection Photos

Operator: NOBLE ENERGY INC - 100322

Location ID: 318182

Inspection Doc. Number: 682504016

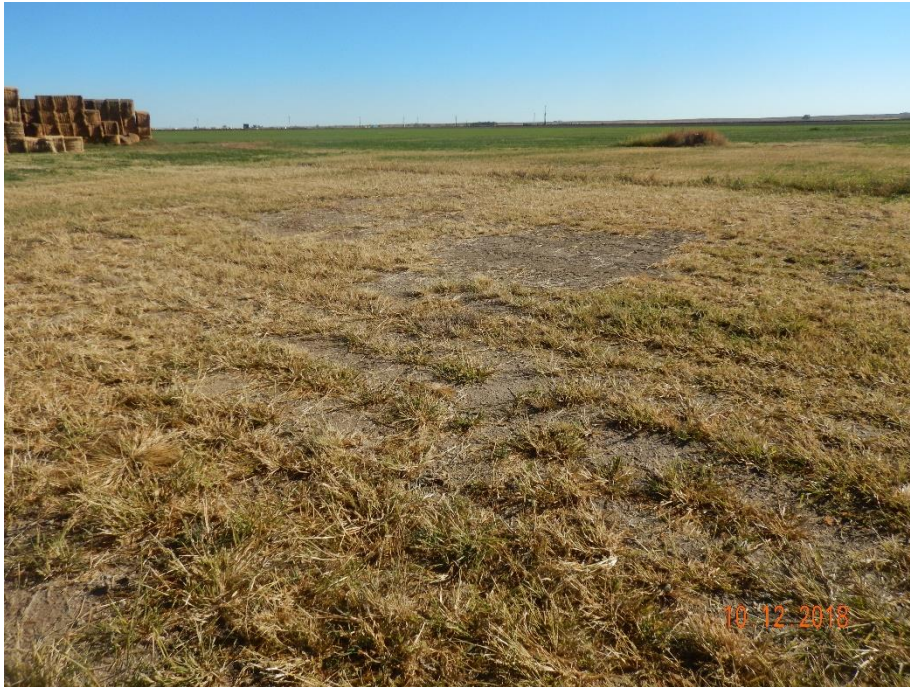
**Photo 1:** Photo from the southwest end of the former battery location, facing northeast. Photo shows large areas of the battery location remains bare and exposed soil. Photo also shows Echinochloa crus-galli (Barnyardgrass) appears to have been planted at the battery and well location. This is an annual grass that can be weedy according to the USDA, reference area is perennial cropland; vegetation is not reflective of the reference area.

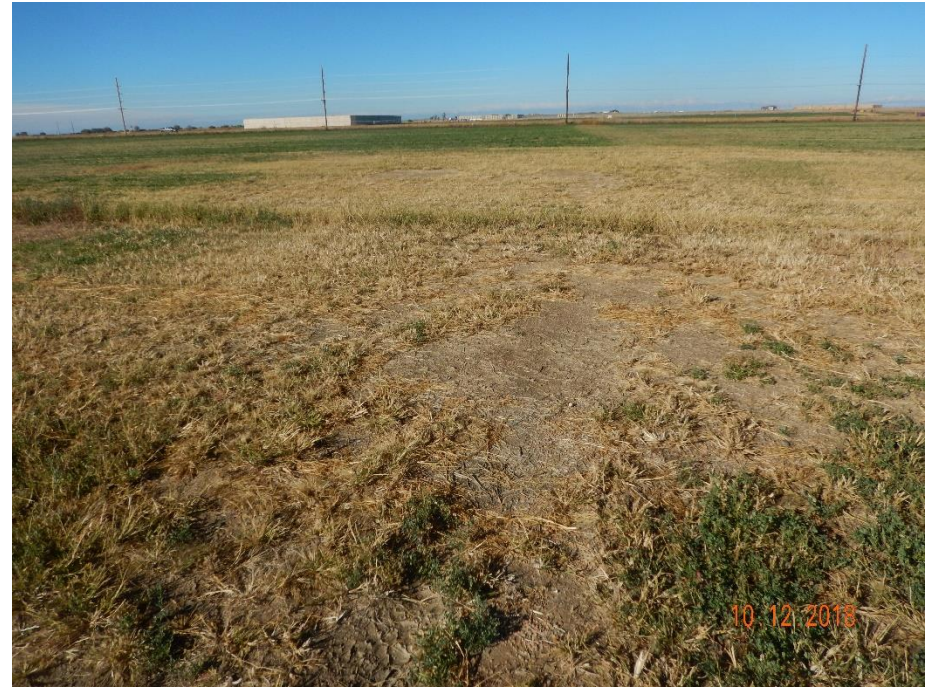
**Photo 2:** Photo from the east end of the former battery location, facing west. See comments under photo 1.

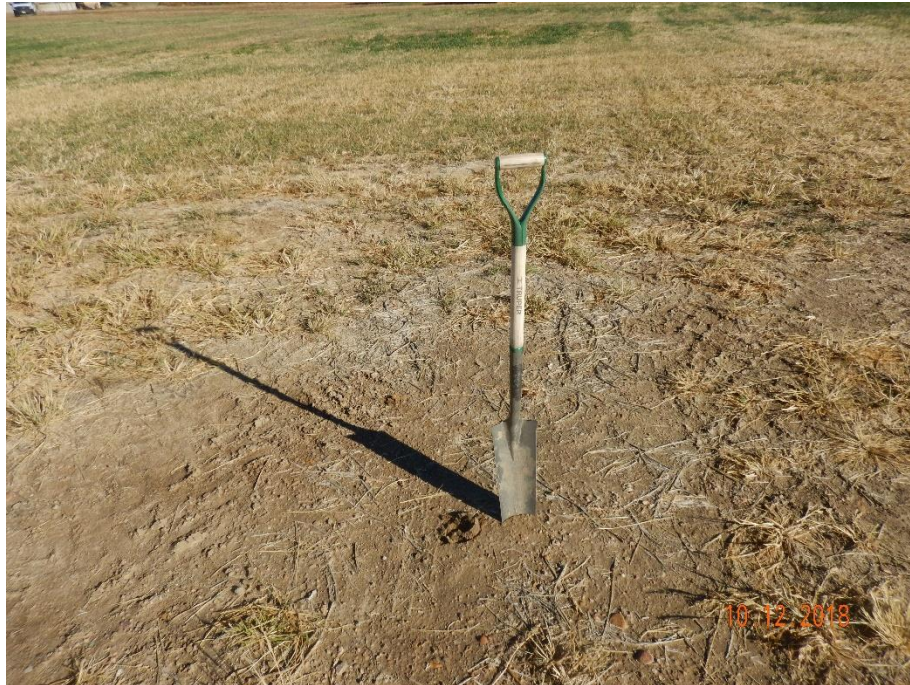
**Photo 3:** Photo taken from the battery location. Photo shows inspector conducted a compaction test; inspector was only able to easily penetrate the top couple inches of the soil on the location. Compaction concerns remain evident.

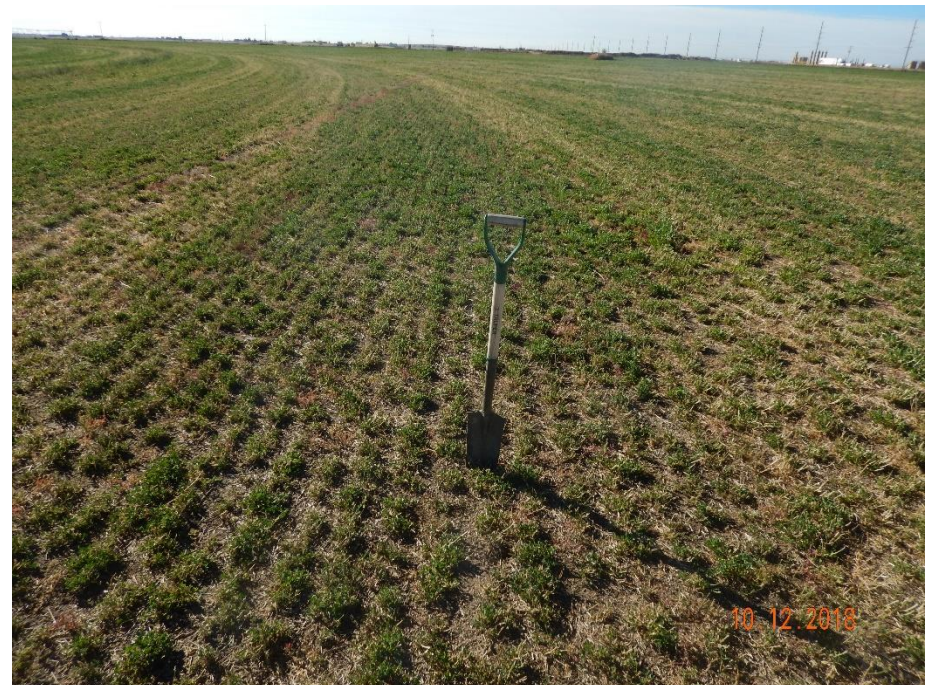
**Photo 4:** Photo taken from the adjacent reference area. Photo shows inspector was able to easily penetrate the top 6-8 inches of soil on the reference area.
