ALANCO ENERGY SERVICES INC - 10493
API# 05-077-10096 Deer Creek SWD #1
Inspection Date : 11/2/2018

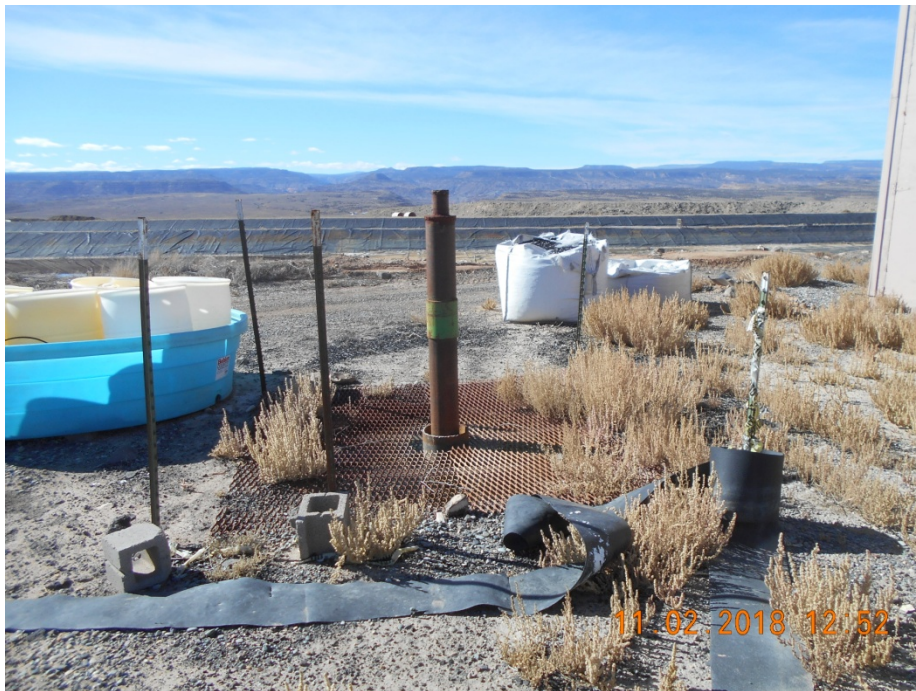
Wellhead with no sign. No fencing.

Trash & debris around wellhead.

4' cellar with mesh grate. 10.75" & 7" casings exposed above grate.

Cellar full of water. No visible cement in annulus.

No valves on casing. 7" casing plug is open ended.

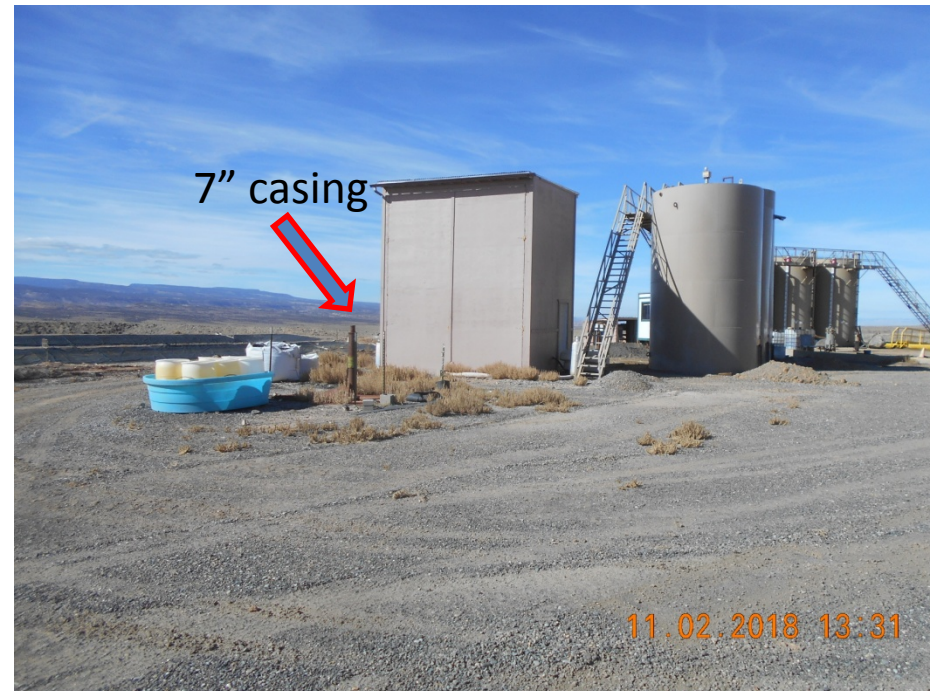
**Overview of wellhead area looking NW with
CDPHE permitted waste water facility equipment
and evap pits in background**

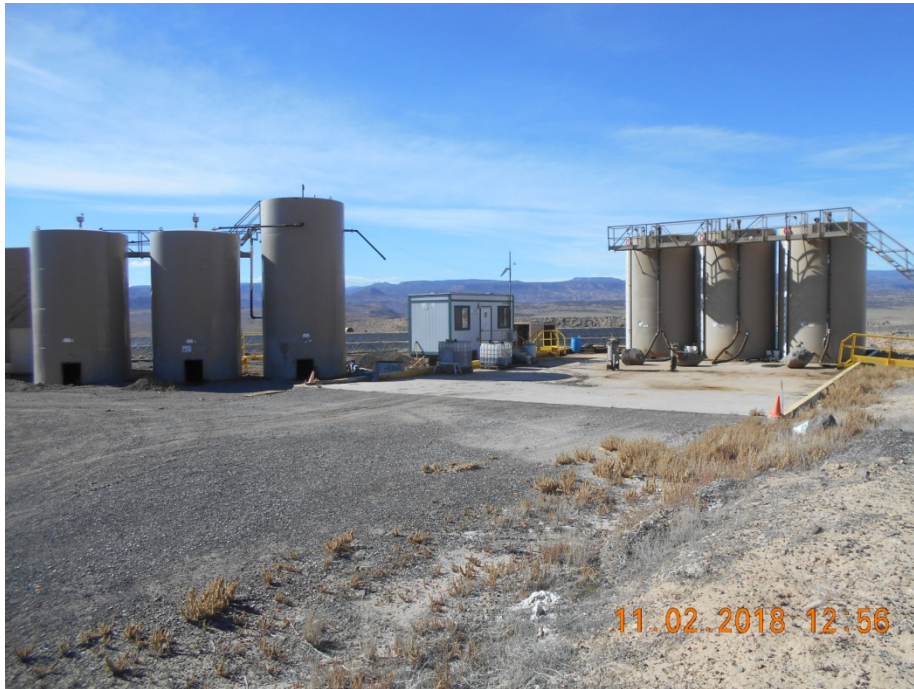
**Overview of water disposal facility looking SW.
2-400 bbl and 1-500 bbl tanks. Access hatches removed.
3-400 bbl tanks with cement bermed offload pad.**

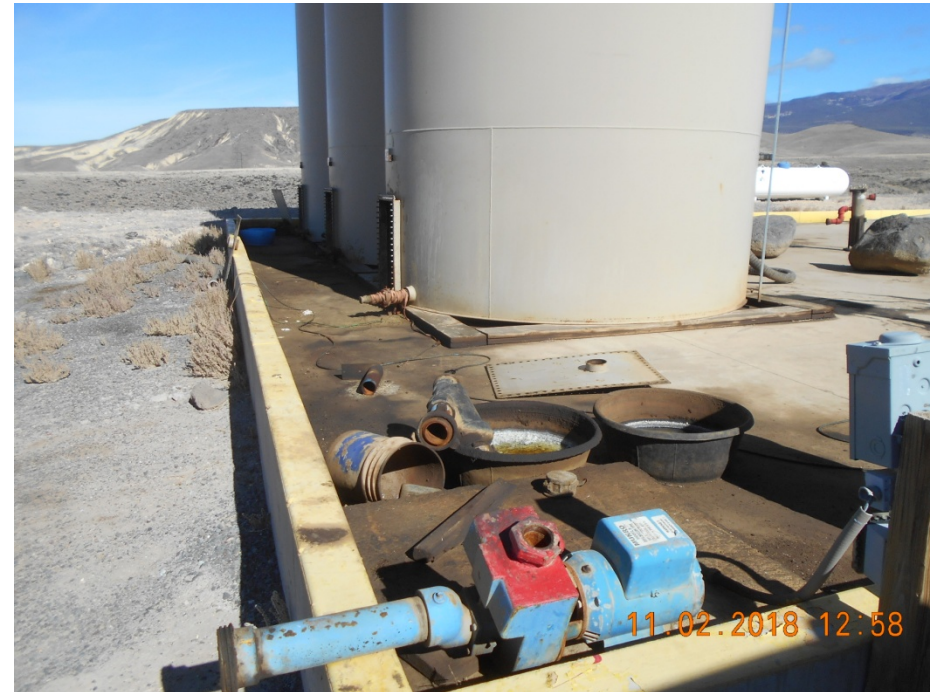
**SW corner looking N of cement bermed offload pad.
3-400 bbl tanks with access hatches removed.**
