Inspection Photos

Operator: DENVER EAST MACHINERY COMPANY
- 24040

Location ID: 374981

Inspection Doc. Number: 682504140
Adams County, CO

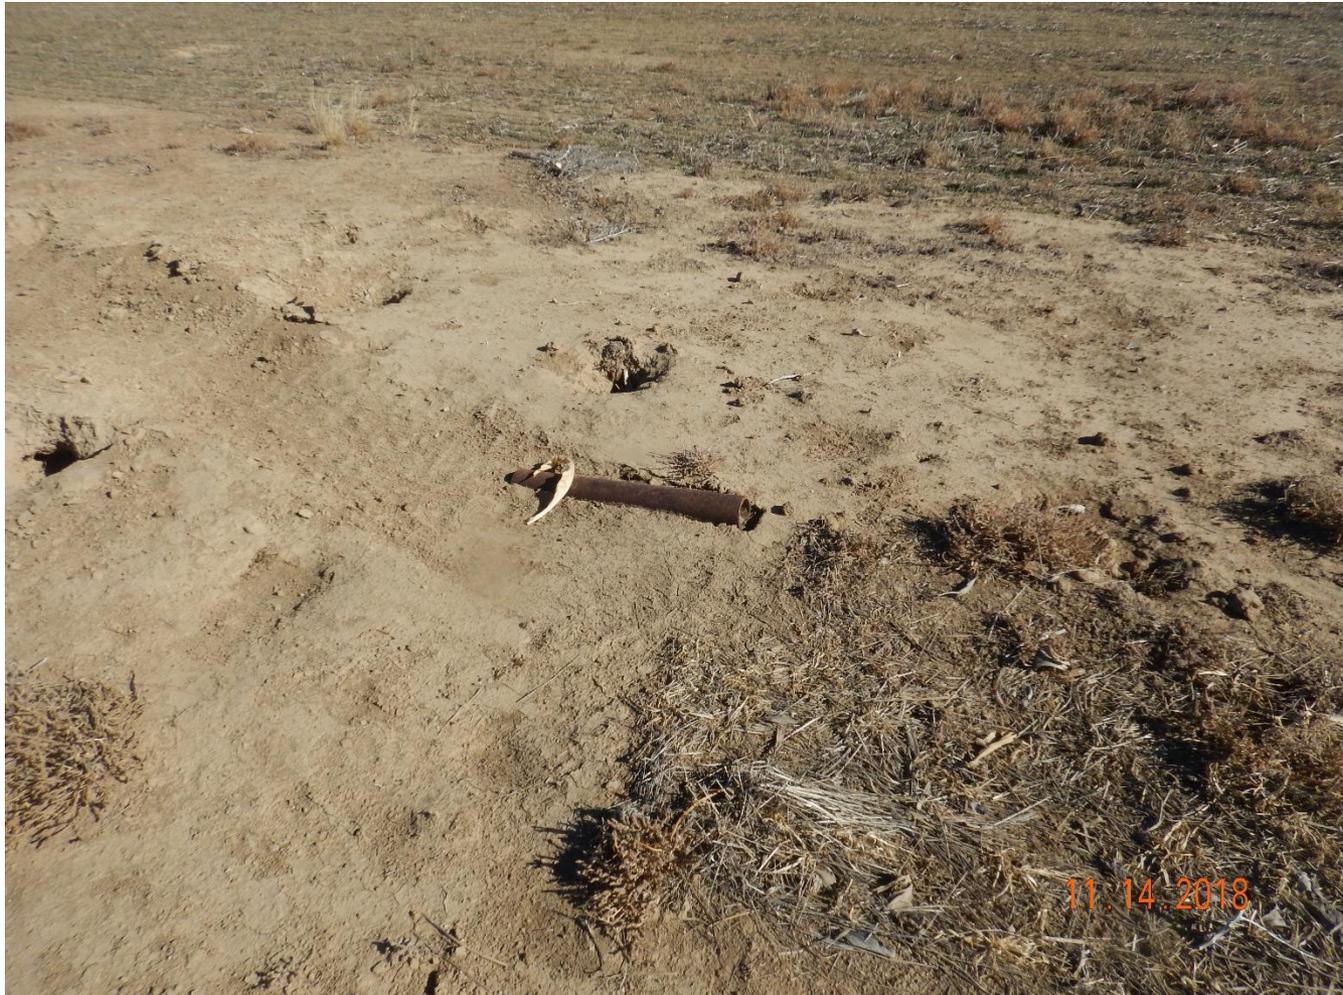
Photo 1: Photo taken from the area of the former battery/pit. Photo shows pipe debris remaining on site.

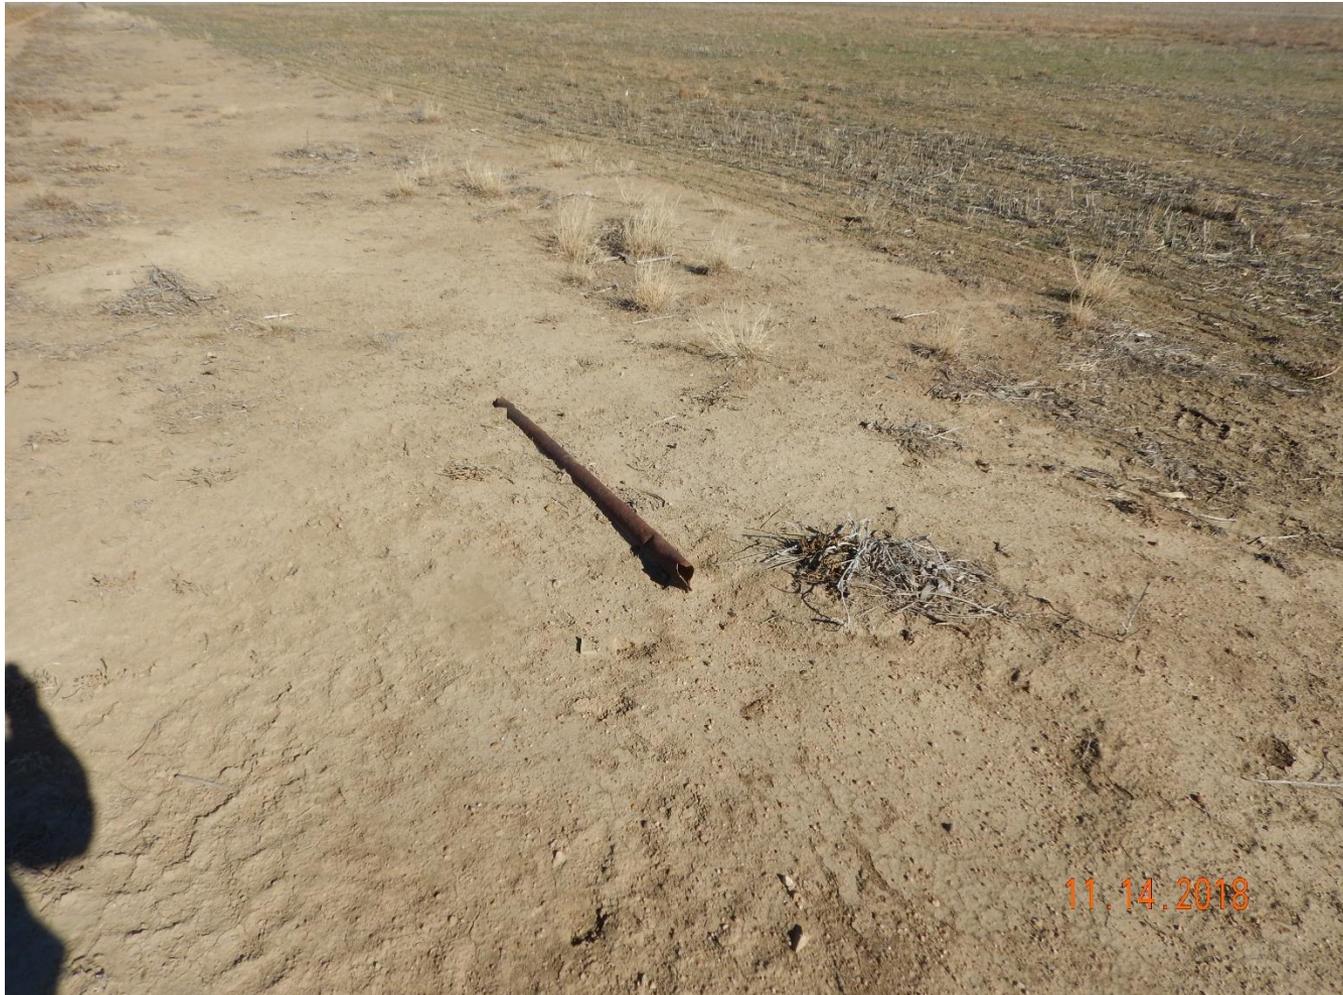
Photo 2: Photo taken from the area of the former battery/pit. Photo shows pipe debris remaining on site.

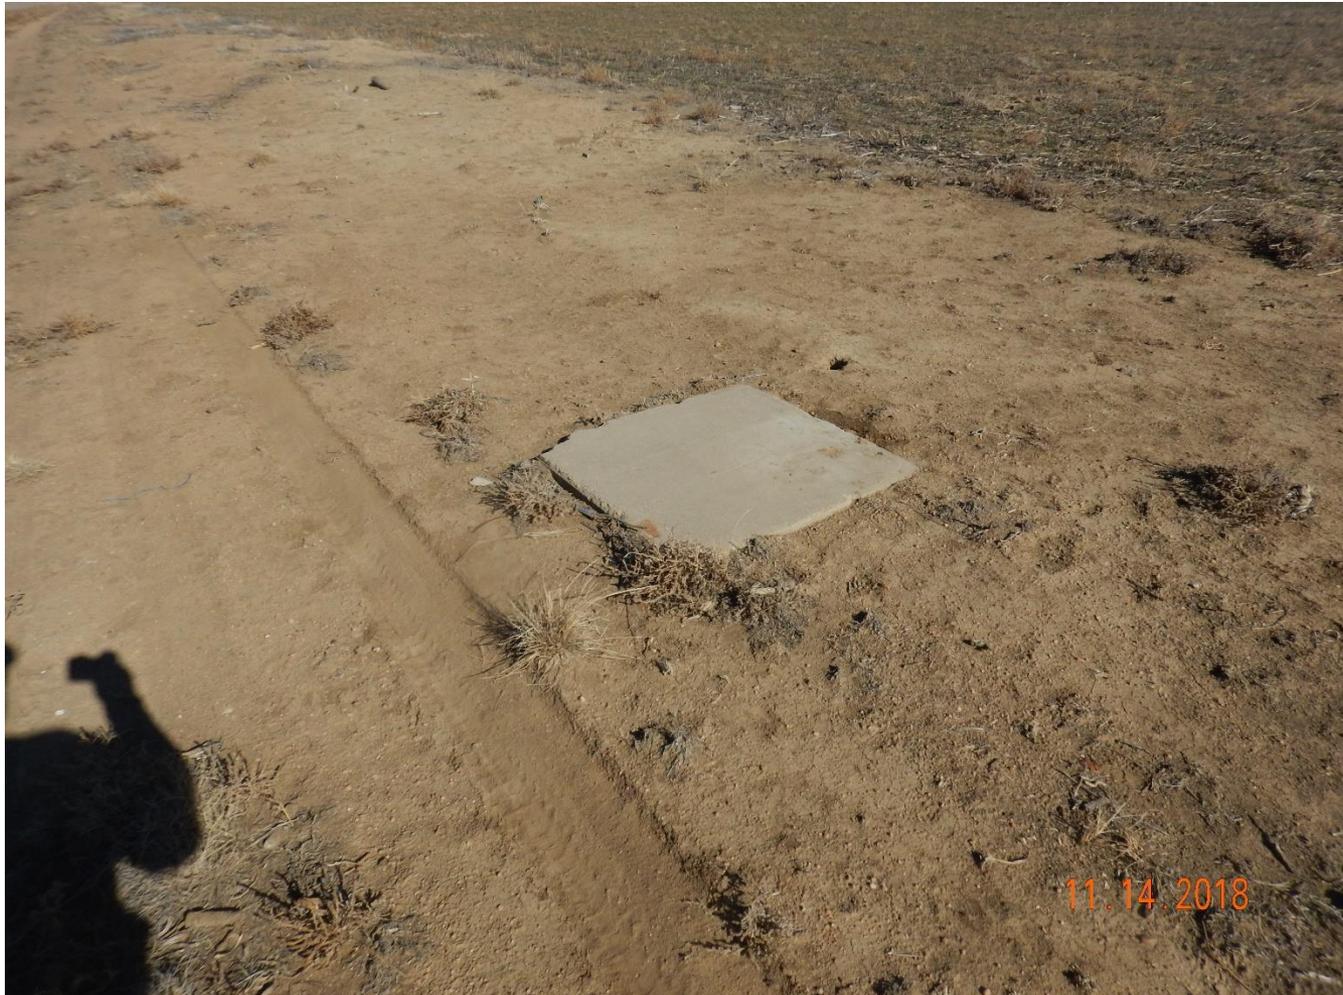
Photo 3: Photo taken from the area of the former battery/pit. Photo shows concrete debris remaining on site.

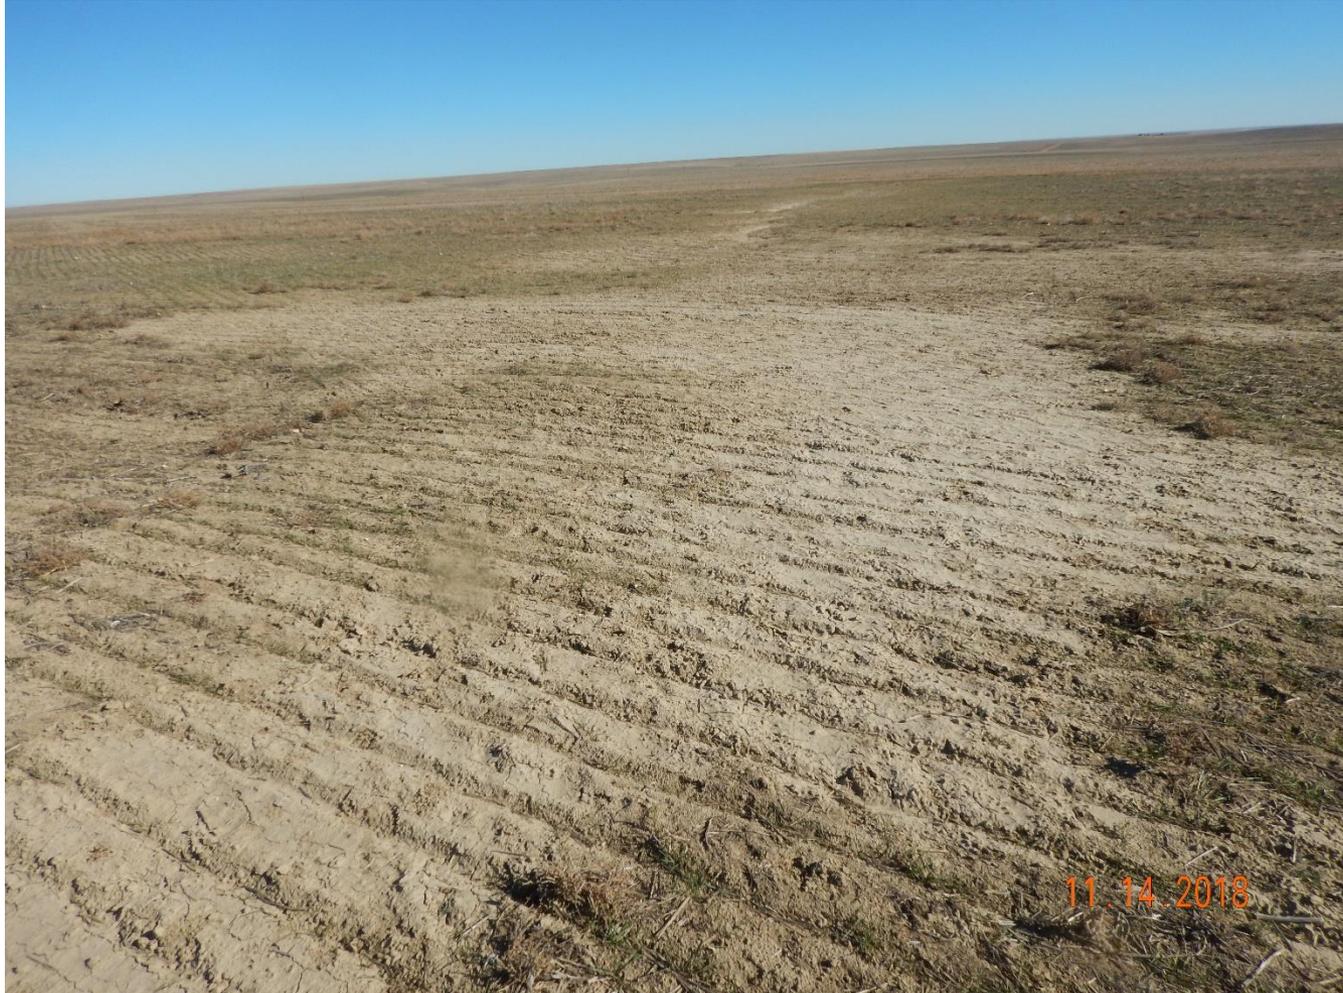
Photo 4: Photo taken from the area of the former battery/pit, facing east. Photo shows area of salt kill down gradient of the pit. Photo shows salt kill remains evident and crop remains unable to establish within these areas.

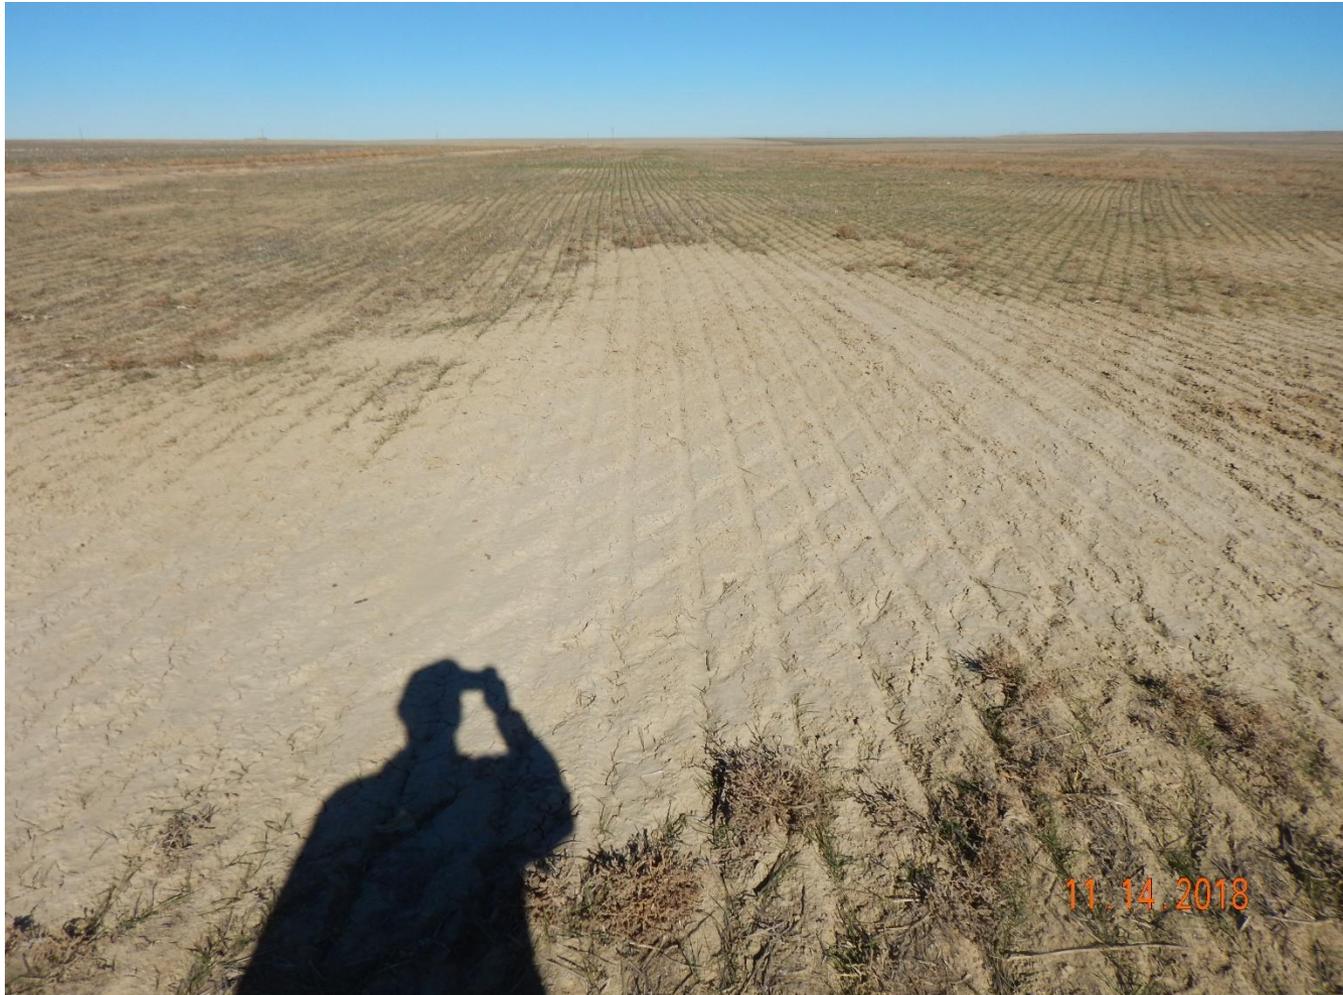
Photo 5: Photo taken from the area of the former battery/pit, facing north. Photo shows area of salt kill down gradient of the pit. Photo shows salt kill remains evident and crop remains unable to establish within these areas.

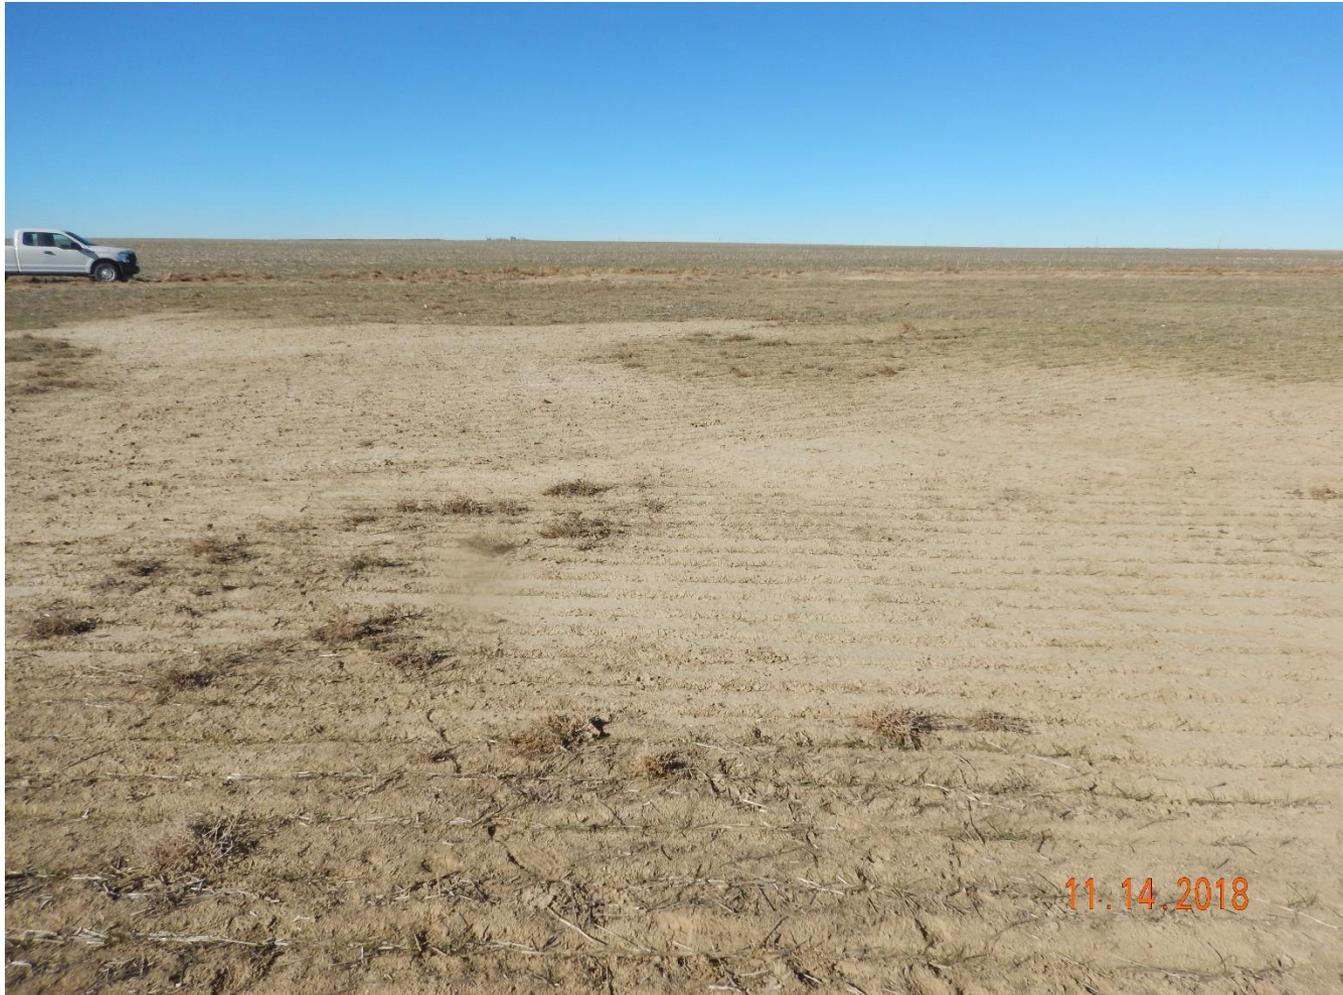
Photo 6: Photo taken from the salt kill, facing west. Photo shows salt kill remains evident and crop remains unable to establish within these areas.

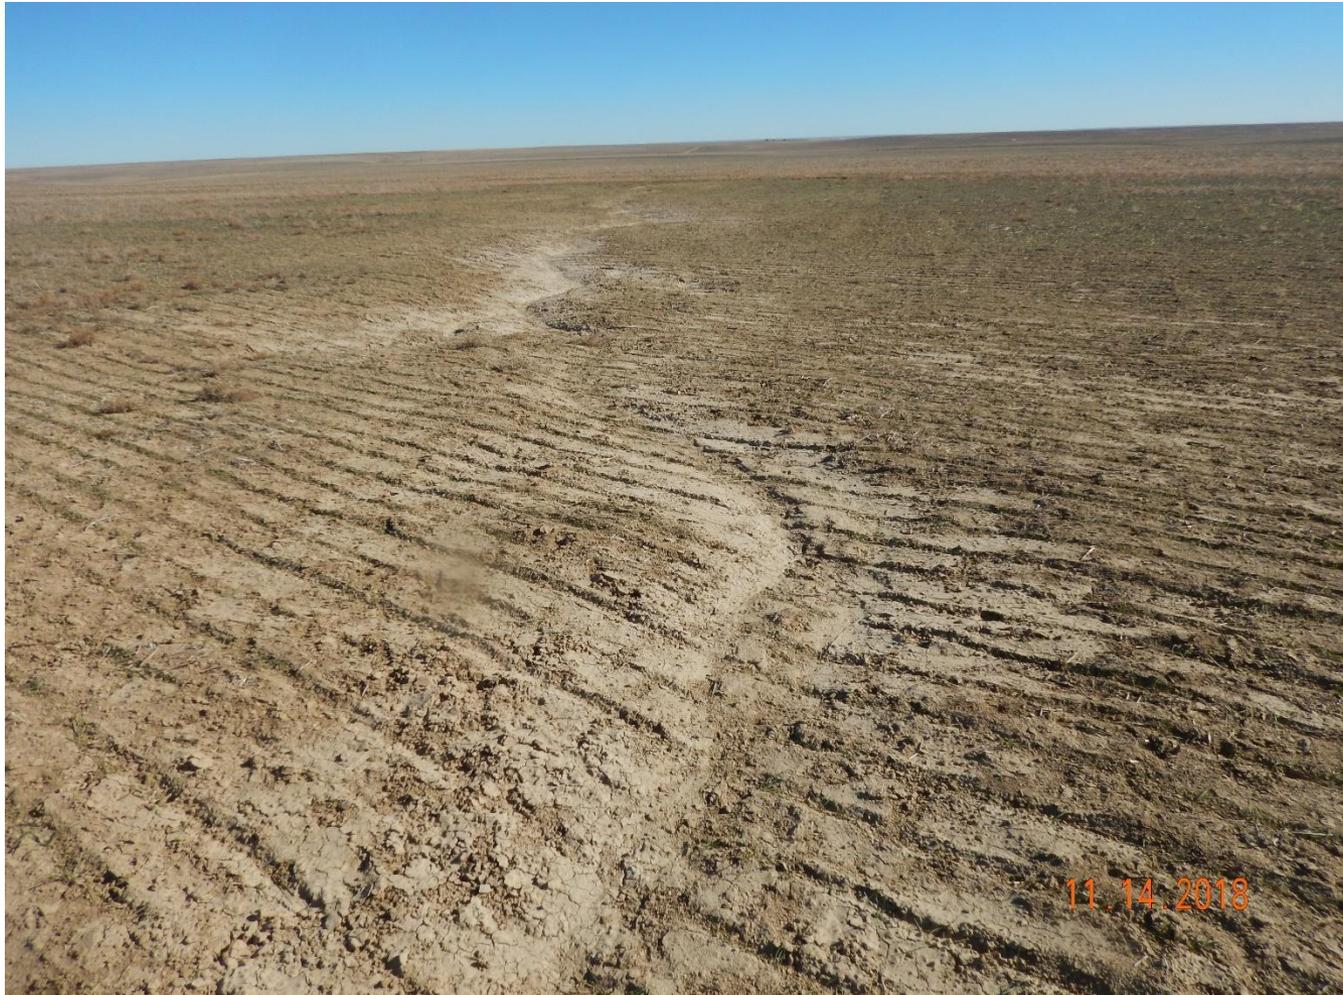
Photo 7: Photo taken from the salt kill, facing east. Photo shows erosion degradation remains evident.

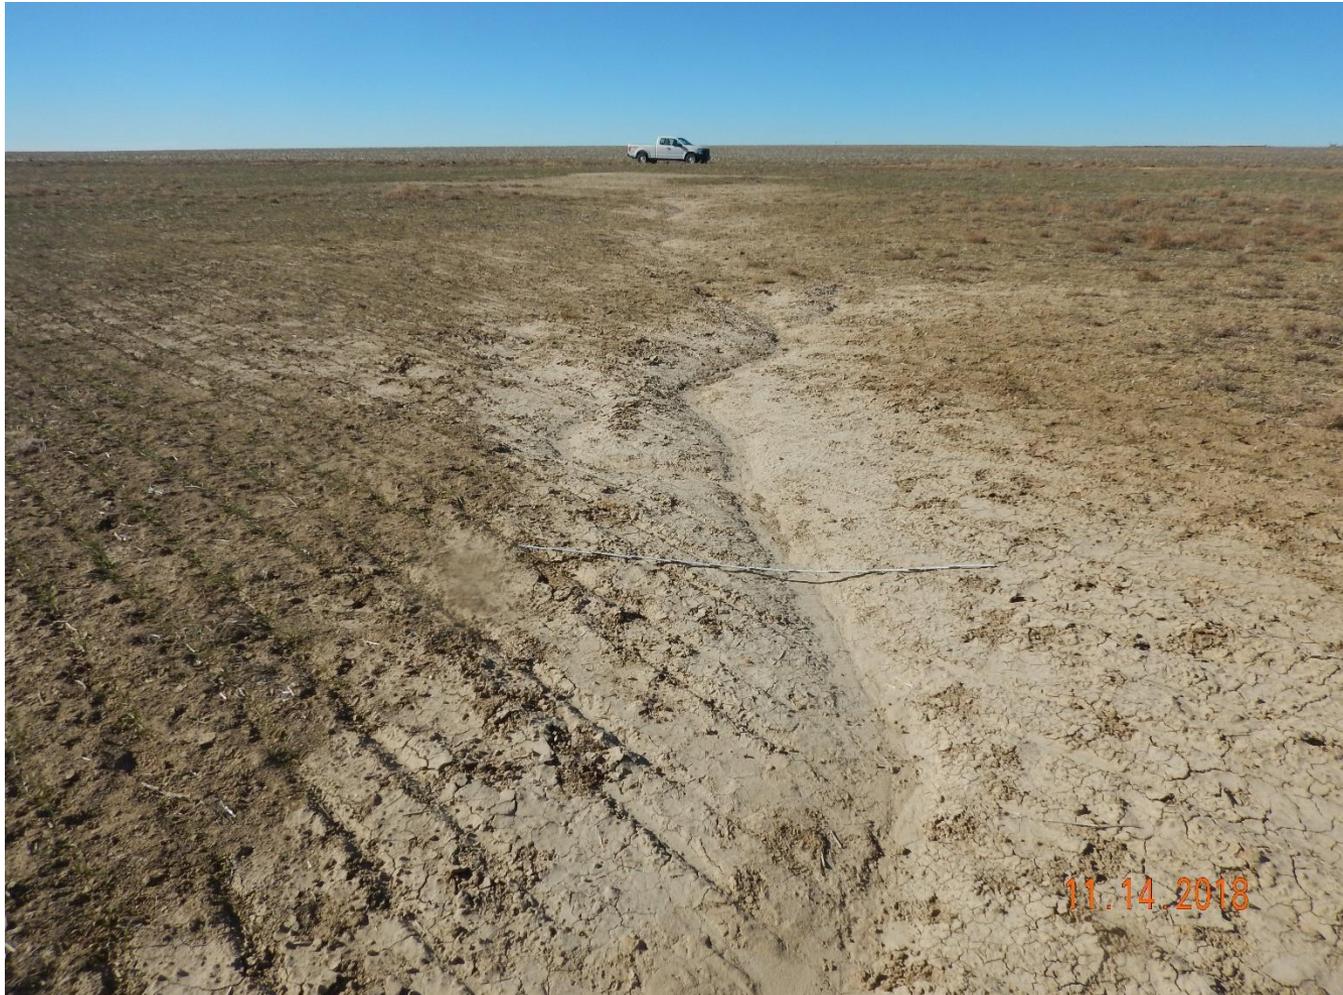
Photo 8: Photo taken from the salt kill, facing west. Photo shows erosion degradation remains evident. 6 foot measuring stick for reference.

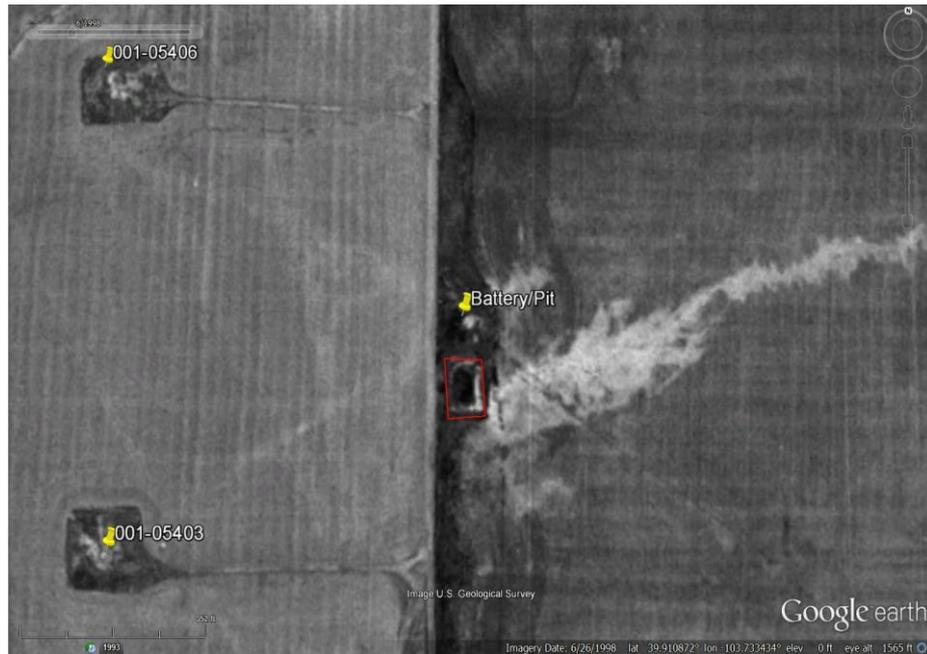
Photo 9: 1998 aerial imagery. Photo shows battery and pit location. Pit in red. Photo also shows a large bare area directly to the east of the well. Bare area likely a salt kill.

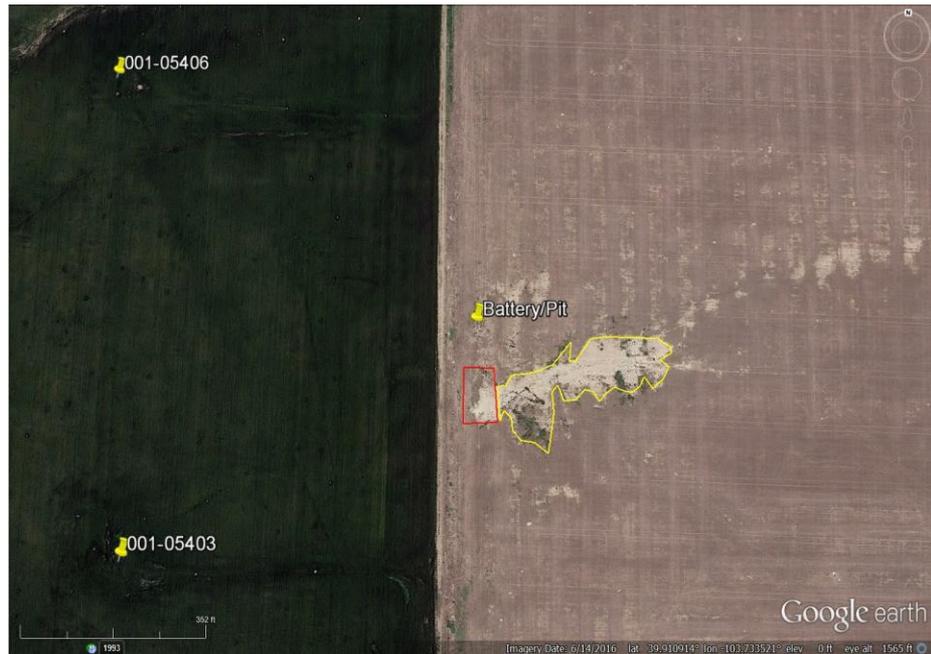
Photo 10: 2016 aerial imagery. Photo shows battery and pit location. Pit in red. Photo also shows a large bare area directly to the east of the well. Bare area likely a salt kill. Main bare area seen in yellow ~1 ac in size.
