Construction and Stormwater Inspection

March 8 & 29, 2019

Operator: ELEVATION MIDSTREAM LLC – 10687

Location ID: 462252

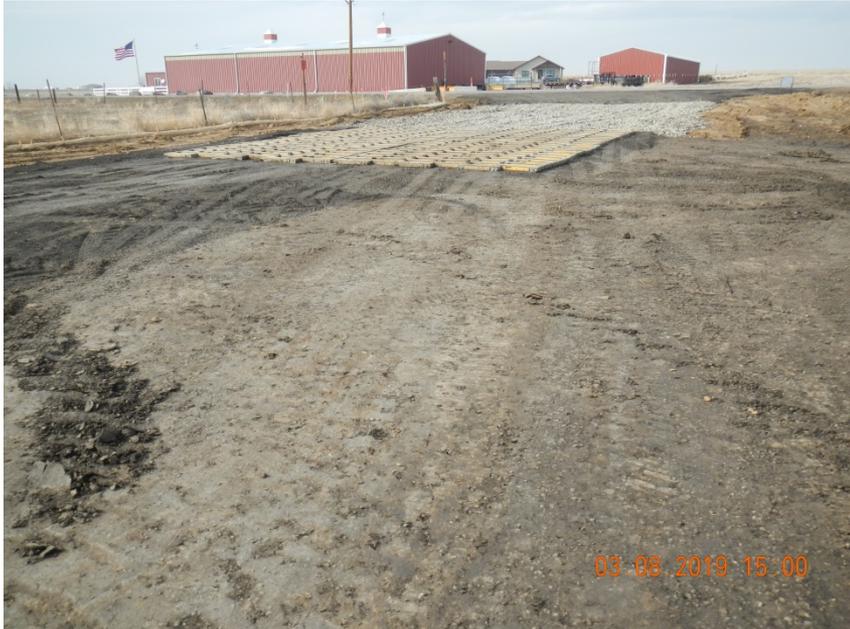
Photo 1. Photo taken from the access road looking at the entrance off CR 6, facing North. Operator has installed gravel and a track pad to potentially limit tracking onto the county road.

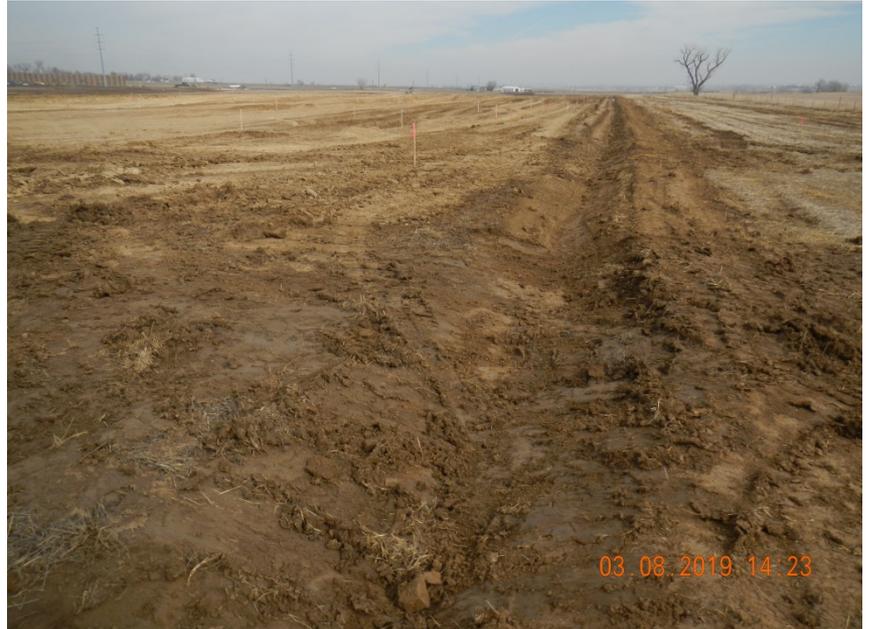
Photo 2. Photo taken from the southern perimeter of the location, facing East. Appears the operator has installed a ditch and berm BMP around the perimeter of the location.

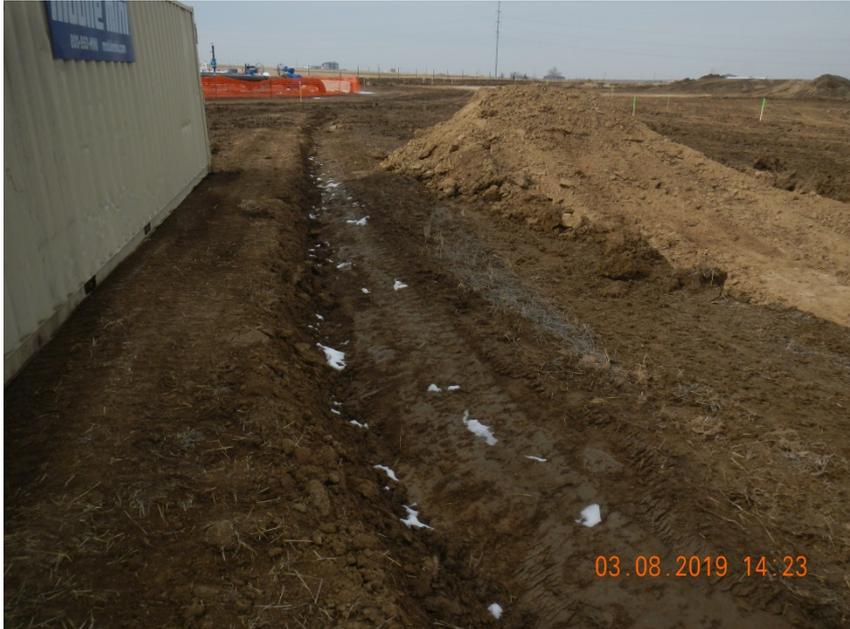
Photo 3. Photo taken from the southwestern perimeter of the location, facing Northwest. See comments from Photo 2.

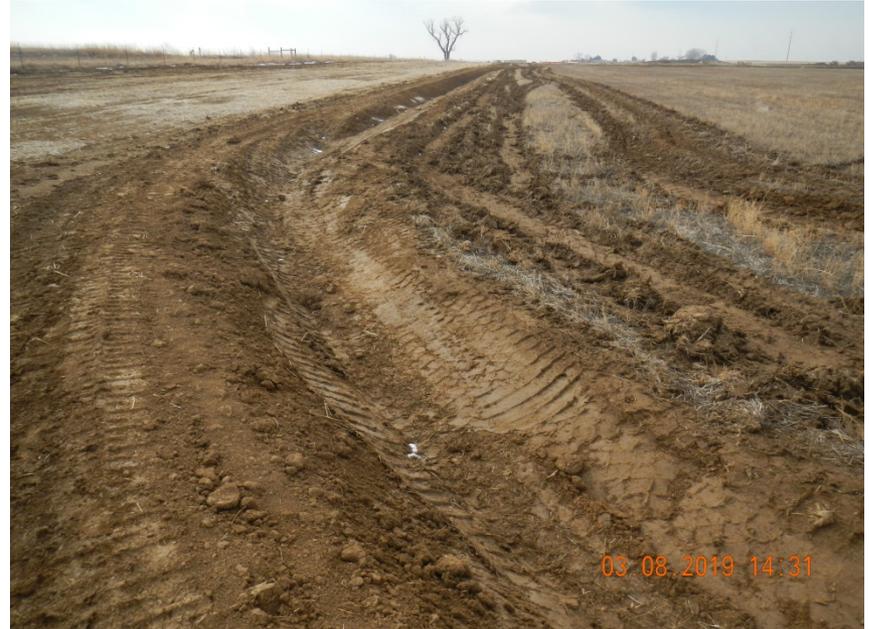
Photo 4. Photo taken from the southeastern perimeter of the location, facing West. See comments from Photo 2.

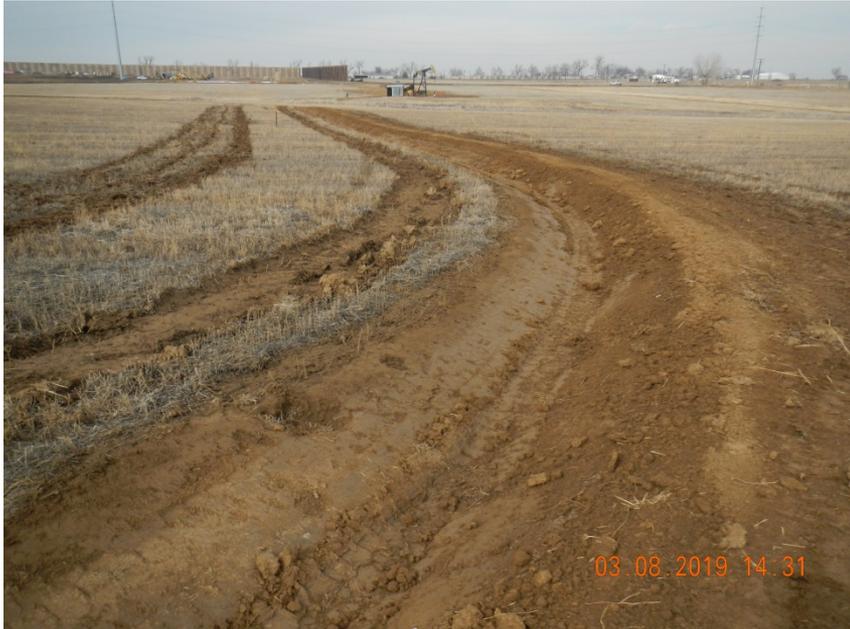
Photo 5. Photo taken from the southeastern perimeter of the location, facing North. See comments from Photo 2.

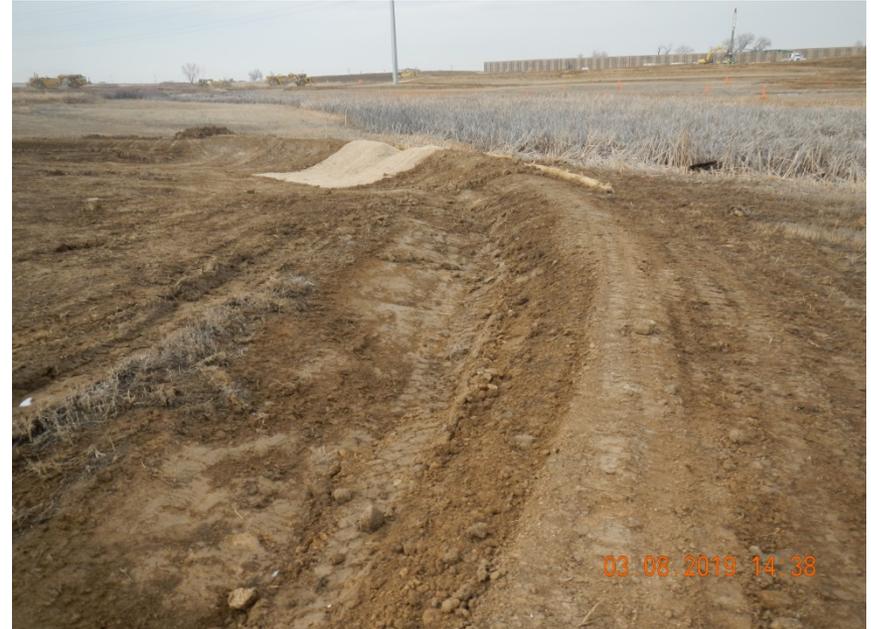
Photo 6. Photo taken from the northern perimeter of the location, facing West. Photo depicts a sediment trap with a an apparent temporary stabilized outlet BMP installed on location.

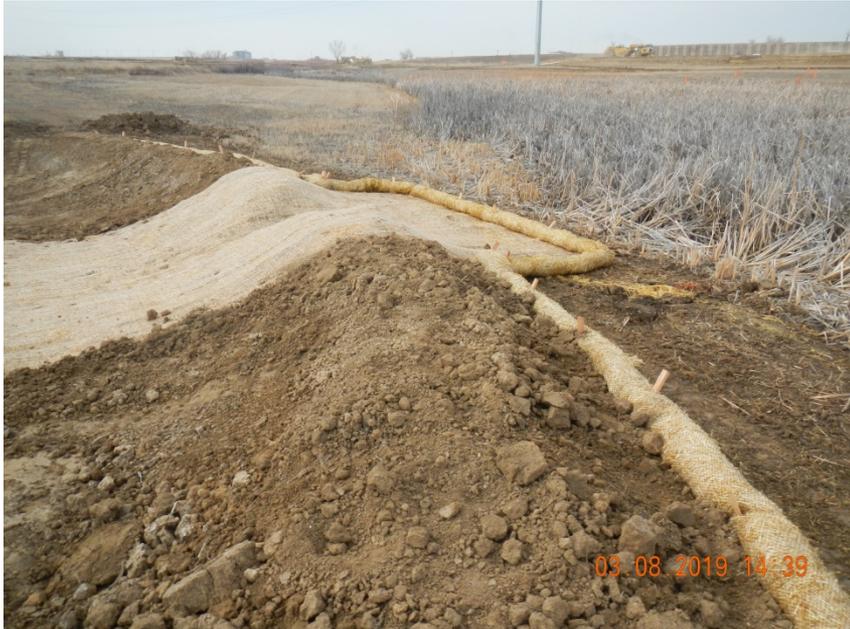
Photo 7. Photo taken from the northern perimeter of the location, facing Northeast. Appears the temporary stabilized outlet is adjacent to the wetlands to the north of the location.

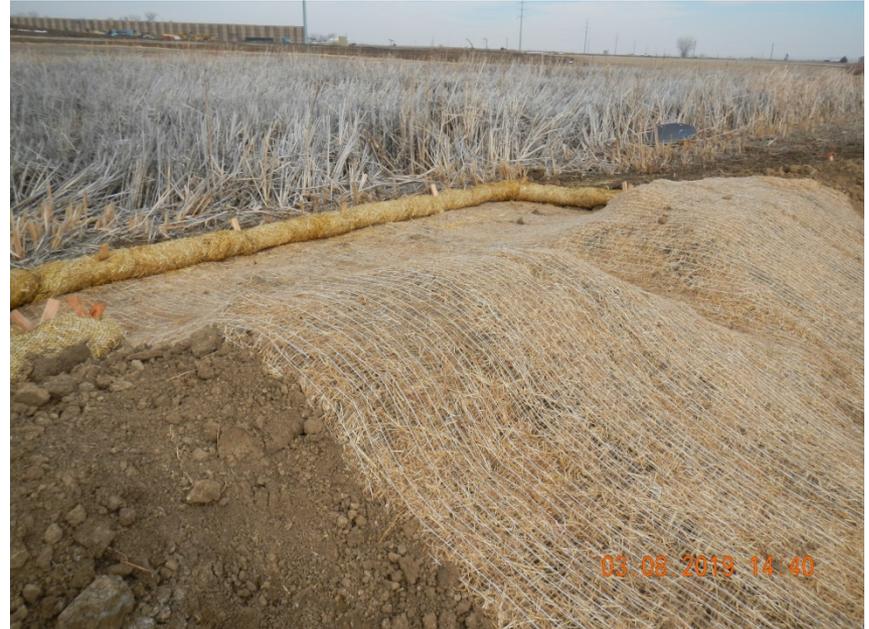
Photo 8. Photo taken from the northern perimeter of the location, facing Northeast. See comments from Photo 7.

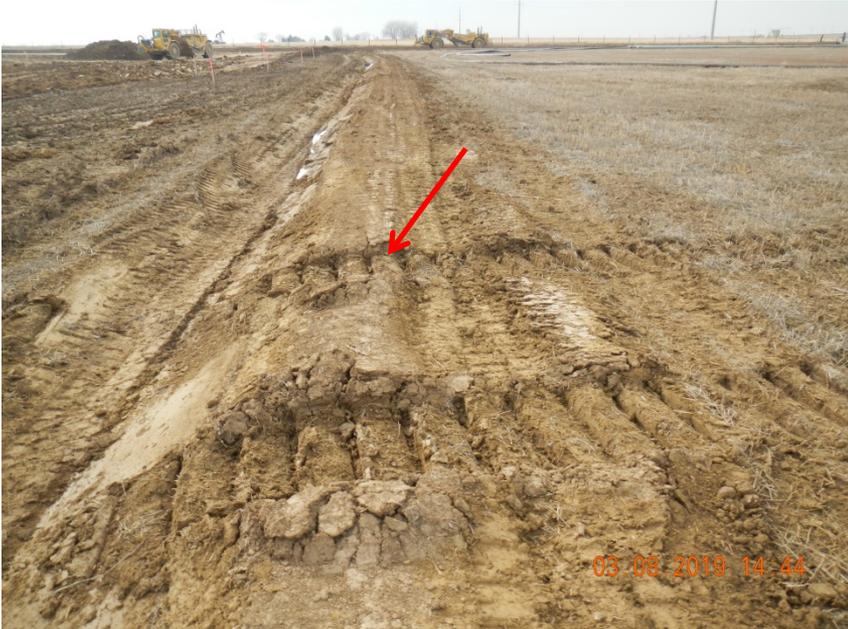
Photo 9. Photo taken from the northern perimeter of the location, facing West. Photo depicts the ditch and berm BMP has been compromised by equipment track through.

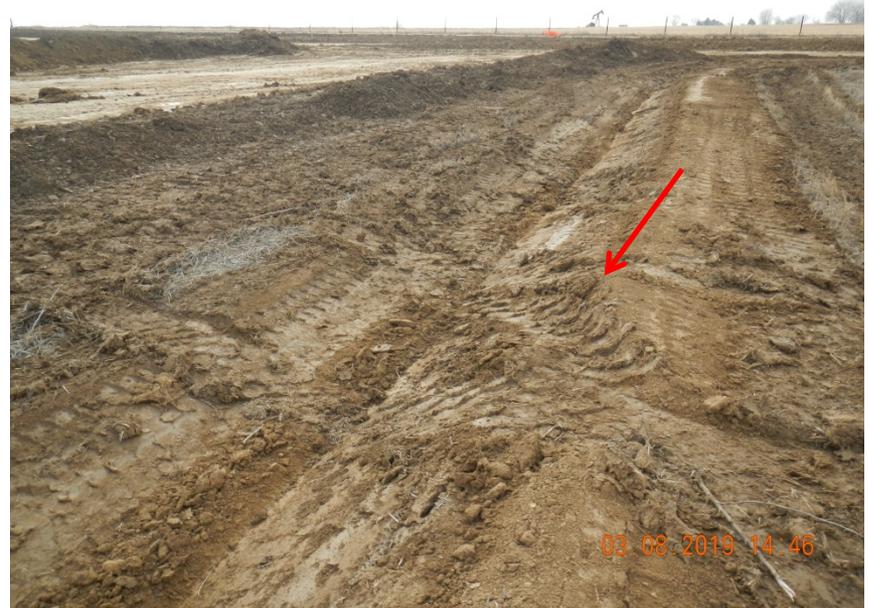
Photo 10. Photo taken from the northern perimeter of the location, facing West. See comments from Photo 9.

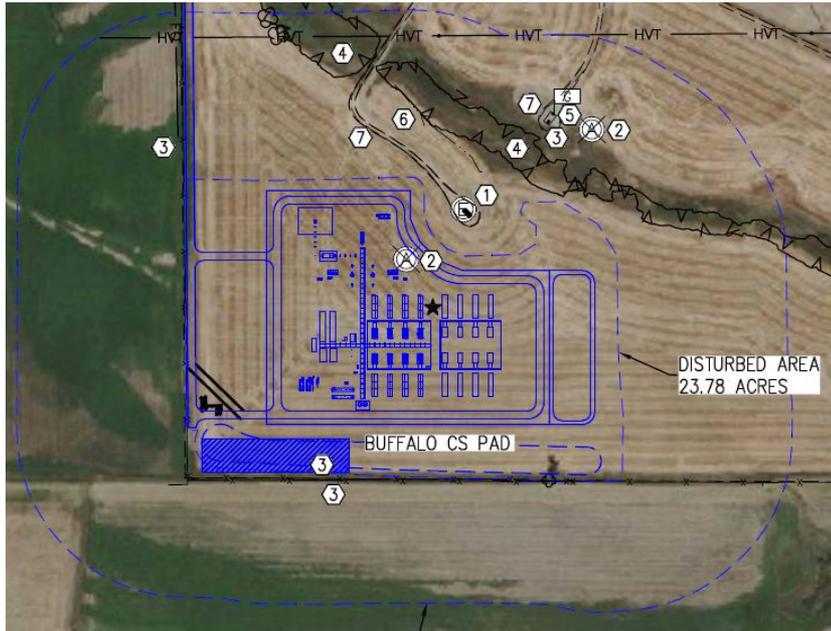
Photo 11. Location Drawing from the approved 2A showing 23.78 acres of disturbed area.

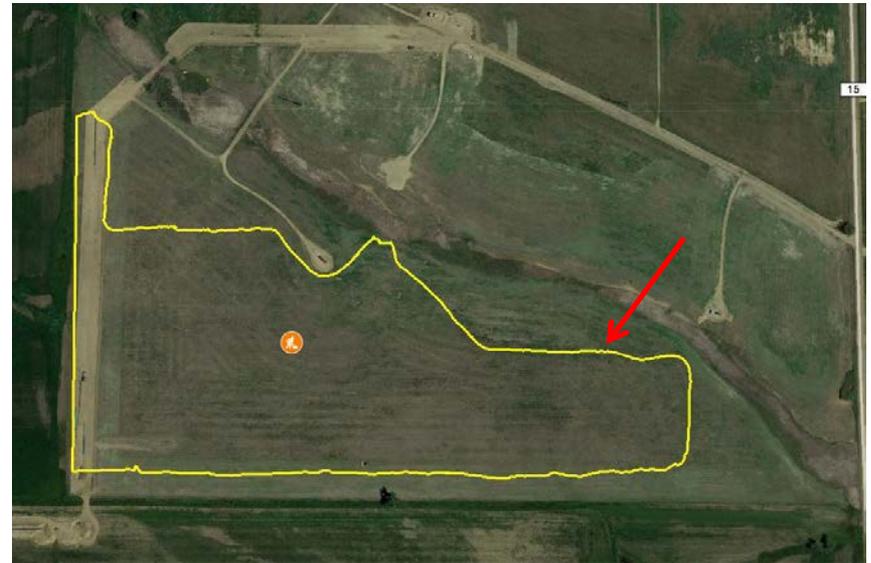
Photo 12. Google Earth Aerial imagery with 30.01 acres of mapped disturbance area displayed in the yellow polygon. Note the apparent extended disturbance area to the east compared to the approved 2A Location Drawing.
