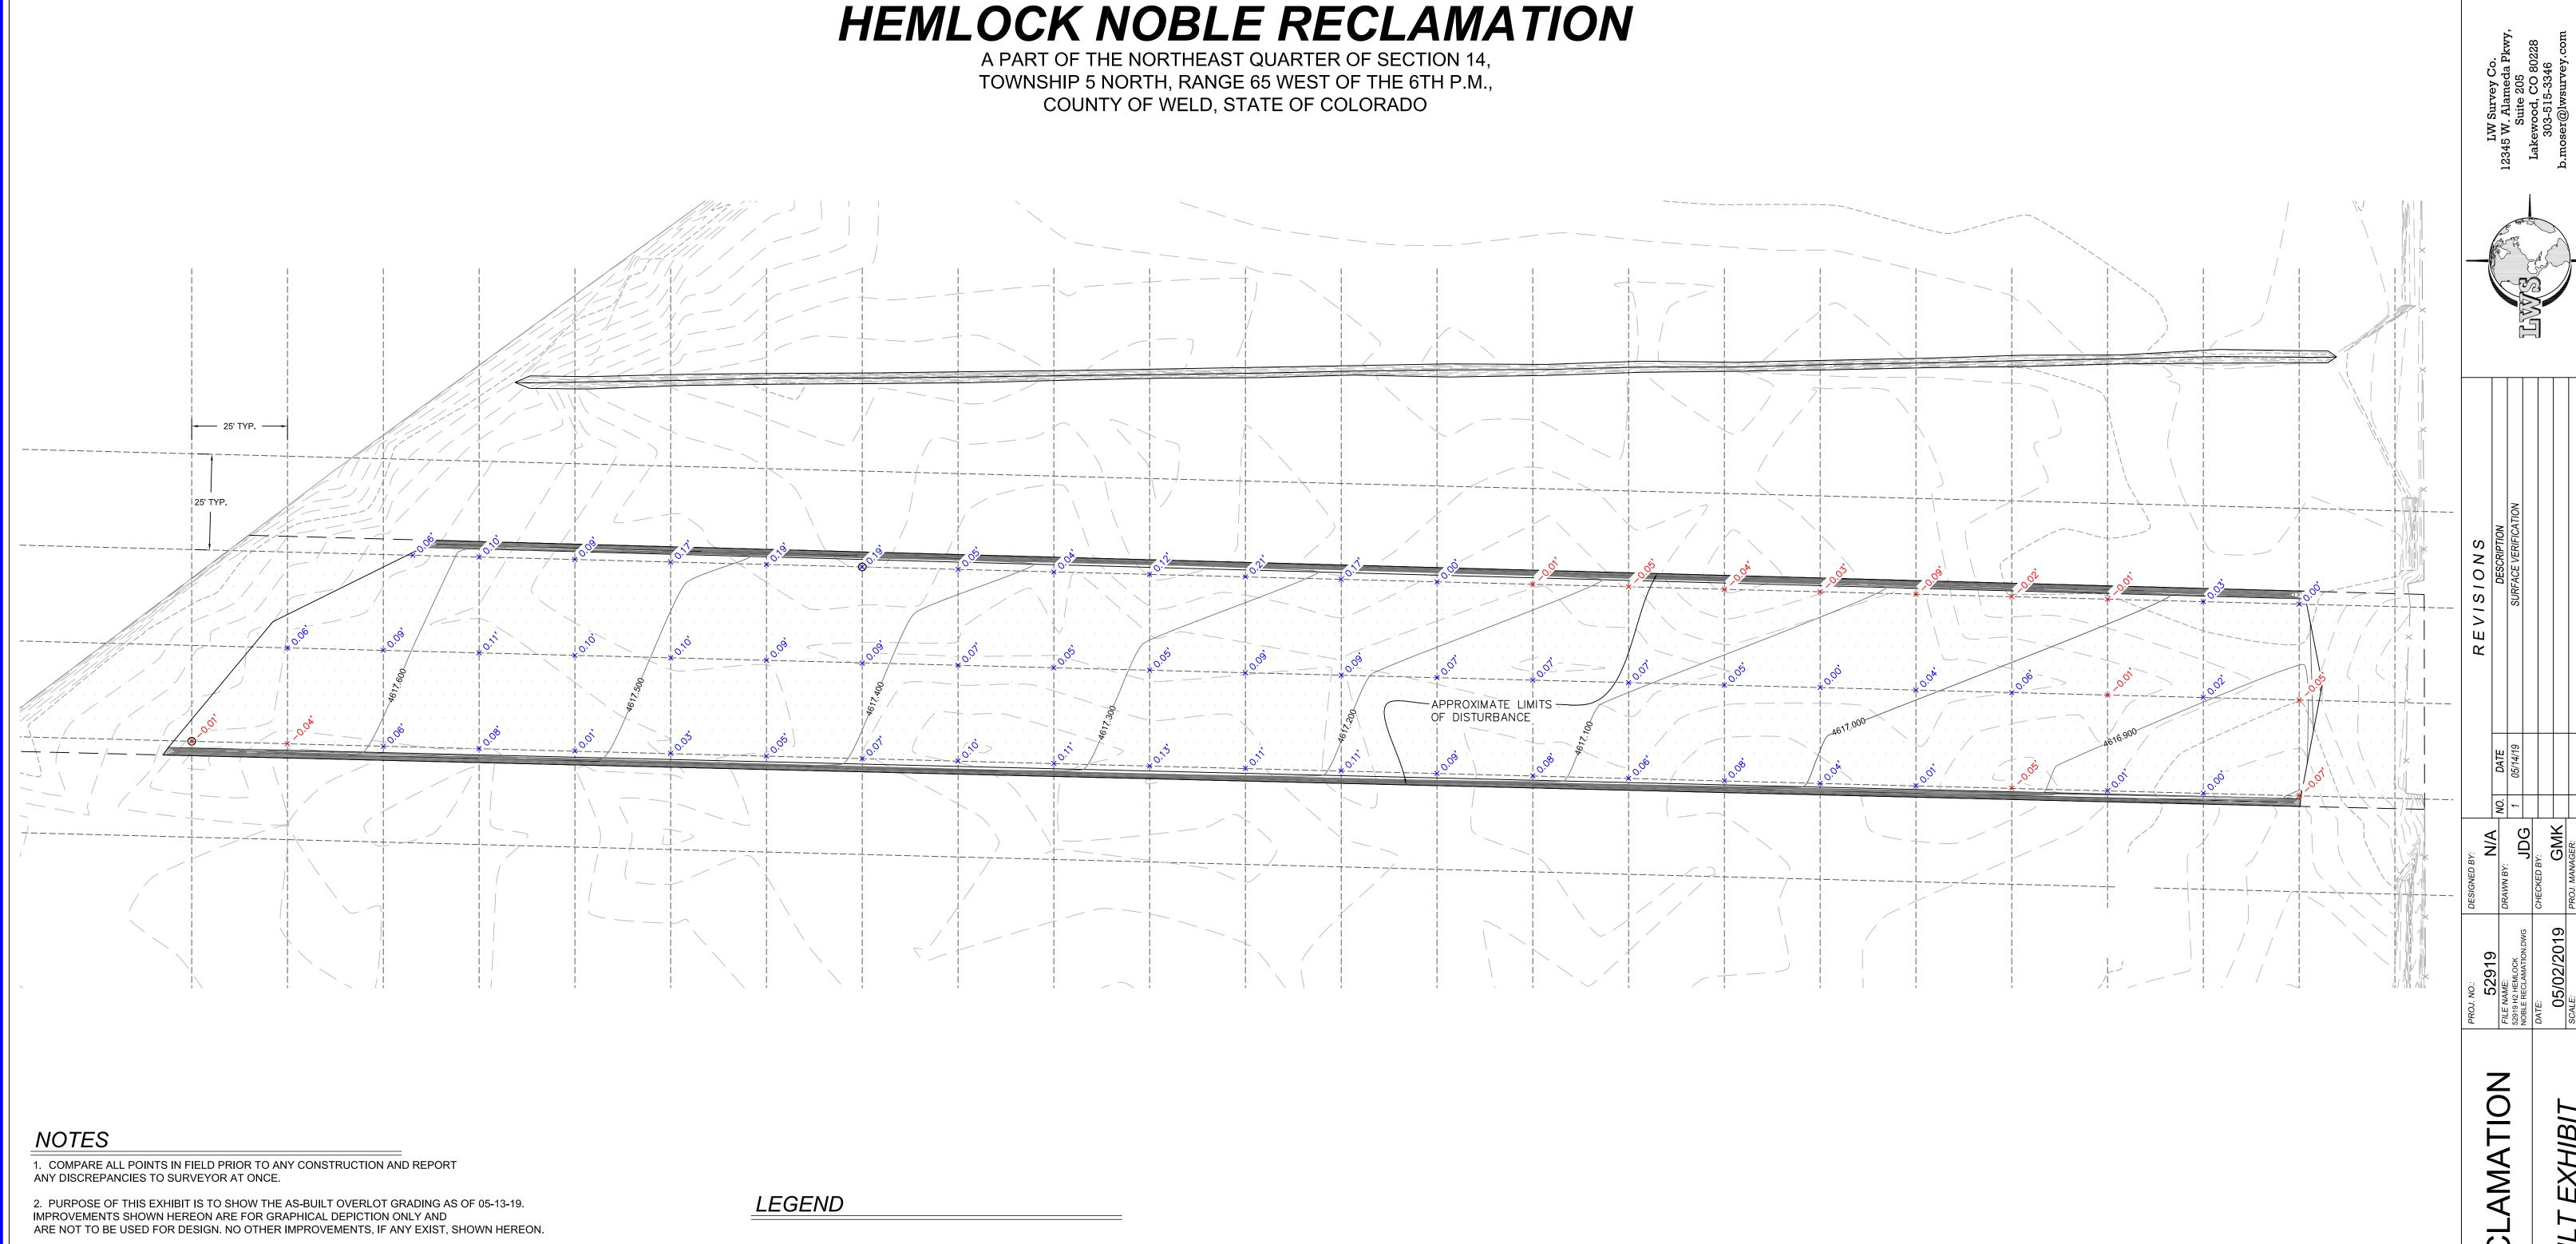
- 3. FIELD WORK WAS COMPLETED ON 05-13-19.
- 4. AS-BUILT MEASUREMENTS WERE TAKEN ON AN APPROXIMATE 25-FOOT GRID ACROSS THE DISTURBED AREA.
- 5. DO NOT SCALE DIMENSIONS FROM THIS EXHIBIT.

- 10. A PROPOSED SURFACE WAS CREATED ACROSS THE AREA OF DISTURBANCE BY HOLDING EXISTING GRADES AT THE WEST AND EAST ENDS OF THE AREA, THEN CREATING A STRAIGHT GRADE FROM EXISTING WEST TO EXISTING EAST.

- 11. IRRIGATION SWALES WERE DESIGNED ON THE NORTH AND SOUTH SIDES OF AREA OF DISTURBANCE AT 0.5' BELOW PROPOSED SURFACE, AND DRAIN FROM WEST TO EAST AT THE SAME SLOPE AS THE SURFACE.
