Final Reclamation Inspection

Operator: EXTRACTION OIL & GAS INC - #10459

Location ID: 336400

Inspection Photos
Location Name: KUGEL #32-18
Location ID: 336400

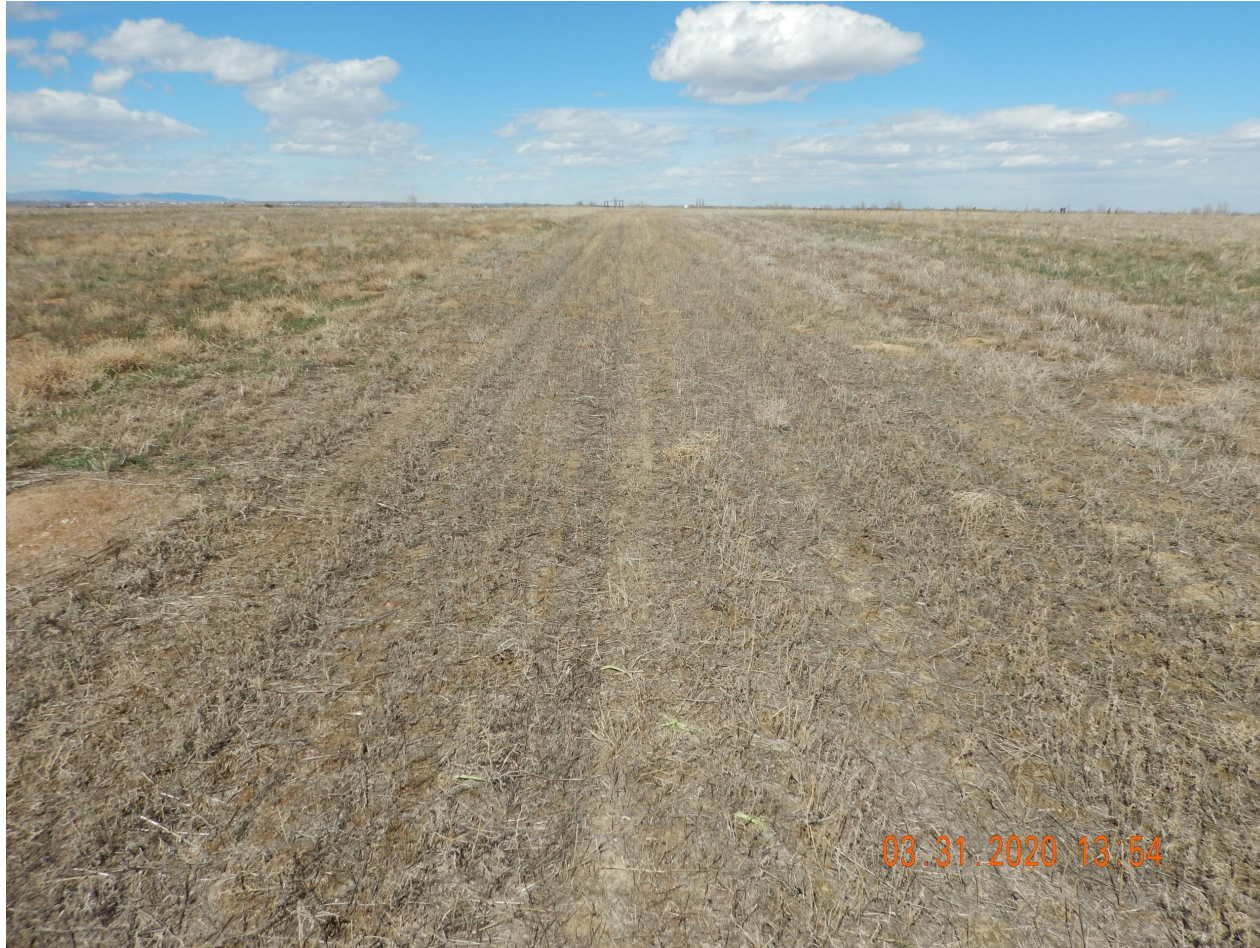
Photo 1. Photo taken from a portion of the well location access road, facing North. Photo illustrates the Operator has performed final reclamation activities but vegetation has not met Rule 1004 standards.

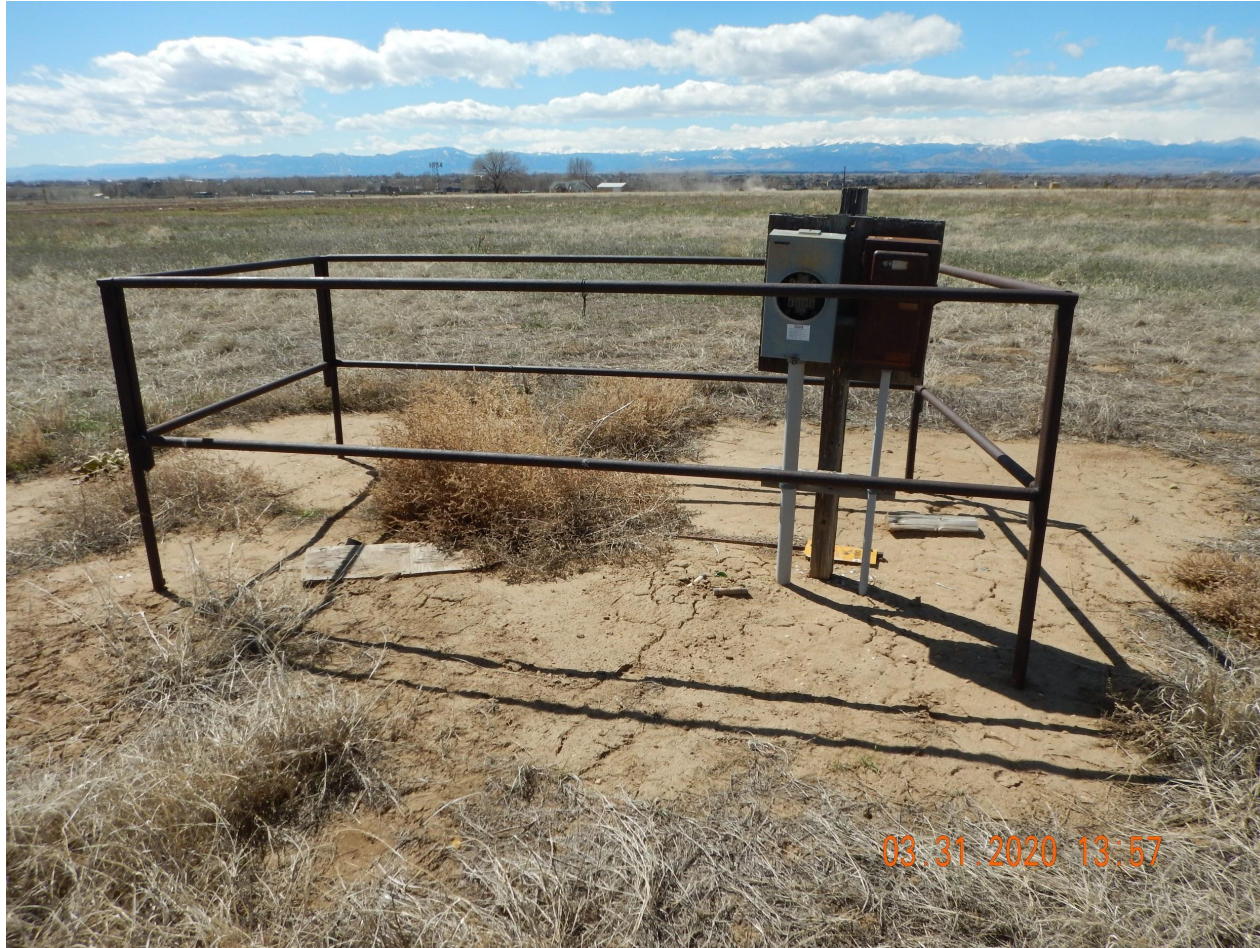
Photo 2. Photo taken from the well location, facing West. Photo illustrates the Operator has failed to remove all equipment from location.

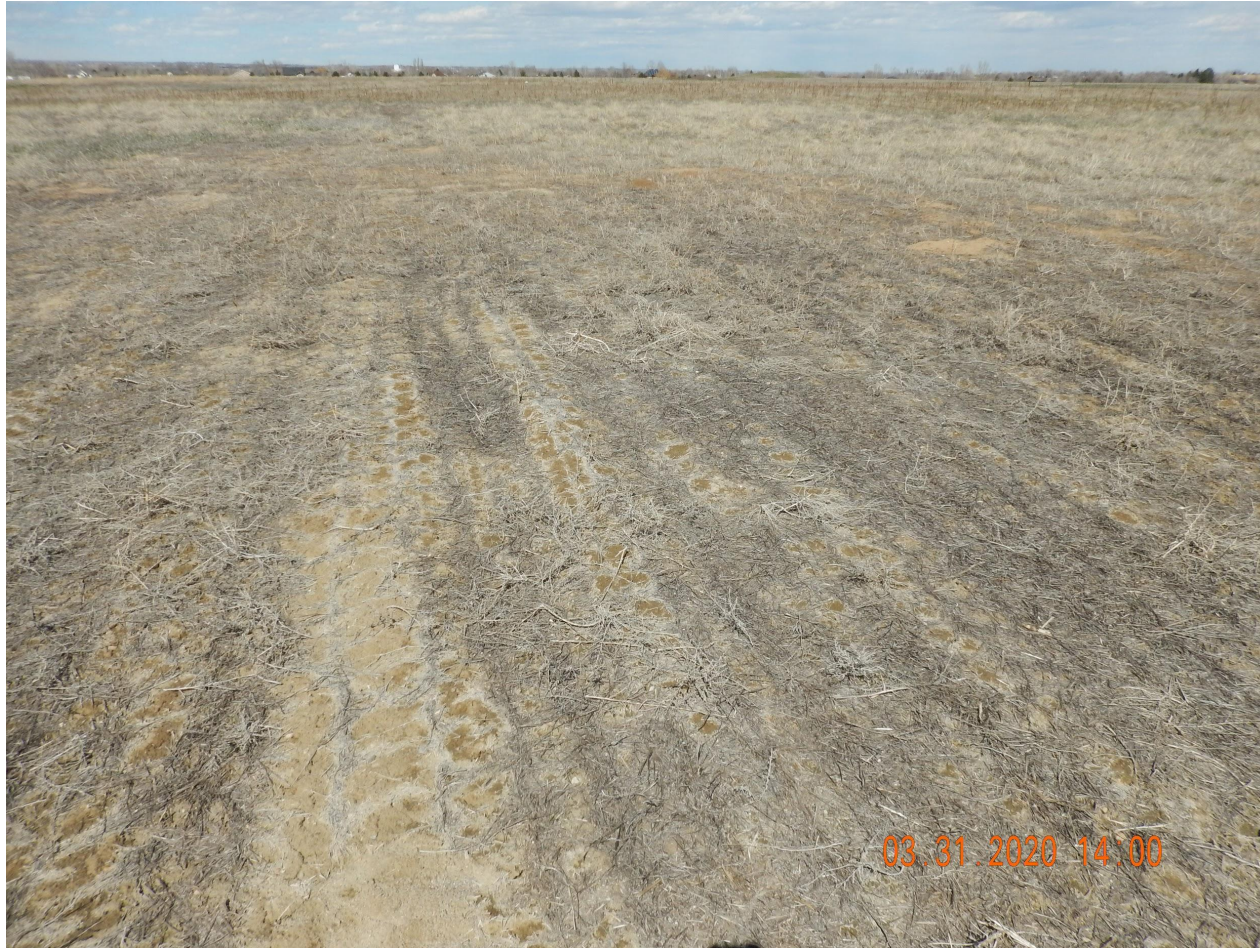
Photo 3. Photo taken from the well location, facing North. See comments under Photo 1.

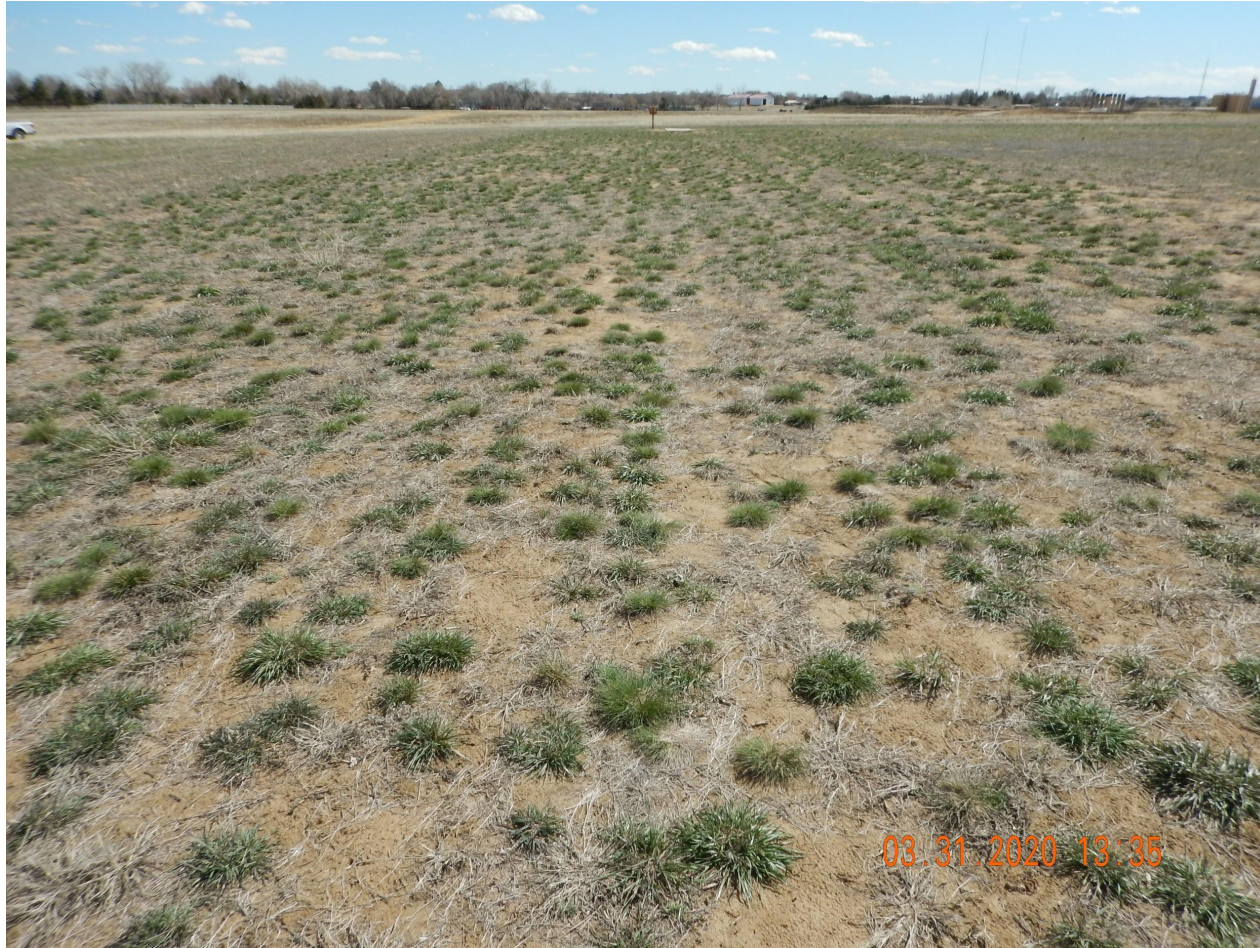
Photo 4. Reference photo taken north of the well location, facing East. See comments under Photo 1. Photo illustrates bunch grasses.

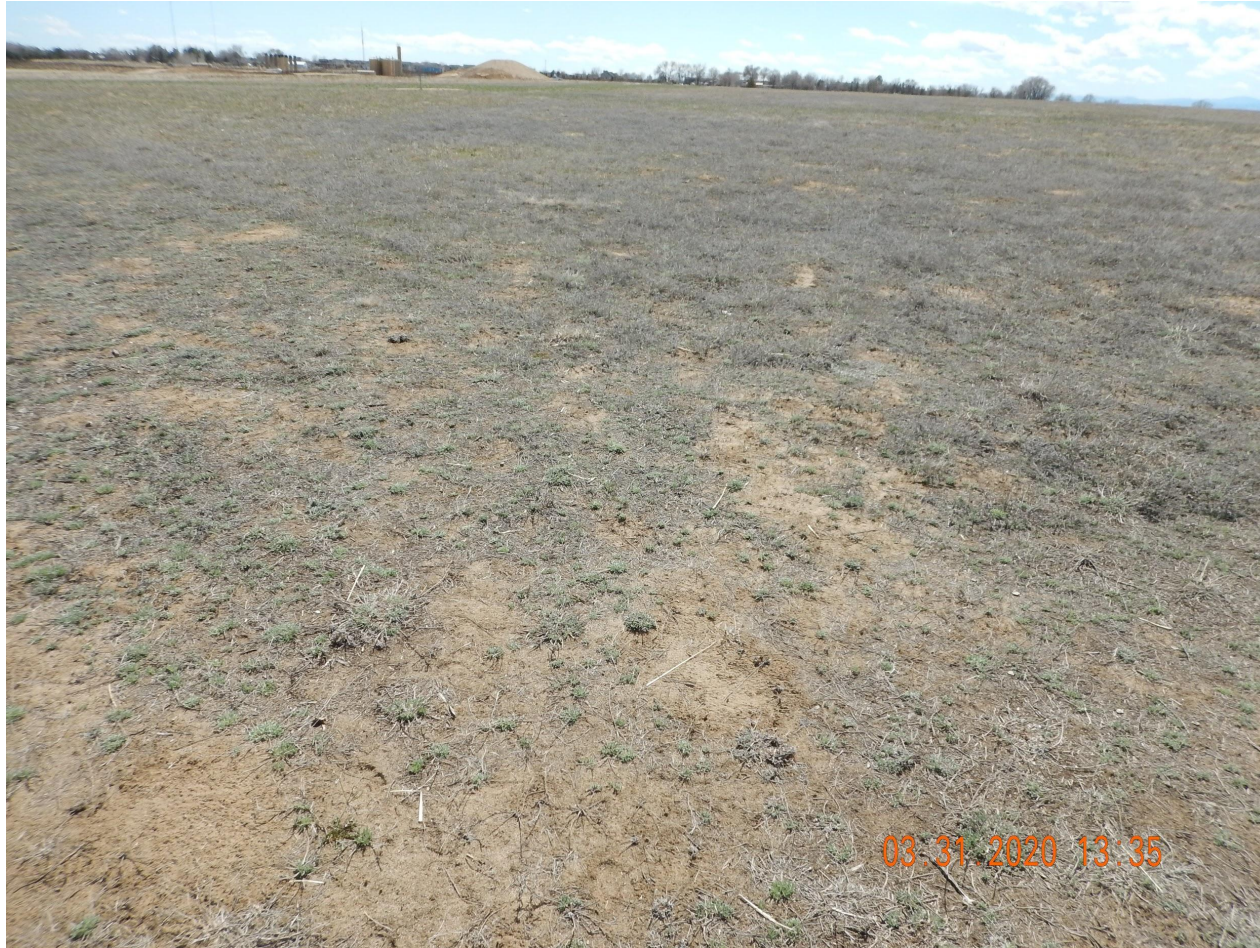
Photo 5. Reference photo taken north of the well location, facing South. See comments under Photo 1.

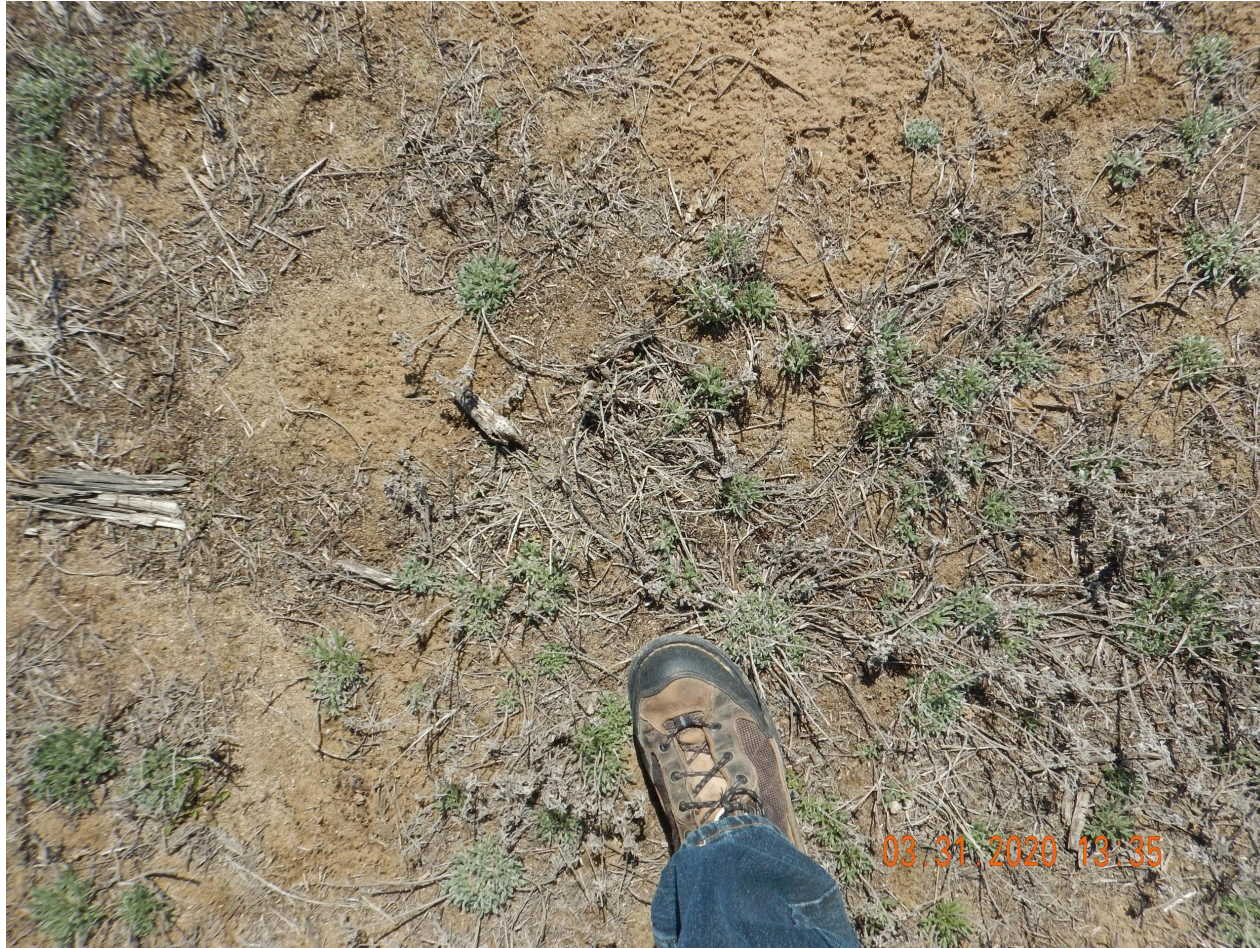
Photo 6. Close up of reference photo #5. Photo illustrates *Artemisia* sp.

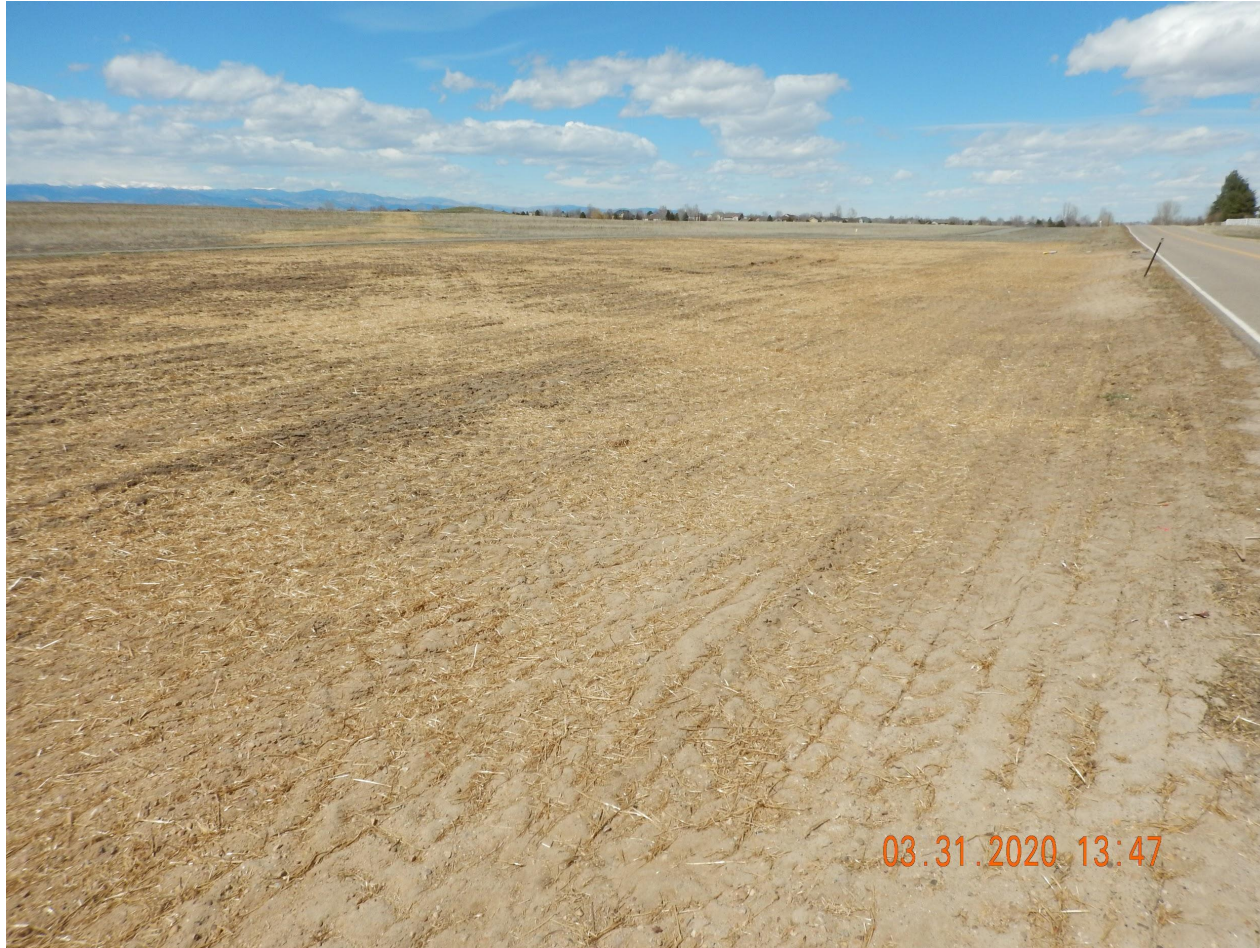
Photo 7. Photo taken from the offsite tank battery location, facing North. Photo illustrates Operator has removed all equipment from the associated offsite tank battery and has performed final reclamation activities with the evidence of drill rows and straw crimped mulch.

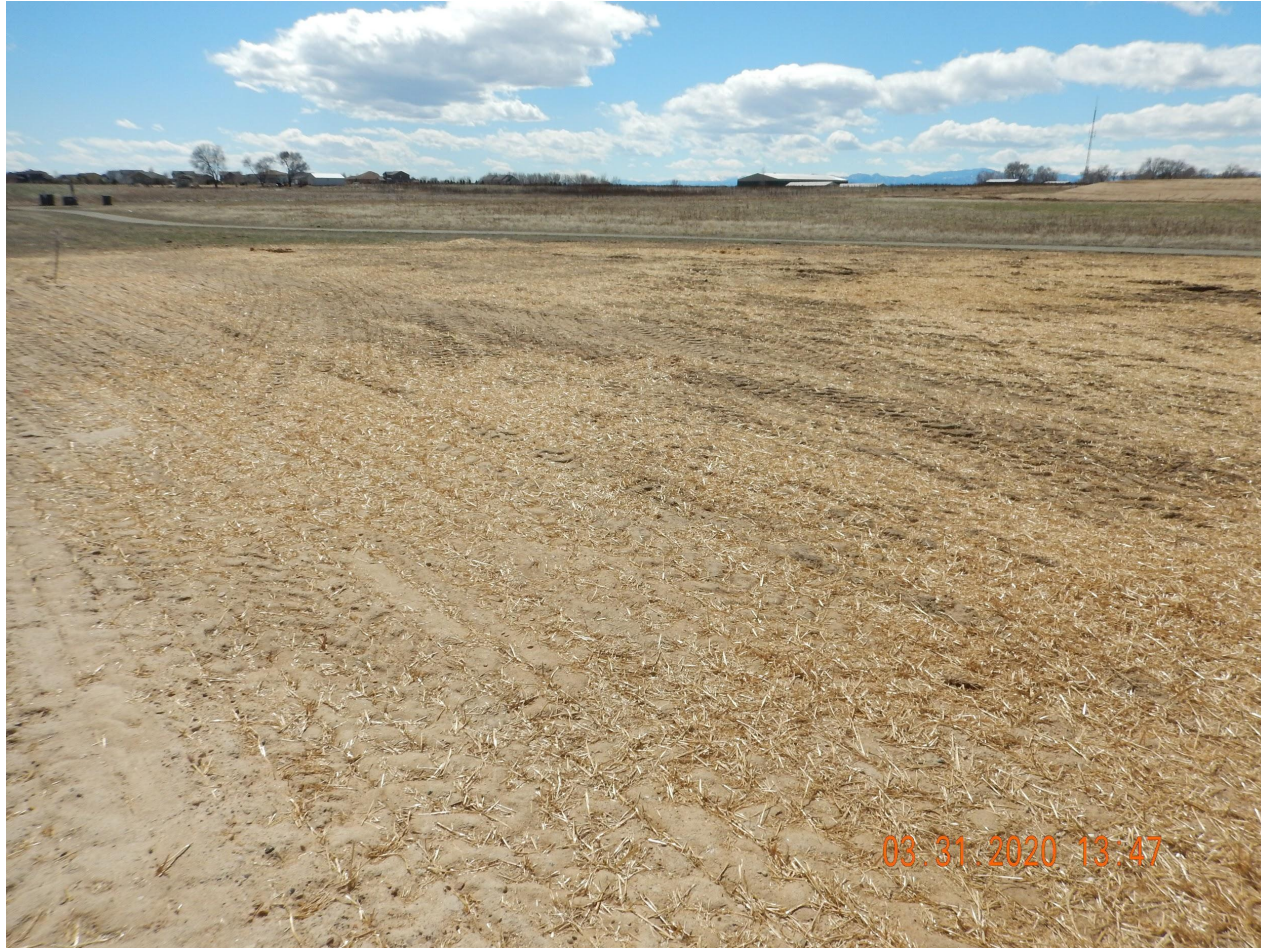
Photo 8. Photo taken from the offsite tank battery location, facing South. See comments under Photo 7.
