Inspection Photos

4/22/2020

Operator: CAERUS PICEANCE LLC - 10456

Location ID: 323997

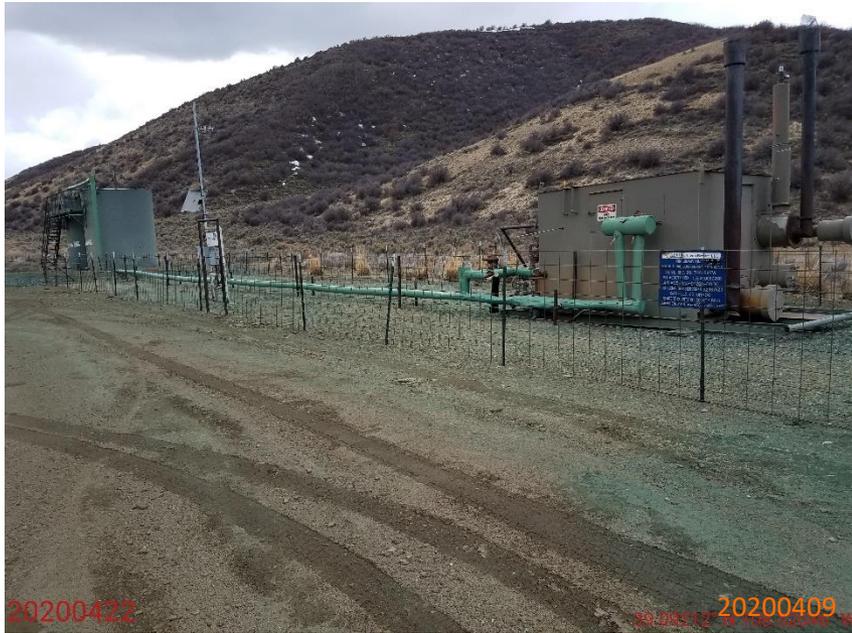
Photo 1: Photo taken from the west end of the Location, facing southwest. Photo of production equipment.

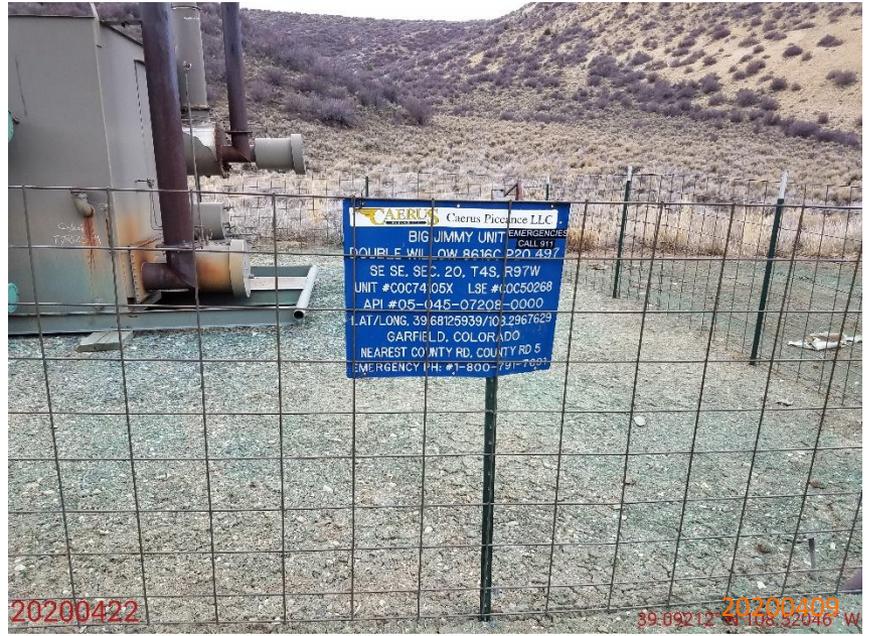
Photo 2: Continued from photo 1. Photo of sign on Location.

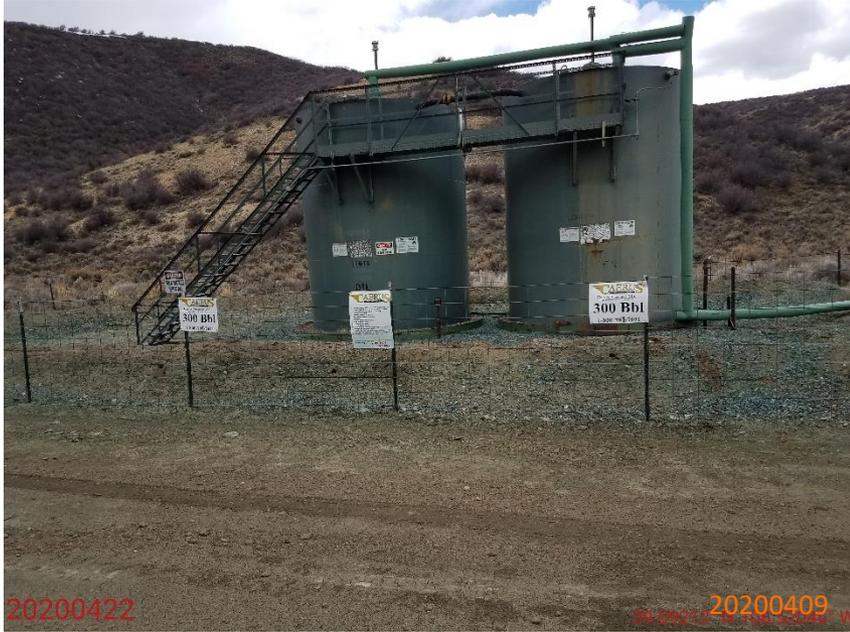
Photo 3: Continued from photo 1. Photo of the two 300 bbl AST. Tank on left “Condensate”, tank on right “produced water”.

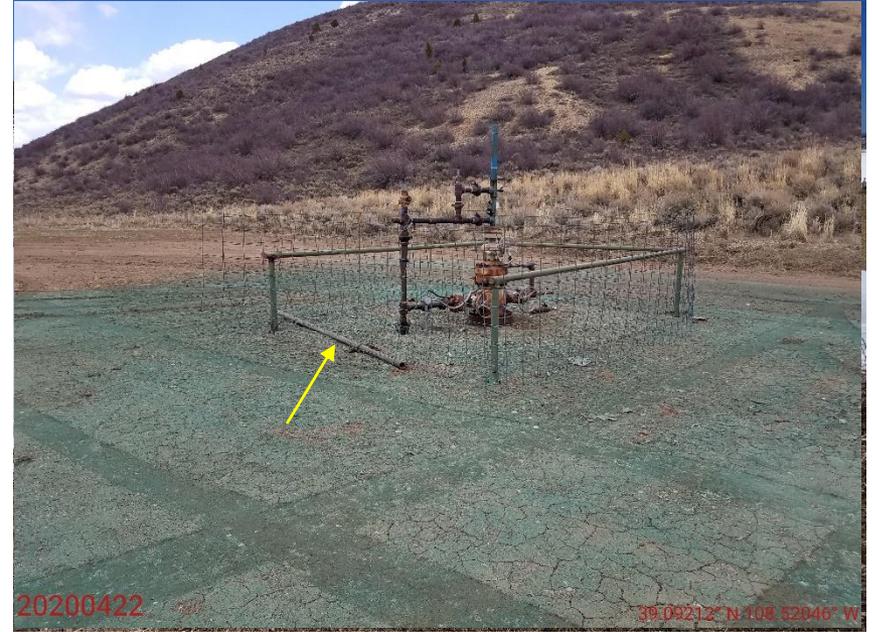
Photo 4: Photo of well. Photo shows unused pipe stored on Locaiton.

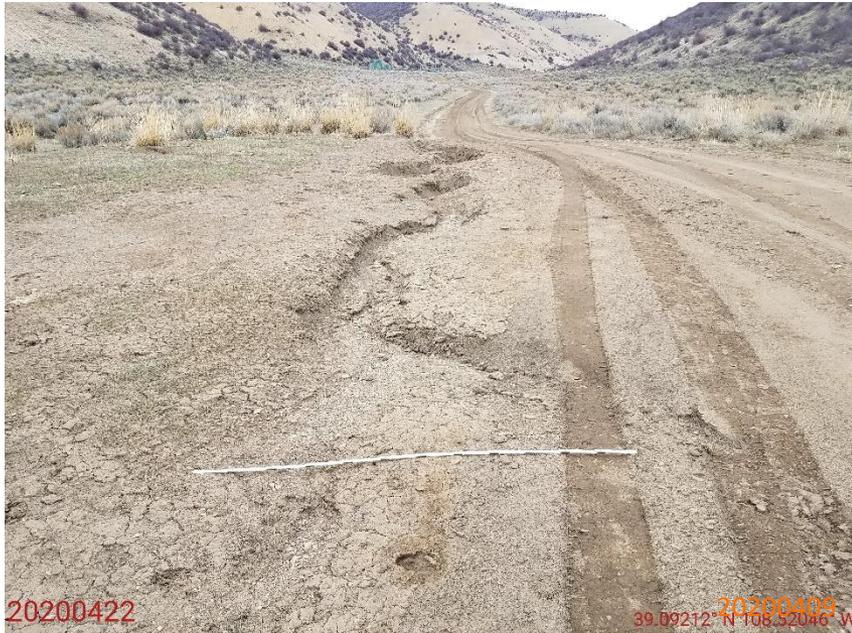
Photo 5: Photo taken from the north end of the Location, facing north. Photo shows erosion degradation due to stormwater runoff from the Location. 6 foot measuring stick for reference.

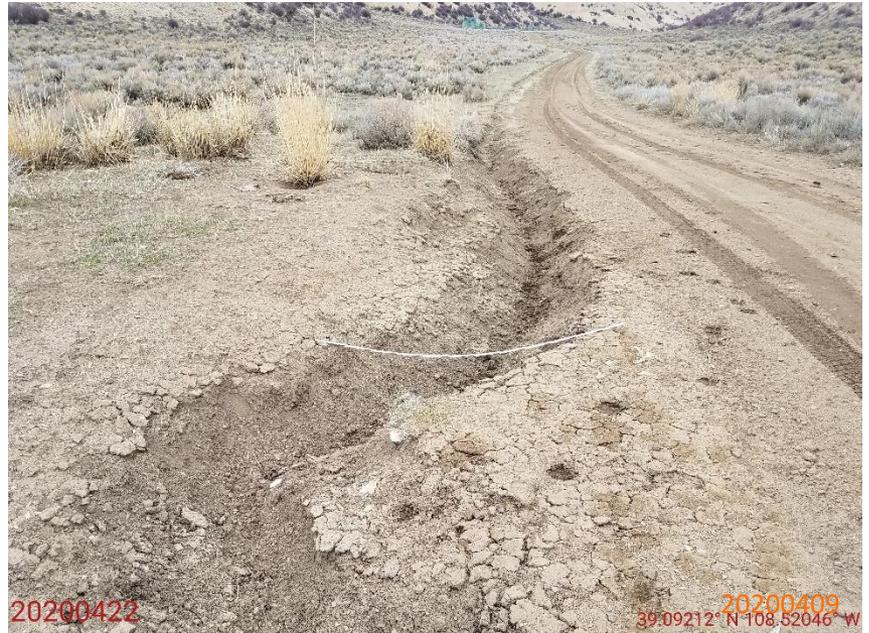
Photo 6: Photo taken from the north end of the Location, facing north. Photo shows erosion degradation due to stormwater runoff from the Location. 6 foot measuring stick for reference.

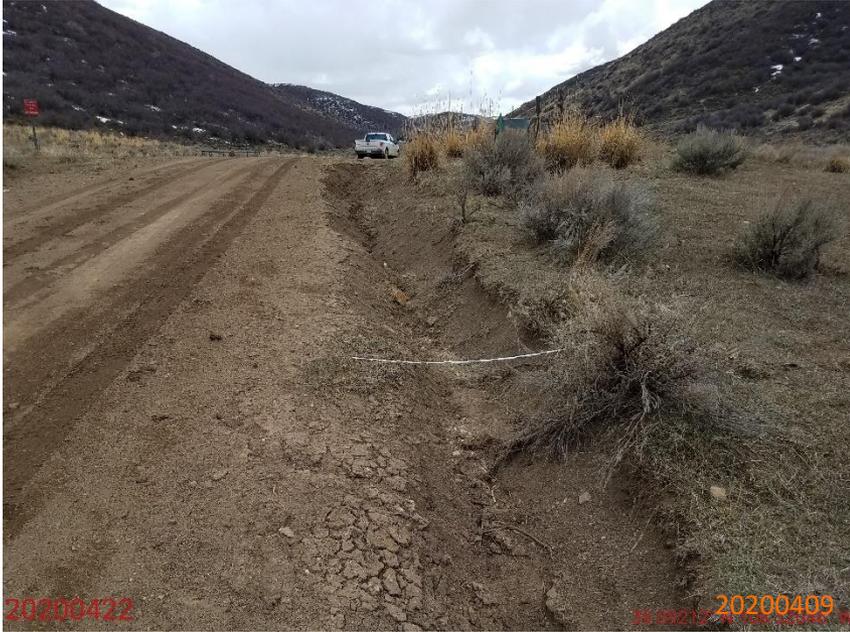
Photo 7: Photo taken from the access road, north of the Location, facing south. Photo shows erosion degradation due to stormwater runoff from the Location. 6 foot measuring stick for reference.

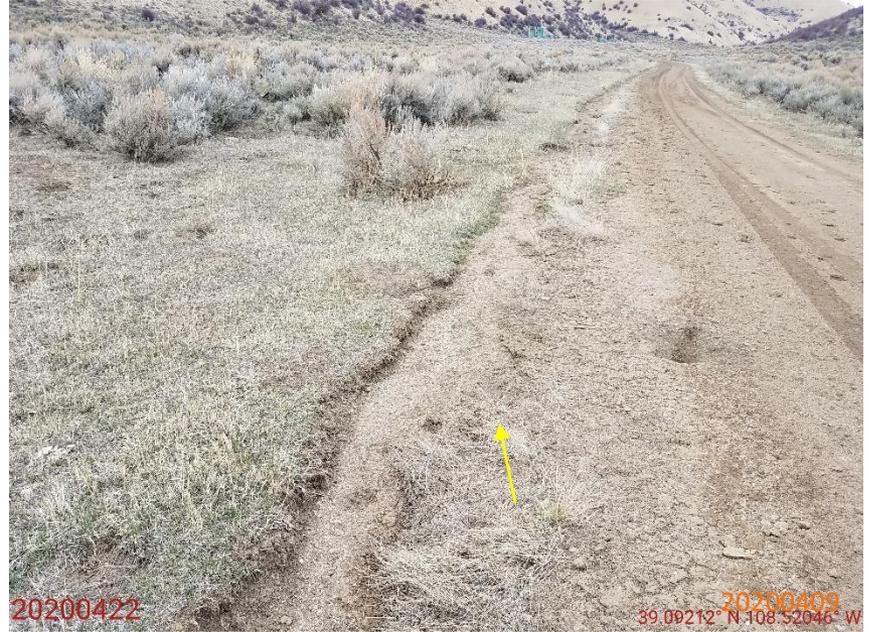
Photo 8: Photo taken from the access road, north of the Location, facing north. Photo shows sediment deposition resulting from erosion degradation and stormwater runoff from the Location.
