# Inspection Photos

Operator: CAERUS PICEANCE LLC # 10456

Location ID: 445862

COGCC

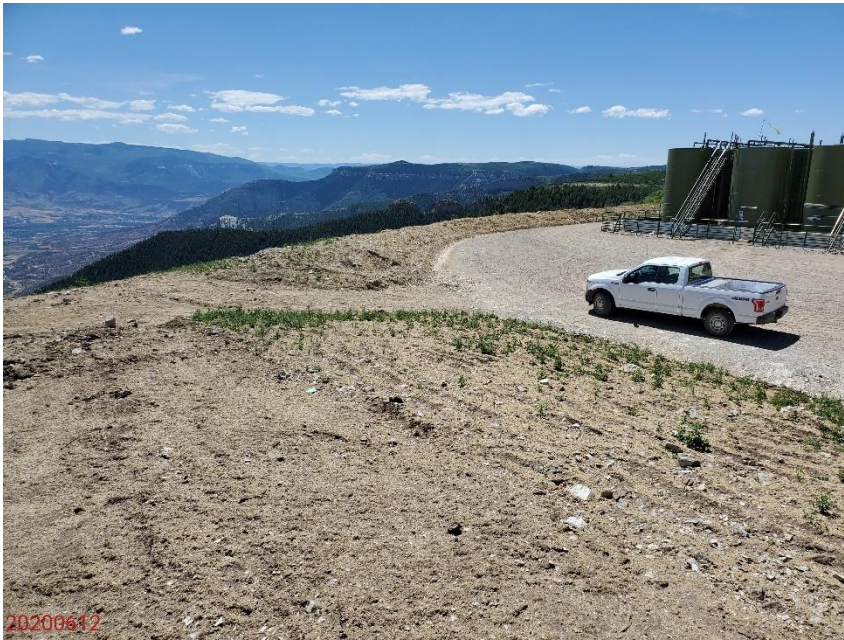
**Photo 1:** Photo taken from the North end of the Location facing southeast. Photos 1-3 provide an overview of the Location from southeast, south to southwest. Photo shows interim reclamation of the Location is in process.

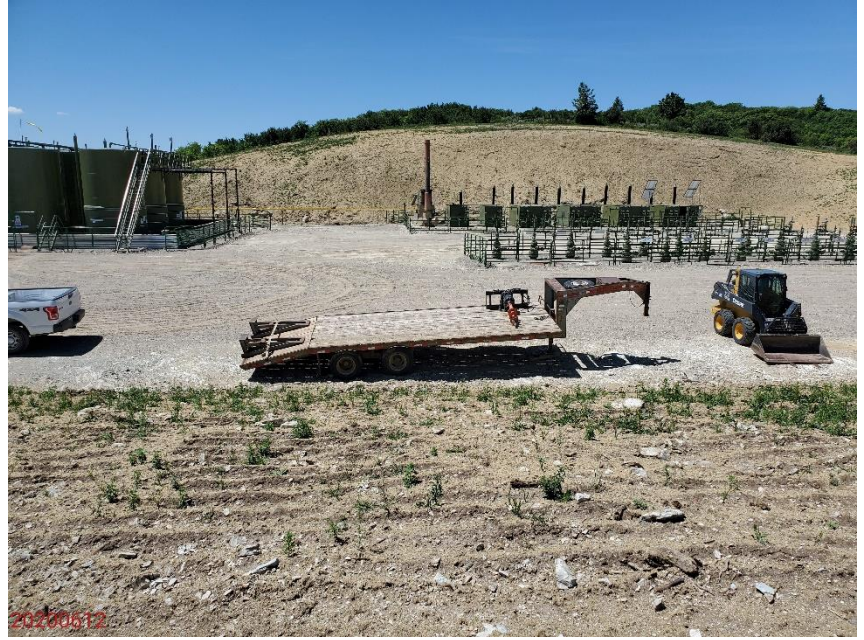
**Photo 2:** See comments under photo 1.

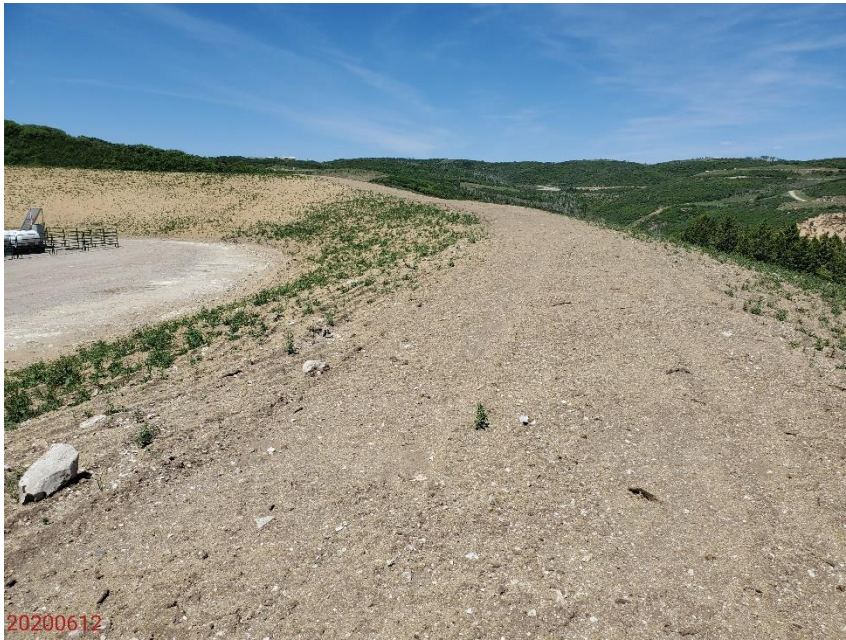
**Photo 3:** See comments under photo 1.

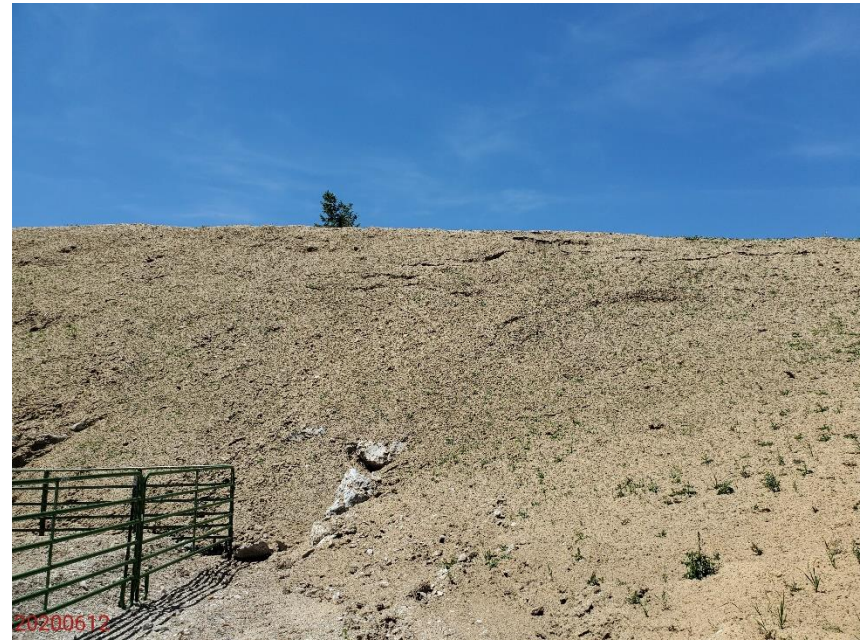
**Photo 4:** Photo taken from the southwest end of the Pad. Photo shows Operator has used a hydromulch to stabilize the seeded soils of the Location. Photo shows areas of the cut slope where soils show sign of destabilization.

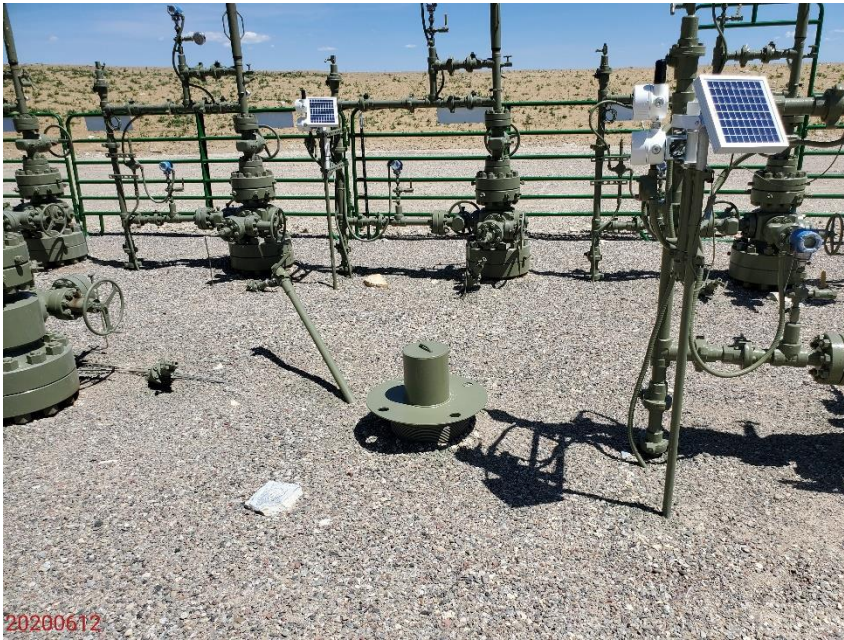
**Photo 5:** Photo of what appears to be the capped 045-23206 well. There does not appear to be signage for this well.

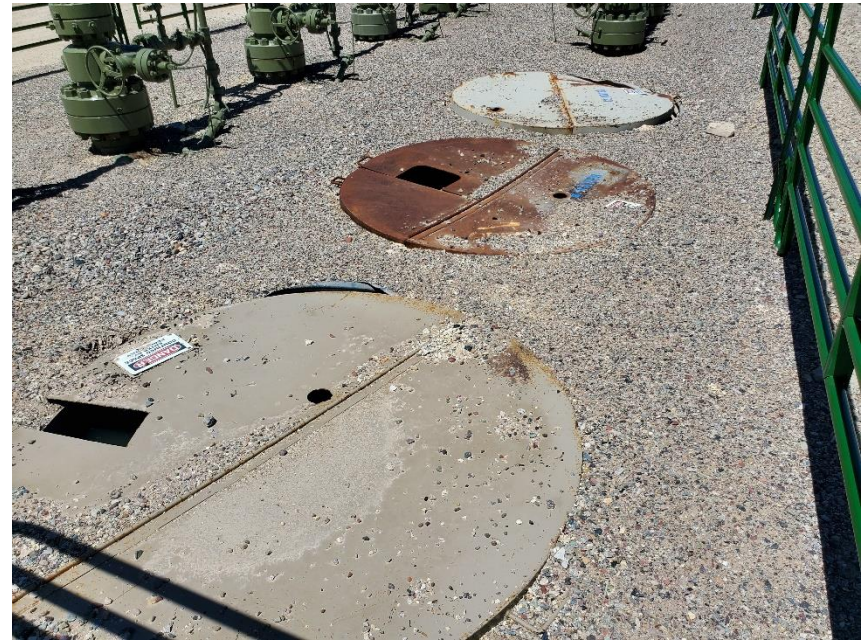
**Photo 6:** Photo of what appears to be 3 conductor settings for wells on the Location. There does not appear to be signage associated with these conductor settings/wells.
