Inspection Photos

Operator: TEP ROCKY MOUNTAIN LLC - 96850

Location ID: 335990

Garfield County, CO

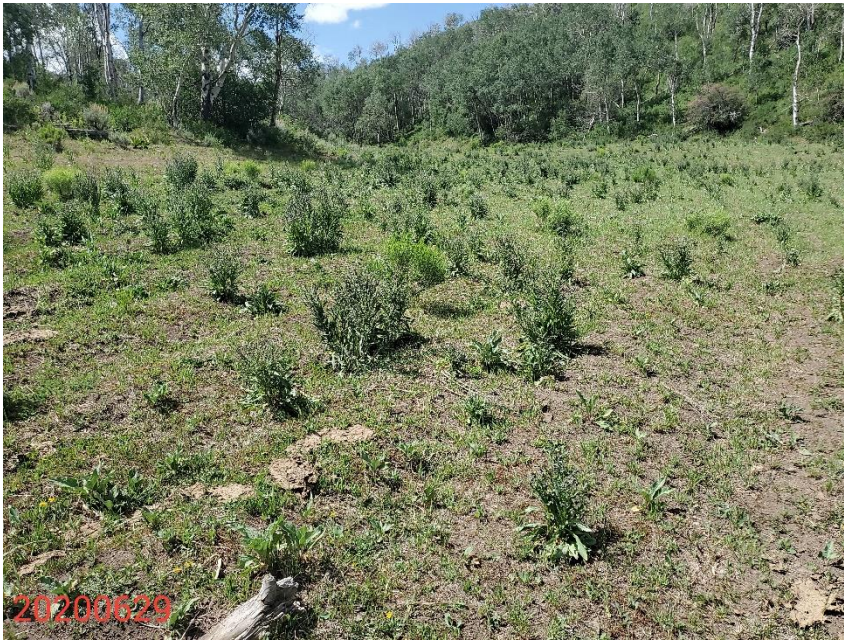
Photo 1: Photo taken from the east end of the Location, facing south. The majority of the taller plants seen in this photo is Hounds Tongue. This is a Colorado State listed noxious weed and requires management. Previous inspection observed weed within the northern drainage of the Location. Photo shows weeds have established throughout Location.

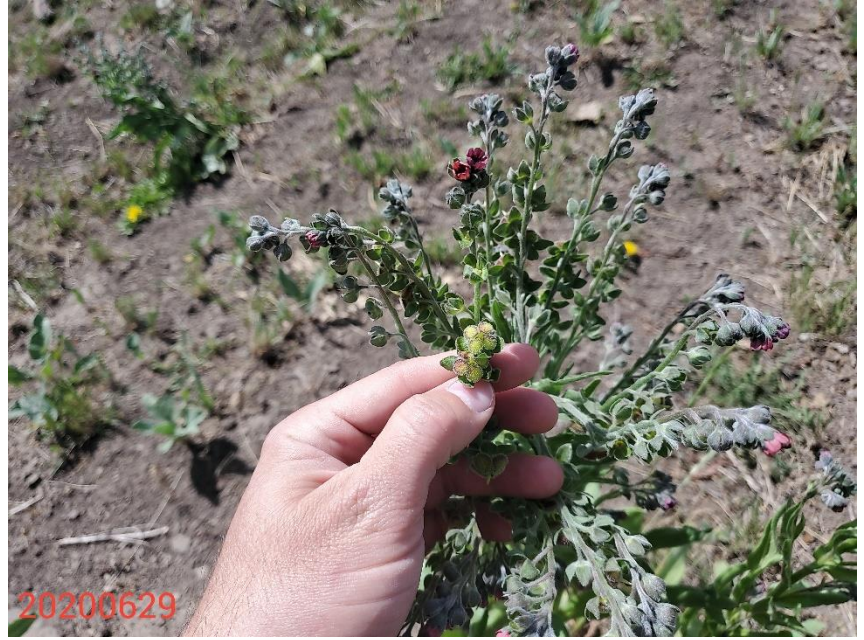
Photo 2: Photo of Hounds Tongue

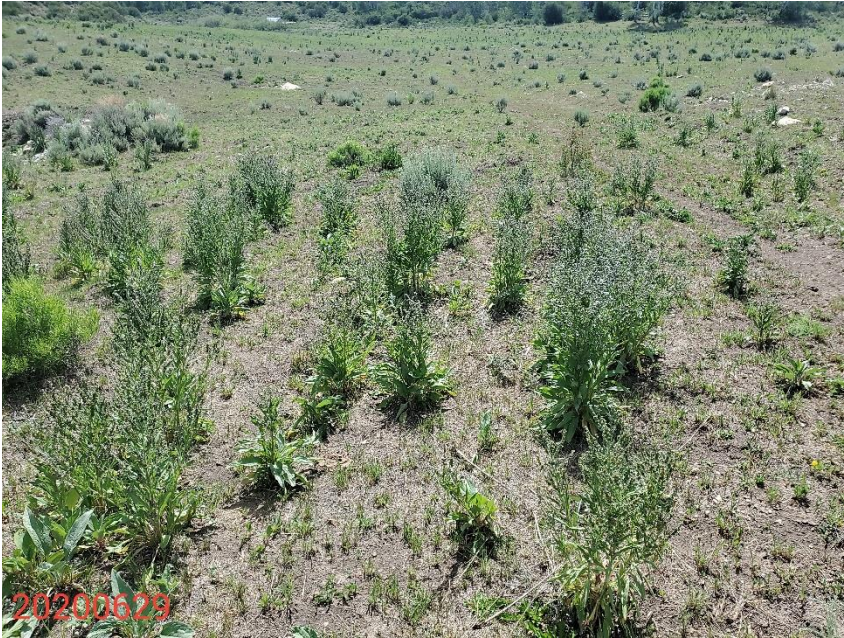
Photo 3: Photo taken from the west end of the Location, facing east. The majority of the taller plants seen in this photo is Hounds Tongue.

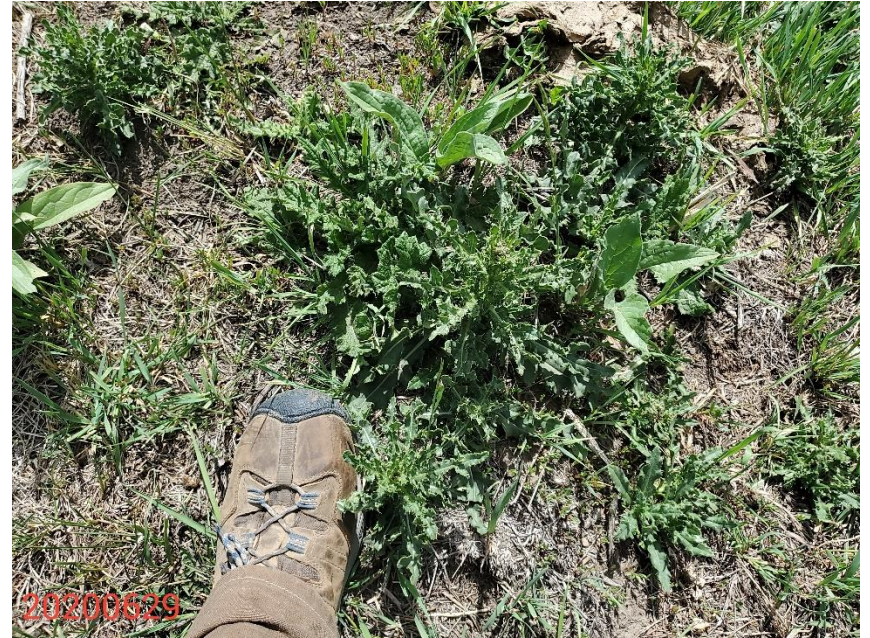
Photo 4: Photo shows Canada Thistle rosettes.
