Location Name: BIG TIMER 32-19, API #: 071-08761, Insp. #:695103932

Colorado Oil & Gas Conservation Commission

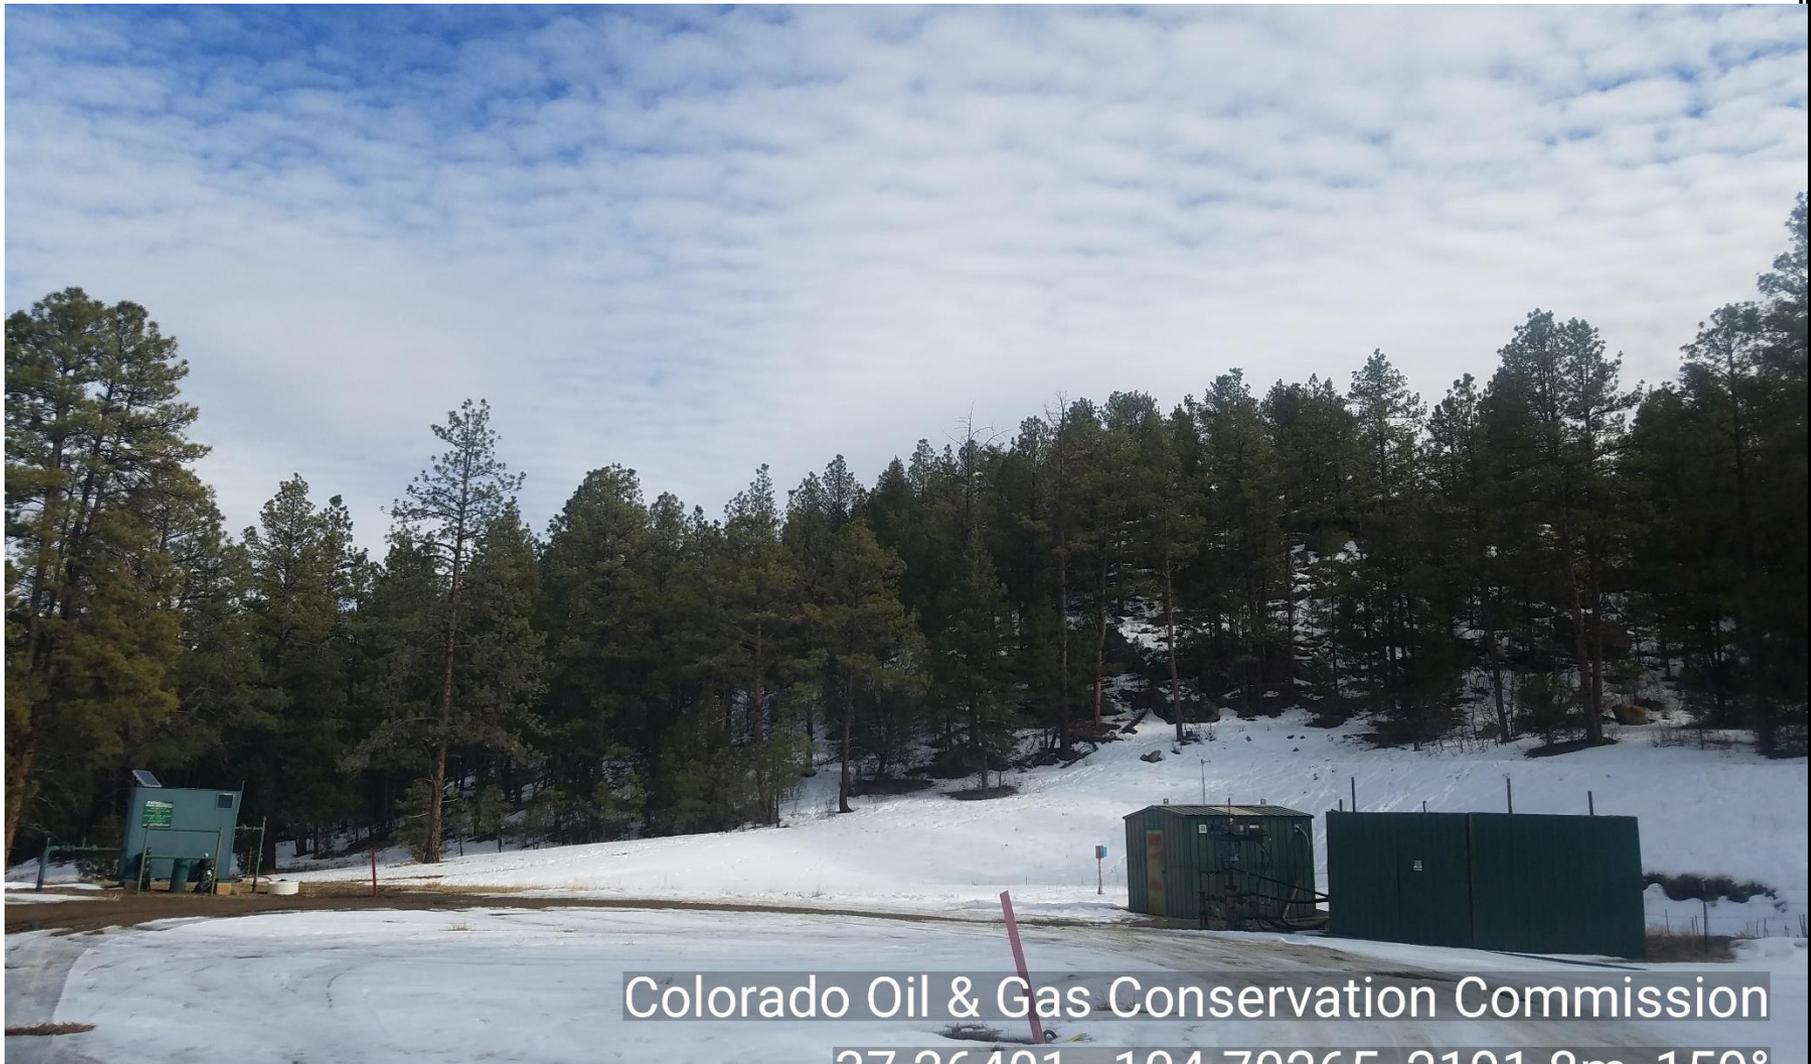
Phone 1: LOCATION

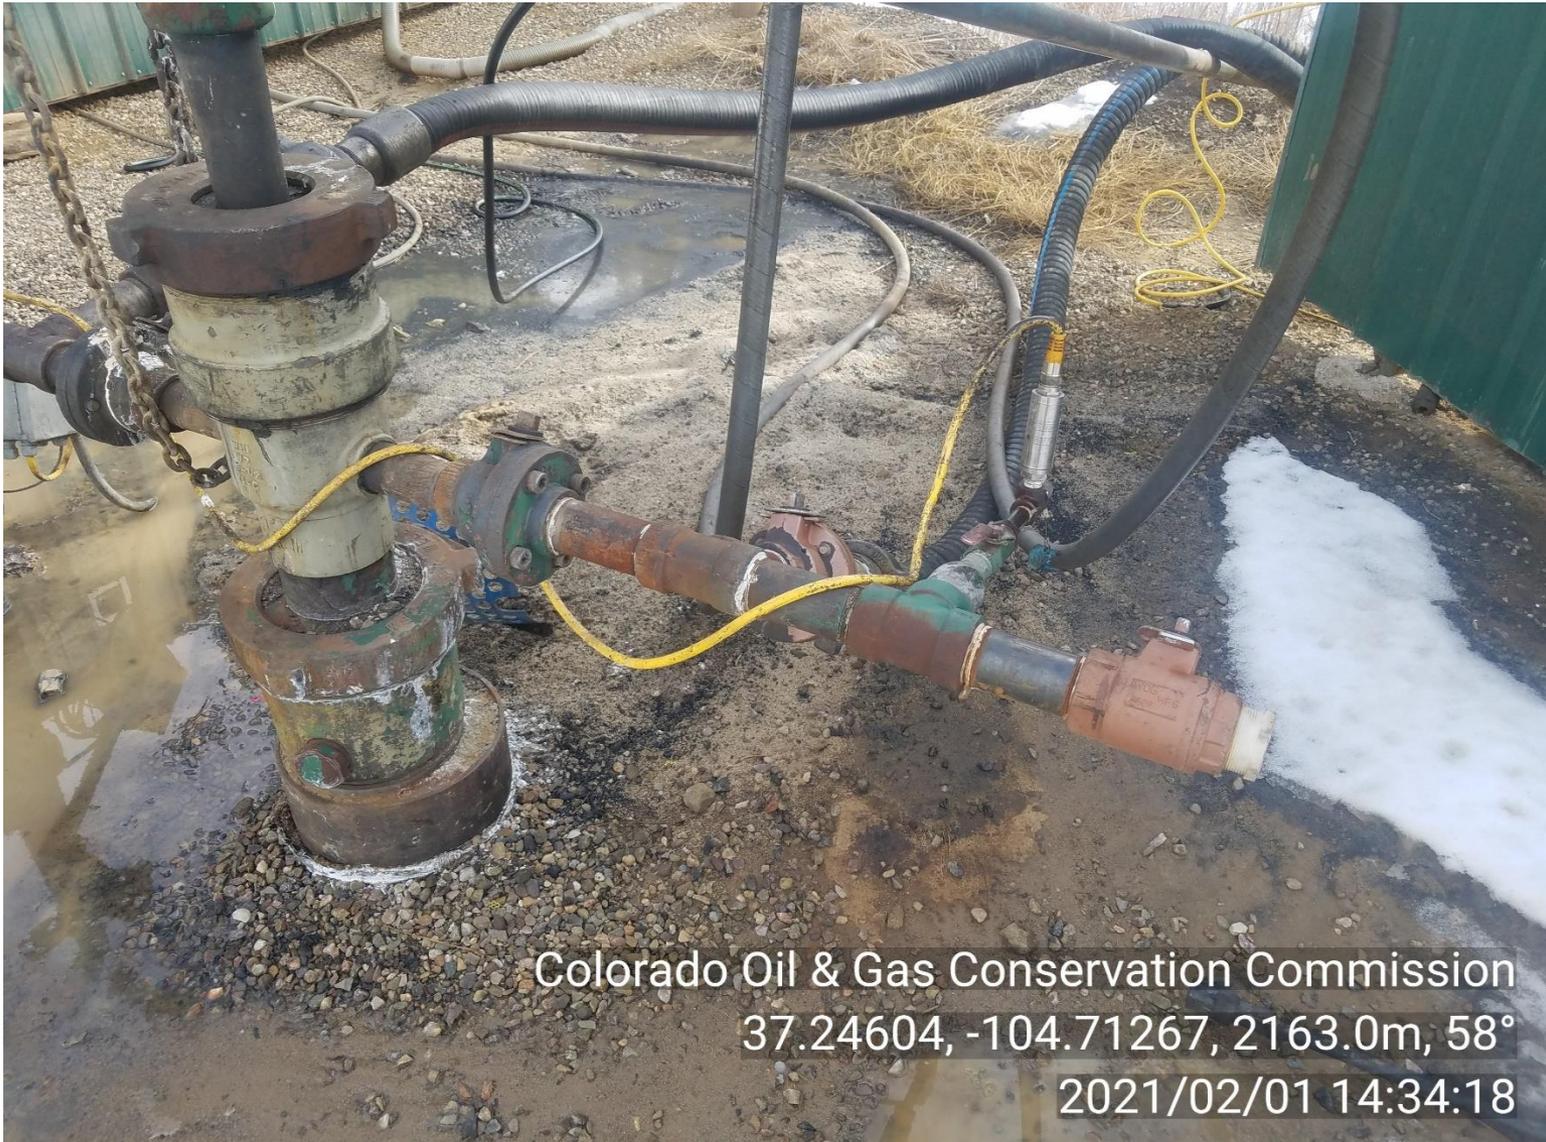
**Phone 3: PILE OF E&P WASTE APPEARS TO BE FRAC SAND AND PERF DUST BAILED FROM WELL BORE NEXT TO WELLHEAD. COMPLY WITH RULE 905. AND 1002.F.(2)F**

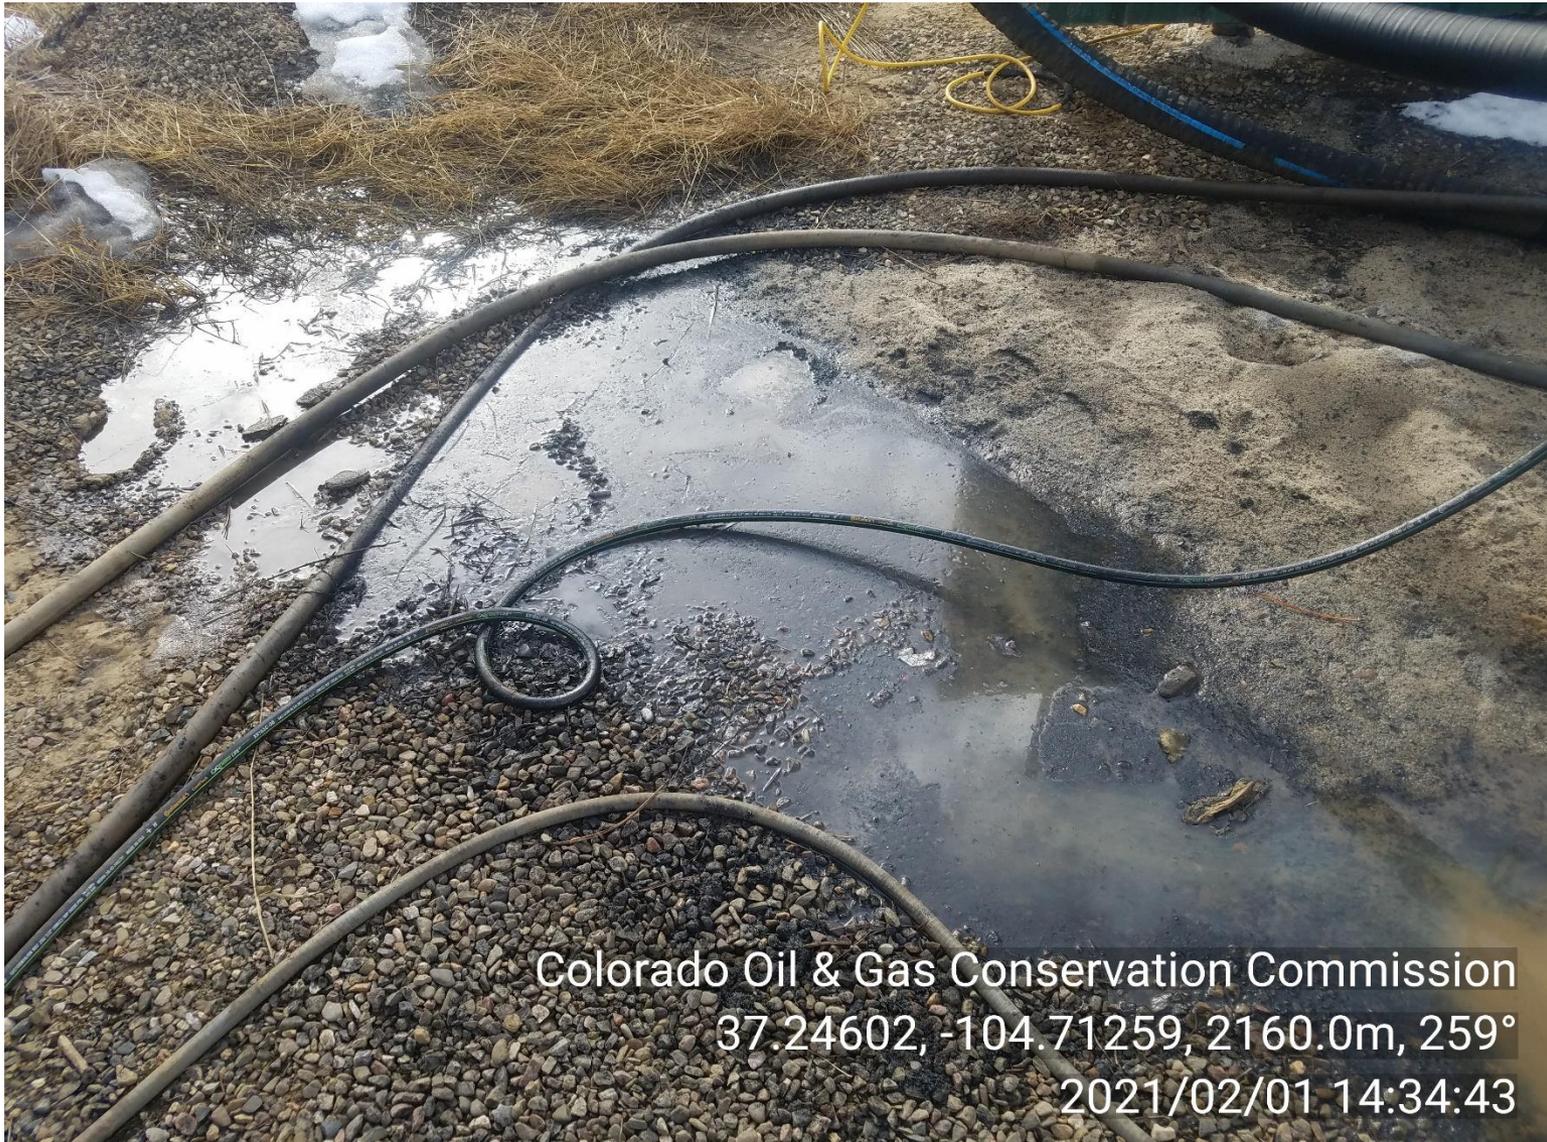
**Phone 4: E&P WASTE APPEARS TO BE PERF DUST FLOATING IN STANDING WATER NEXT TO WELLHEAD. COMPLY WITH RULE 905 AND 1002.F.(2)F**

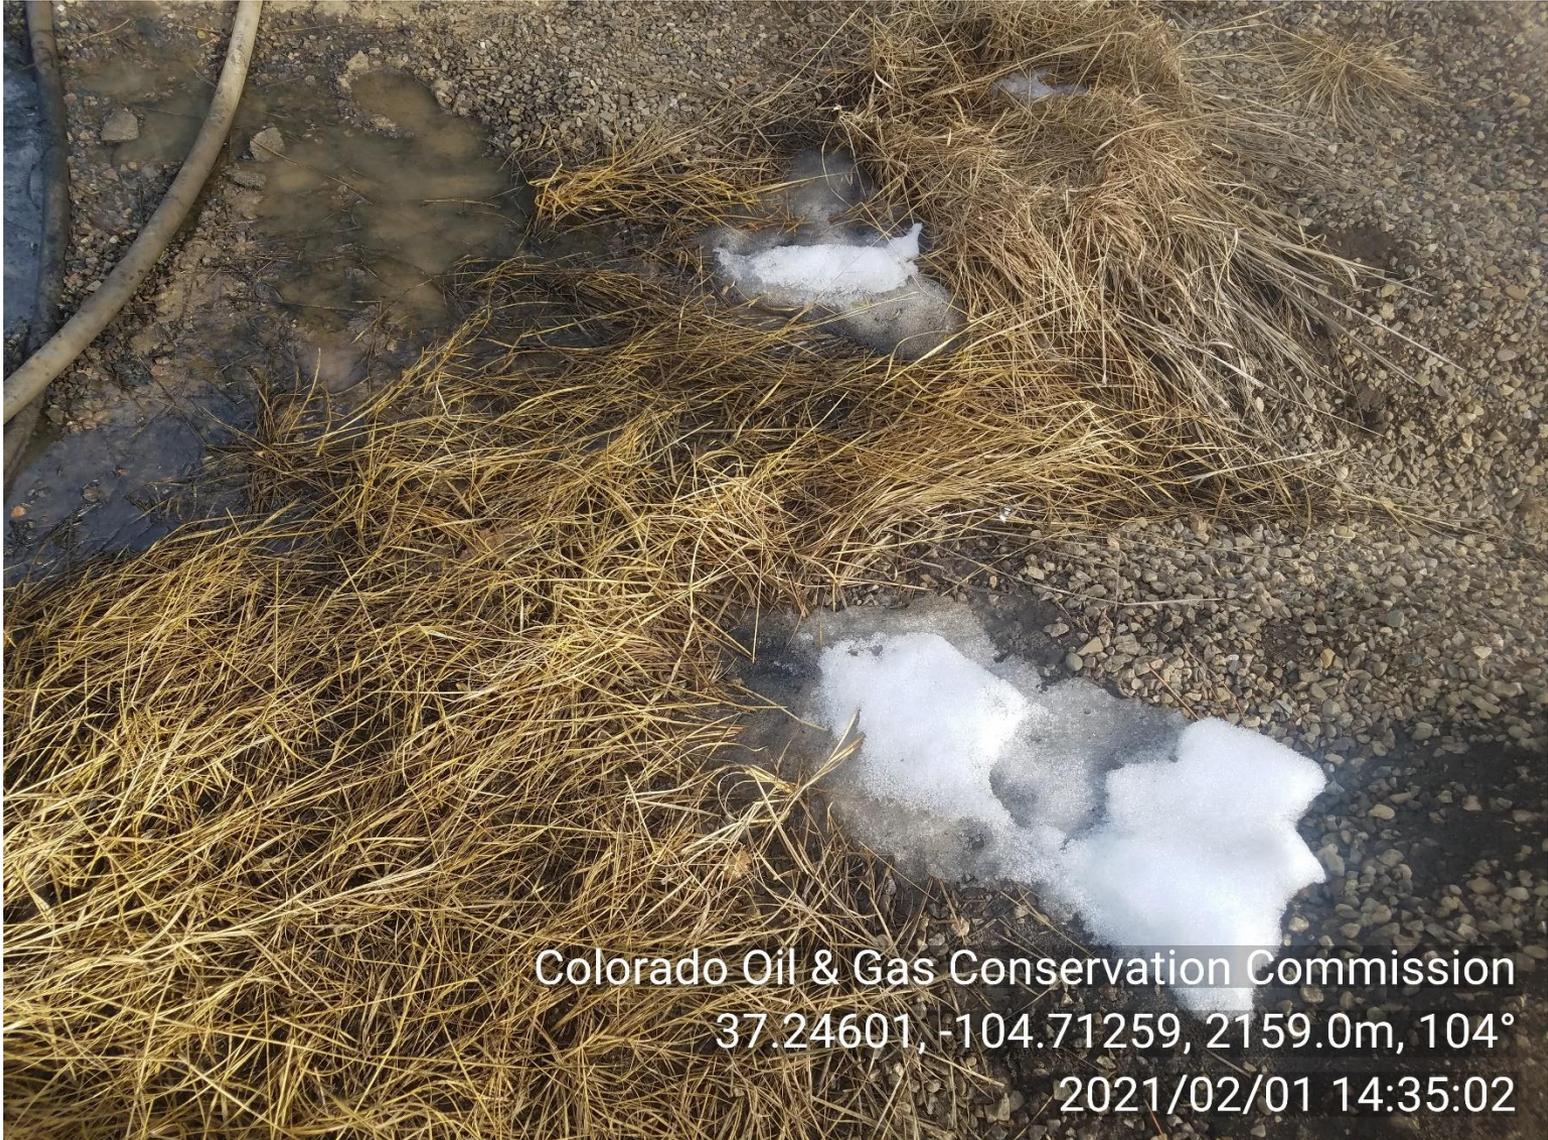
**Phone 5: E&P WASTE APPEARS TO BE PERF DUST ON SNOW AND GRASS BY WELLHEAD NEST TO PIT.  
COMPLY WITH RULE 905 AND 1002.F.(2)F**

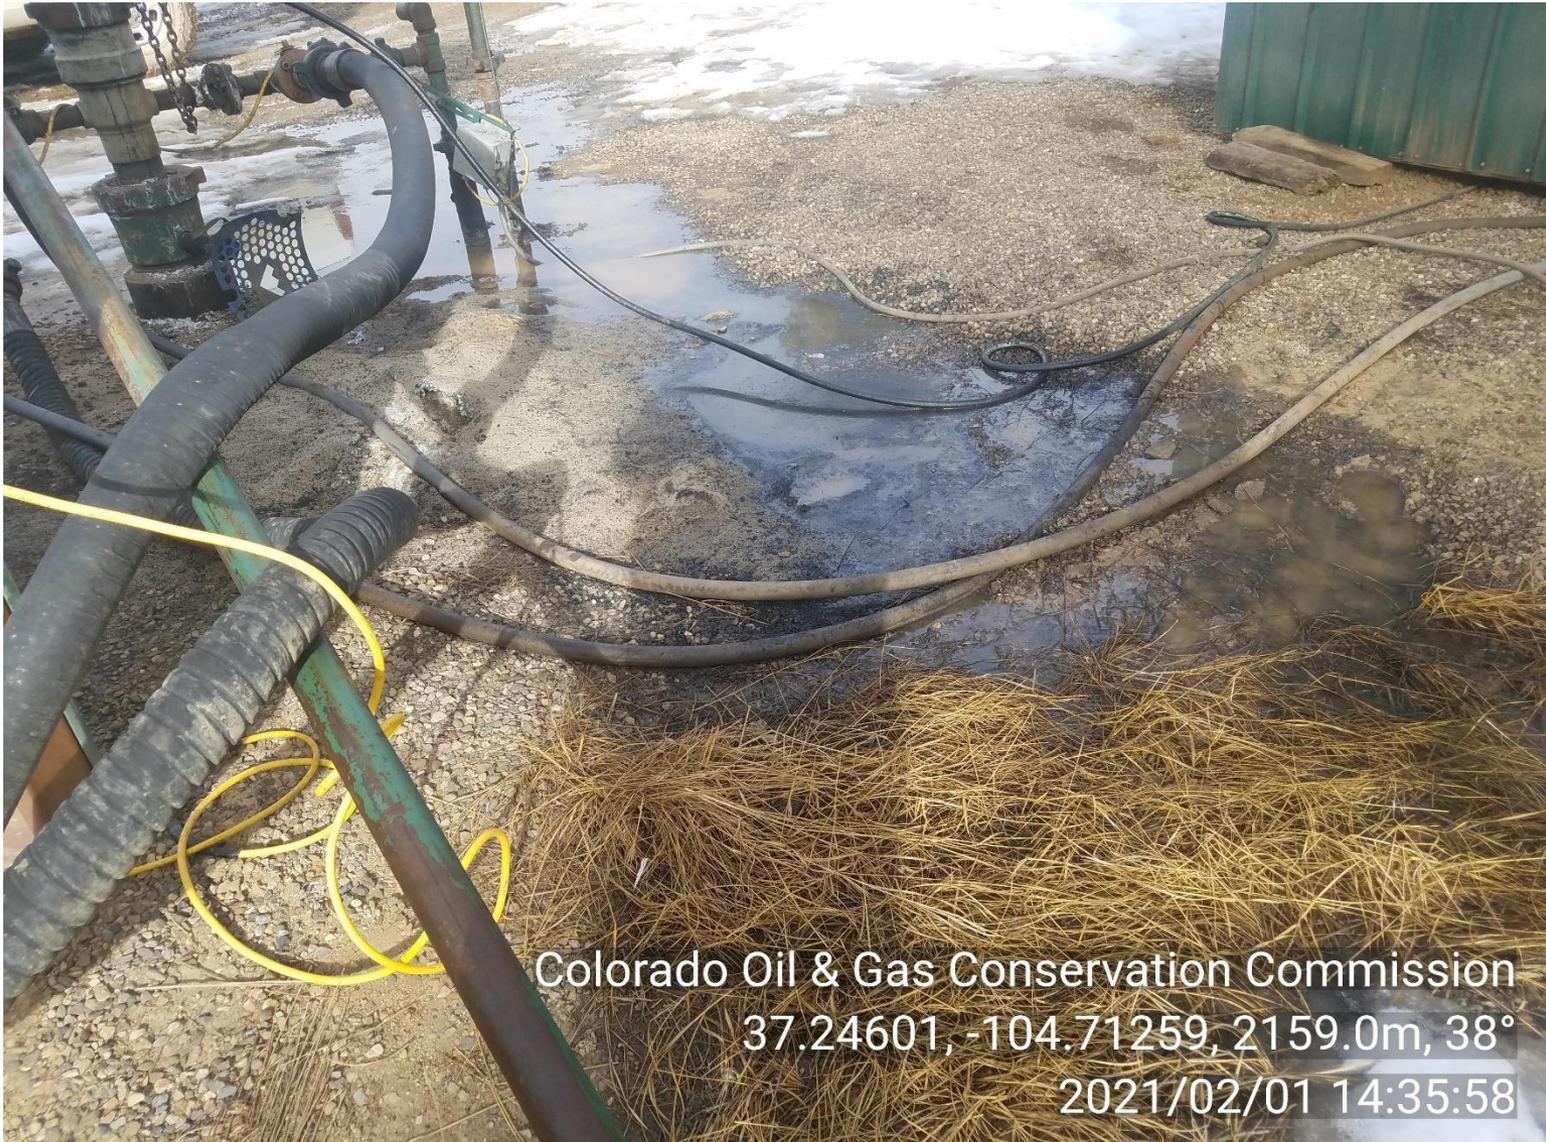
**Phone 6: ANOTHER IMAGE OF E&P WASTE APPEARS TO BE PERF DUST ON SNOW AND GRASS BY WELLHEAD NEST TO PIT. COMPLY WITH RULE 905 AND 1002.F.(2)F**

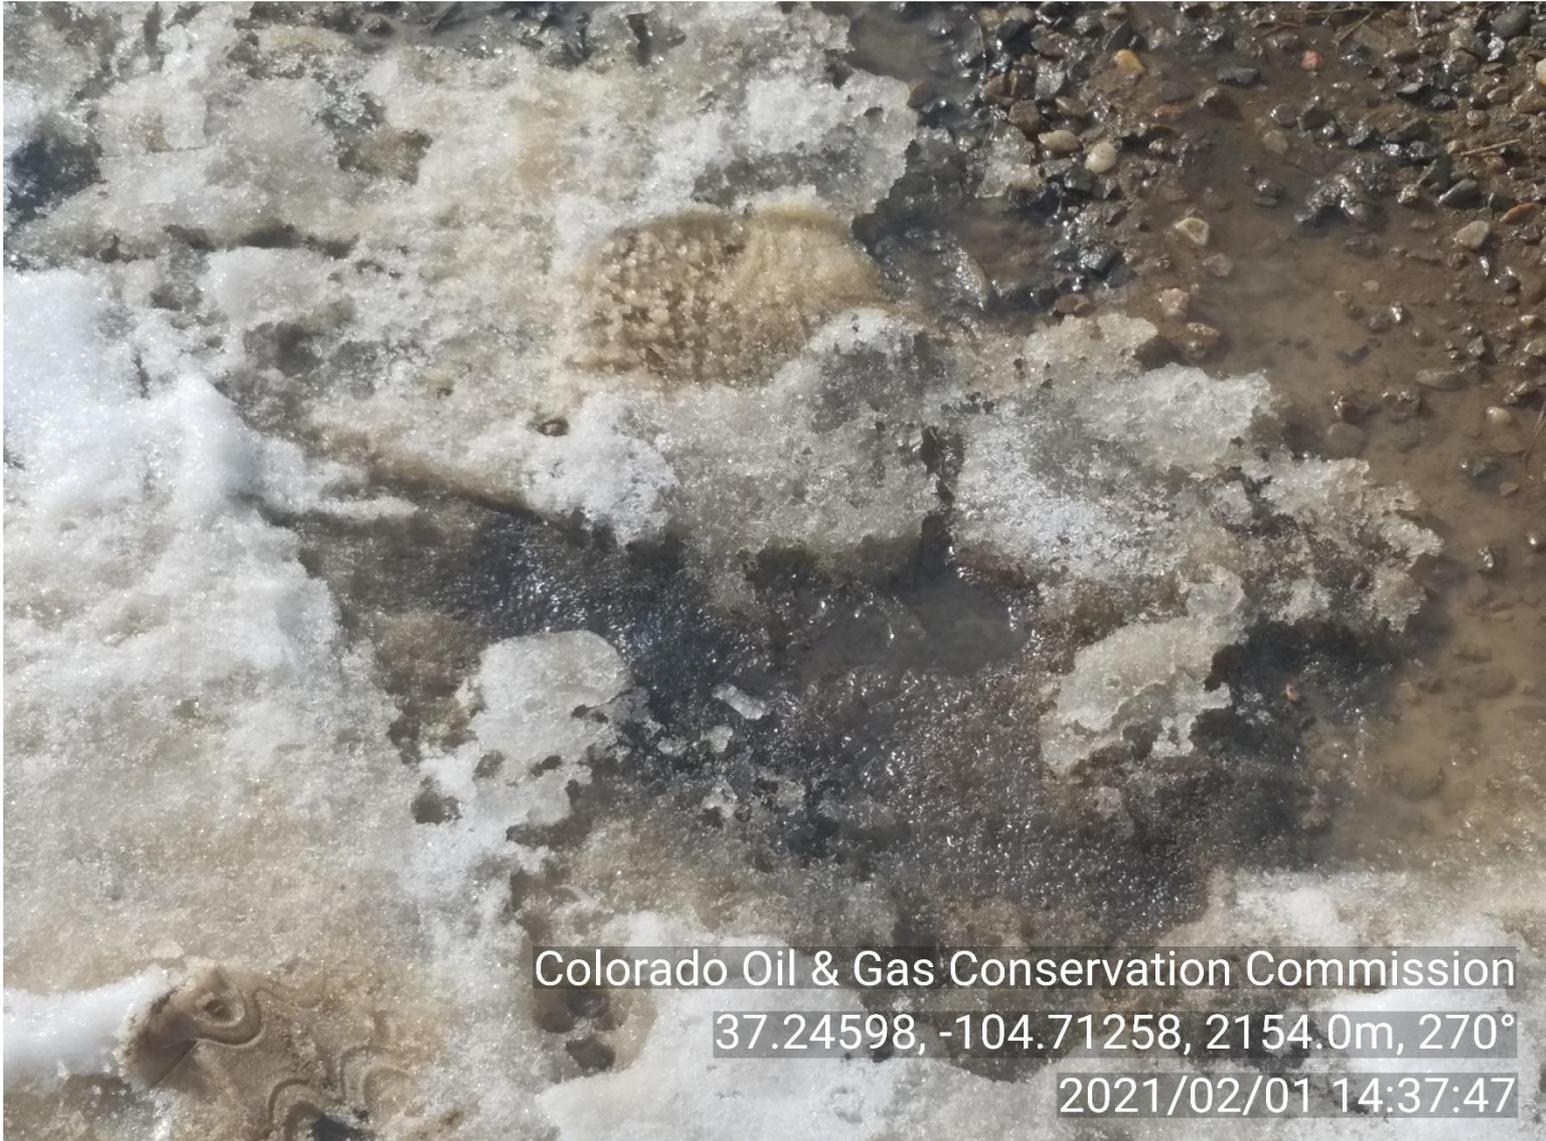
**Phone 7: CLOSER IMAGE OF E&P WASTE APPEARS TO BE PERF DUST ON SNOW AND GRASS BY WELLHEAD NEST TO PIT. COMPLY WITH RULE 905 AND 1002.F.(2)F**

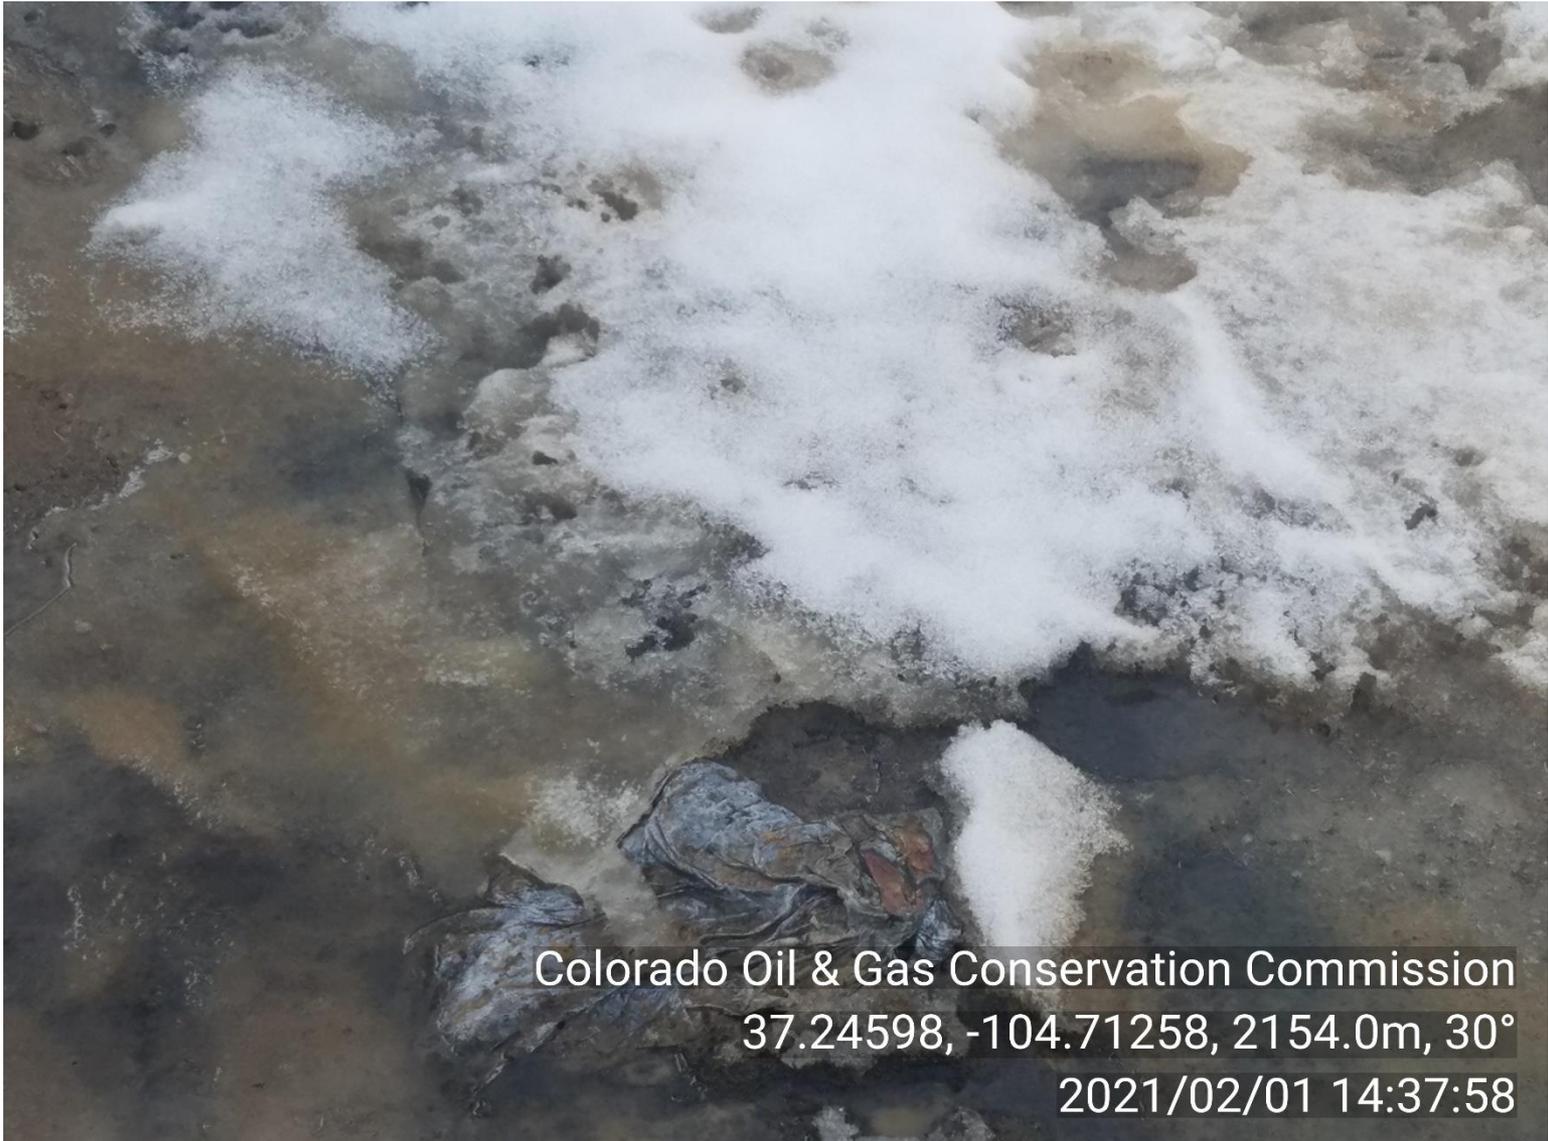
**Phone 8: TRASH NEAR WELLHEAD. COMPLY WITH RULE 606.**

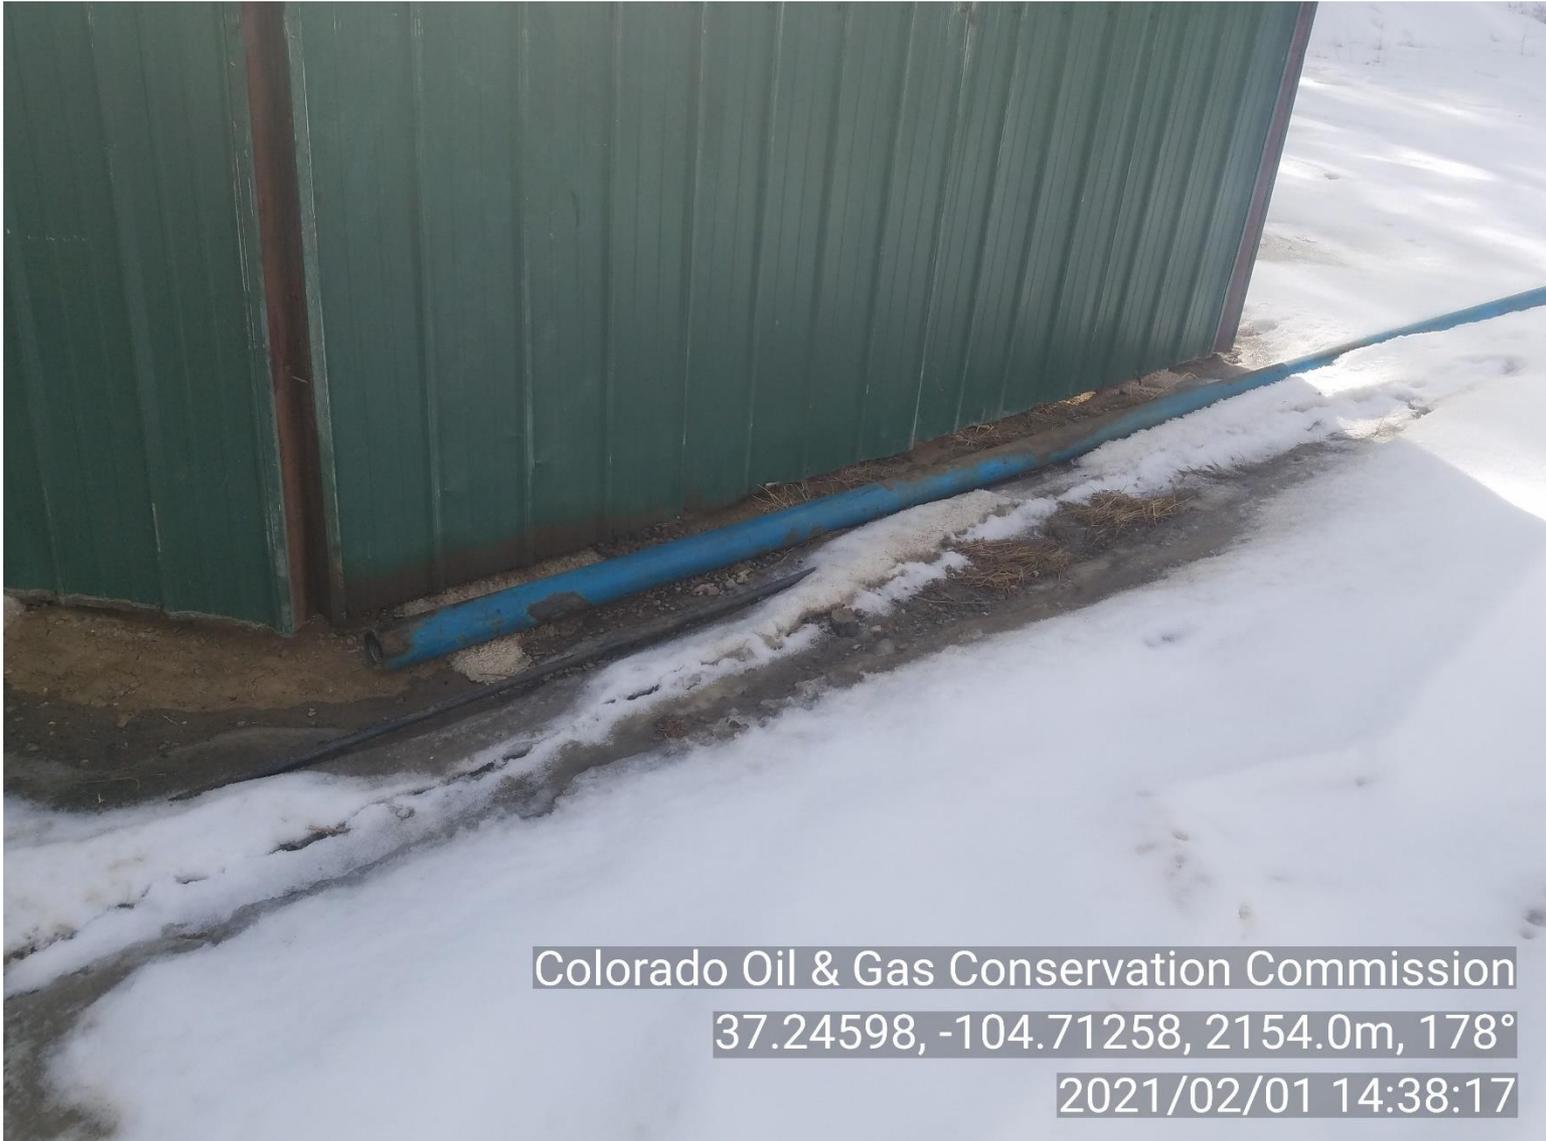
Phone 9: UNUSED EQUIPMENT STORED ON LOCATION (OLD PUMP AND SUCKER RODS). **COMPLY WITH RULE 606.**

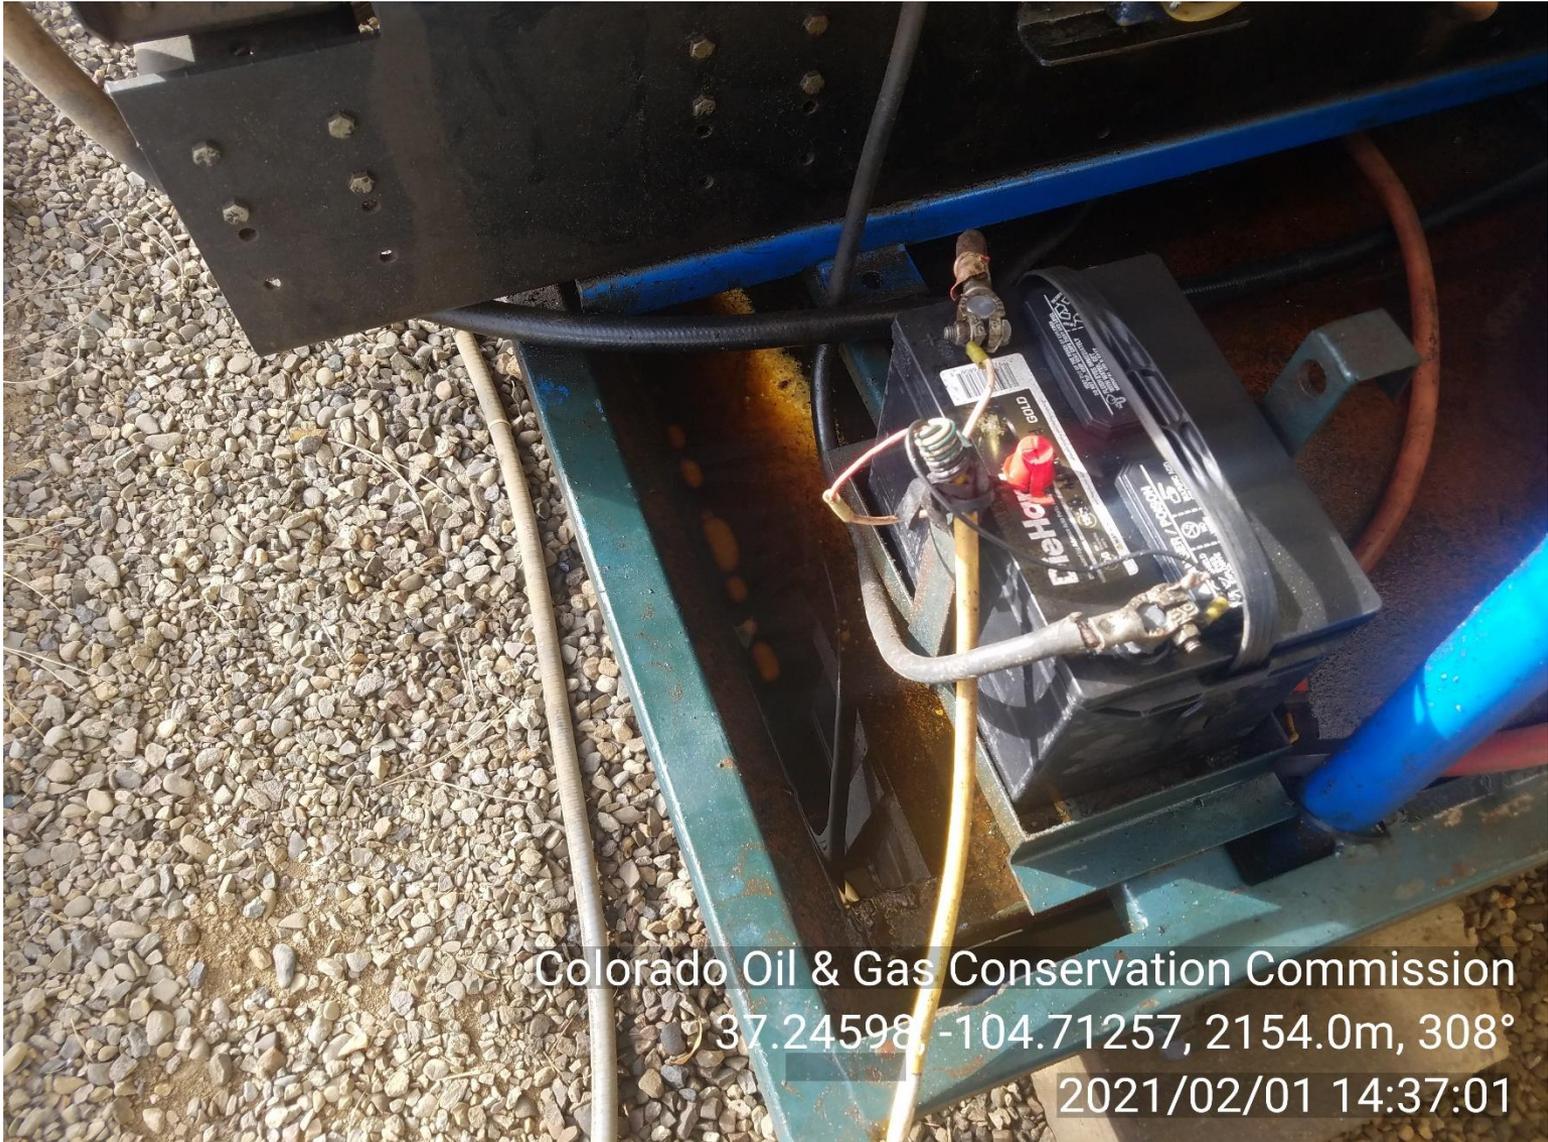
**Phone 10: OIL IN COMPRESSOR ENGINE SKID. COMPLY WITH RULE 1002.f.(2)A AND Comply with general provisions of the oil and gas act for wildlife protection.**

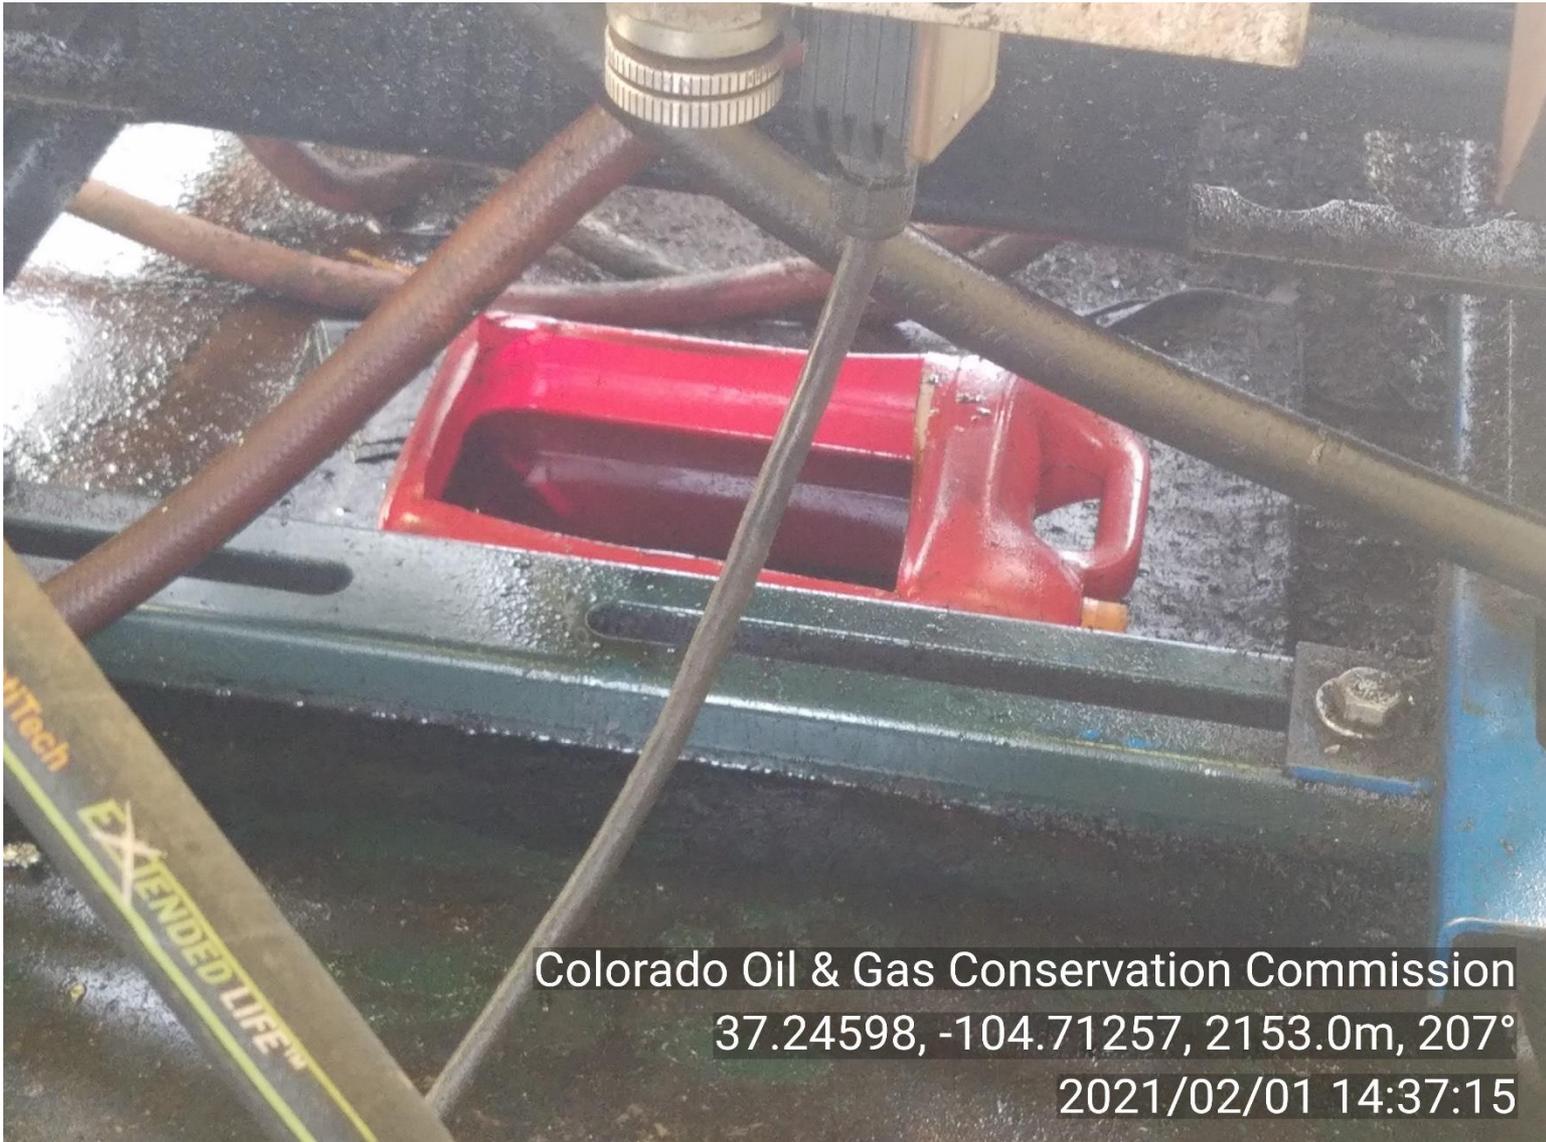
**Phone 11: DRAIN PAN WITH OIL IN COMPRESSOR ENGINE SKID. COMPLY WITH RULE 1002.f.(2)A AND Comply with general provisions of the oil and gas act for wildlife protection.**

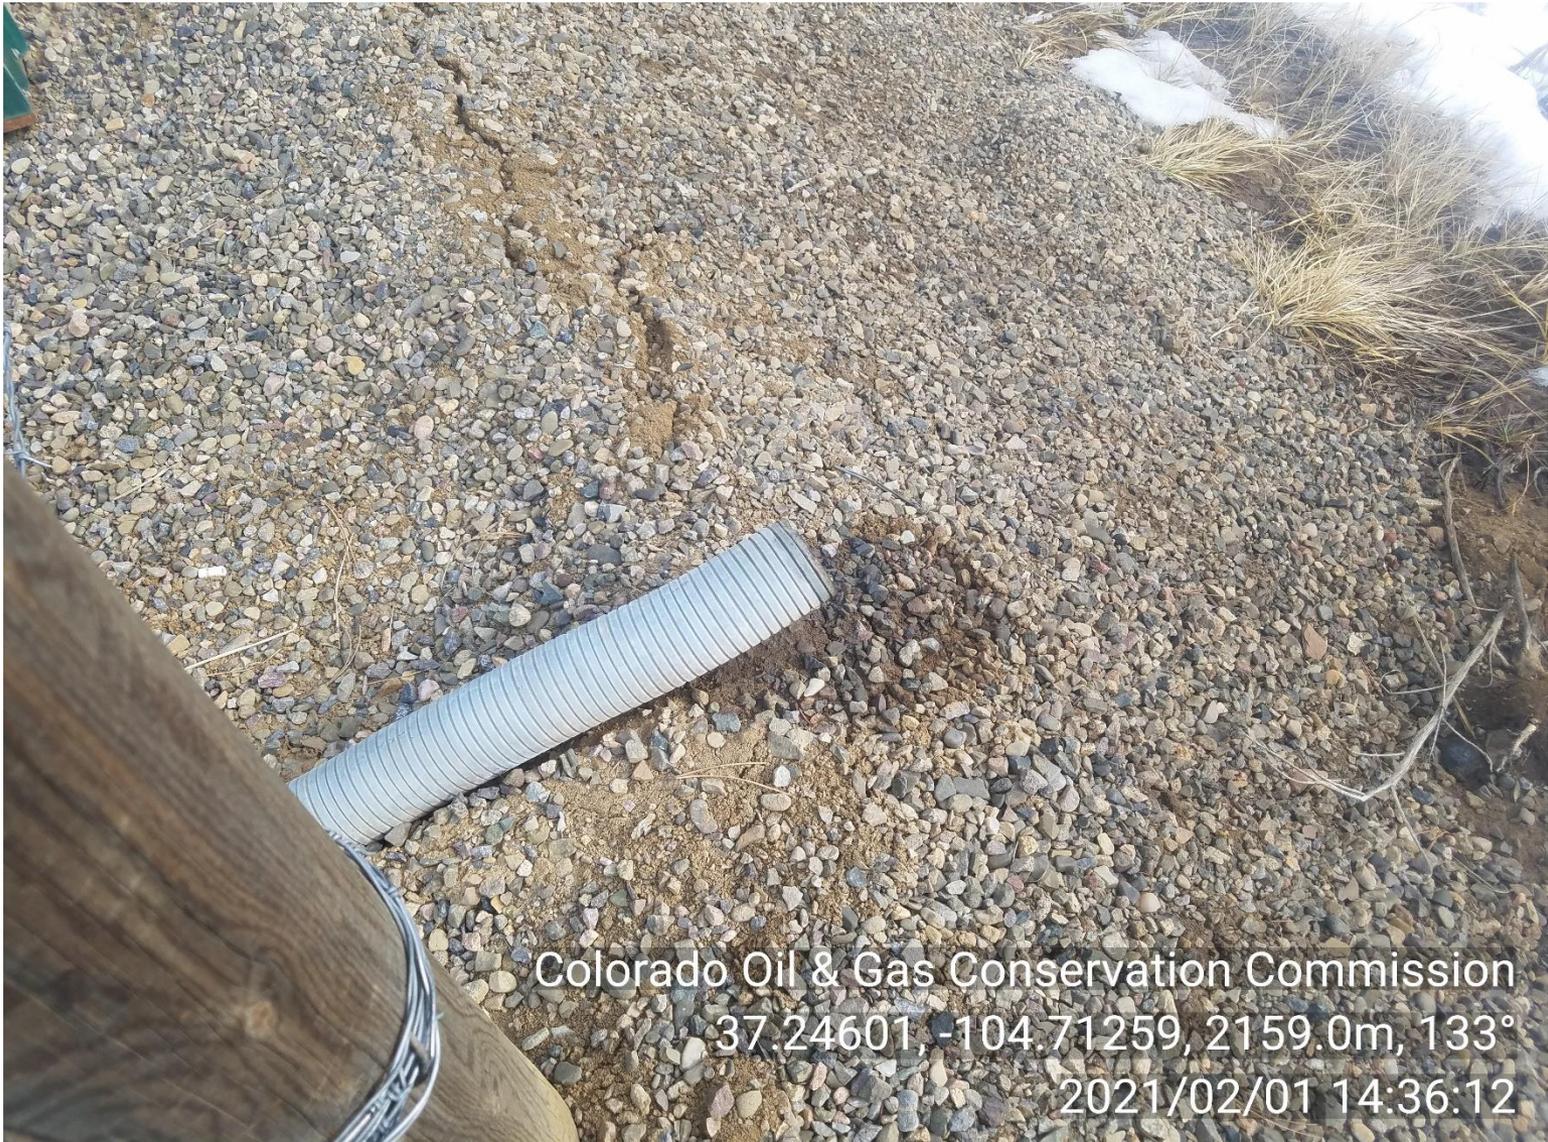
**Phone 12: AREA OF IMPACTED SOIL NEAR MUFFLER OUTLET FROM COMPRESSOR ENGINE.**

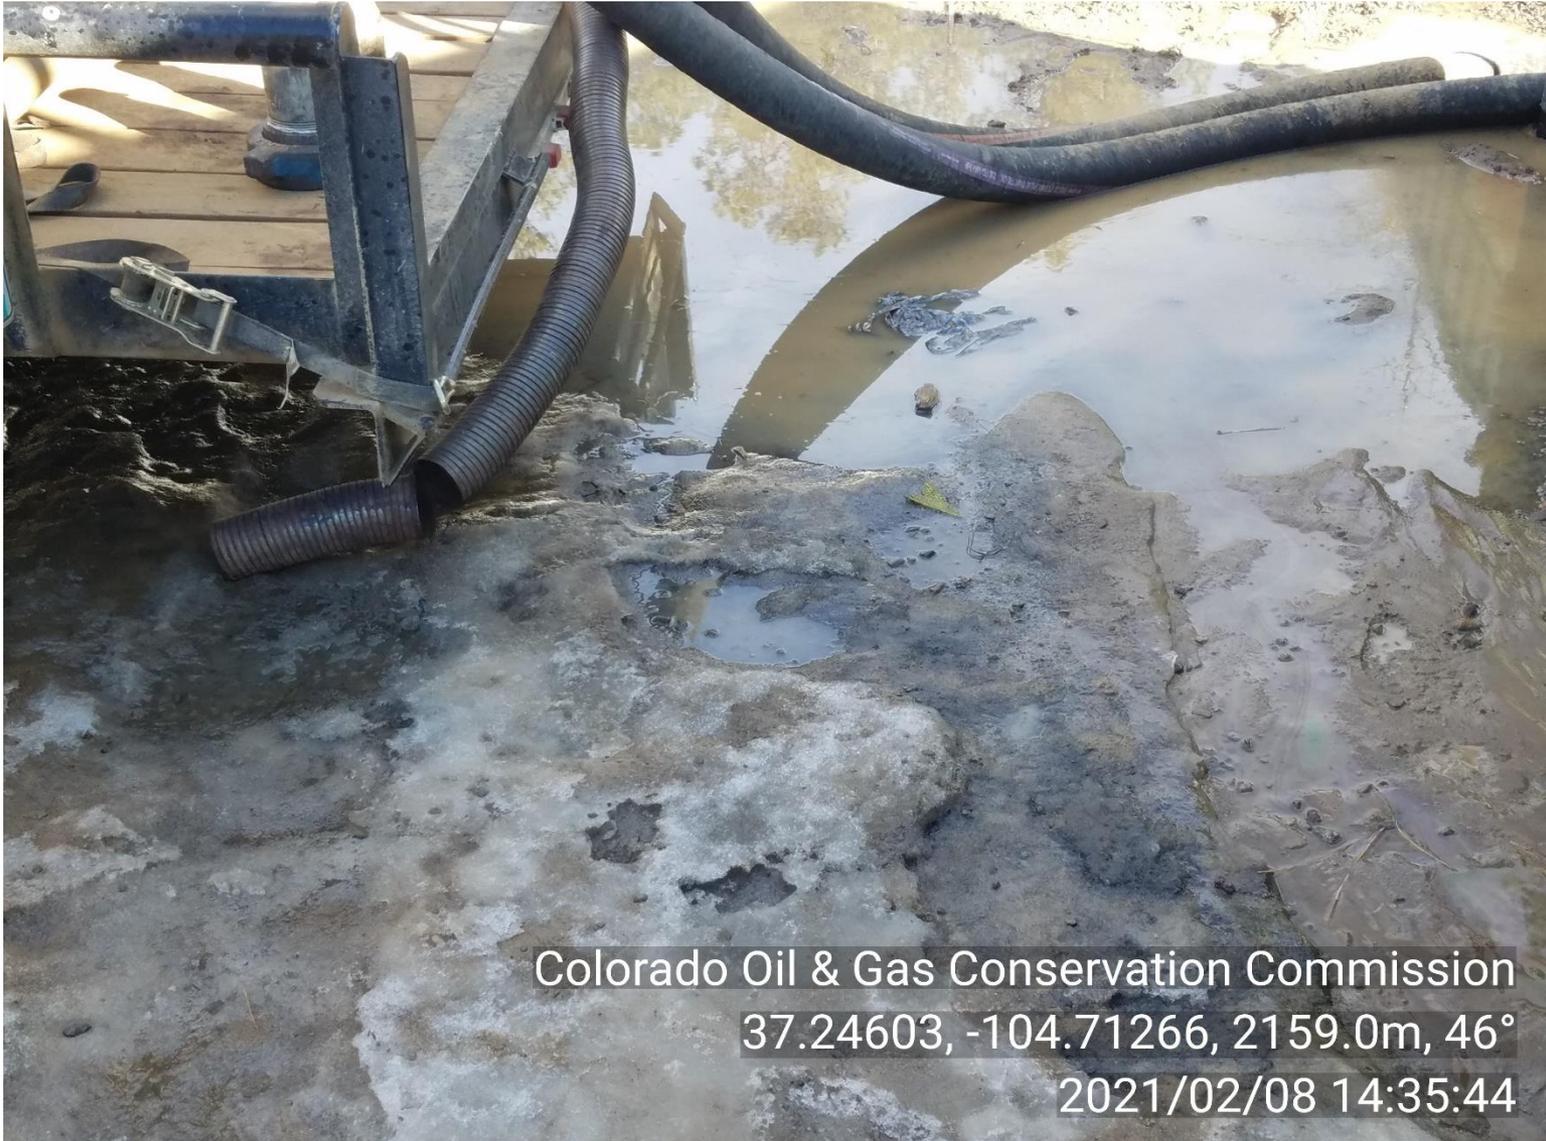
**Phone 13: PHOTO TAKEN 7 DAYS AFTER ORIGINAL INSPECTION SHOWING THAT NOTHING HAS BEEN CLEANED UP. NOT I HAVE NOT TURNED ORIGINAL INSPECTION INTO THE OPERATOR PRIOR TO THIS PHOTO BEING TAKEN DUE TO WAITING FOR COMPLAINT.**
