Location Name: BIG TIMER 32-19, API #: 071-08761, Insp. #:695103932

Colorado Oil & Gas Conservation Commission

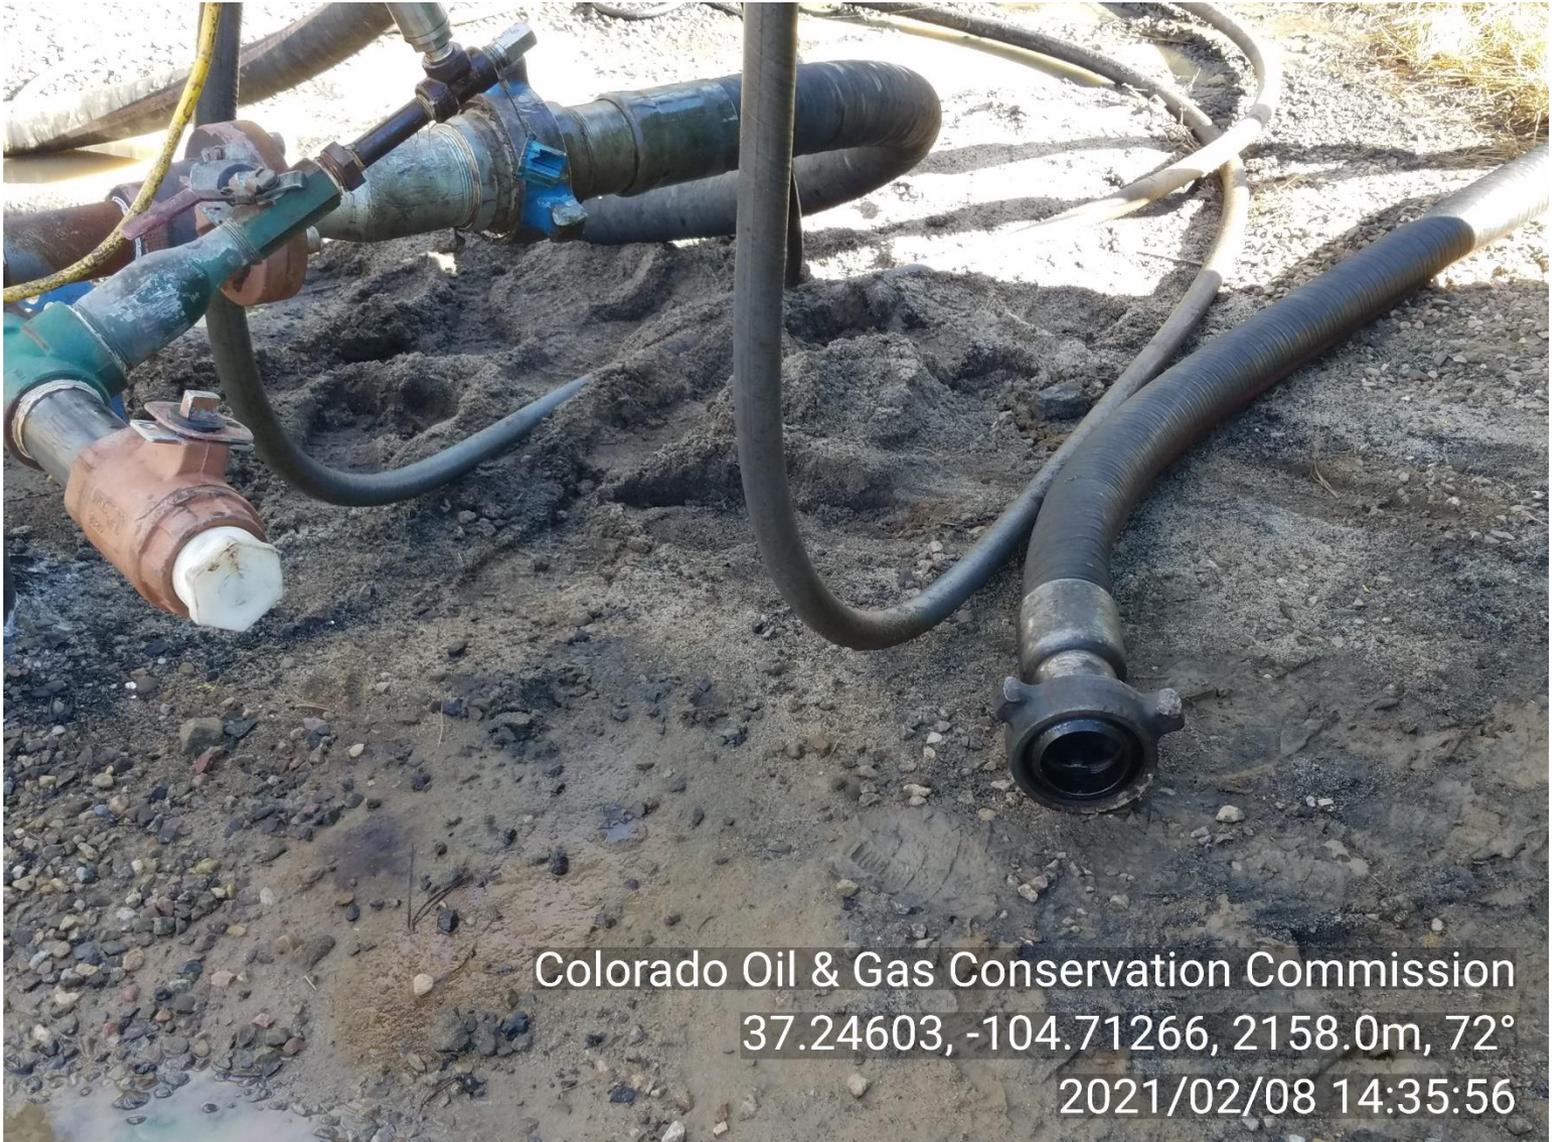
**Phone 14: PHOTO TAKEN 7 DAYS AFTER ORIGINAL INSPECTION SHOWING THAT NOTHING HAS BEEN CLEANED UP. NOTE: I HAVE NOT TURNED ORIGINAL INSPECTION INTO THE OPERATOR PRIOR TO THIS PHOTO BEING TAKEN DUE TO WAITING FOR COMPLAINT.**

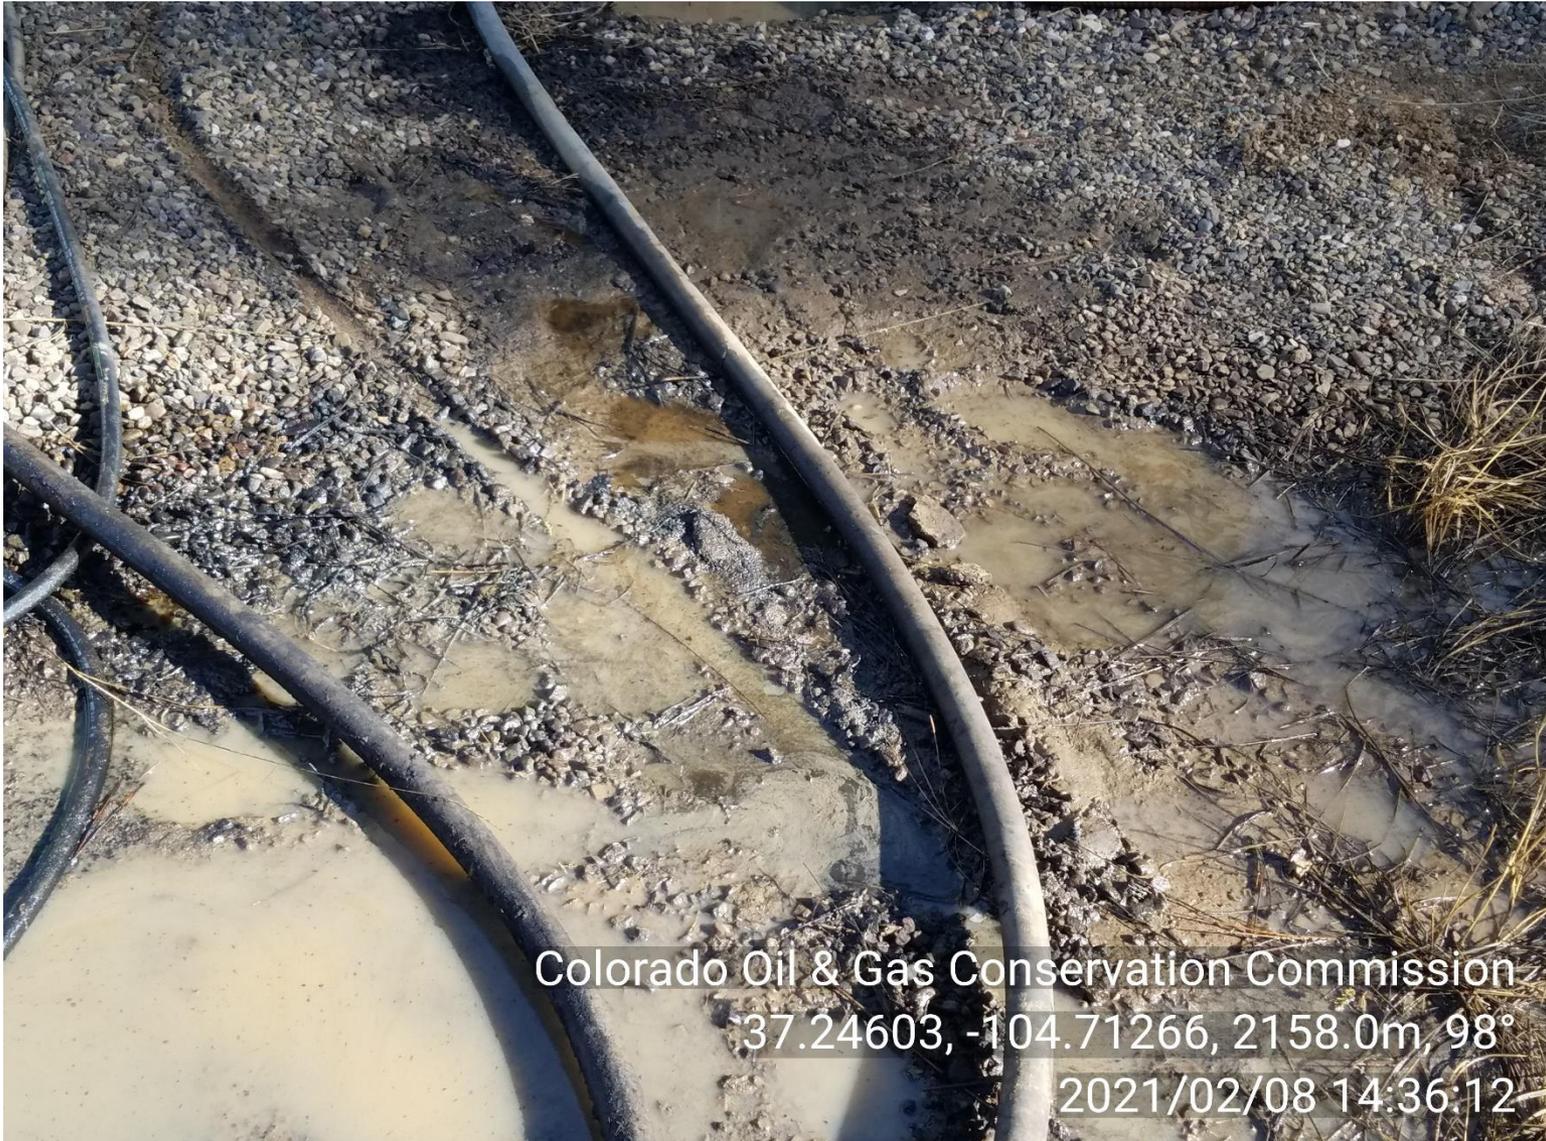
**Phone 15: PHOTO TAKEN 7 DAYS AFTER ORIGINAL INSPECTION SHOWING THAT NOTHING HAS BEEN CLEANED UP. NOTE: I HAVE NOT TURNED ORIGINAL INSPECTION INTO THE OPERATOR PRIOR TO THIS PHOTO BEING TAKEN DUE TO WAITING FOR COMPLAINT.**

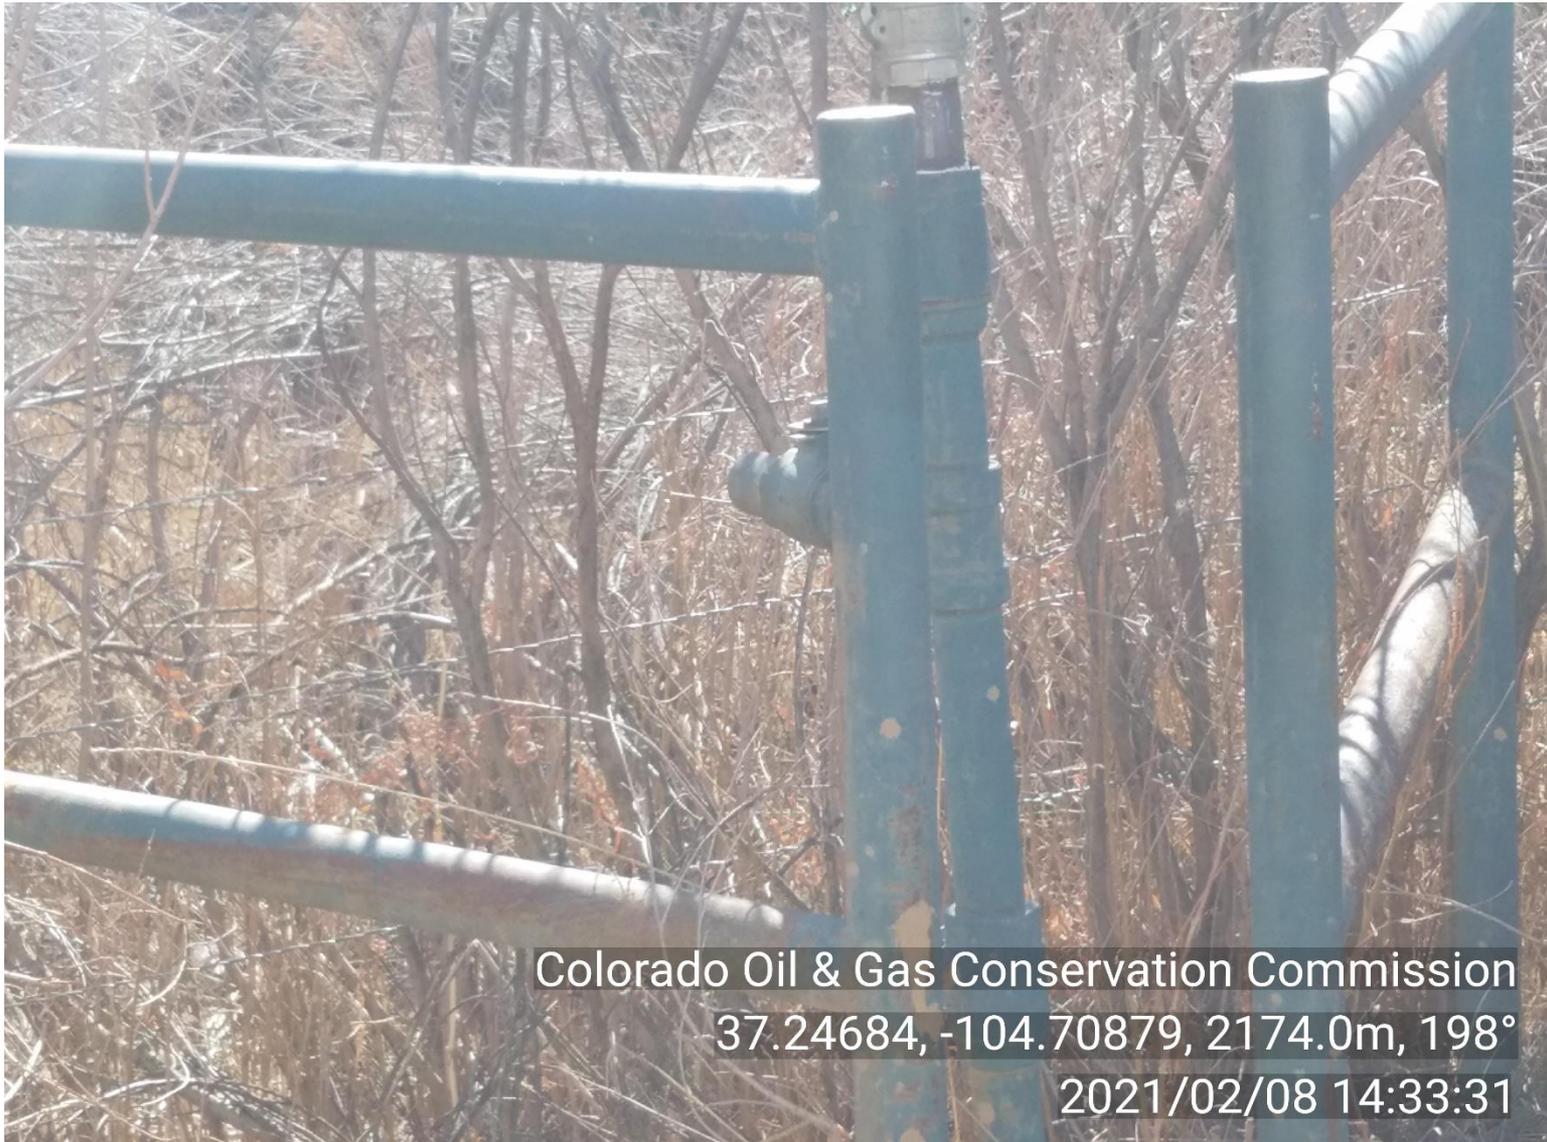
**Phone 16: DRIP JUST EAST OF BIG TIMER LOCATION NEAR REILLY CREEK. AT TIME OF INSPECTION I DO NOT SEE ANY EVEDANCE THAT THE DRIP HAS BEEN DRAINED ON THE GROUND.**
