# Inspection Photos

6/15/2021

Operator: SG INTERESTS I LTD - 77330

Location ID: 428197

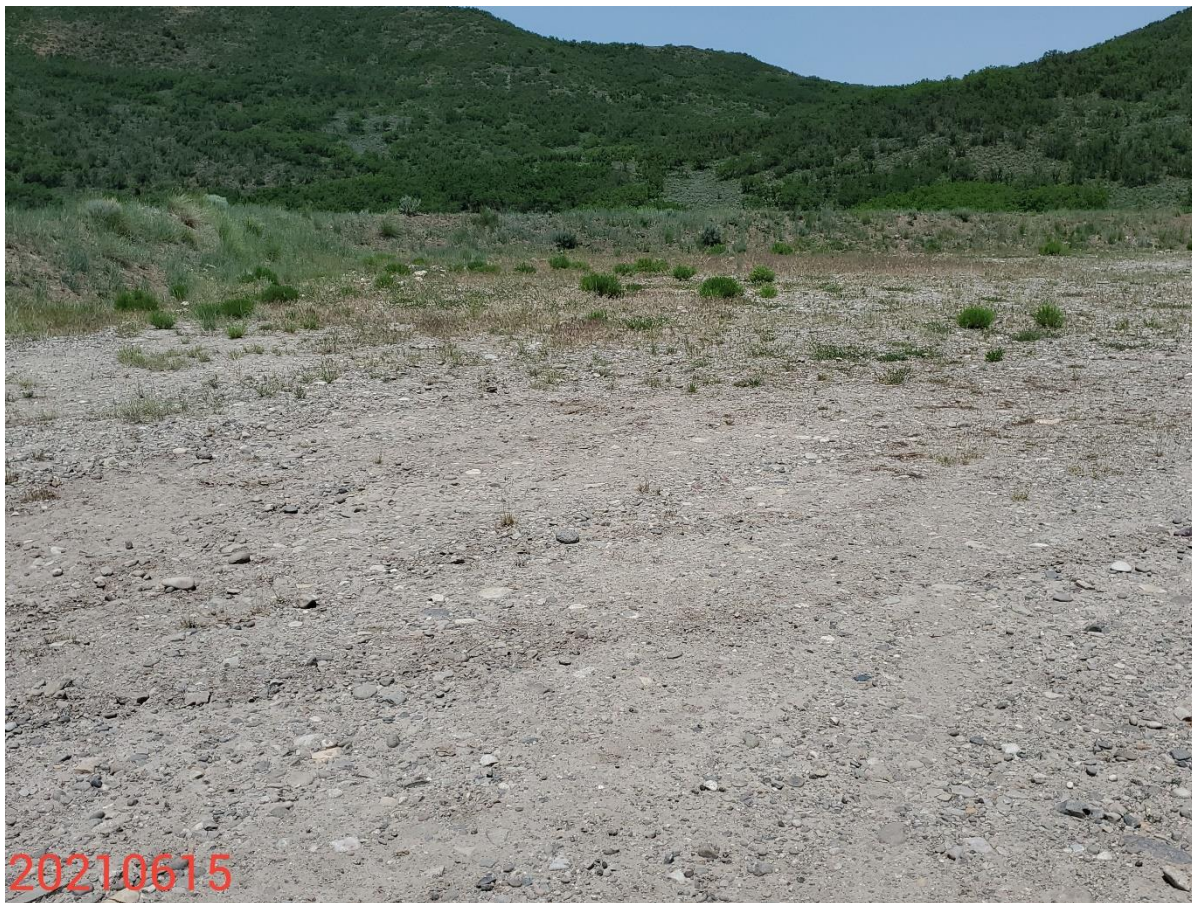
**Photo 1:** Photo taken from the southwest end of the Location, facing north. Photos 1-3 provide an overview of the Location from north, northeast to east.

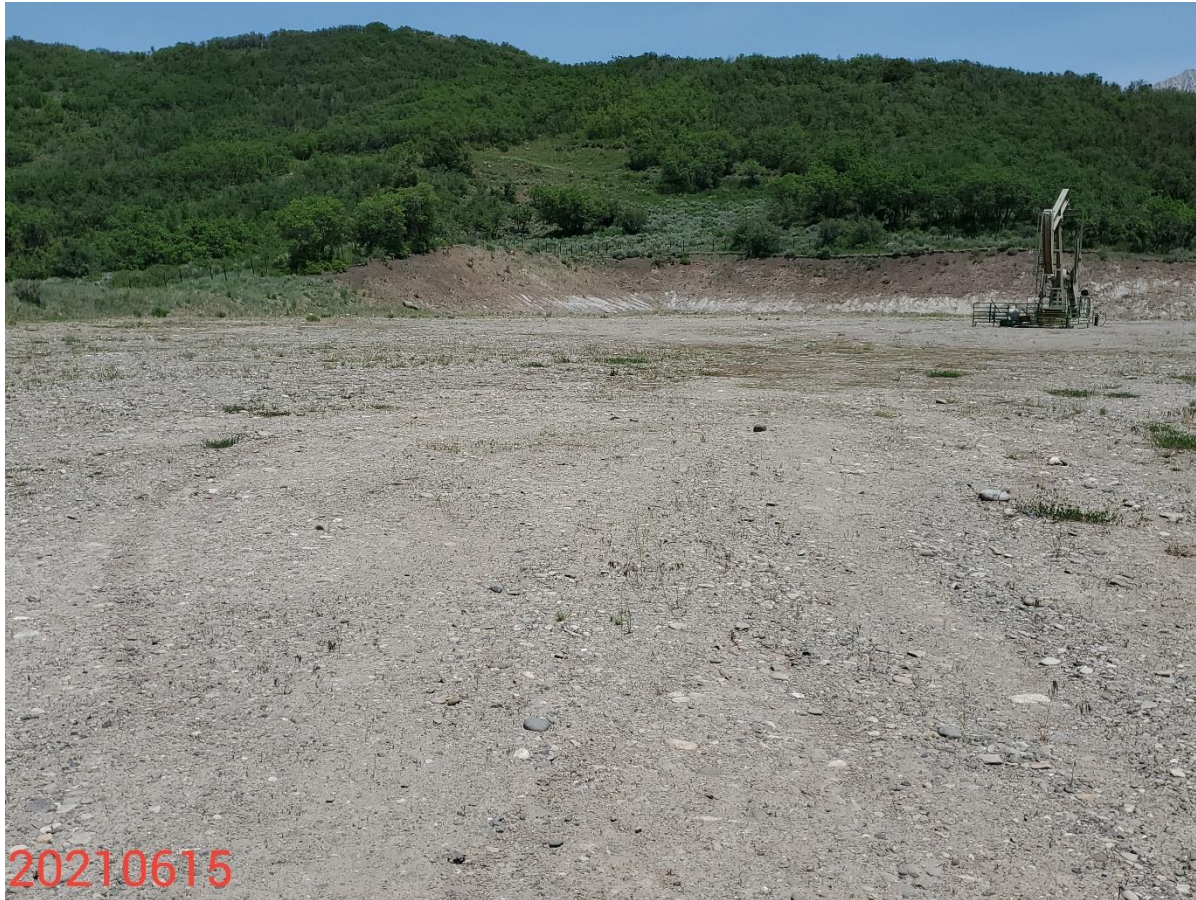
**Photo 2:** See comments under photo 1.

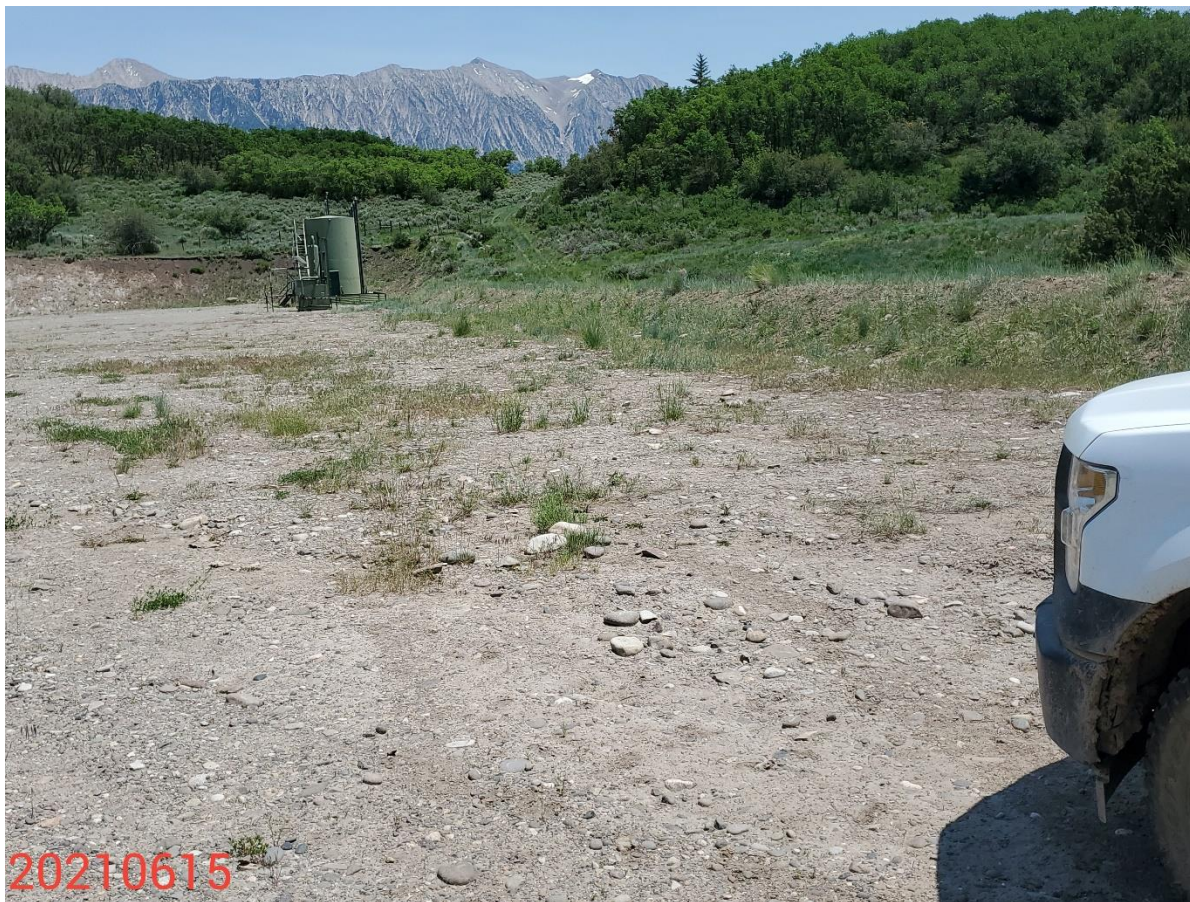
**Photo 3:** See comments under photo 1.

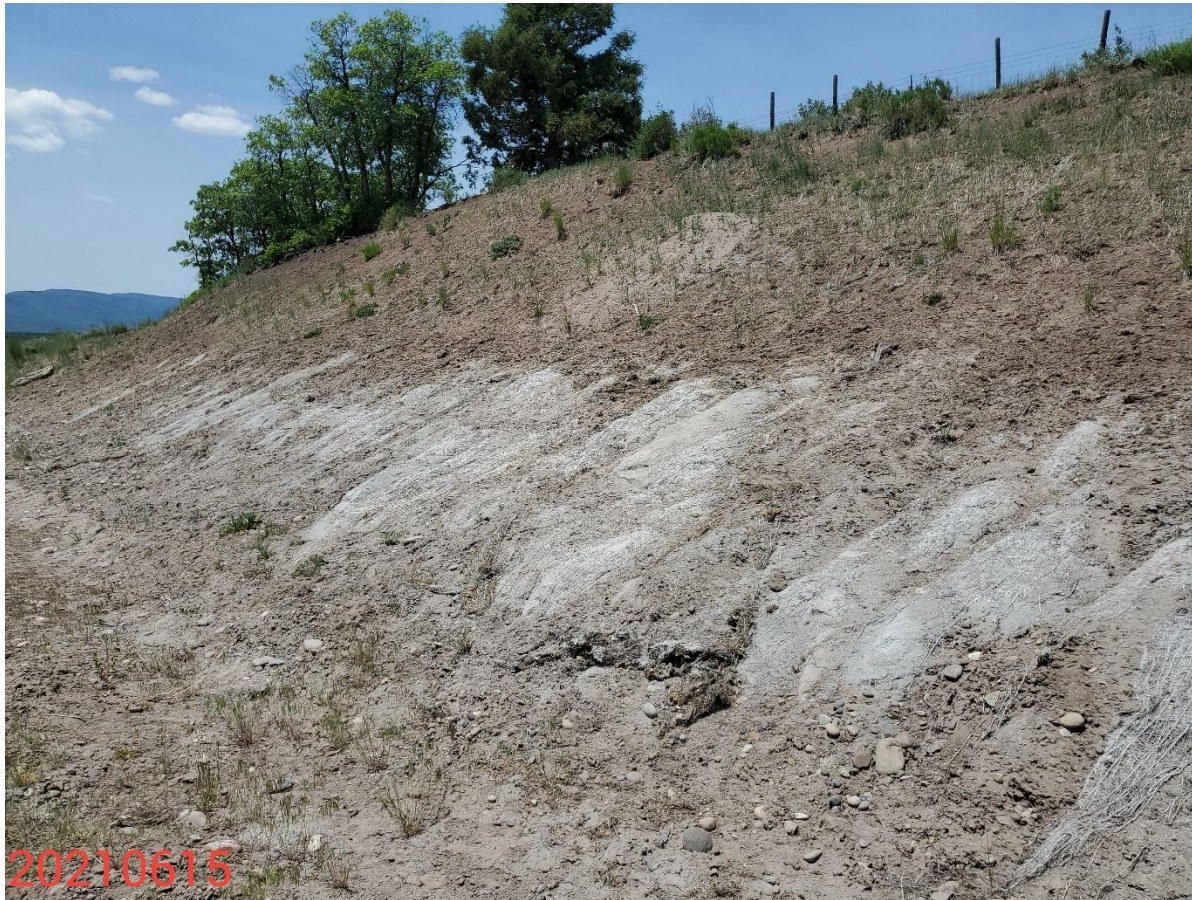
**Photo 4:** Photo taken from the cut-slopes on the northeast corner of the Location, facing west. Photo shows control measures (short term and long term) control measures to protect and stabilize the cut-slopes remain missing or insufficient.

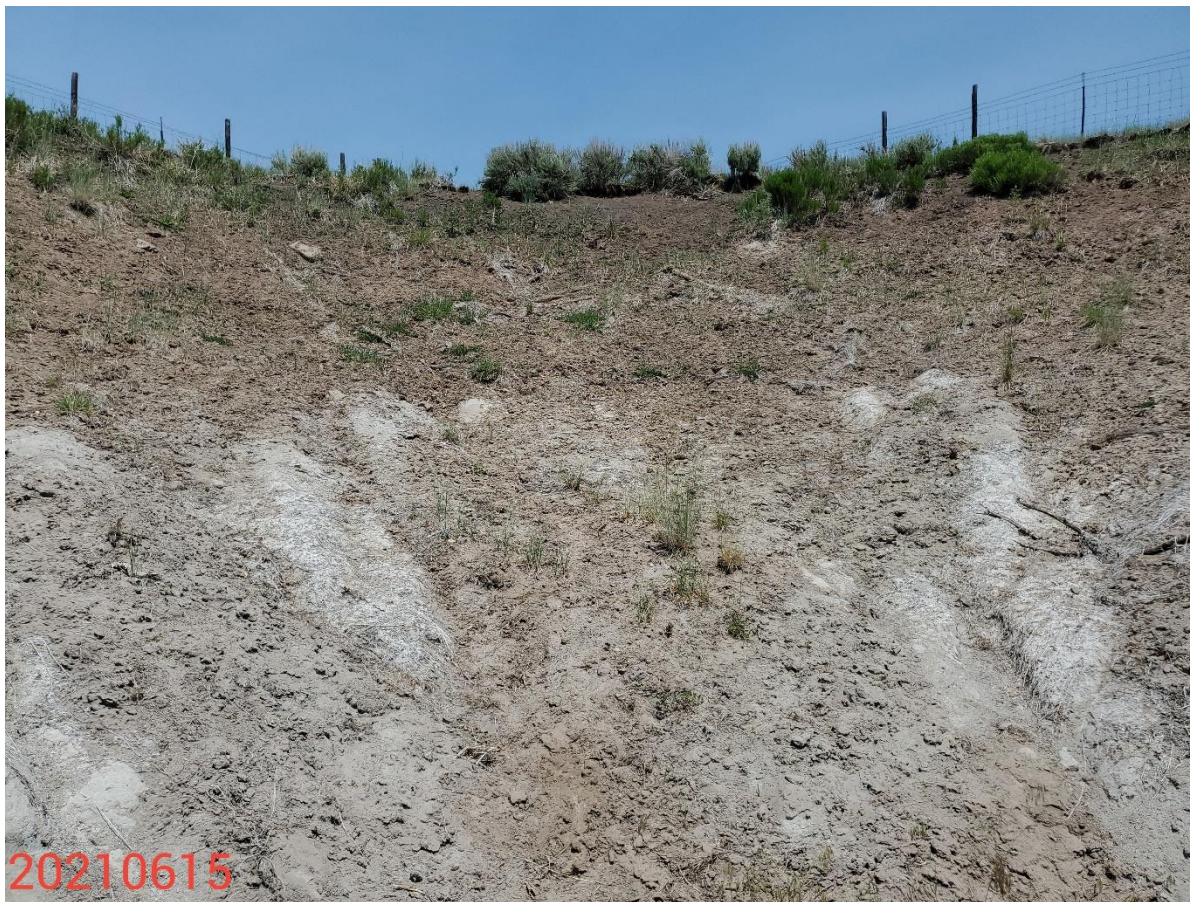
**Photo 5:** Photo taken from the cut-slopes on the northeast corner of the Location, facing northeast. Photo shows control measures (short term and long term) control measures to protect and stabilize the cut-slopes remain missing or insufficient.

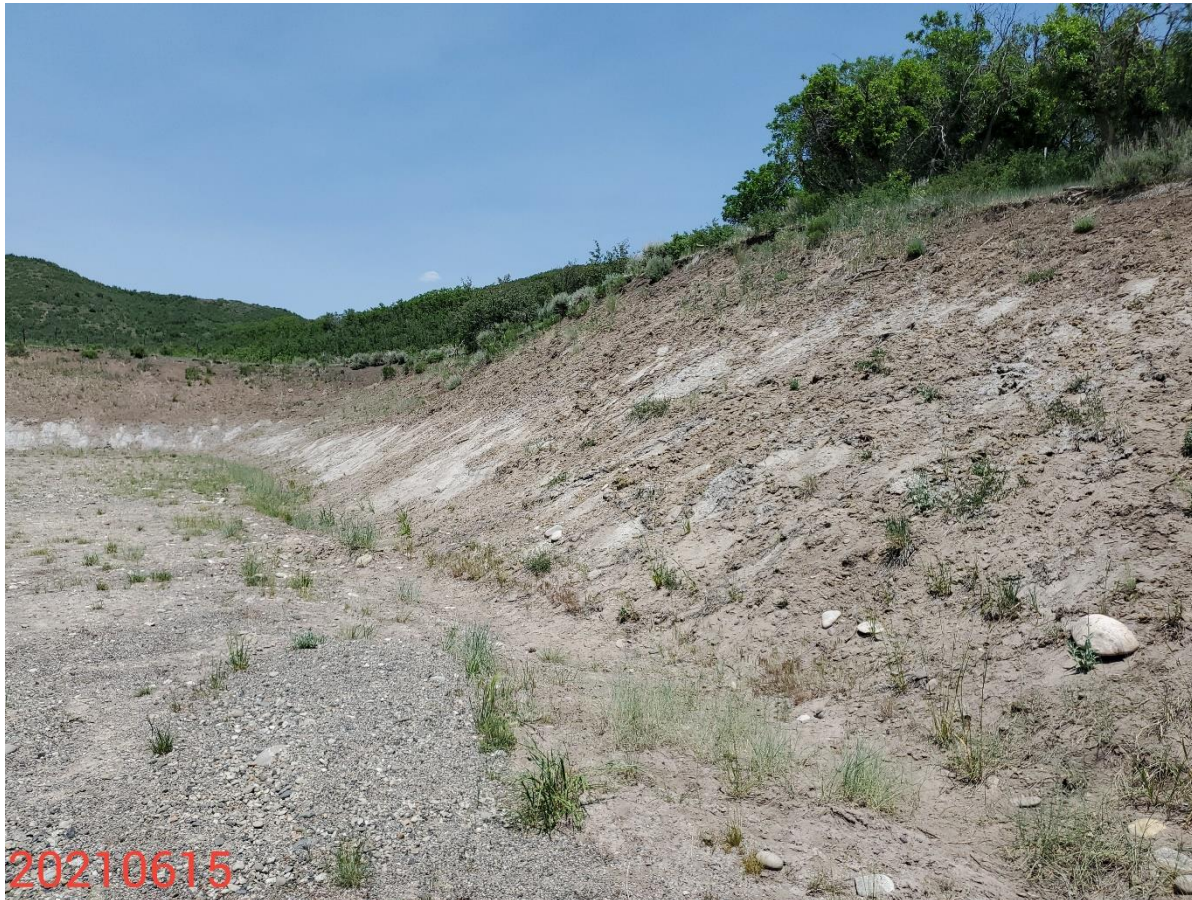
**Photo 6:** Photo taken from the cut-slopes on the southeast corner of the Location, facing north. Photo shows control measures (short term and long term) control measures to protect and stabilize the cut-slopes remain missing or insufficient.

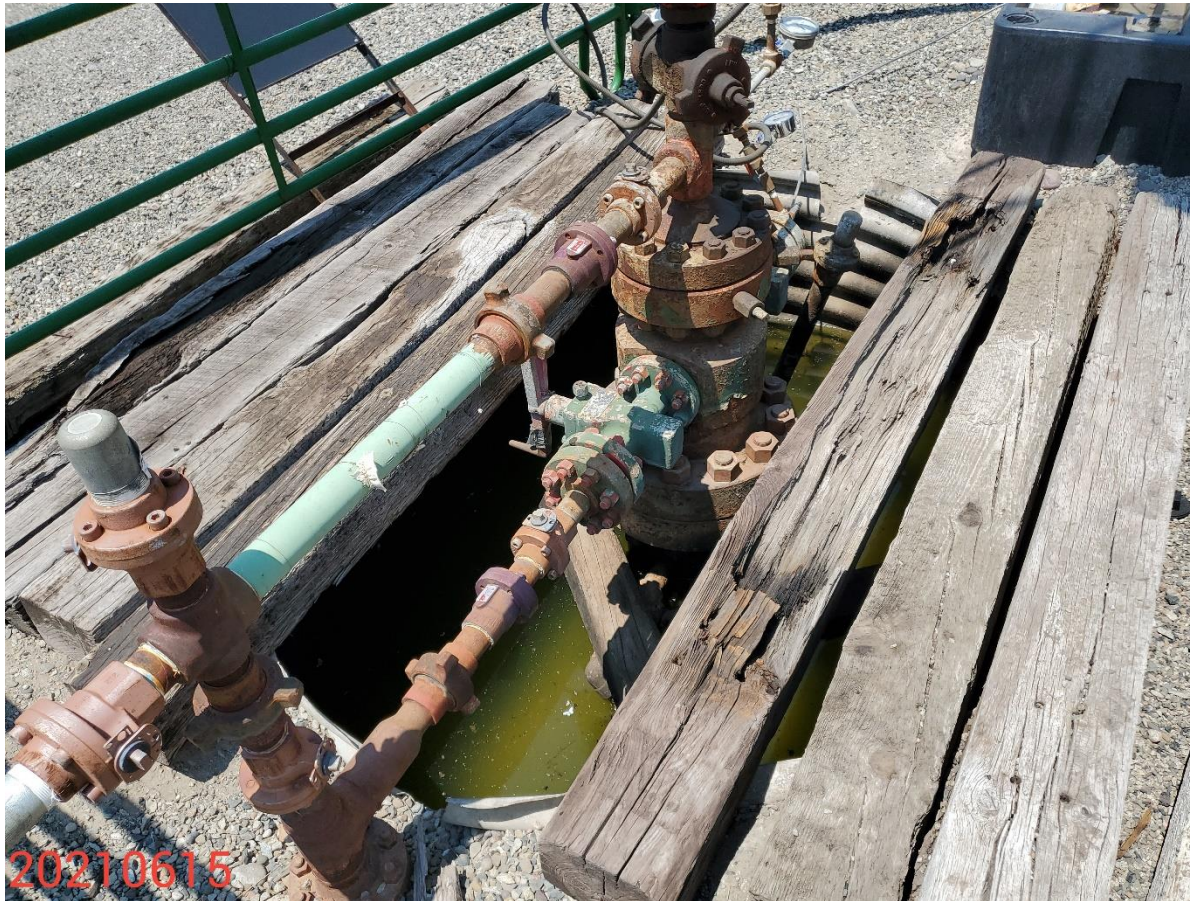
**Photo 7:** Photo off wellhead and cellar. Photo shows control measures to prevent wildlife access to the cellar, and to protect wildlife resources remain missing or inadequate. Photo also shows fluids/chemicals within cellar have not been removed.

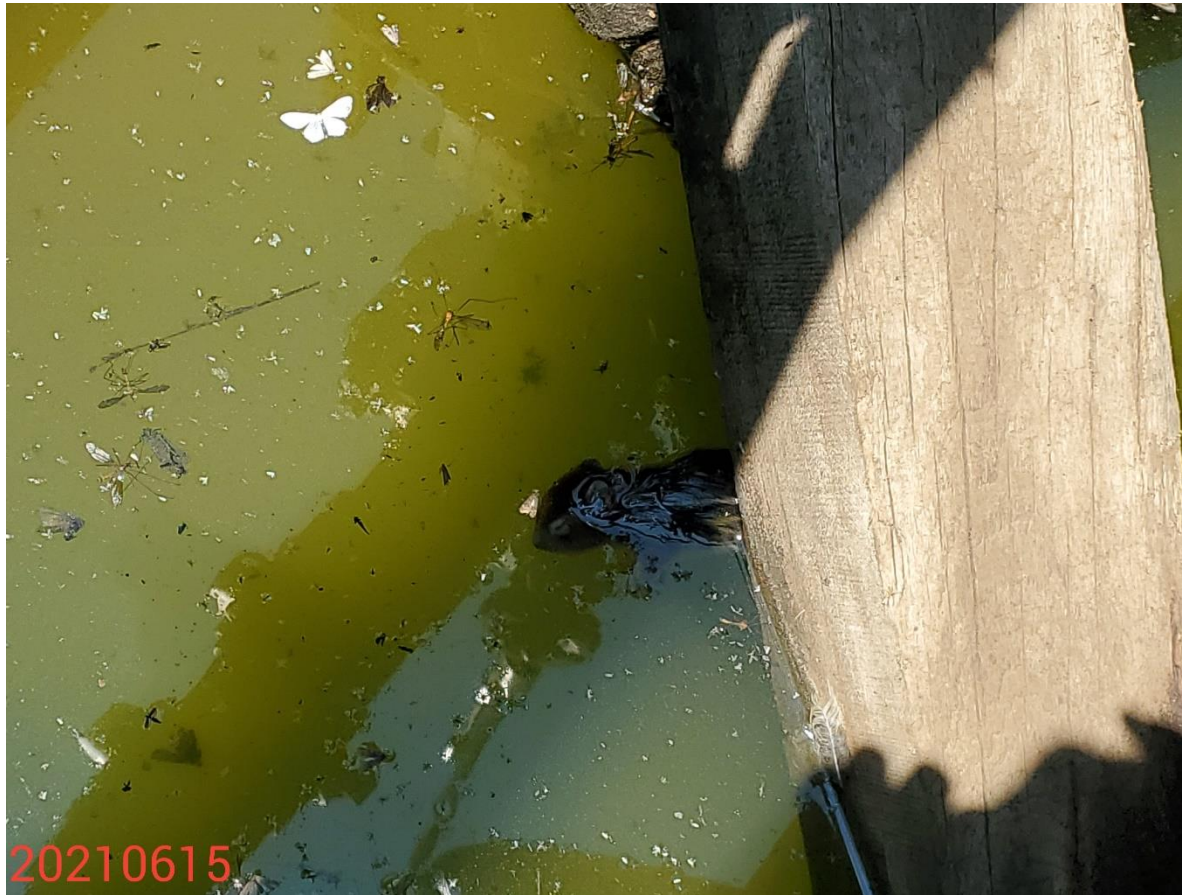
**Photo 8:** Continued from photo 7. Photo shows wildlife mortality (ground squirrel) within the cellar. Control measures to prevent wildlife access to the cellar, and to protect wildlife resources remain missing or inadequate. Photo also shows fluids/chemicals within cellar have not been removed.

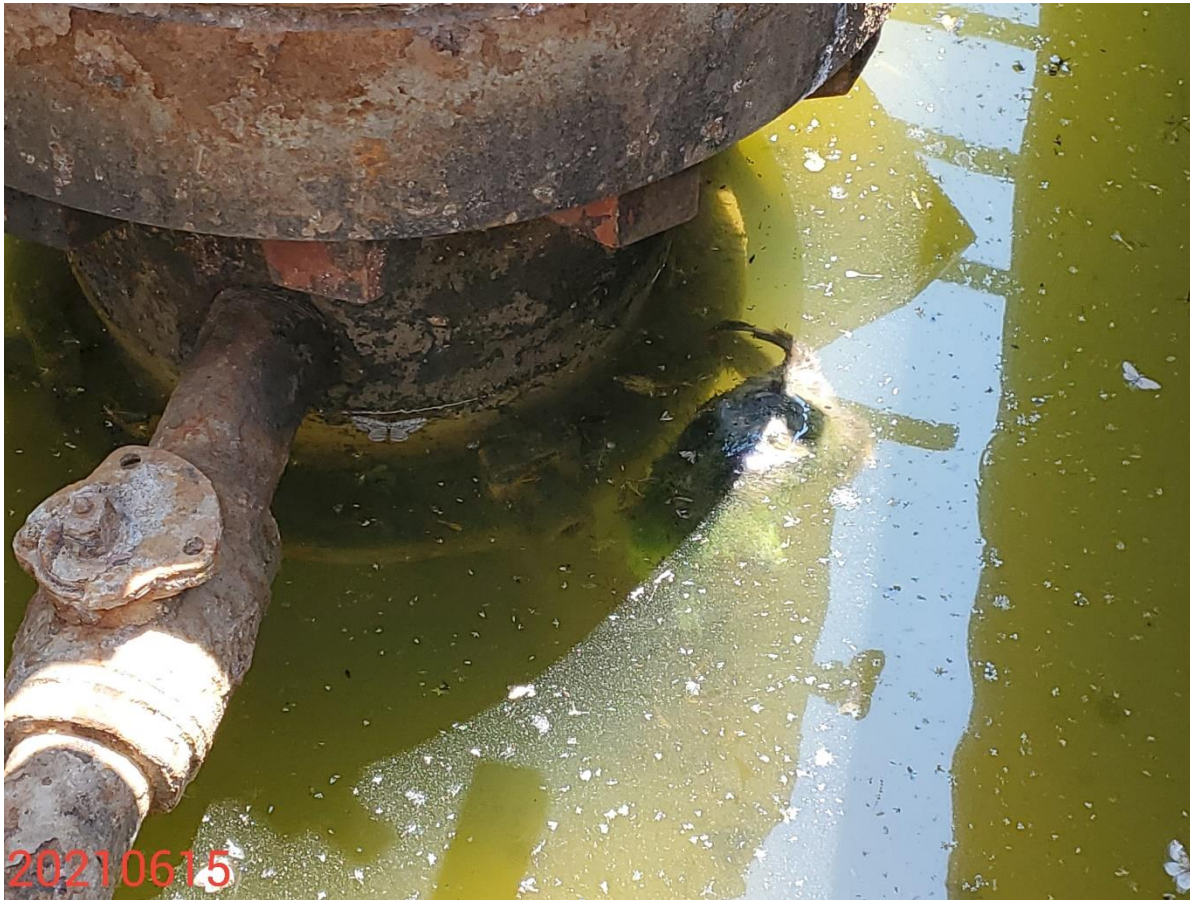
**Photo 10:** Continued from photo 7. Photo shows wildlife mortality (ground squirrel) within the cellar. Control measures to prevent wildlife access to the cellar, and to protect wildlife resources remain missing or inadequate. Photo also shows fluids/chemicals within cellar have not been removed.
