Inspection Photos  
Operator: Simcoe  
API: 067-06659  
Date: 10/13/2021

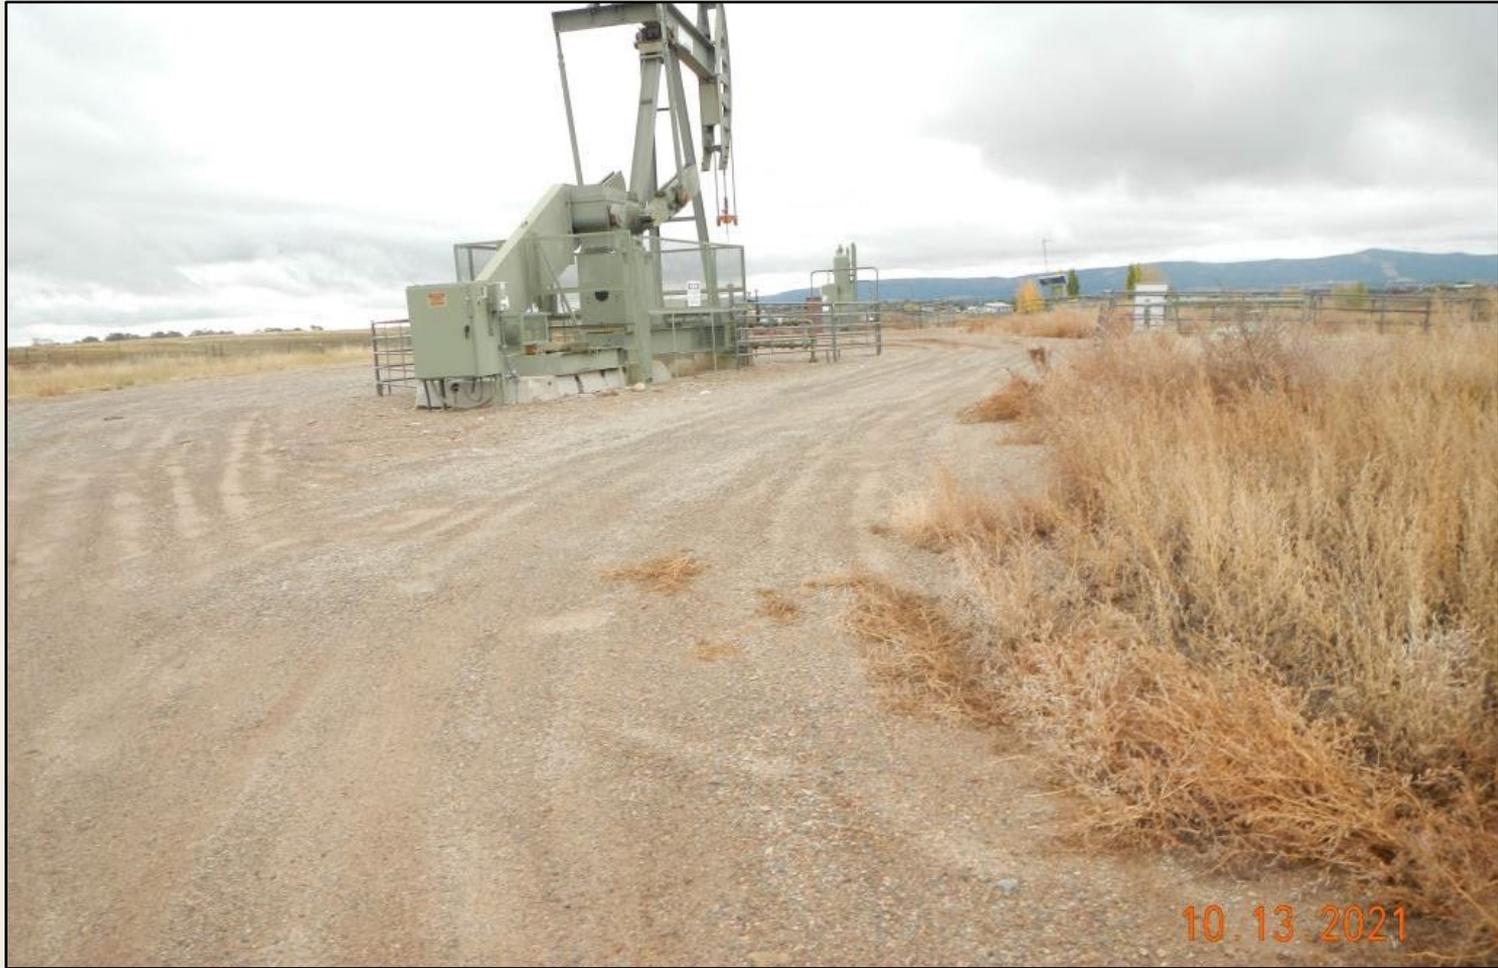
Photo 1. View of project area from the well pad entrance facing center.

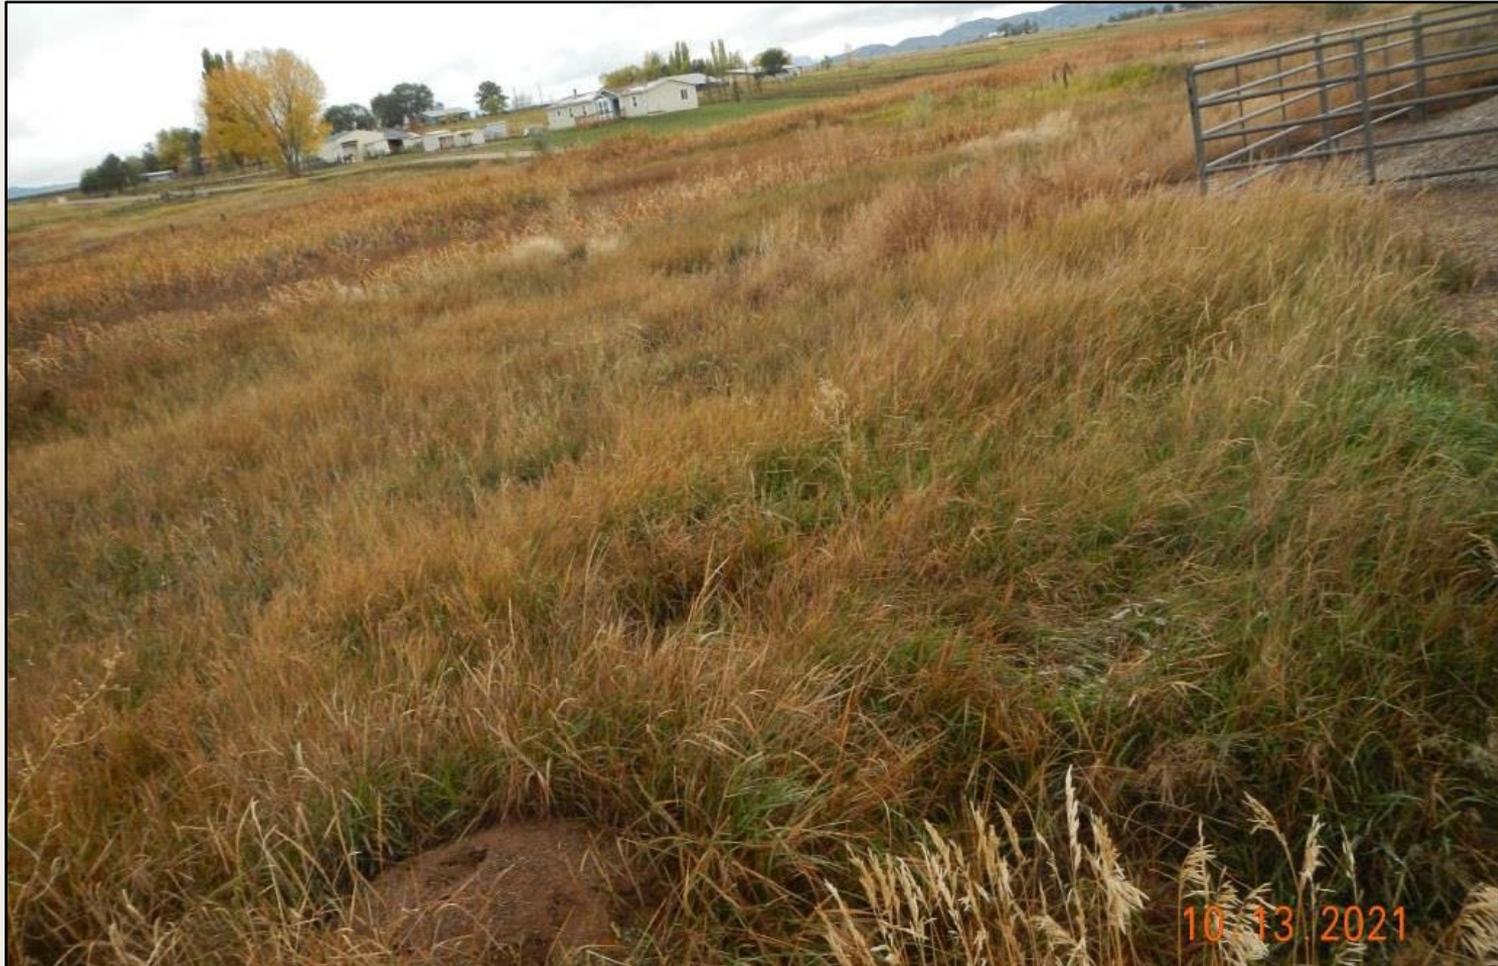
Photo 2. View of the western project area from the southwestern corner facing northward. Revegetation is progressing with irrigated grasses such as smooth brome, red fescue, and thickspike whatgrass.

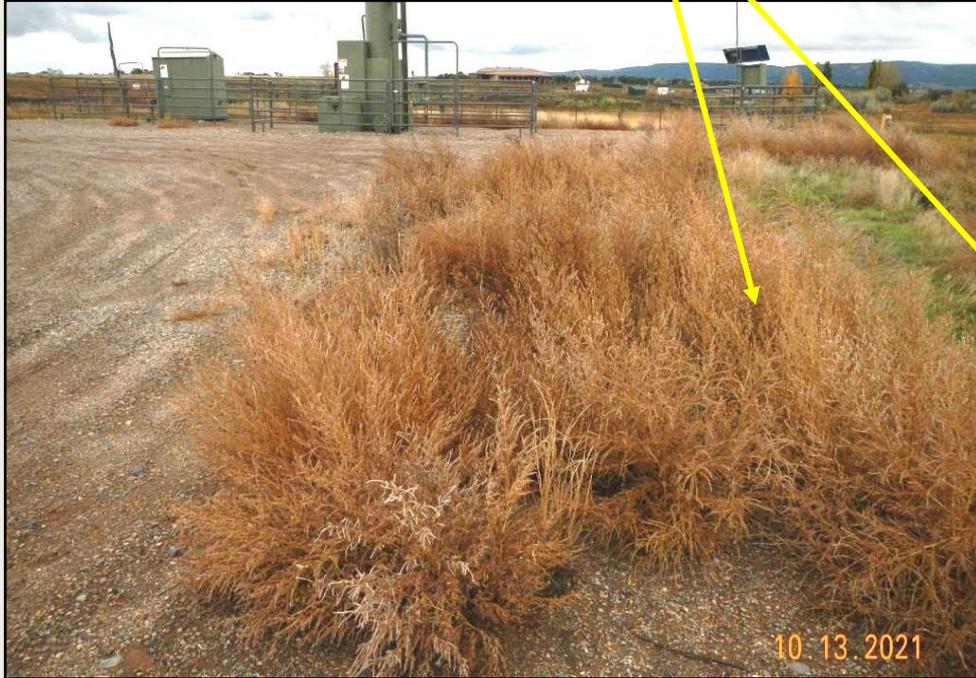
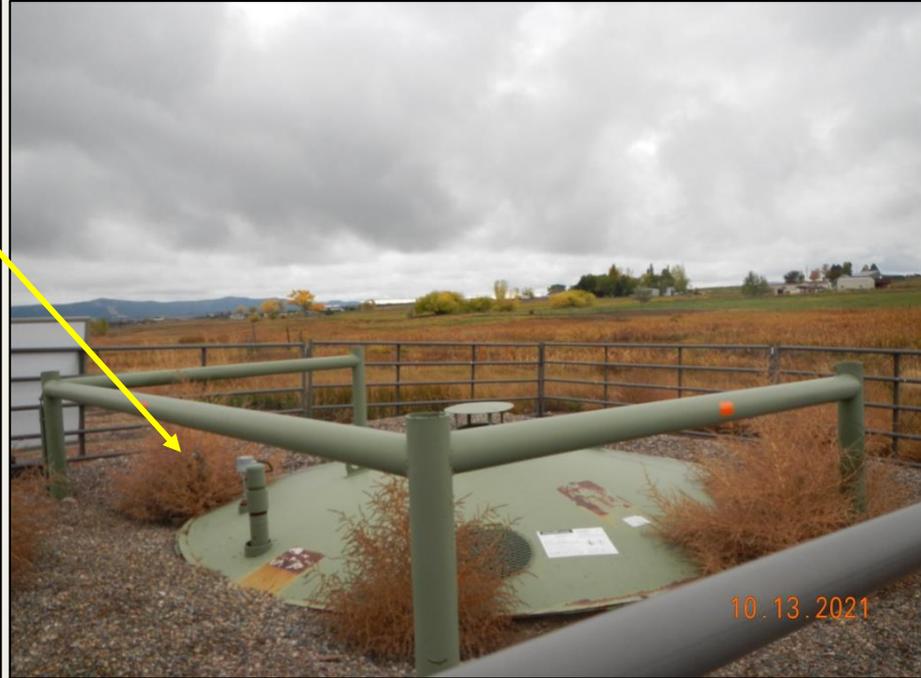
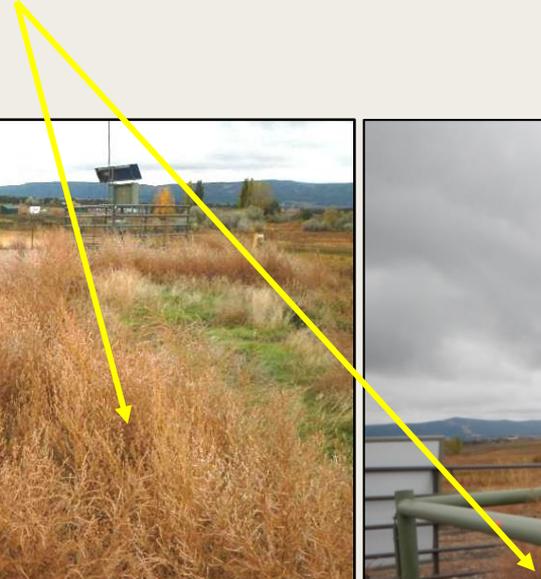
# Kochia debris

Photo 3. View of dense kochia debris within the project area and growing around partially buried vessel.

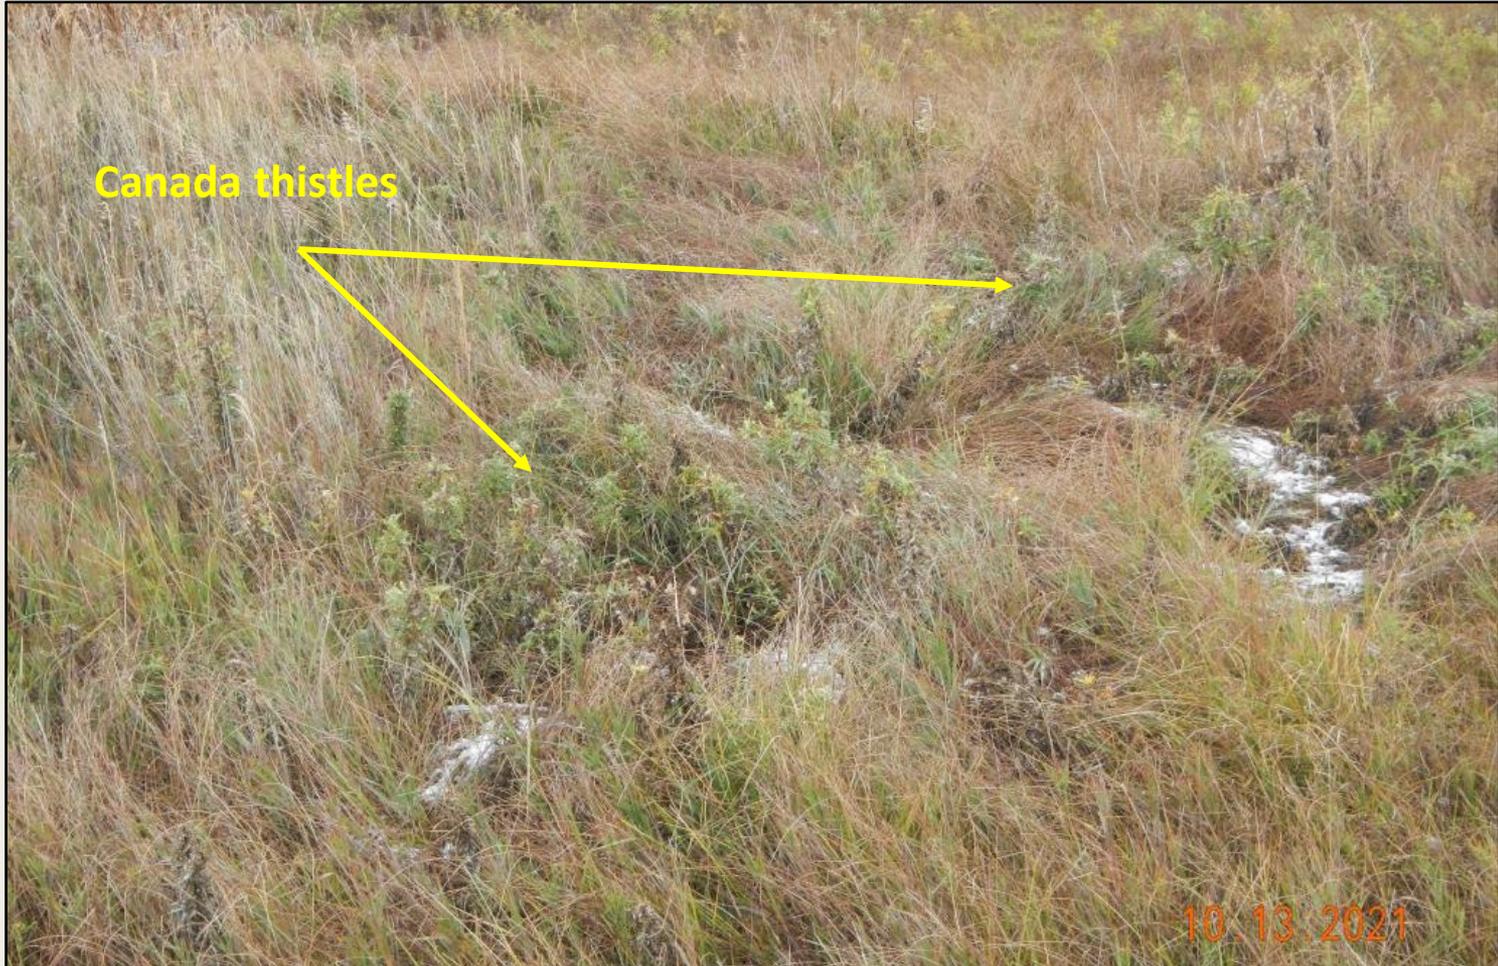
Photo 4. View of Canada thistles (approx. 100 individuals) within the northwestern project area.

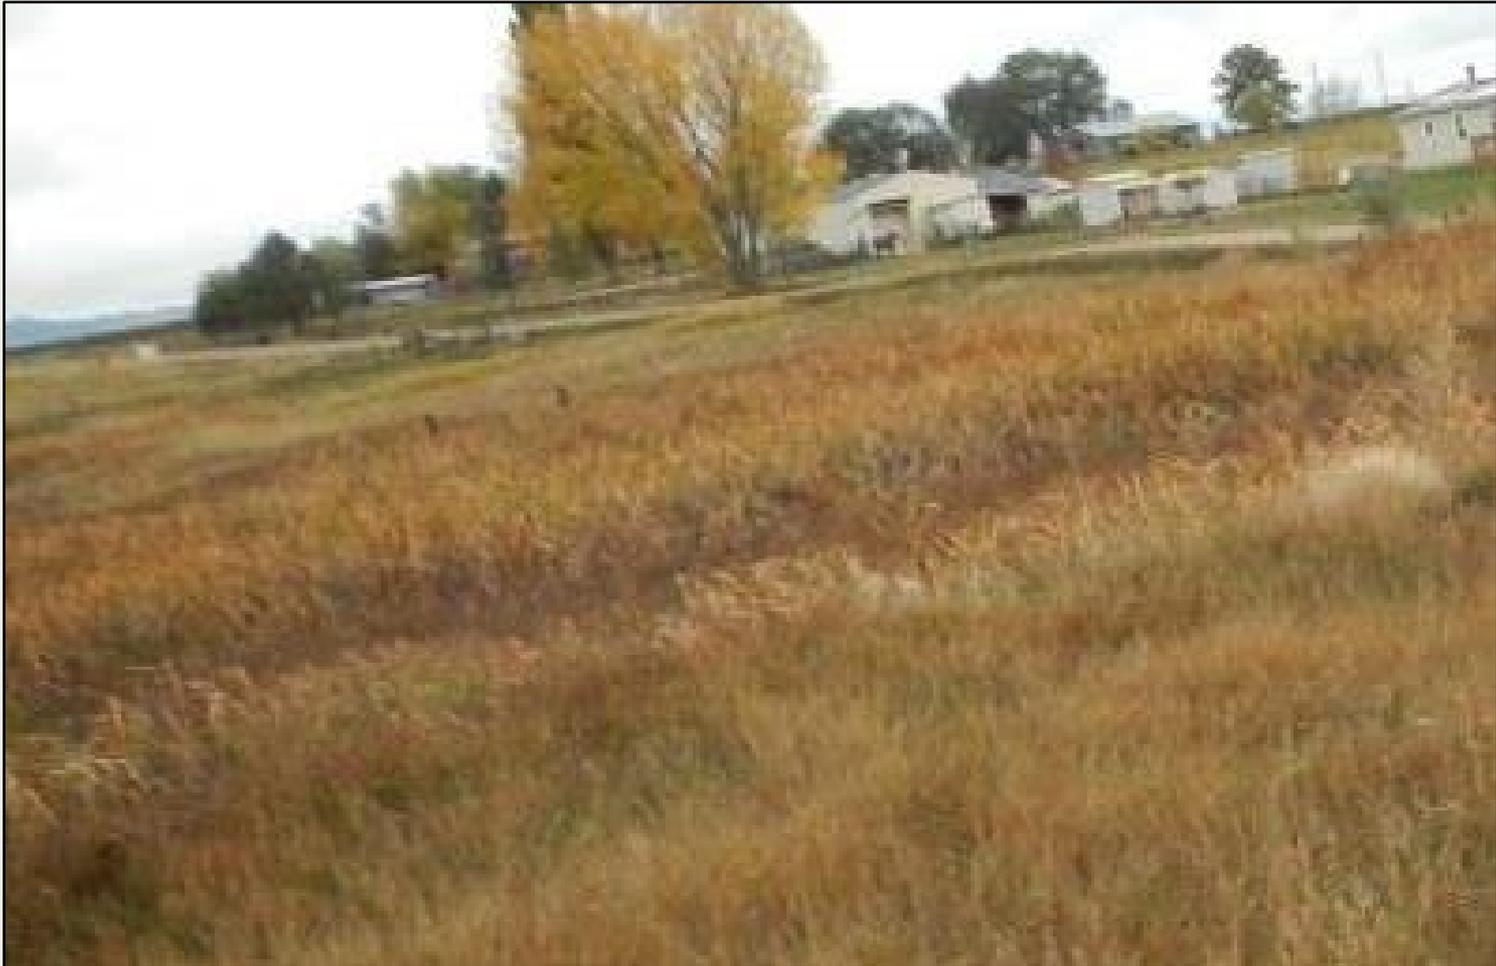
Photo 5. View of reference area comprised of irrigated grass fields mixed with irrigated grasses such as smooth brome and red fescue, as well as wetland vegetation such as cattails, rushes, and foxtail barley.
