Inspection Photos  
Operator: Hilcorp  
API: 067-07403  
Date: 11/3/2021

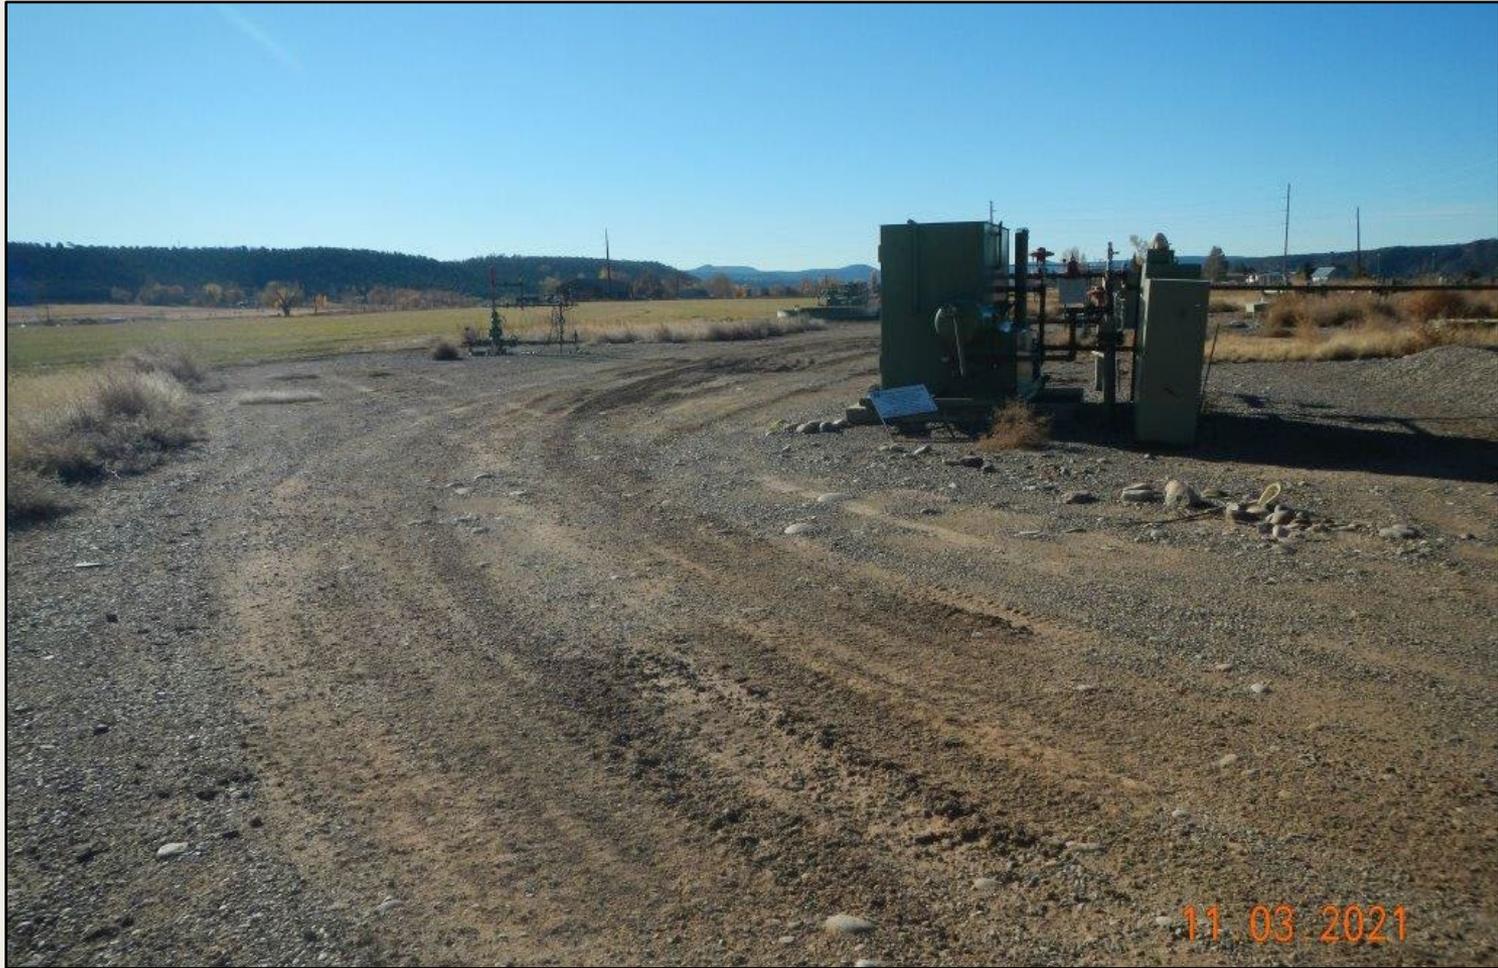
Photo 1. View of the project area from the well pad entrance facing center.

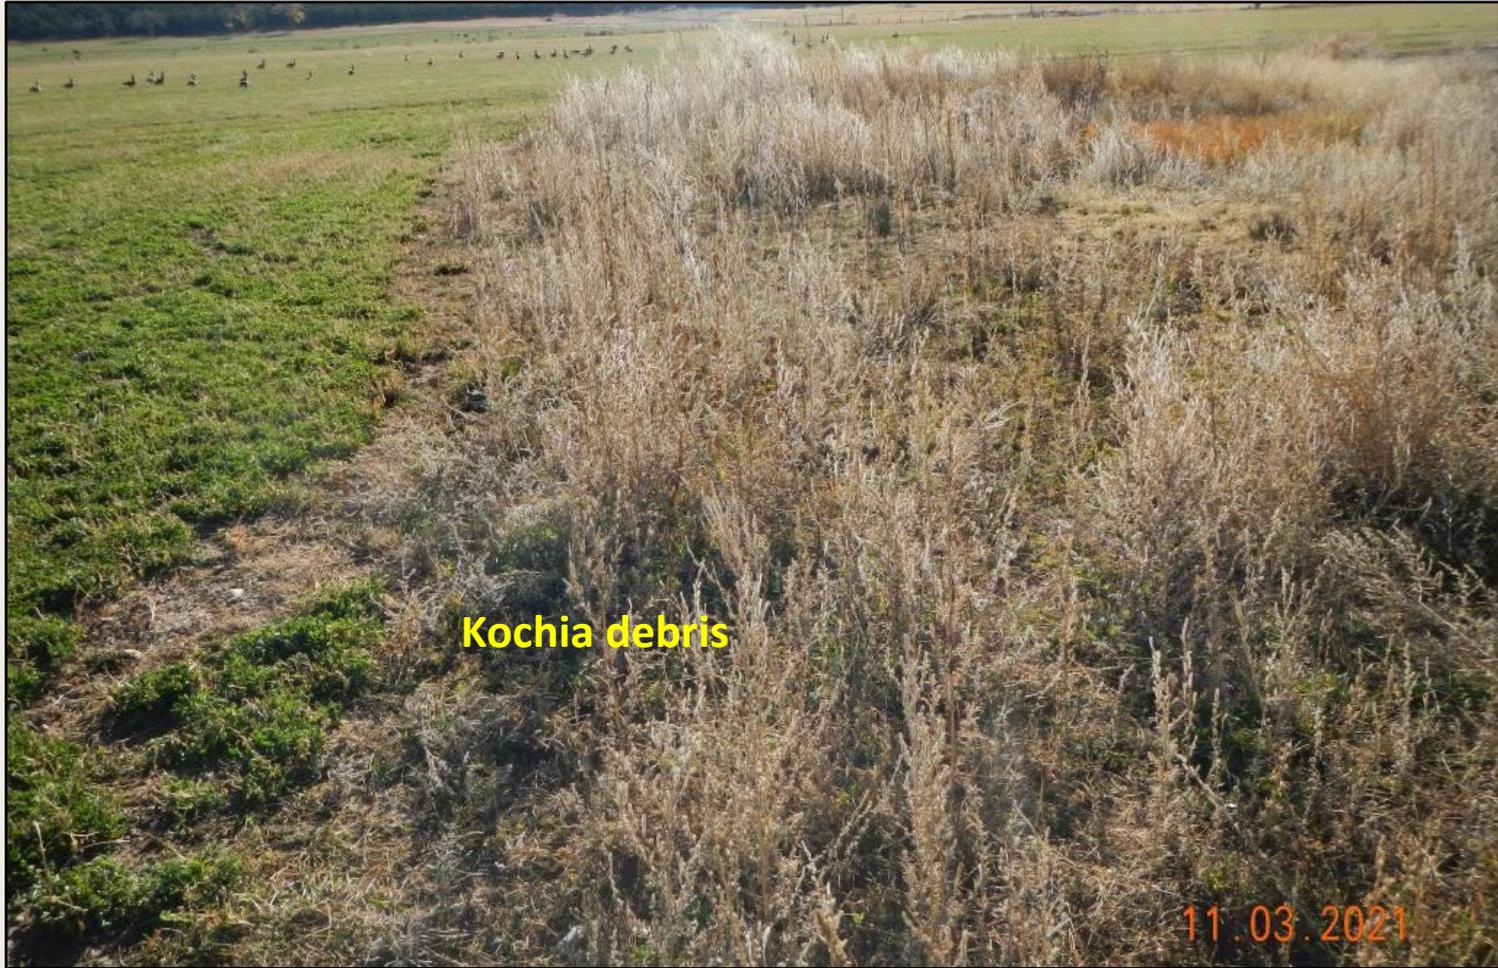
Photo 2. View of the northern project area from the northwestern edge facing eastward. Dense kochia is present. Some desirable vegetation such as sand dropseed is also present. Edge of project area is line with green vegetation to weeds.

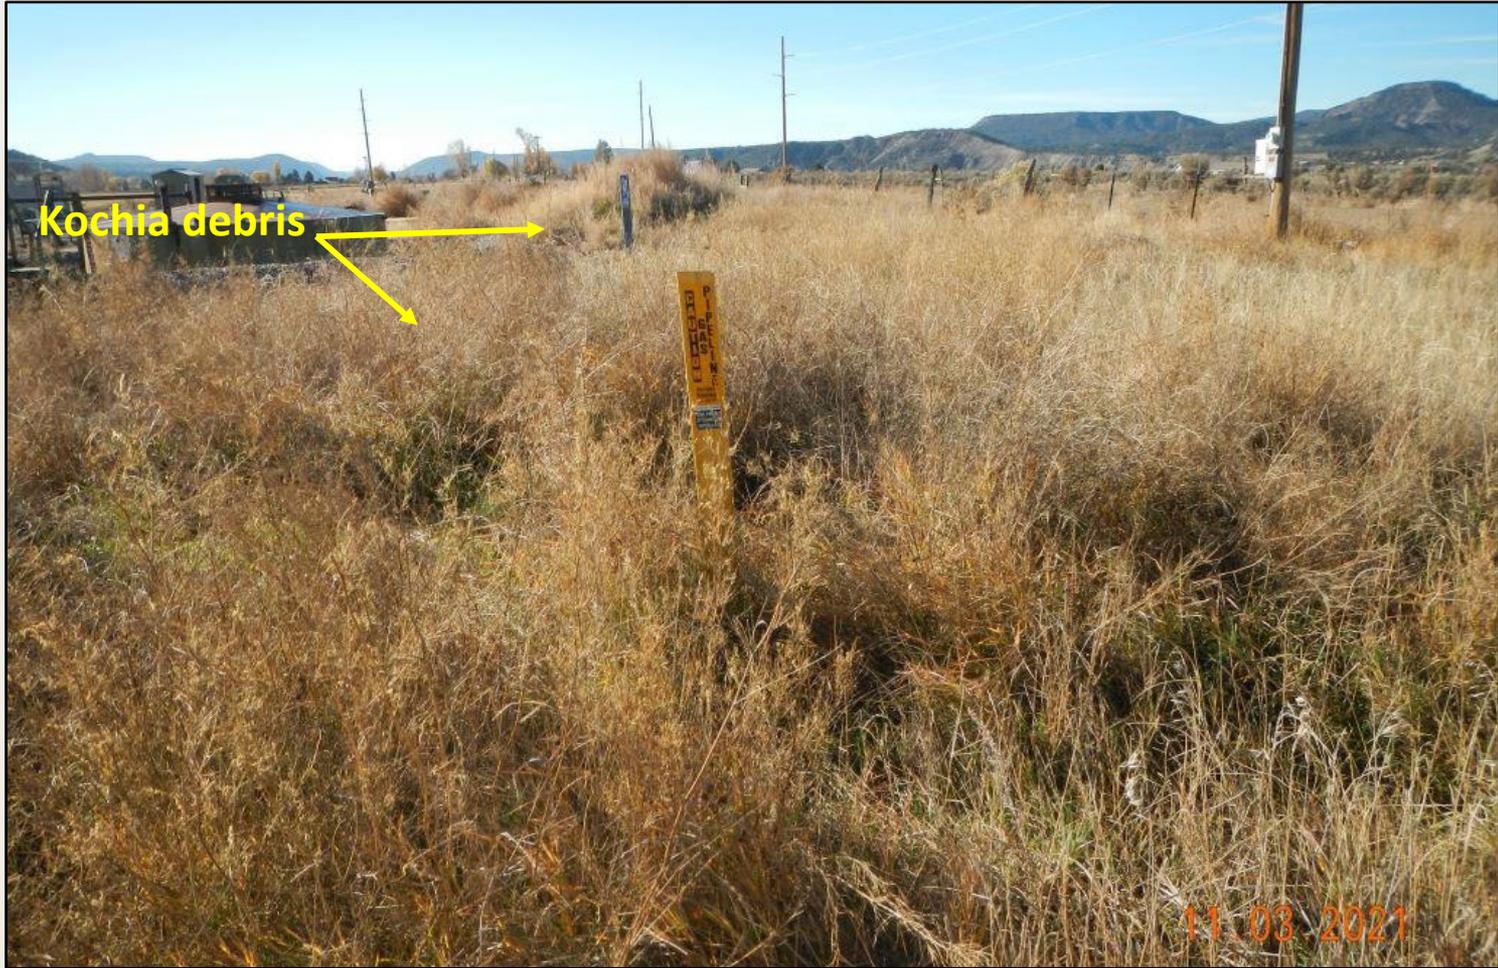
Photo 3. View of the western project area from the northwestern corner facing southward. Revegetation is comprised of alfalfa and smooth brome. Tall kochia, up to 4ft tall present.

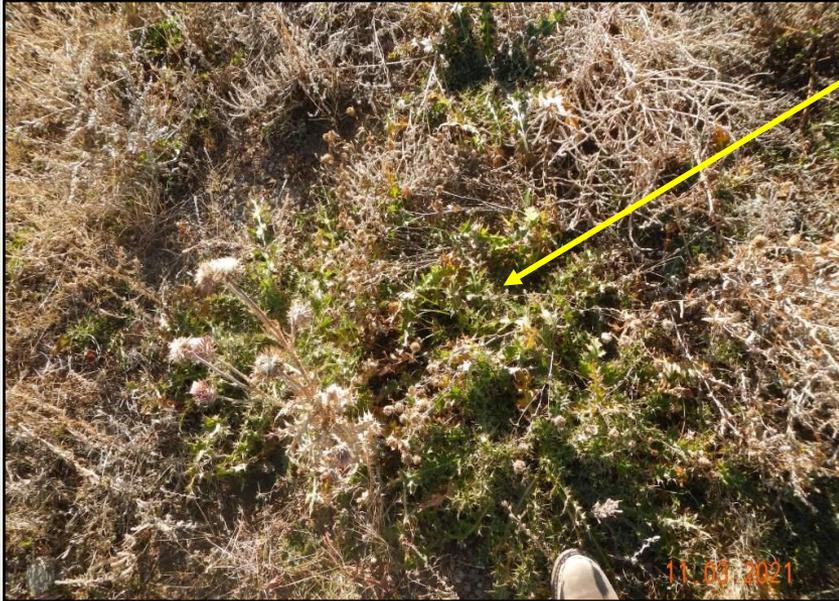
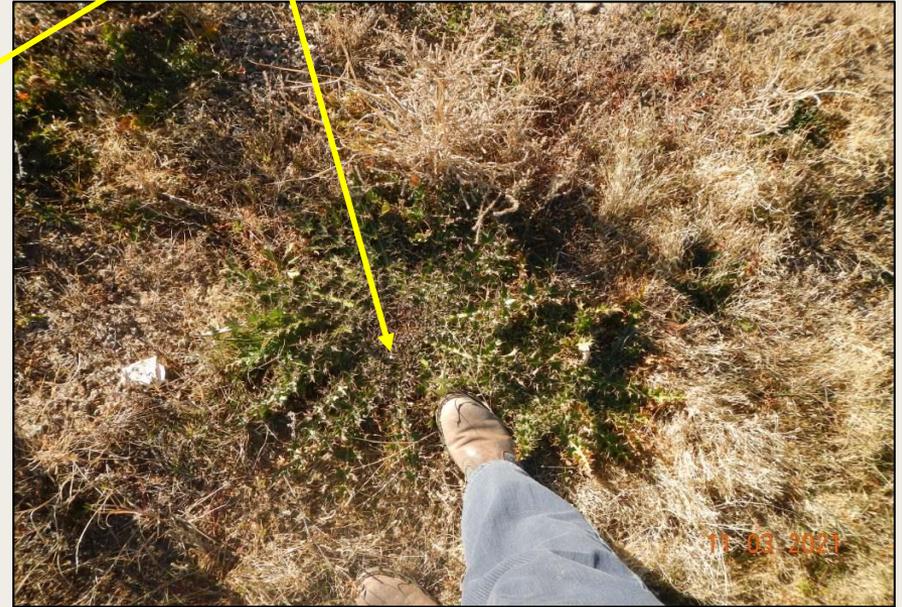
Musk thistles

Photo 4/5. View of musk thistle rosettes, approximately 15 individuals observed.

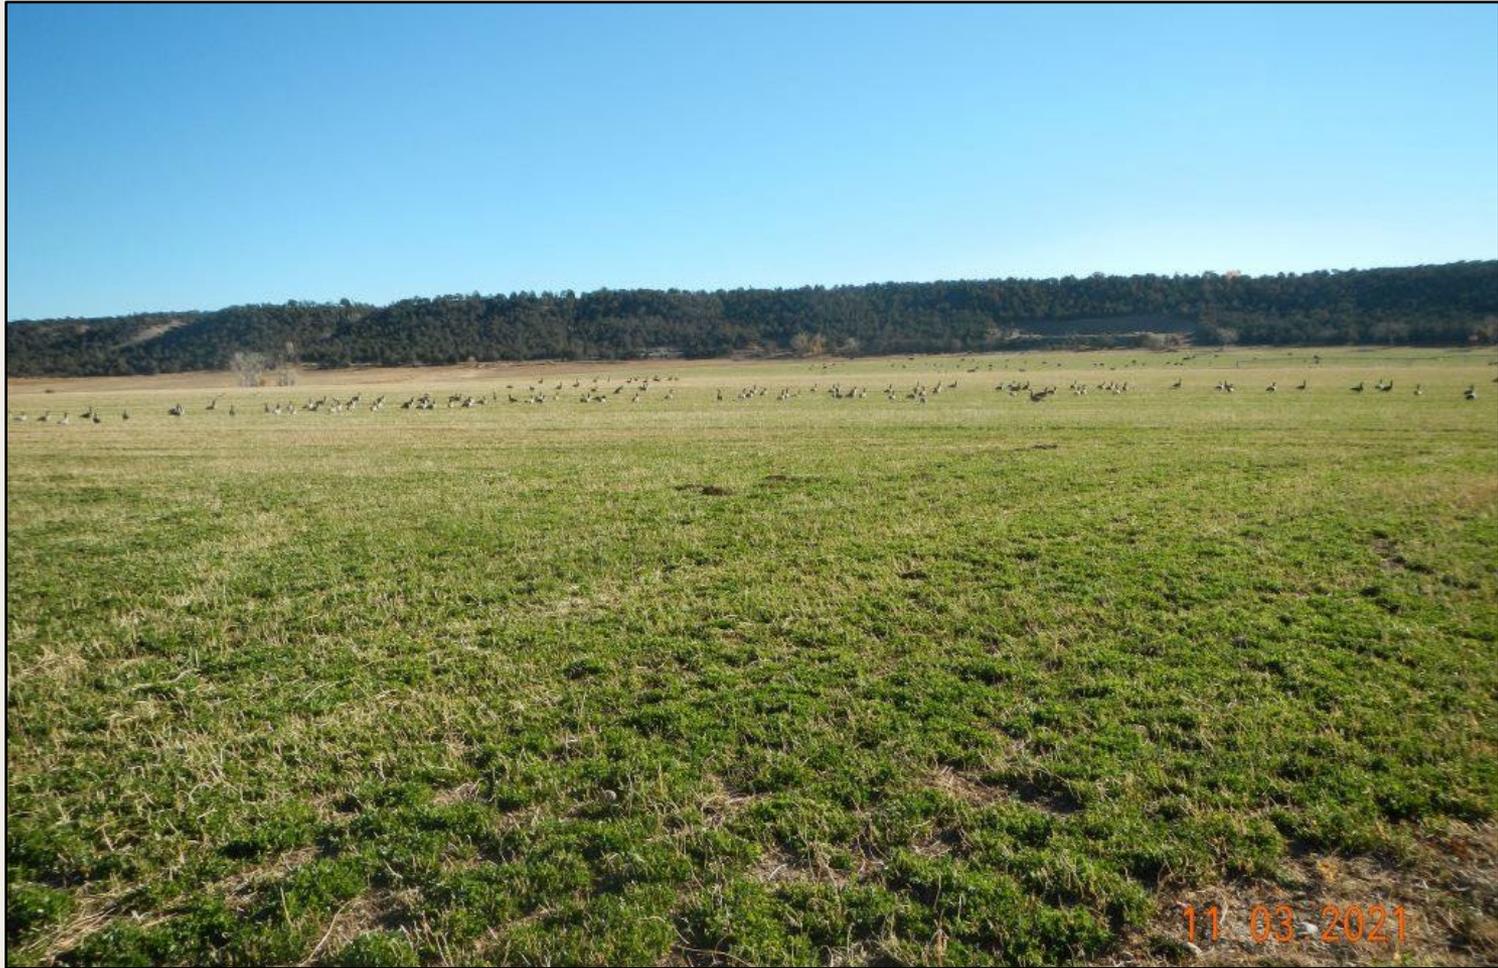
Photo 6. View of reference area comprised of irrigated grass field. Grasses are not in identifiable condition at this time.
