Inspection Photos

Operator: MARALEX RESOURCES INC - 53255

Location ID: 312639

Mesa County, CO

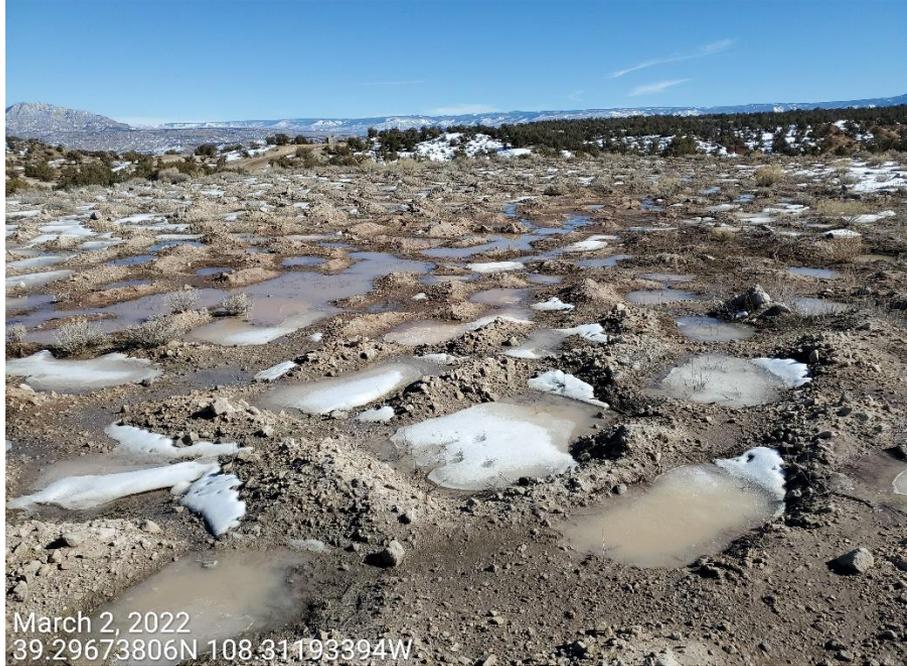
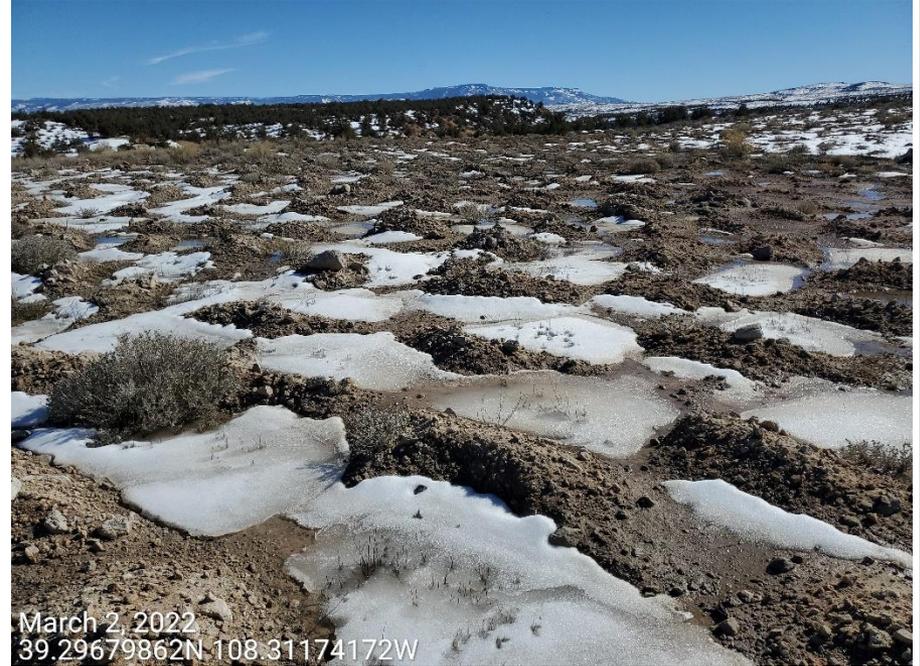
Photo 1: Photos taken from the Location. Photos examples showing that the Location is not progressing towards 1004 reclamation standards; Location predominantly bare and exposed soil; little to no desirable plant establishment evident.
