# Inspection Photos

Location Name: Wilson Creek Unit-63N94W /34NENW

Inspection Document #: 702800263

Anna O'Malley  
Reclamation Specialist, COGCC

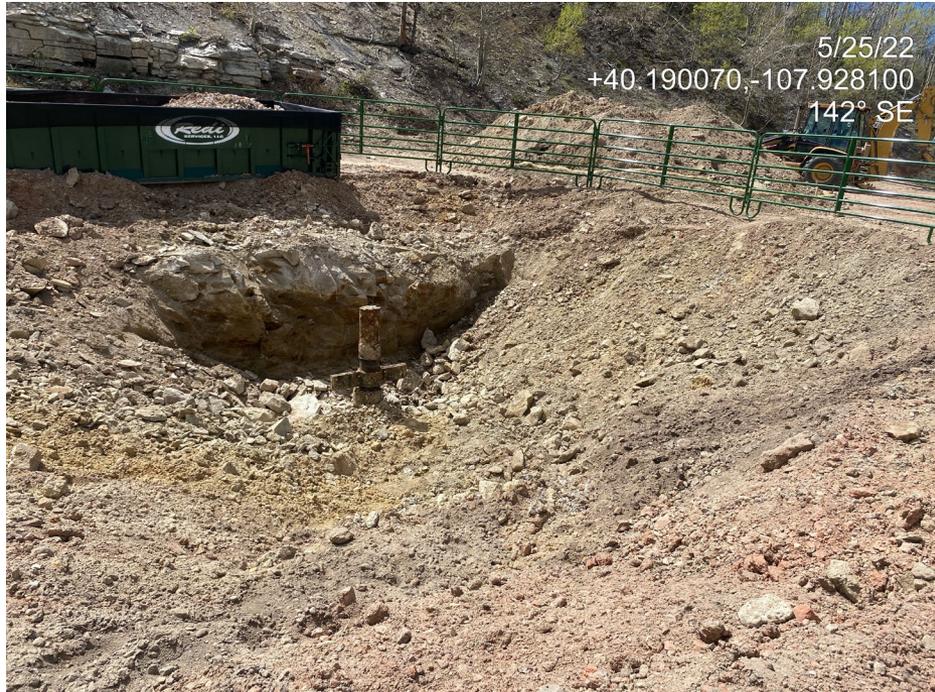
**Photo 1.** Photo taken from the center of the Location shows the excavation around the wellhead. Fence panels completely enclose the area and the slope of the pit is sufficiently gently to allow for wildlife egress.

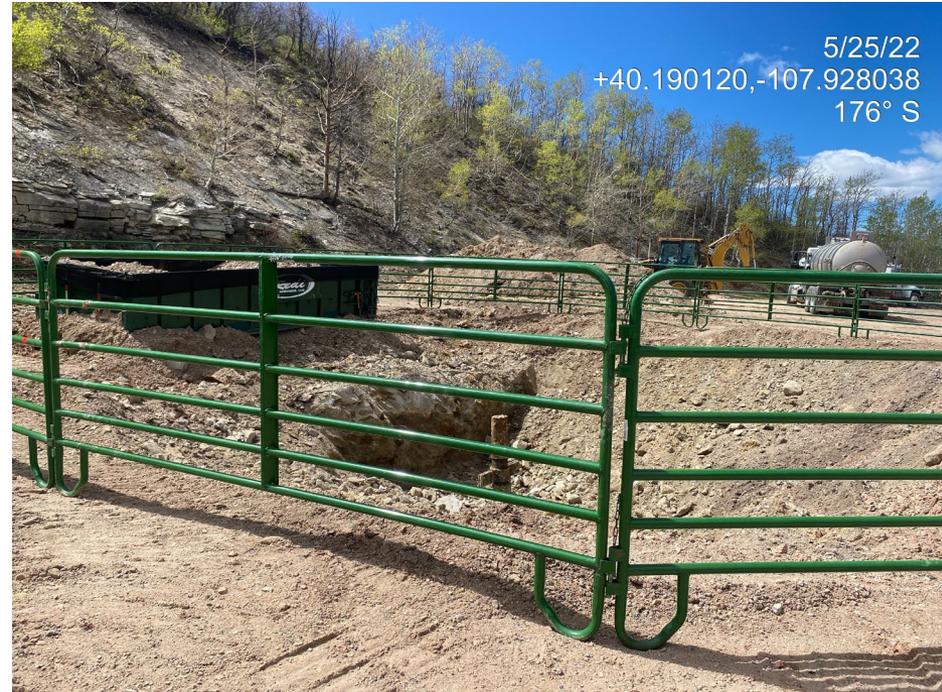
**Photo 2.** Refer to Photo 1 comments.

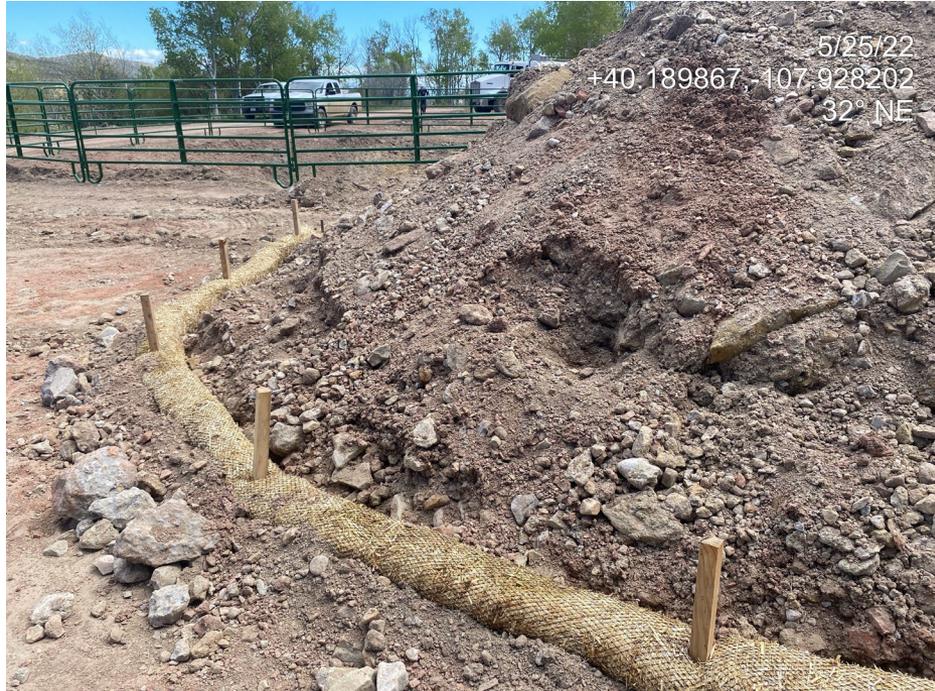
**Photo 3.** Photo taken from the south of the Location shows a pile of material excavated from around the well. A straw wattle has been installed as a control measure to prevent E&P waste from migrating off Location.

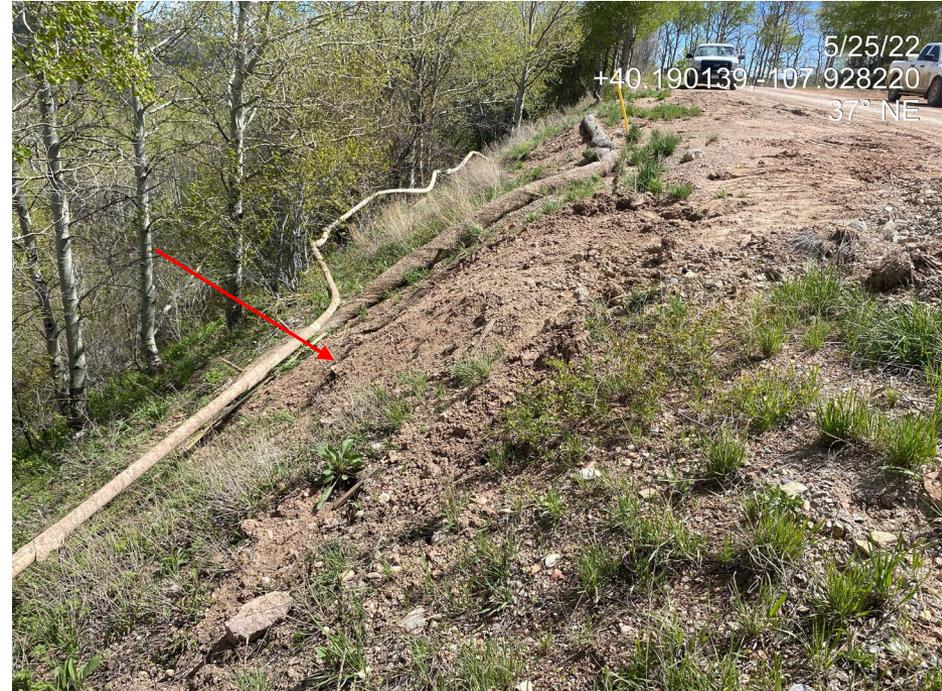
**Photo 4.** Photo taken from the northwest of the Location shows a straw wattle in disrepair and not functioning to control sediment transport from the Location.

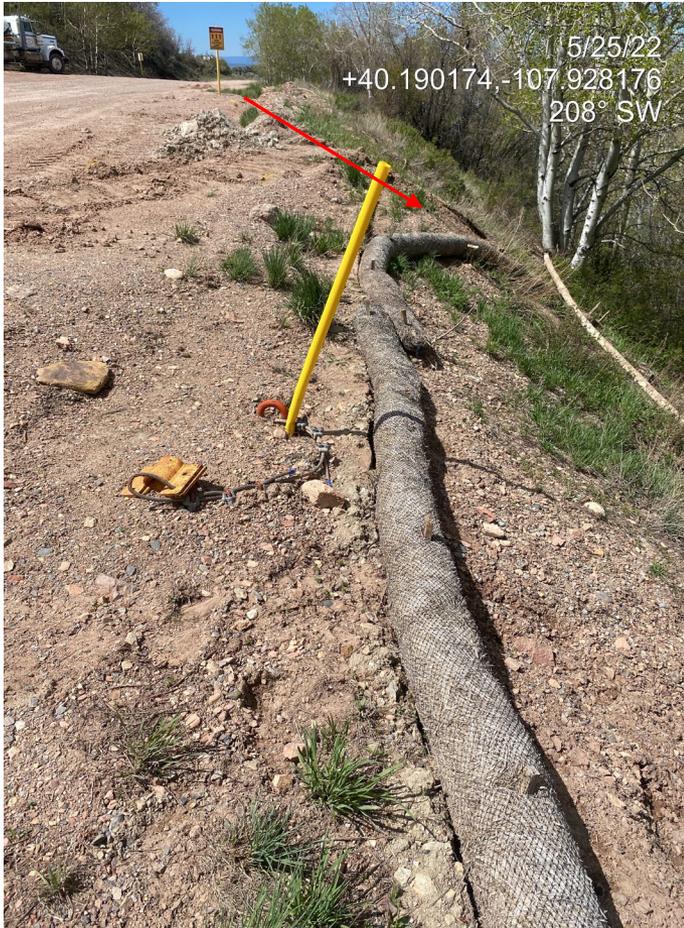
**Photo 5.** Photo taken from the northwest of the Location shows a straw wattle in disrepair and not functioning to control sediment transport from the Location.

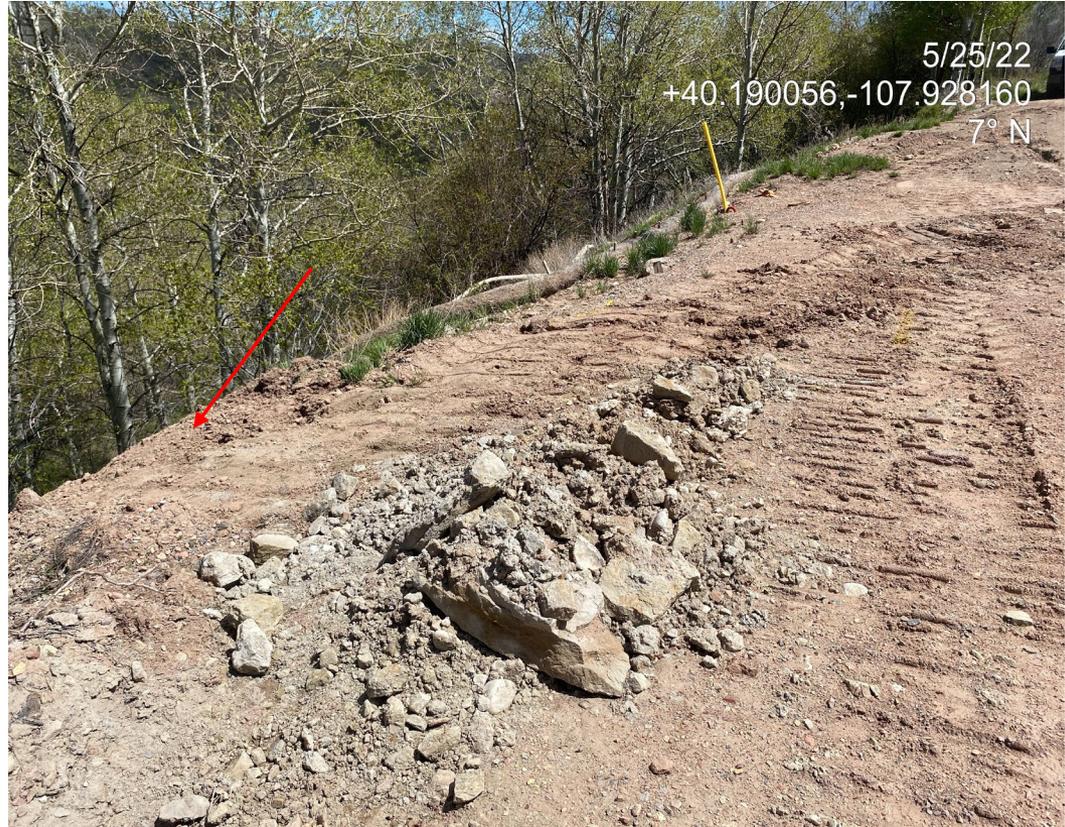
**Photo 6.** Refer to Photo 5 comment.
