Inspection Photos and Issue Report

7/19/2022

Operator: LARAMIE ENERGY LLC # 10433

Location #312531

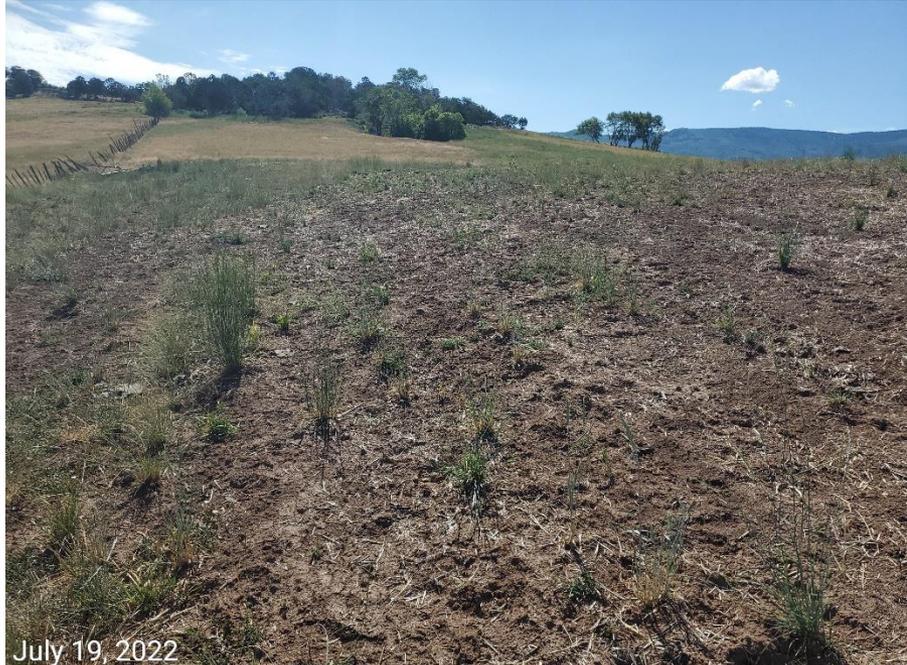
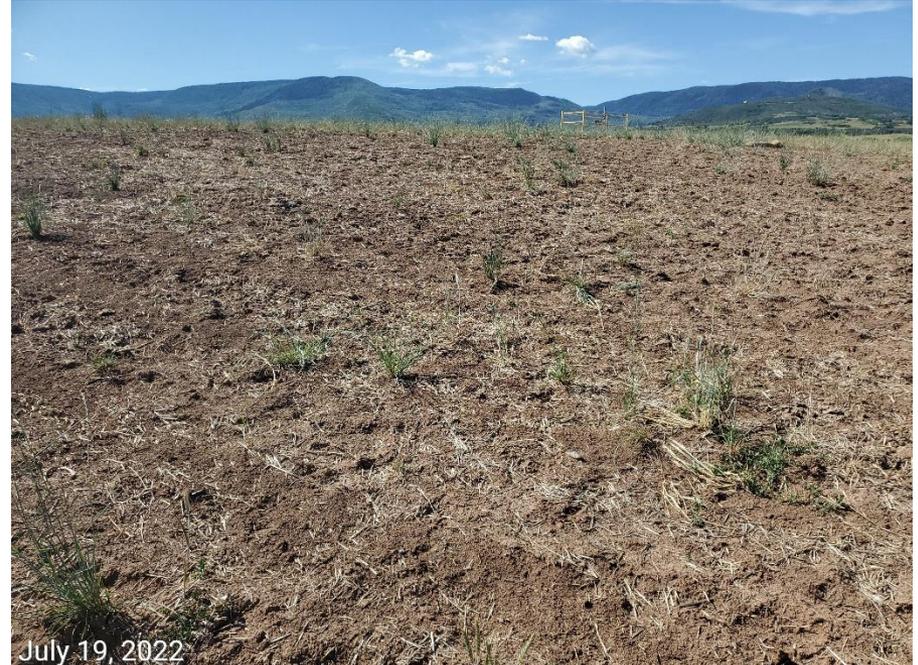
Photo 1: Photos 1-2 taken from the north end of the Location. Photos provide an overview of the Location facing east, southeast, southwest to west. Revegetation activities were conducted 2021; location is within its second growing season. Though desirable vegetative establishment is evident, germination has not been uniform and additional reclamation work will be likely. Additionally, evidence of grazing pressure from livestock is evident, and is likely hindering reclamation from progressing towards 1004 standards.

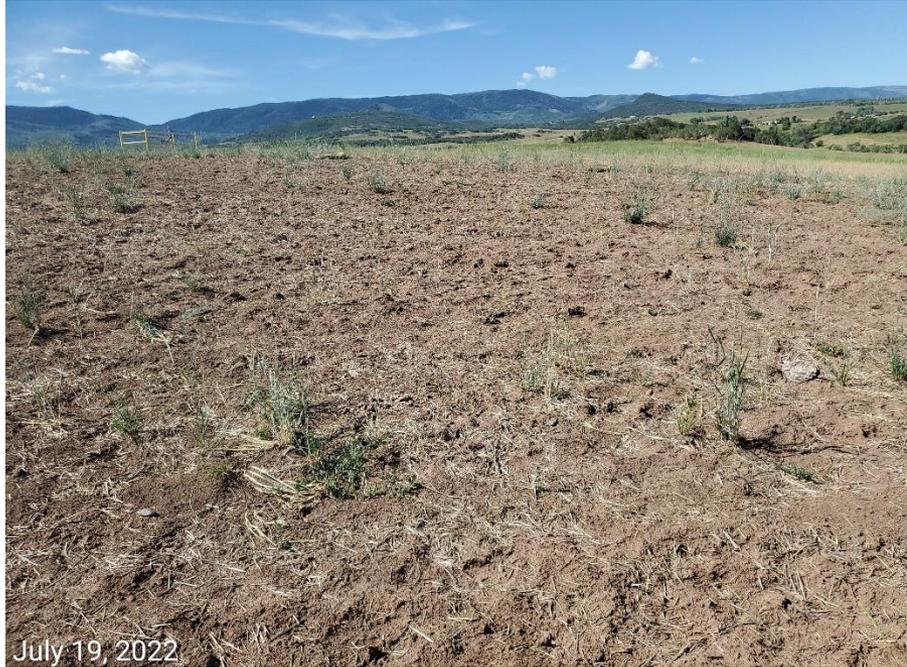
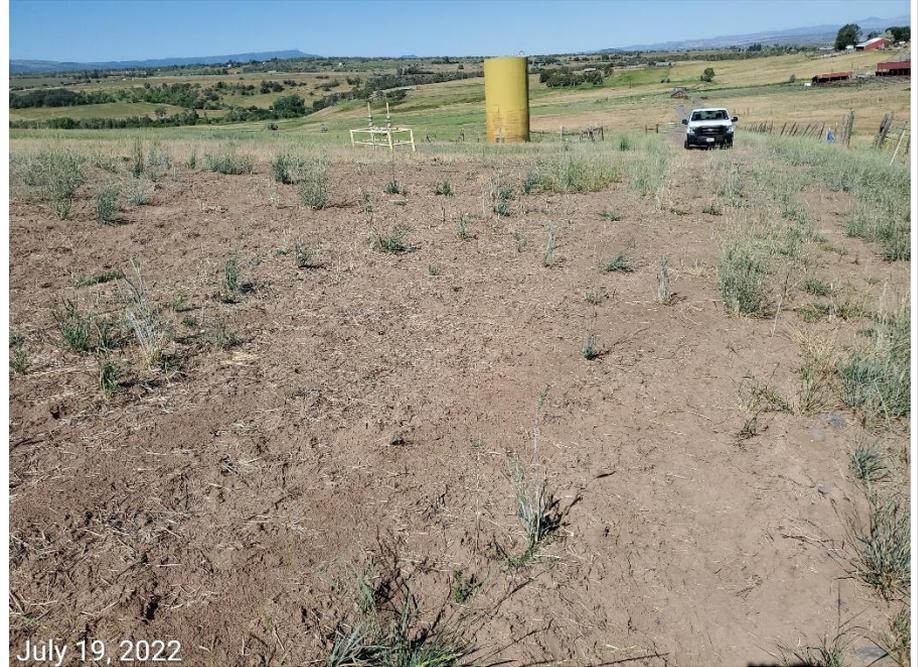
Photo 2: See comments under photo 1.

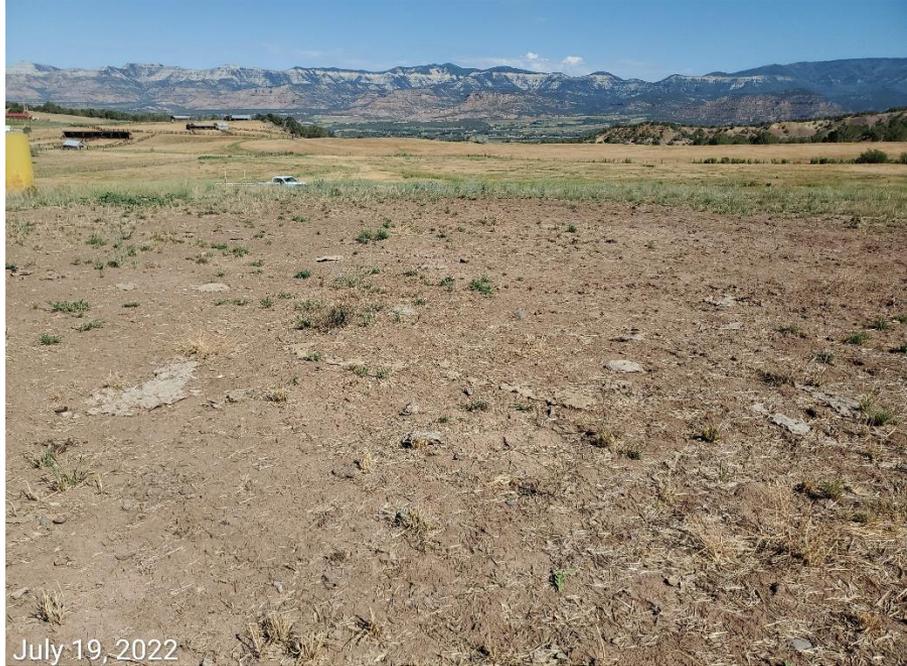
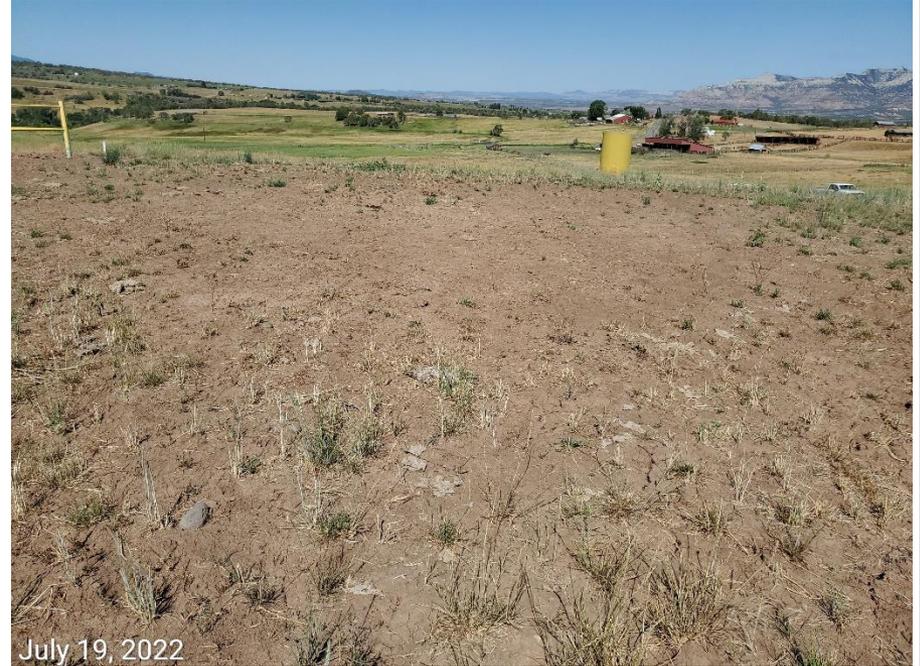
Photo 3: Photos show examples of areas on the Location where uniform establishment does not appear to be progressing towards 1004 standards; evidence of grazing pressure from livestock is evident, and is likely hindering reclamation from progressing towards 1004 standards

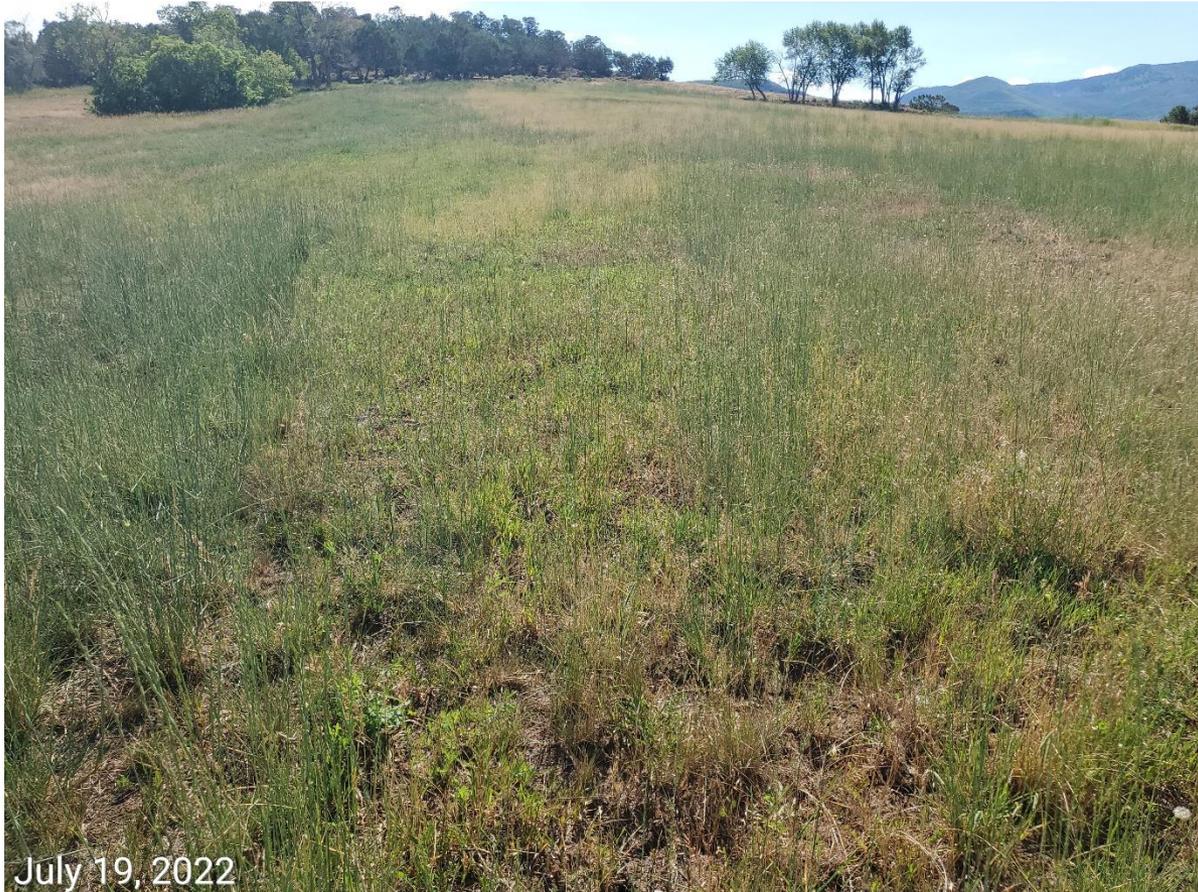
Photo 4: Photo of the adjacent reference area for comparison to vegetation on the reclamation area.

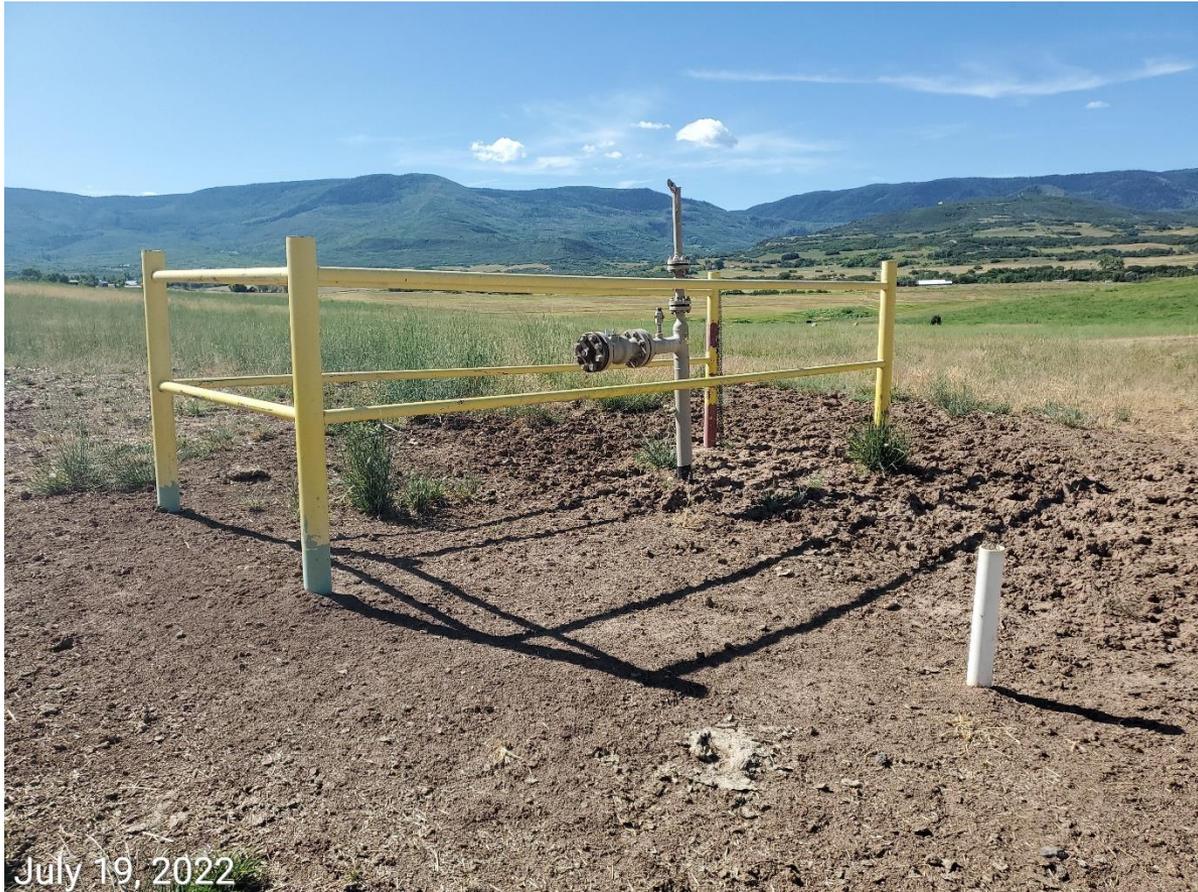
Photo 5: Previous inspections required Operator to remove surface equipment remaining on the Location pursuant with Rule 1004.a. Photo shows riser equipment has not been removed per the corrective action, and 1004 Rules.
