Final Reclamation Inspection

Operator: GREAT WESTERN OPERATING LLC -10110

Location ID: 335863

Inspection Photos
Location Name: Sauvage 12-7
Location ID: 335863

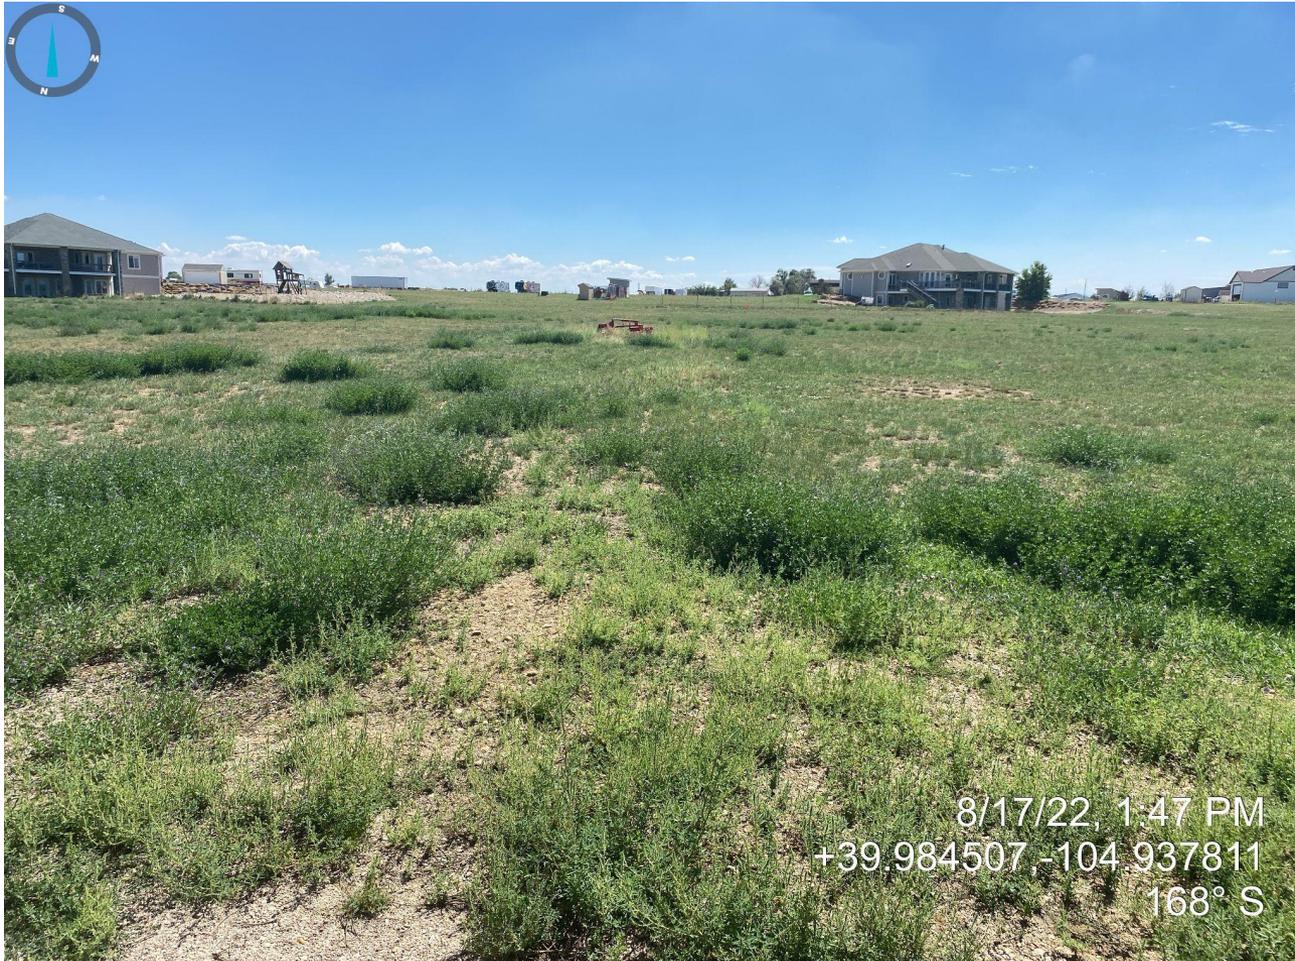
Photo 1. Location photo taken from northern portion, facing south. Photo illustrates location has not been reclaimed with presence of gravel/road base and annual weedy vegetation; e.g. kochia and russian thistle.

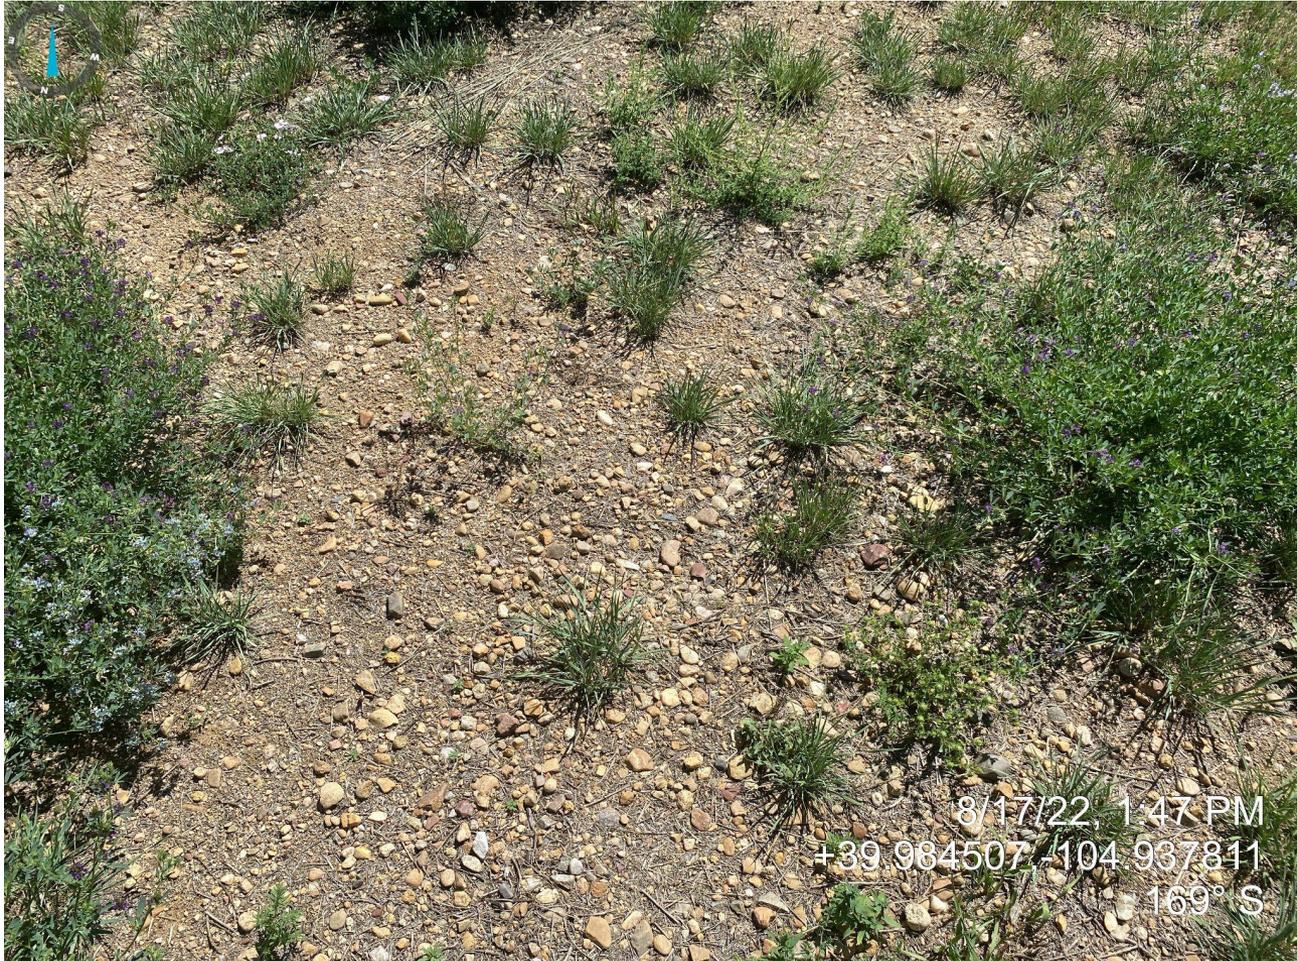
Photo 2. See comments in Photo 1.

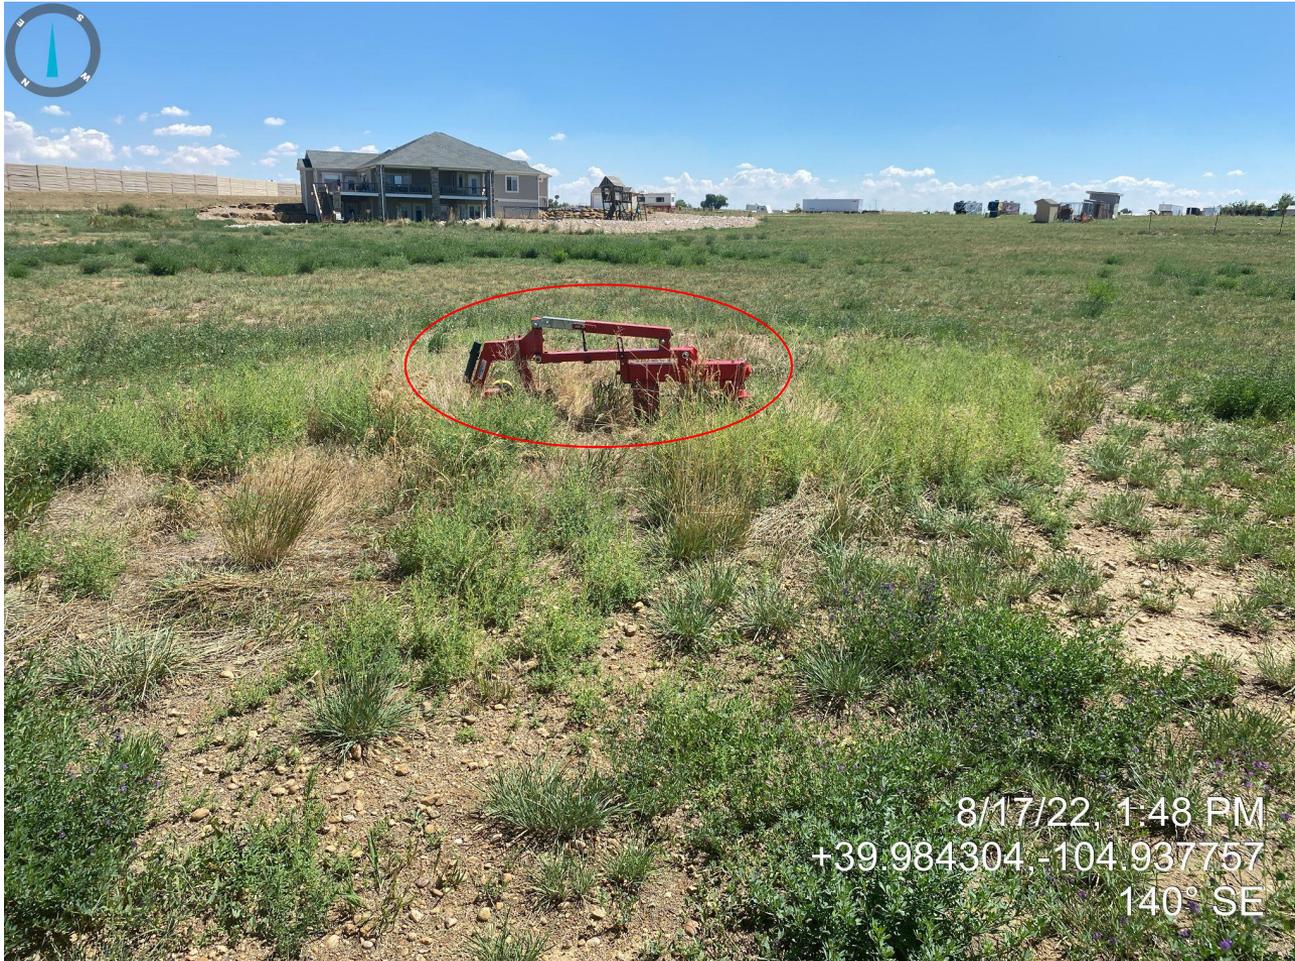
Photo 3. Location photo taken from southern portion, facing southeast. Photo illustrates location has not been reclaimed with presence of gravel/road base. Red implement on location is property of surface owner (highlighted in red).

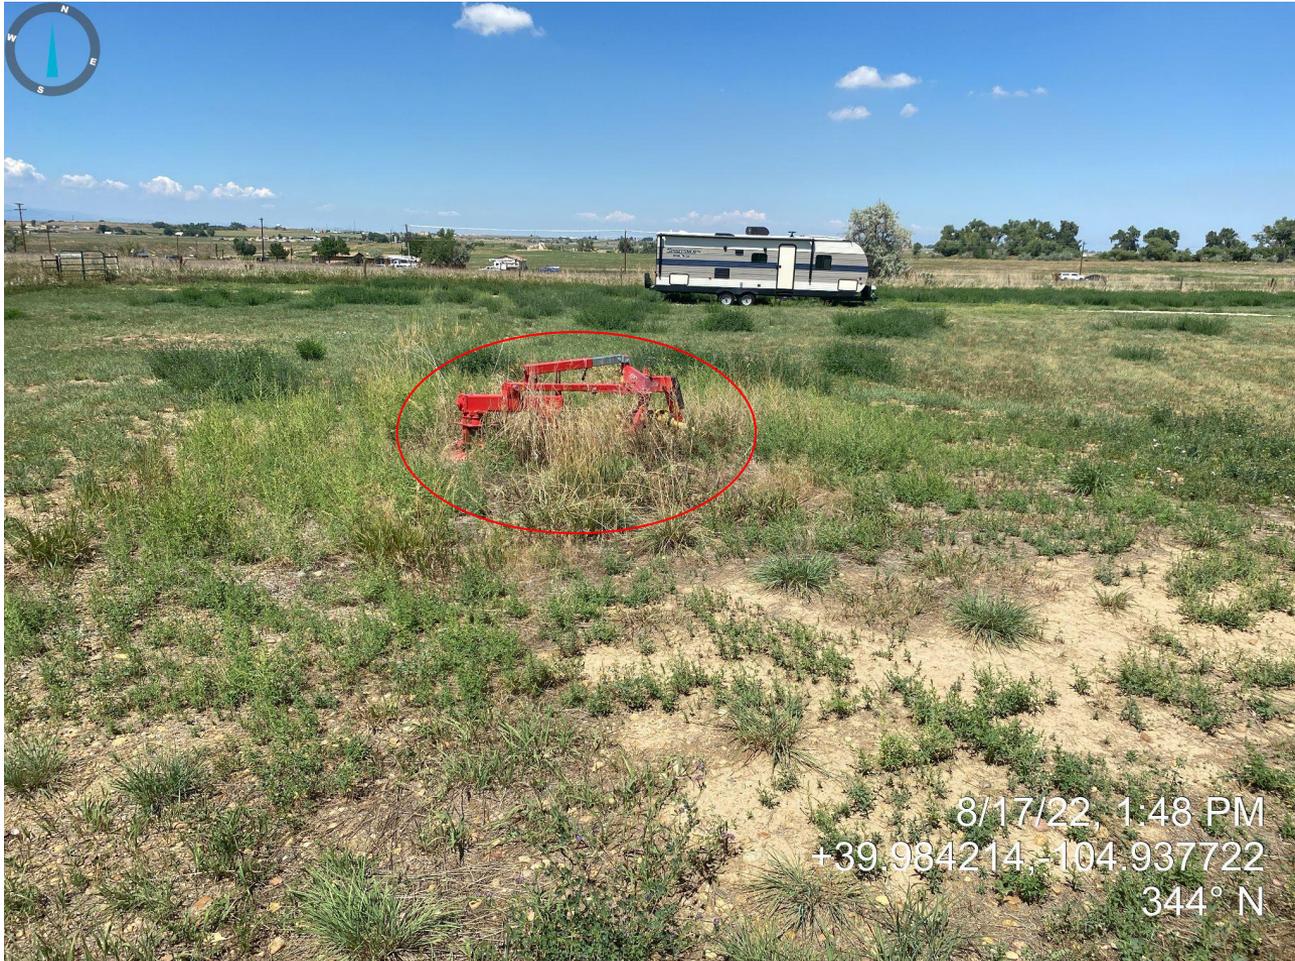
Photo 4. See comments in Photo 3. Photo facing north.

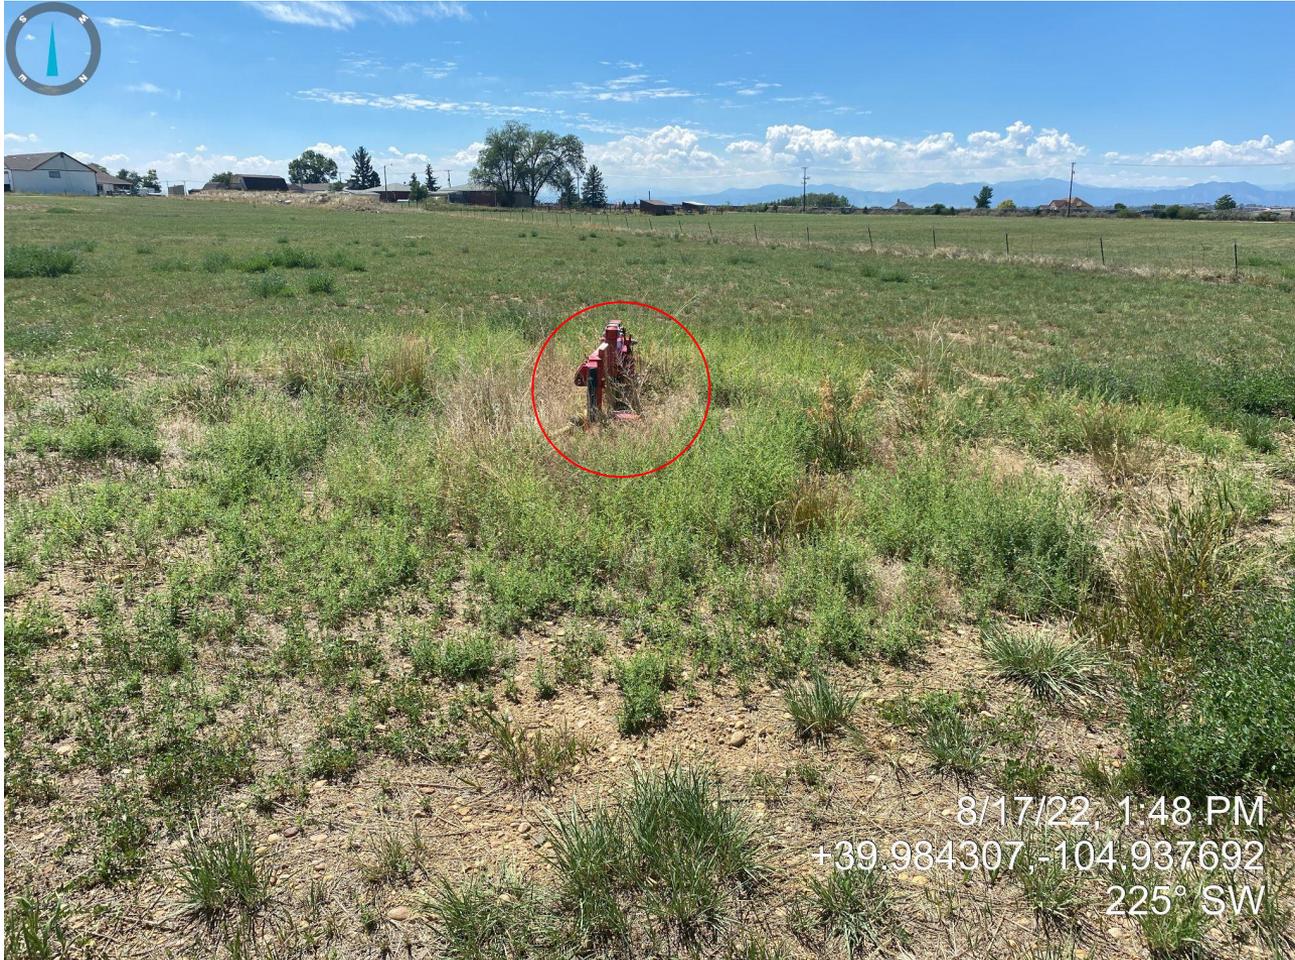
Photo 5. See comments in Photo 3. Photo facing southwest.

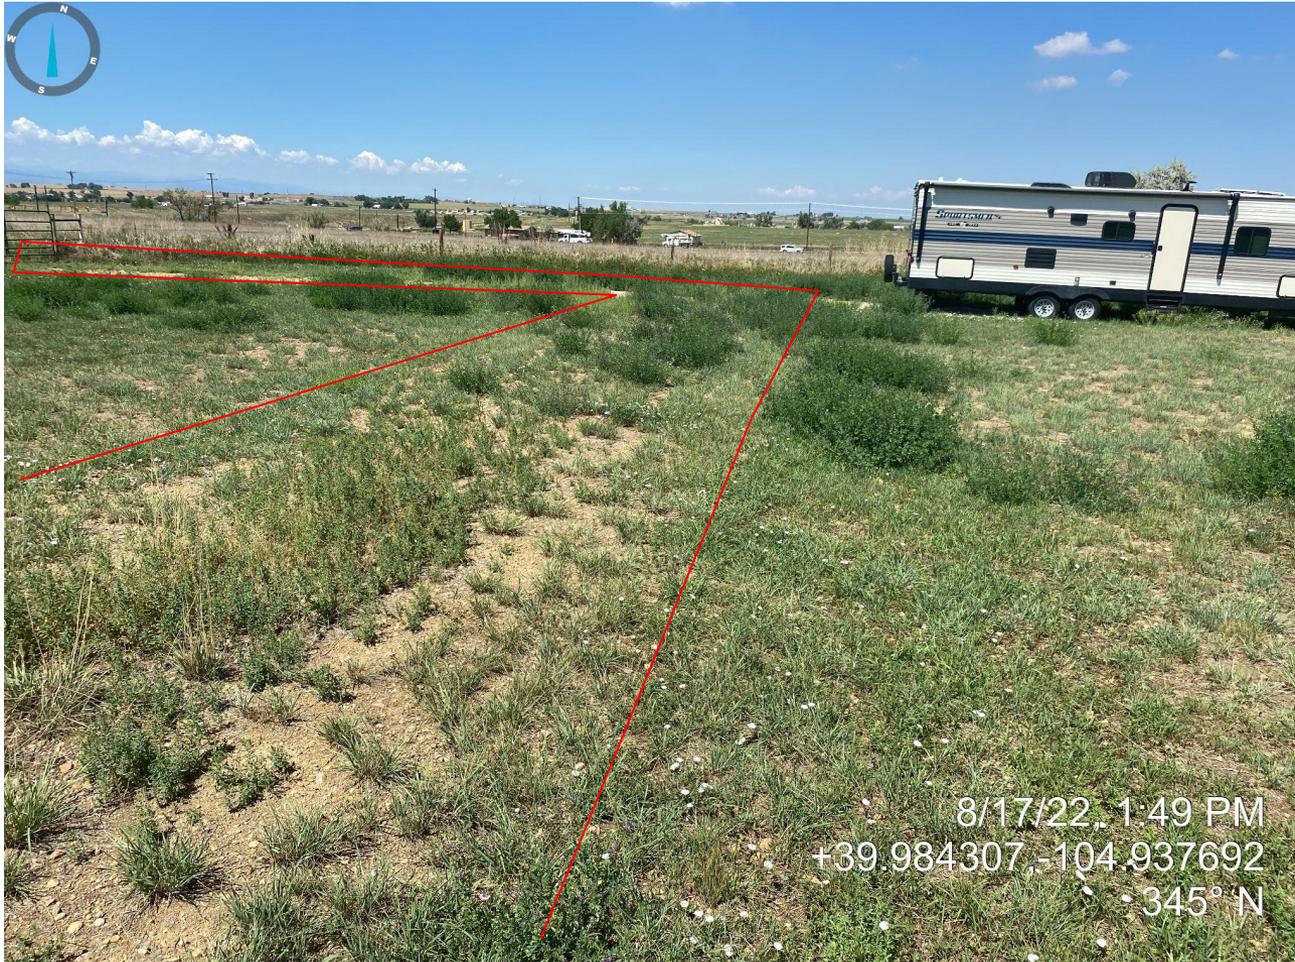
Photo 6. Location photo taken from southern portion, facing north. Photo illustrates location access road has not been reclaimed with presence of gravel/road base(highlighted in red).
