**Motu East Pad – Facility ID 439455– Status: PR**

**Doc #: 697504024**

**Follow up to field inspection report doc  
#697500782**

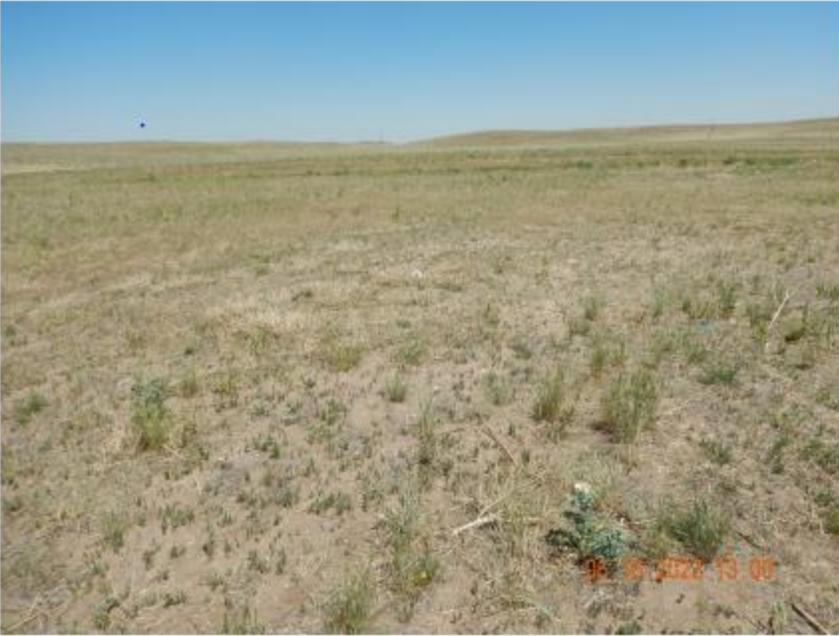
**Photo 6.** Photo taken from the northern interim reclamation area, facing East. Photo illustrates interim reclamation has been performed; however, an introduced seed mix was used which is not reflective of reference area vegetation per Rule 1003.

**Corrective Action 5**-Operator shall redo the revegetation in accordance to Rule 1003. Establish vegetation with total perennial, non-invasive uniform plant cover of at least eighty (80) percent of reference area levels. Use an approved seed mixture provided by the local NRCS. Ensure erosion controls are implemented to stabilize the seeded soil, and continue to monitor and manage this site until the location meets Rule 1003 standards, including stormwater and weed management. Operator shall provide the seed mixture in the required FIRR response. Revegetation activities shall be complete no later than 11/21/22 or as soon as environmental conditions will permit.

The corrective action was completed on 10/29/2022 by CB Services. Re seeding was done in accordance with the approved seed mixture by the landowner.
