Final Reclamation Inspection

Operator: KERR MCGEE OIL & GAS ONSHORE LP #47120

Location ID: 330420

Inspection Photos
Location Name: HSR-KNOX #16-3
Location ID: 330420

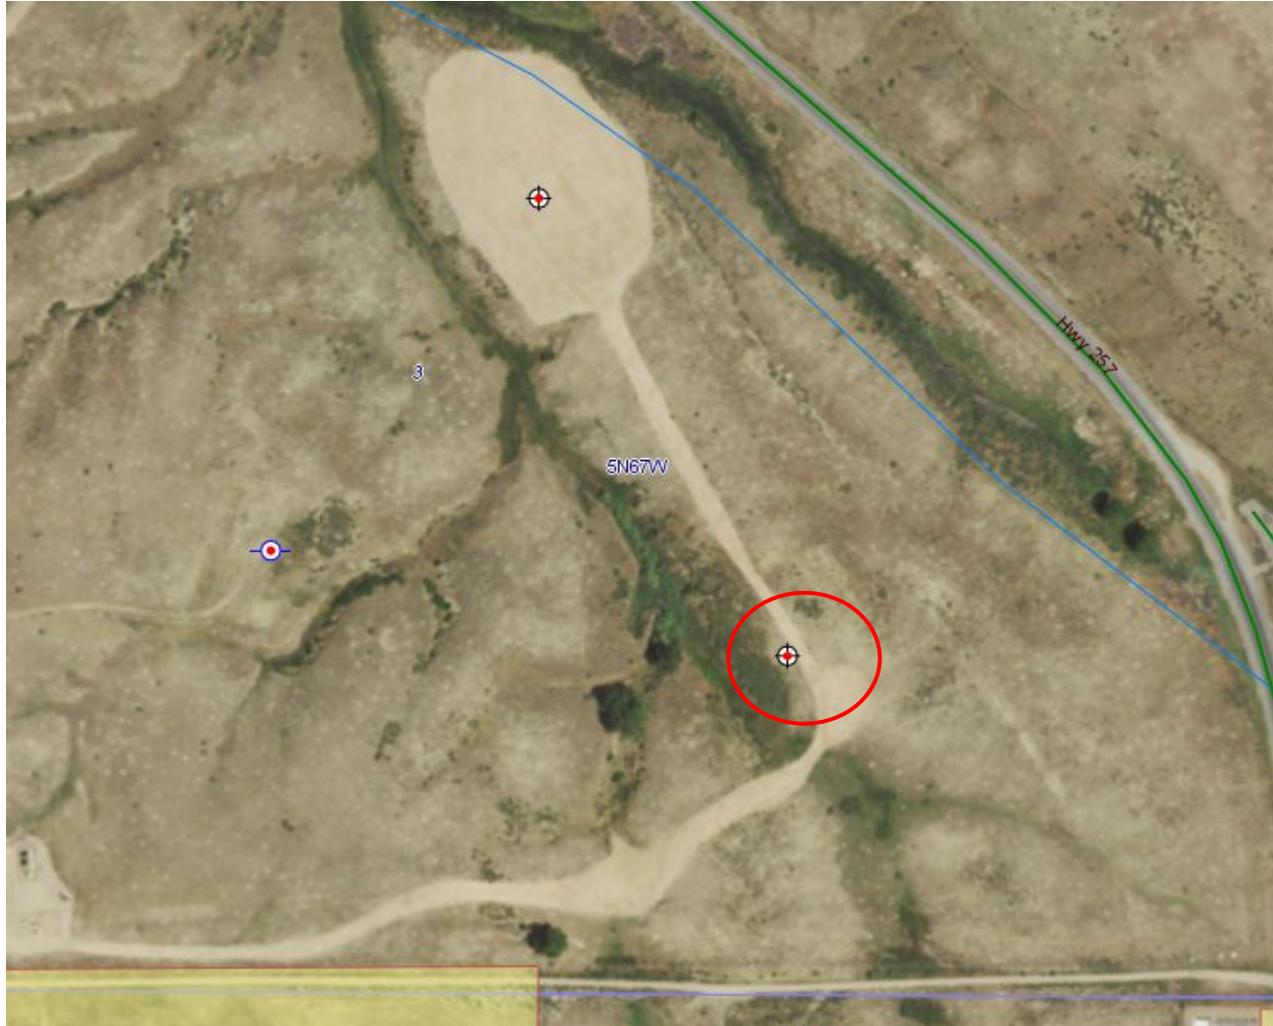
Photo 1. COGCC GISOnline aerial imagery from 2019 illustrates the well location (red circle). The associated access road was also utilized for the northern well which will be addressed under that well and the associated tank battery is still active.

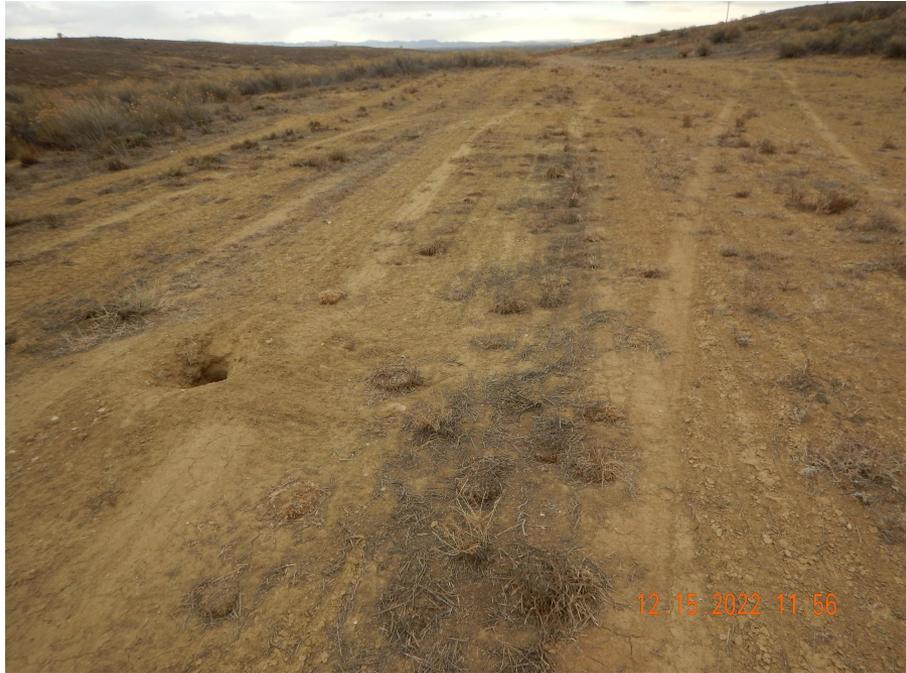
Photo 2. Photo taken from the well location, facing North. Photo illustrates there is some establishment of grass species observed but it is predominately bare ground.

Note- vehicle traffic (not from COGCC) and prairie dog burrows. Also, portions of the photo are of the access road that was reclaimed back in 2019; whereas, the well location was plugged back in 2013.

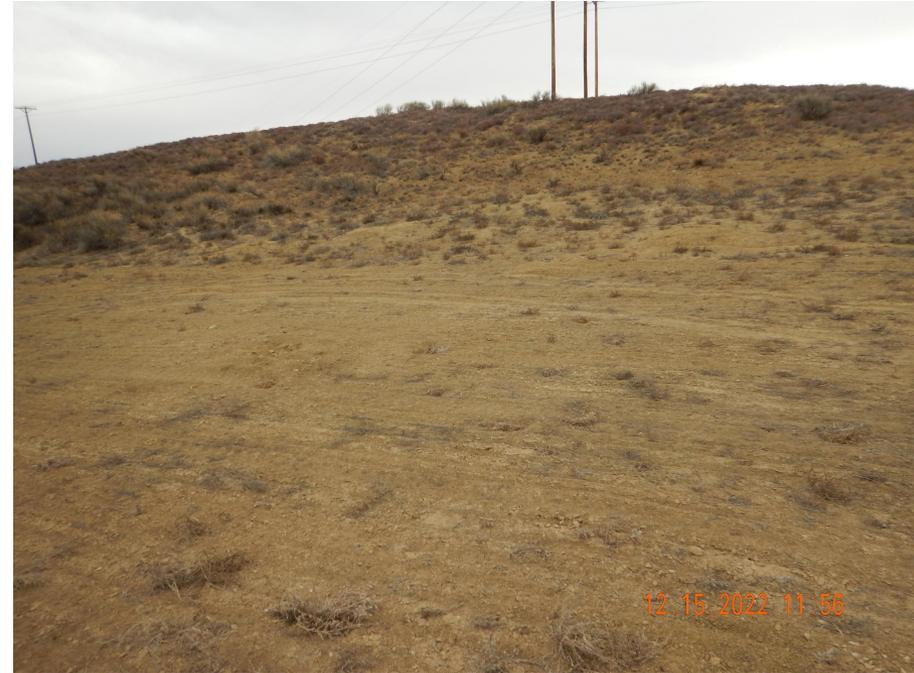
Photo 3. Photo taken from the well location, facing East. See comments under Photo 2.

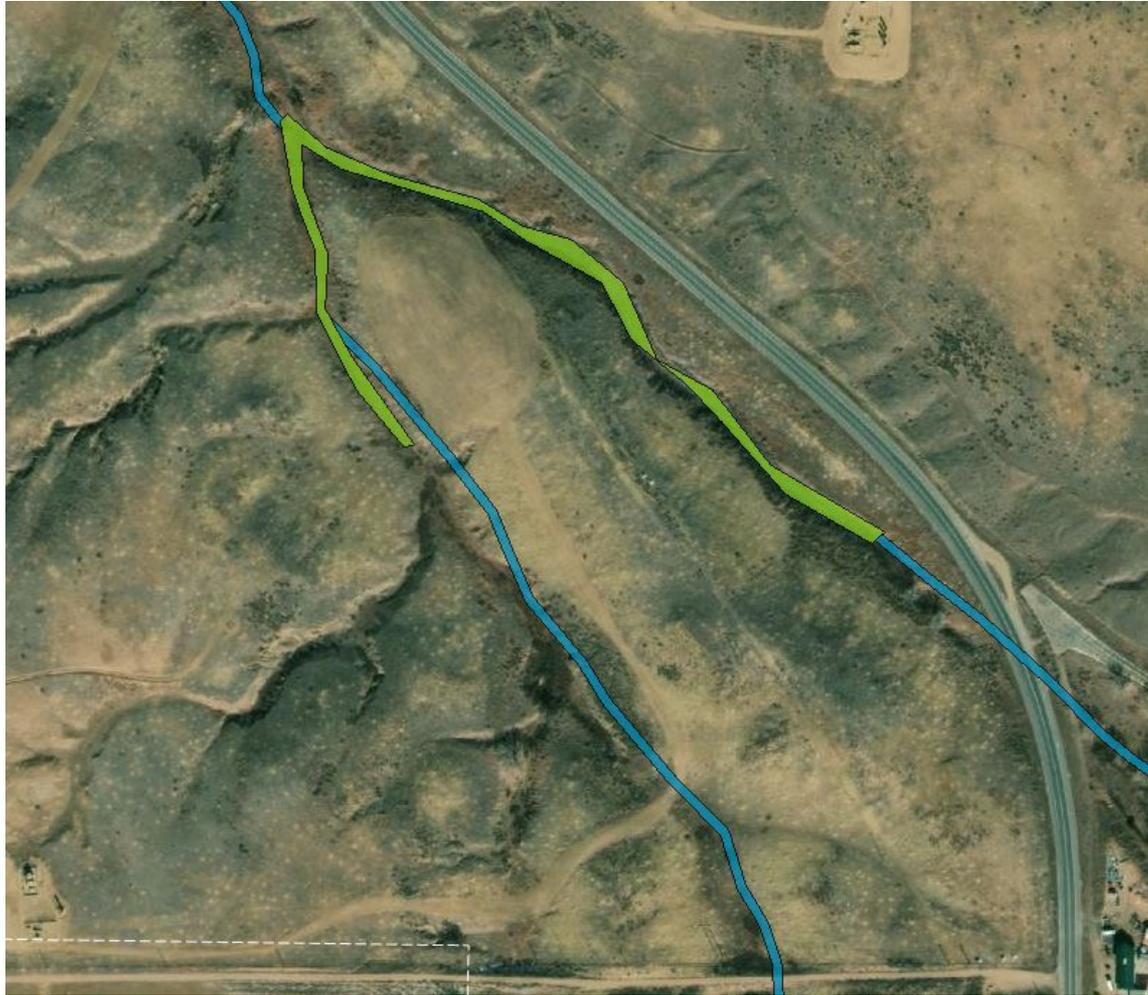
Photo 4. National Wetlands Inventory aerial illustrates Riverine habitat, Freshwater Emergent and Freshwater Forested/Shrub wetland downgradient of location.

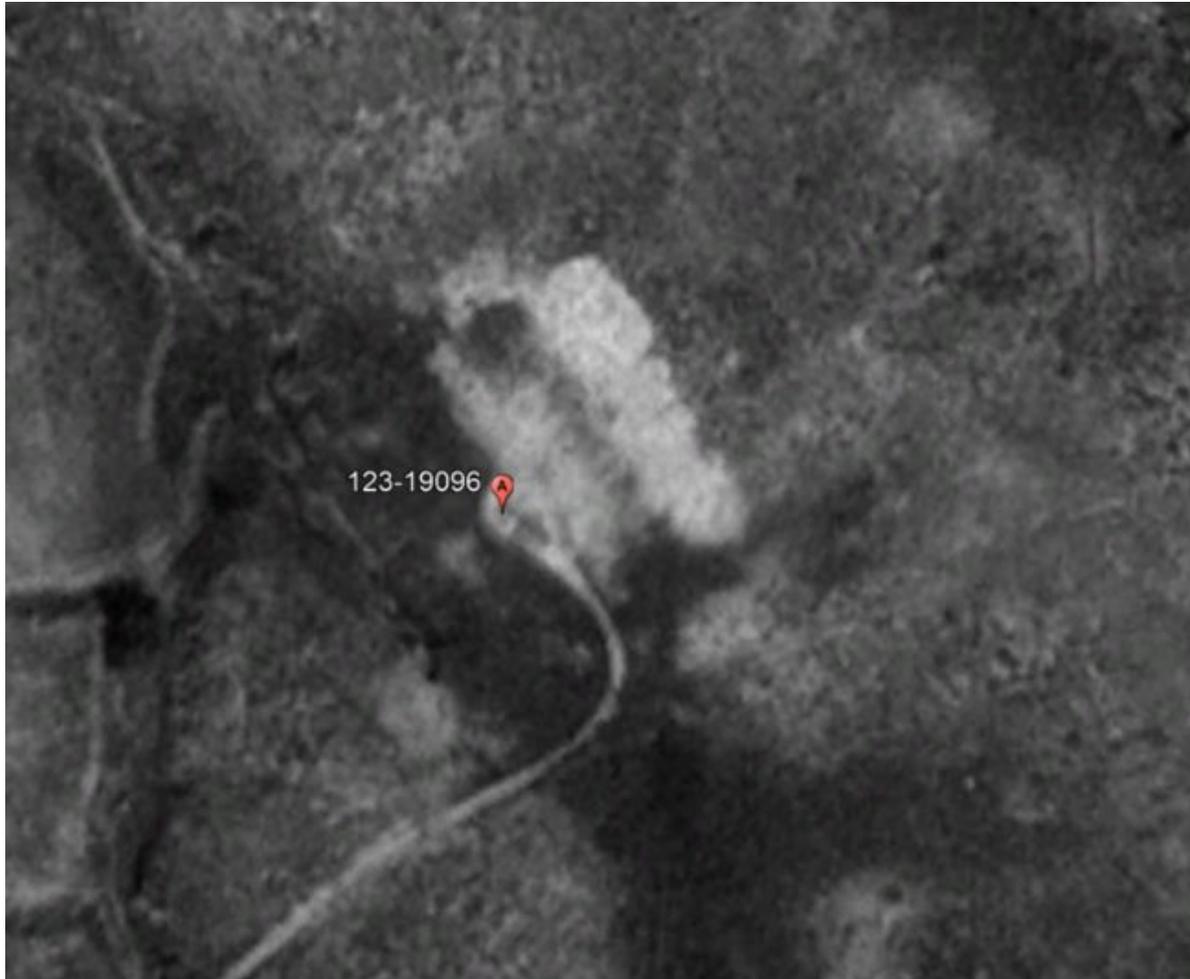
Photo 5. Google Earth aerial imagery from 1999 illustrating the well location disturbance extent.
